Re: Site Assessment, Remediation, and Closure Report
SV Big Bertha #001
API No. 30-025-33883
GPS: Latitude 32.9383888 Longitude -103.3277969
UL "F", Sec. 11, T16S, R36E
Lea County, NM
NMOCD Ref. No. NGRL0834056660

Pima Environmental Services, LLC (Pima) has been contracted by Armstrong Energy Corporation to perform a spill assessment, remediation activities, and submit this closure report for a produced water release that occurred at the SV Big Bertha #001. The initial C-141 was submitted on September 15th, 2022 (Appendix C). This incident was assigned Incident ID NGRL0834056660, by the New Mexico Oil Conservation Division (NMOCD).

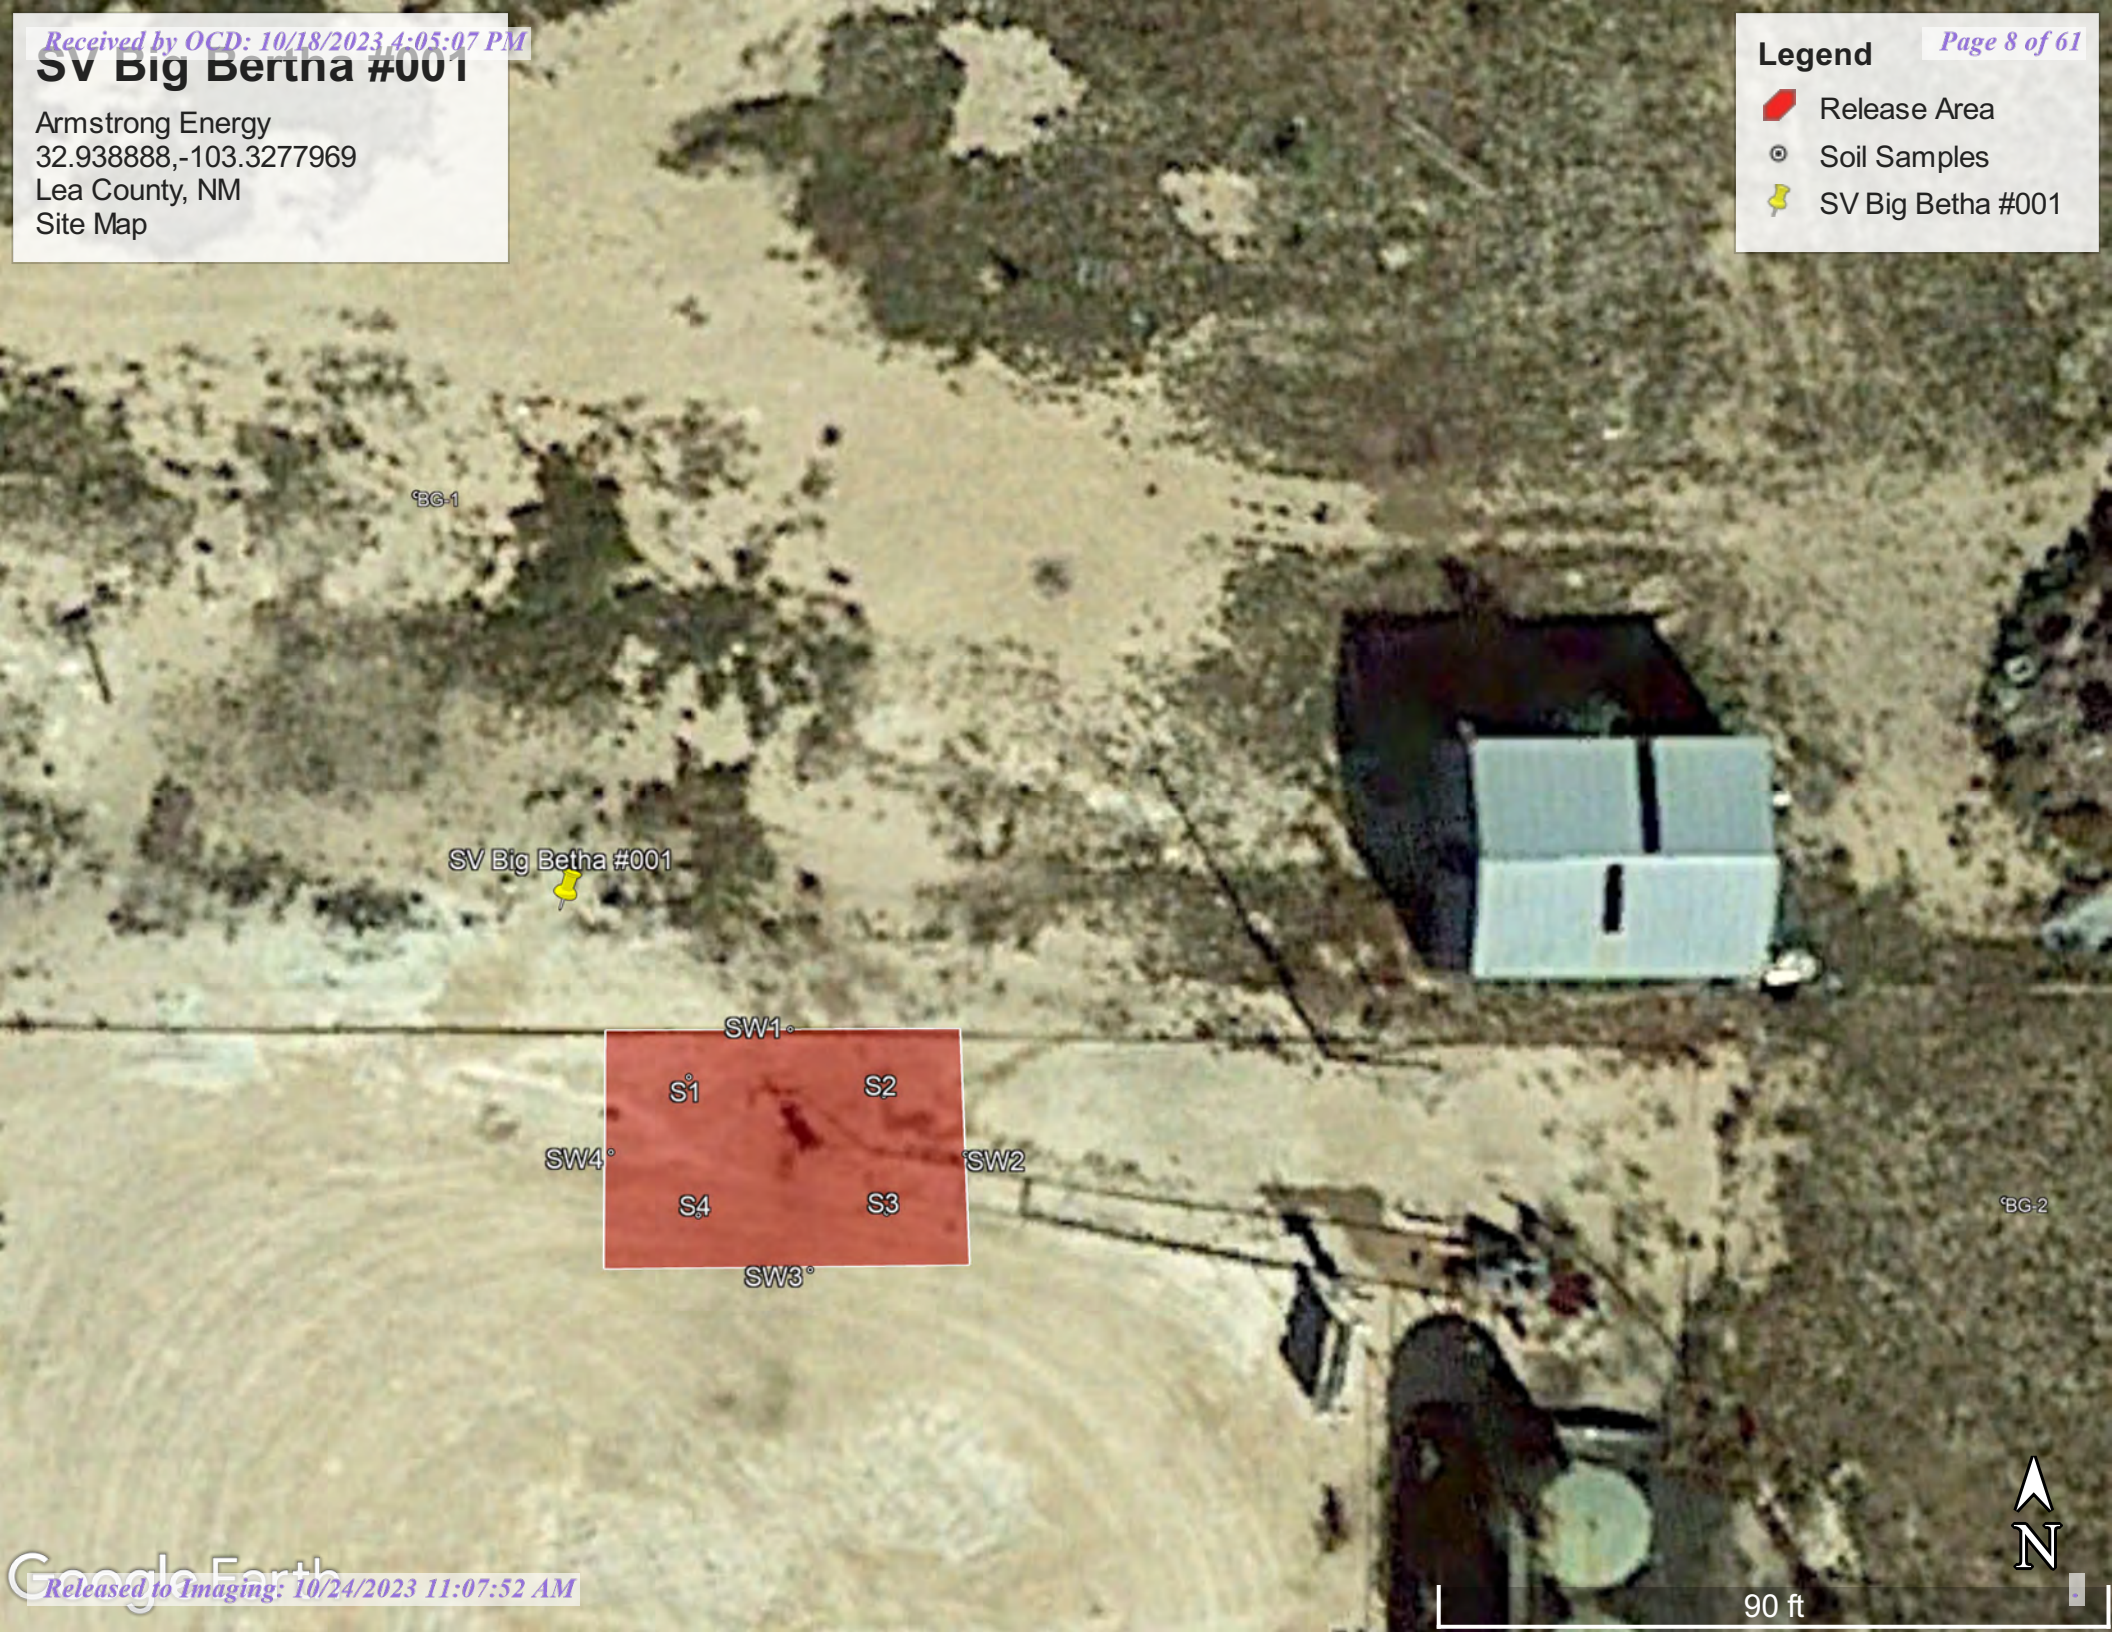
Armstrong Energy
32.938888,-103.3277969
Lea County, NM
Site Map

NGRL0834056660: On September 11th, 2008, a nipple on the downside of the choke washed out releasing 190 barrels of produced water. A vacuum truck was called to location and used to recover the standing fluid, a total of 160 barrels of produced water was recovered.

On November 23rd, 2022, Pima Environmental Services mobilized personnel to the site to conduct delineation activities. Pima sampled the surrounding release area. Laboratory results of this sampling event can be found in the following data table.

Due to analytical levels falling below NMOCD closure criteria, no further immediate action is required. Pima Environmental will address any superficial staining surrounding the production equipment.

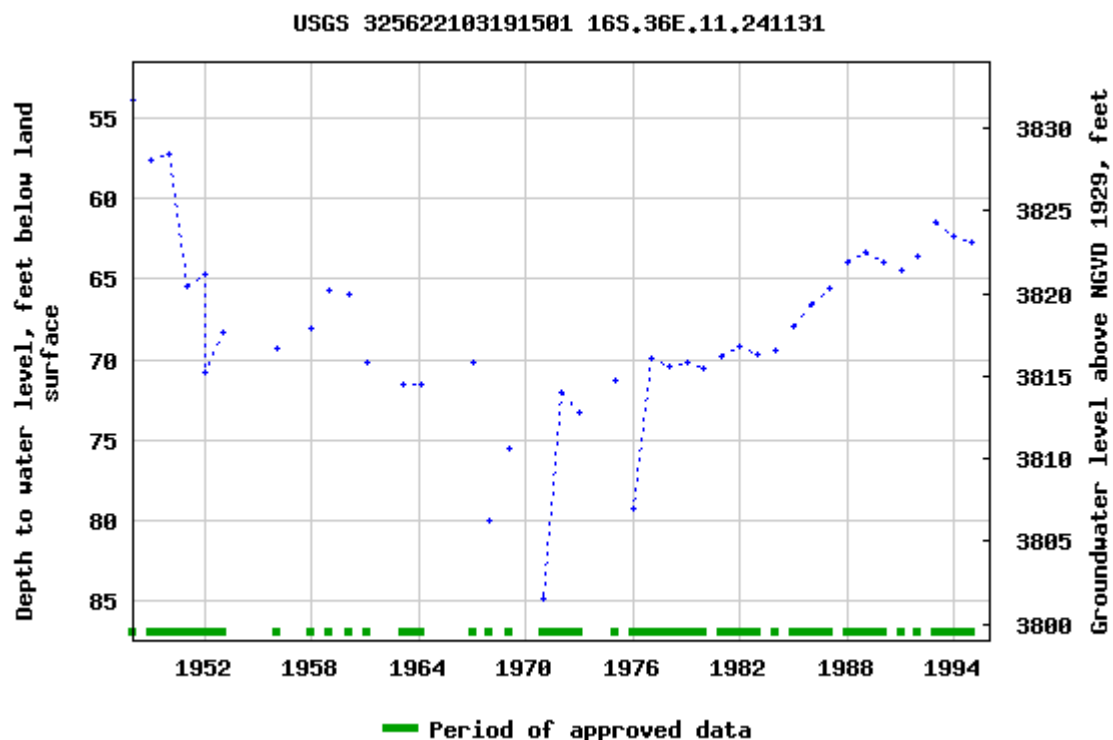
USGS 325622103191501 16S.36E.11.241131

The depth of the well is 100 feet below land surface.

This well is completed in the Ogallala Formation (121OGLL) local aquifer.
