CLOSURE REPORT

Mesa Verde Bone Spring 046H

**Lea County, New Mexico
32.2120 N, 103.6843 W
NMOCD Incident ID: nAPP2308945772
API# 30-025-48816**

August 1, 2023
Ensolum Project No. 03B1417064

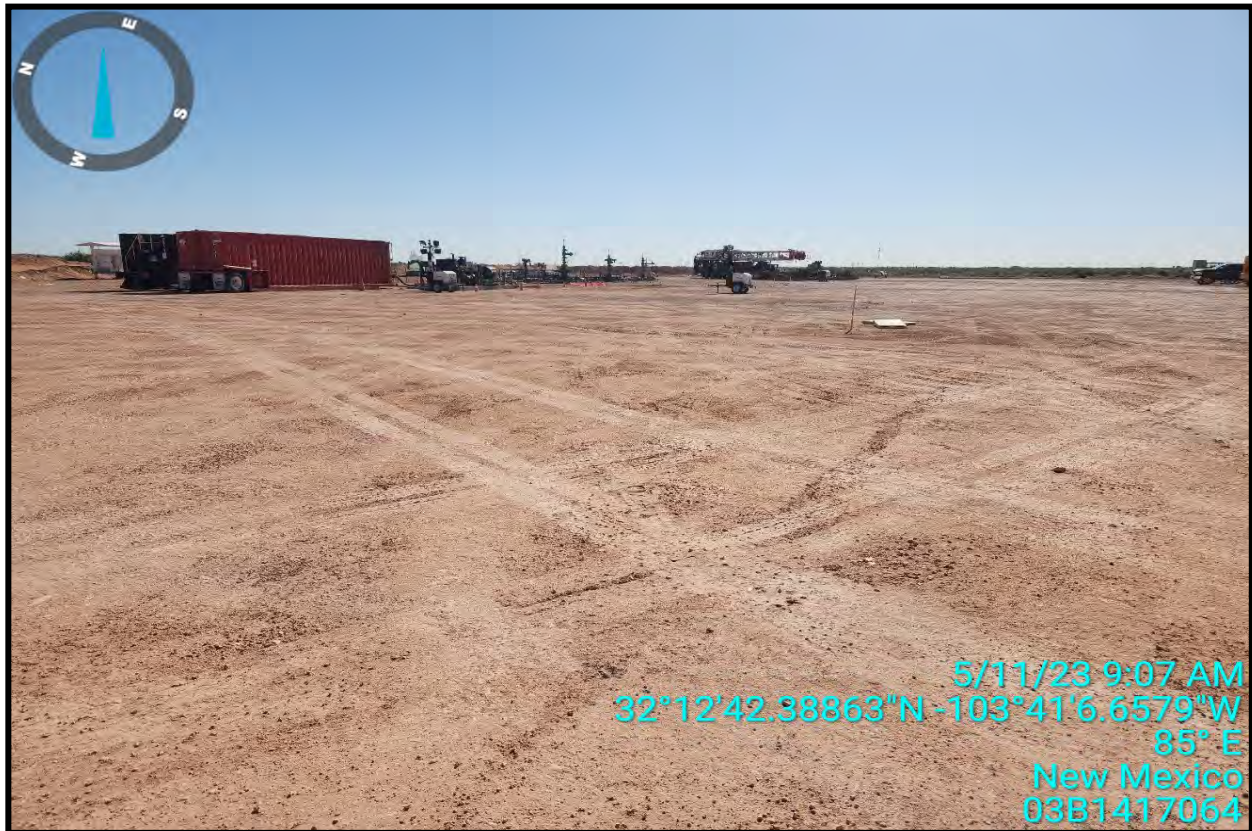
View of the initial release area, prior to excavation activities, facing east.

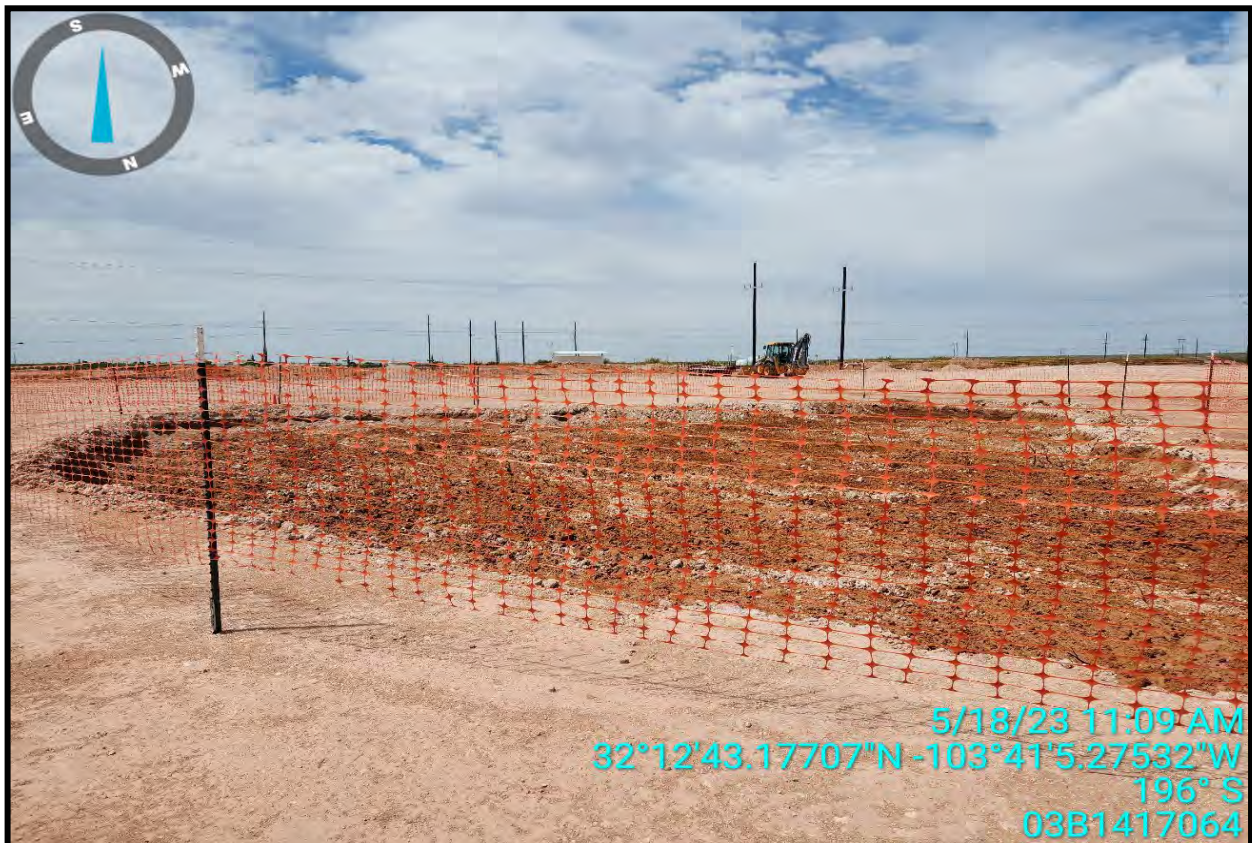
View of the excavation area during response action activities, facing south.

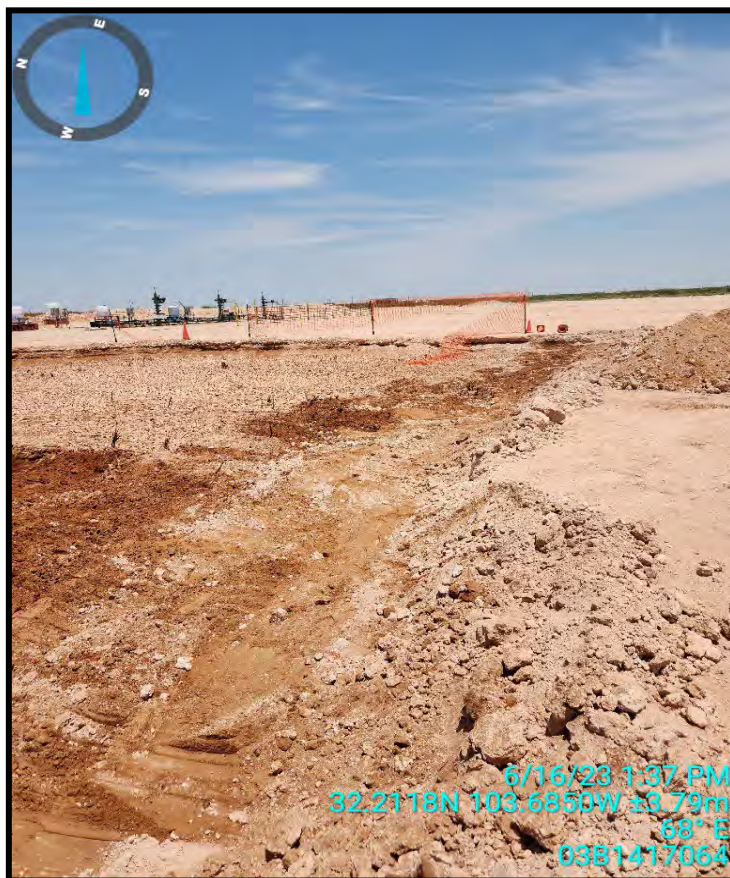
View of the excavation area during response action activities, facing east.

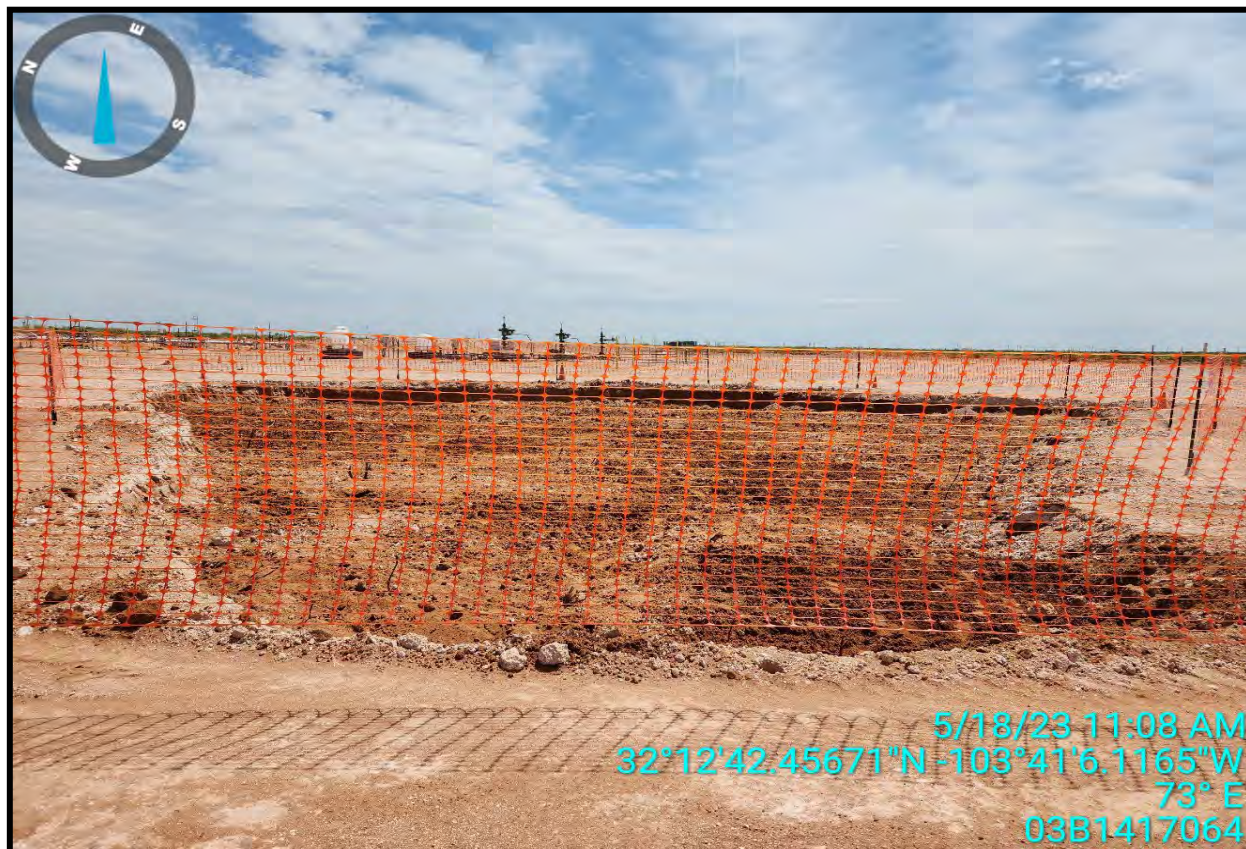
View of the excavation area during response action activities, facing northeast.
