**Re: Closure Request
SEMU #37
Incident Number NAPP2316638385
Lea County, New Mexico**

Ensolum, LLC (Ensolum), on behalf of Maverick Permian, LLC (Maverick), has prepared this *Closure Request* to document assessment, excavation, and soil sampling activities performed at the SEMU #37 (Site). The purpose of the Site assessment, excavation, and soil sampling activities was to address impacts to soil resulting from a release of crude oil and produced water at the Site. Based on the excavation activities and laboratory analytical results from the soil sampling events, Maverick is submitting this *Closure Request*, describing remediation that has occurred and requesting closure for Incident Number NAPP2316638385.

Maverick Permian, LLC
Closure Request
SEMU #37

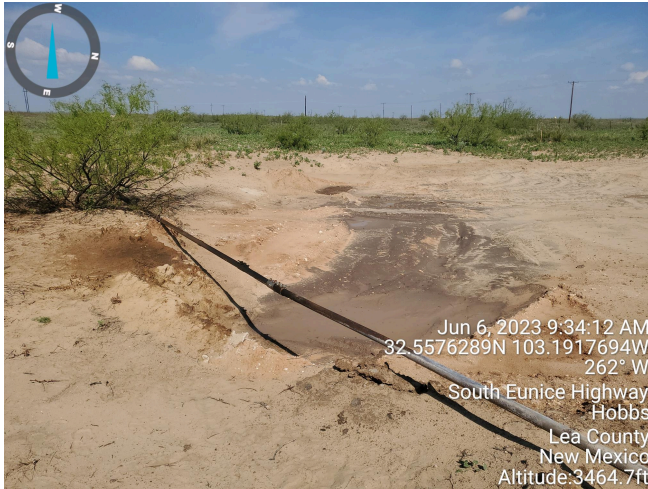
Photograph 1 Date: 06/06/2023
Description: Photo of release area taken during initial site assessment activities.

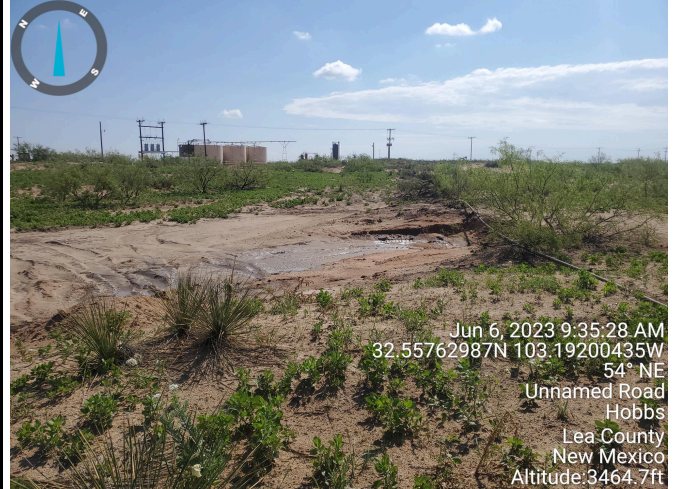
Photograph 2 Date: 06/06/2023
Description: Photo of release area taken during initial site assessment activities.

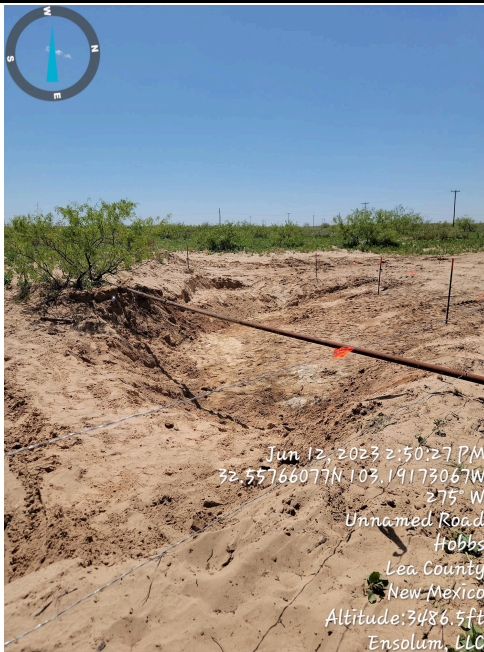
Photograph 3 Date: 06/12/2023
Description: Photo of excavation extent taken during excavation activities.

The excavation measured approximately 585 square feet in areal extent. A total of approximately 65 cubic yards of impacted soil was removed during the excavation activities. The impacted soil was transported and properly disposed of at the R360 Disposal Facility located in Hobbs, New Mexico. After completion of confirmation sampling, the excavation was secured with fencing.

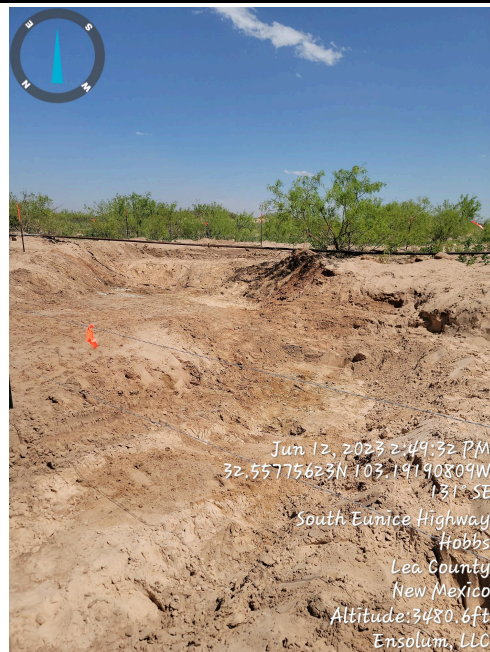
Photograph 4 Date: 06/12/2023
Description: Photo of excavation extent taken during excavation activities.
