CLOSURE REPORT

Federal 23 CTB

**Eddy County, New Mexico
32.3715 N, 103.7424 W
RP No. 2RP-4962
API No. 30-015-26377
Incident ID No. nAPP2314344835**

June 7, 2023

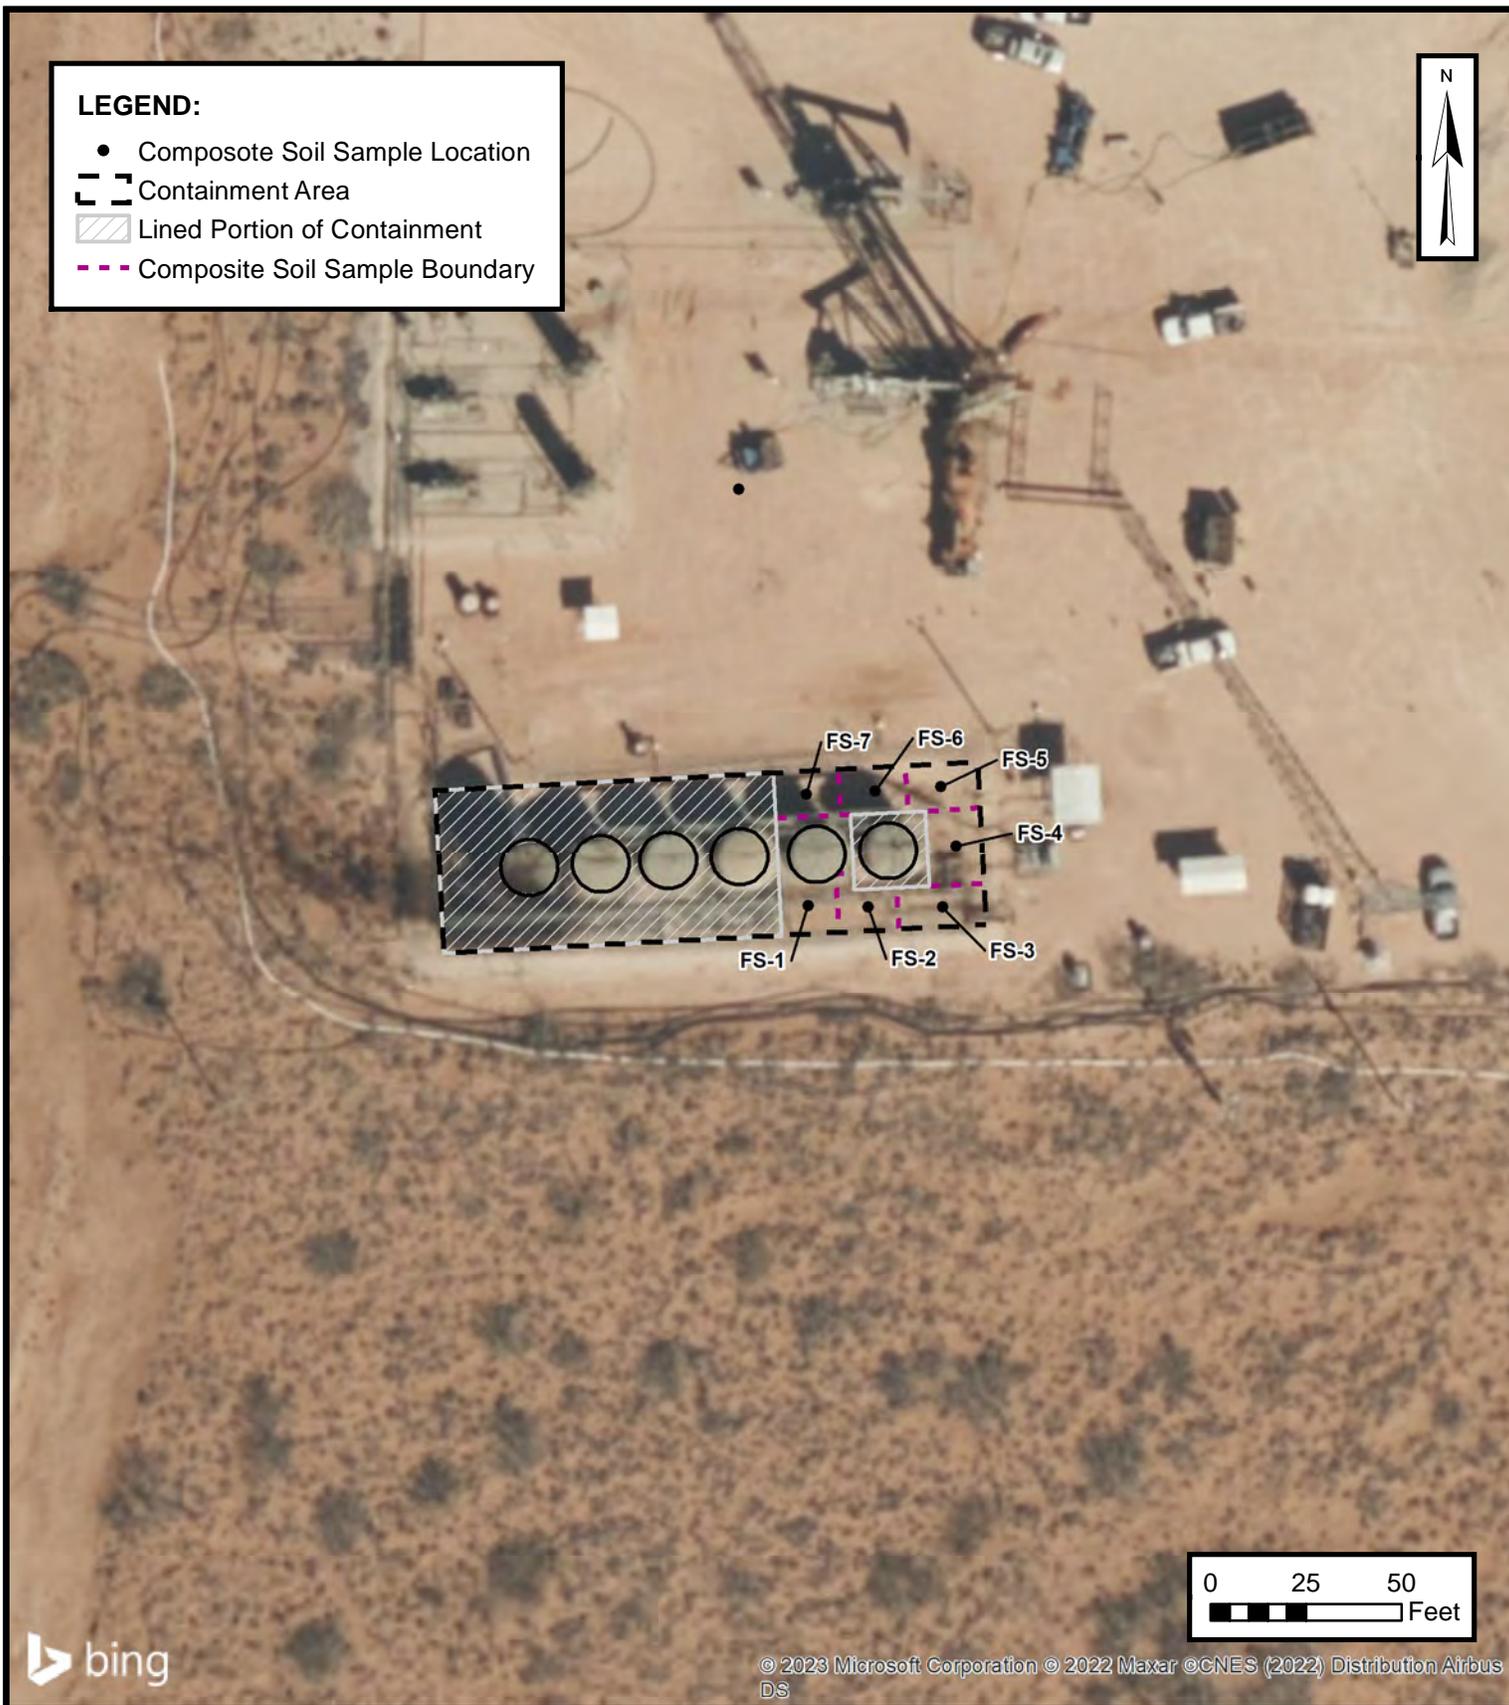
FIGURE
3

Figure 3 identifies approximate soil sample locations and approximate dimensions of the impacted area with respect to the Site (**Appendix A**). Photographic documentation of the field activities is included in **Appendix C**.

SITE MAP

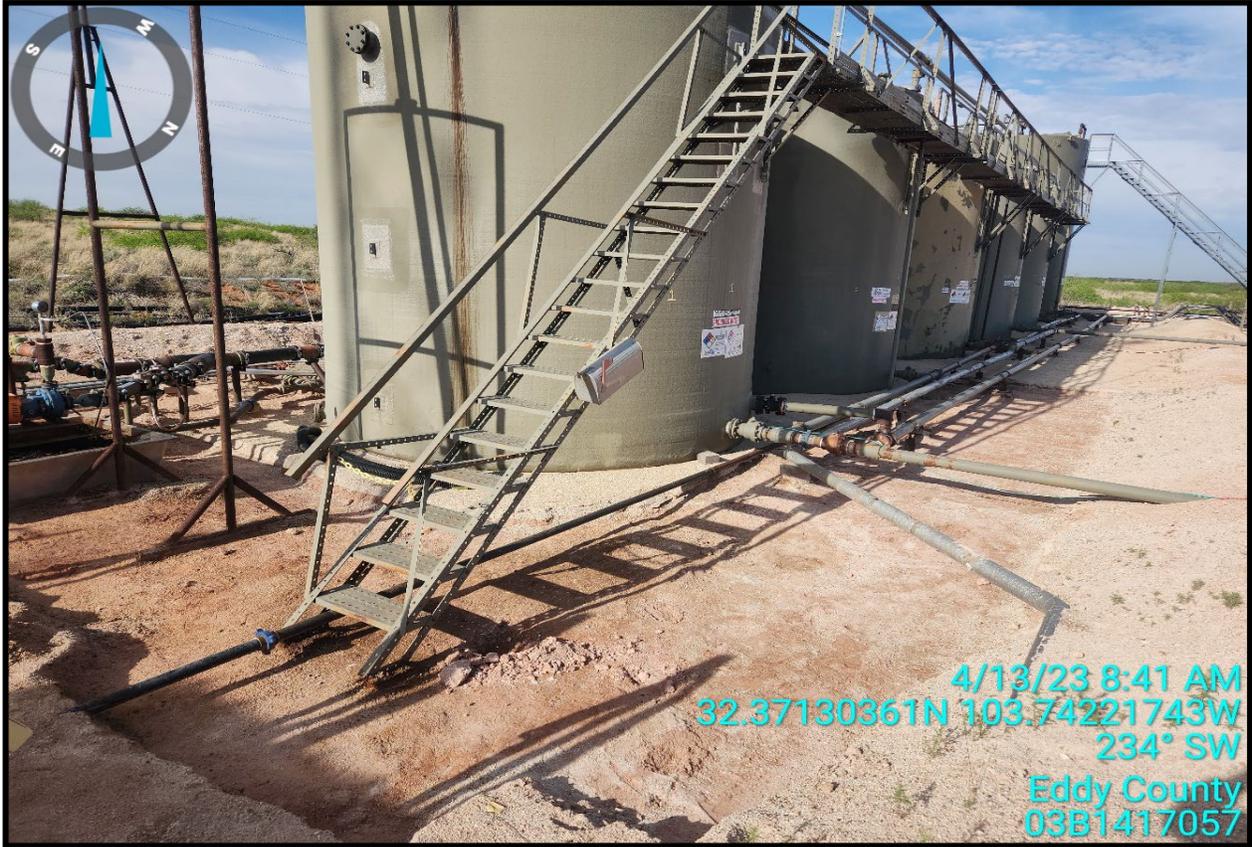
View of the final excavation area, facing southwest.

The final excavation area measured approximately impacted area measured approximately 50 feet long by 45 feet wide. The maximum depth of the excavation measured approximately one foot bgs.

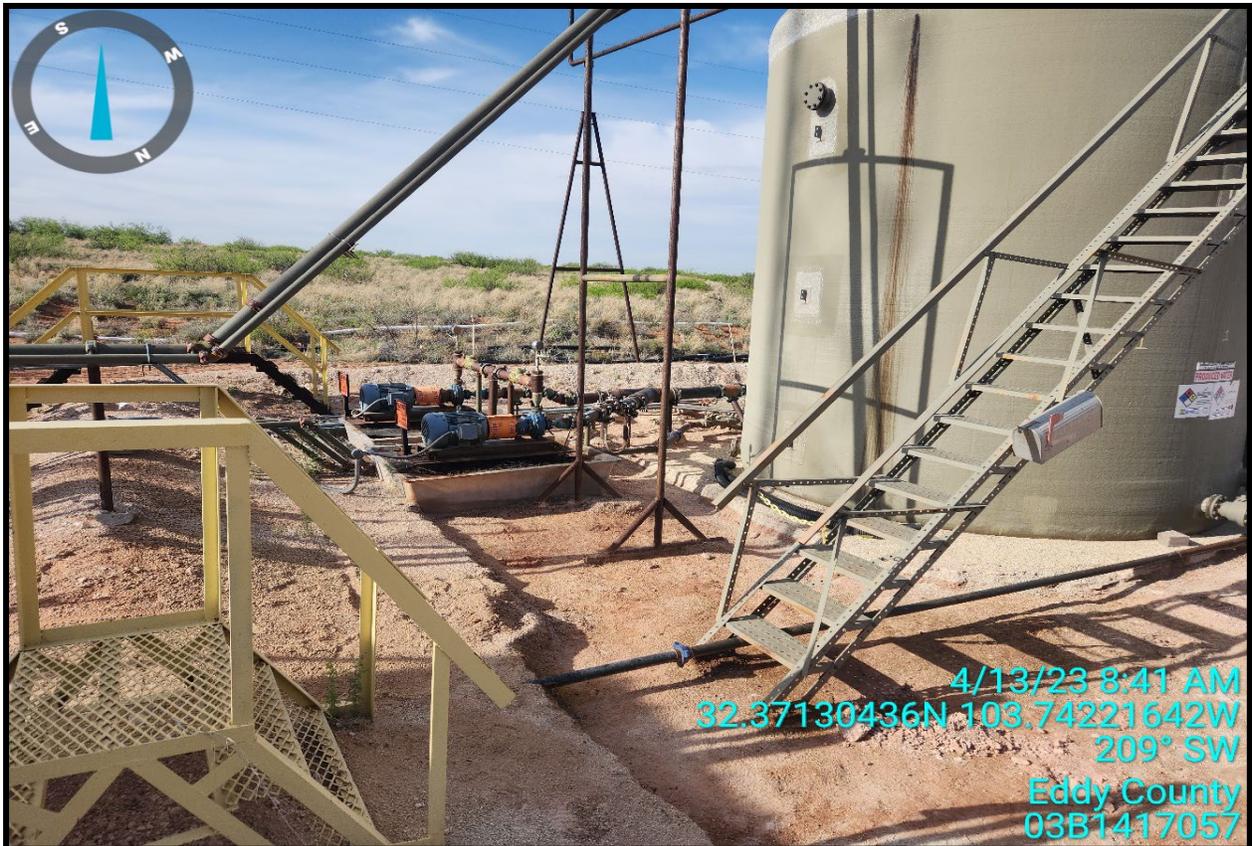
View of the final excavation area, facing southwest.

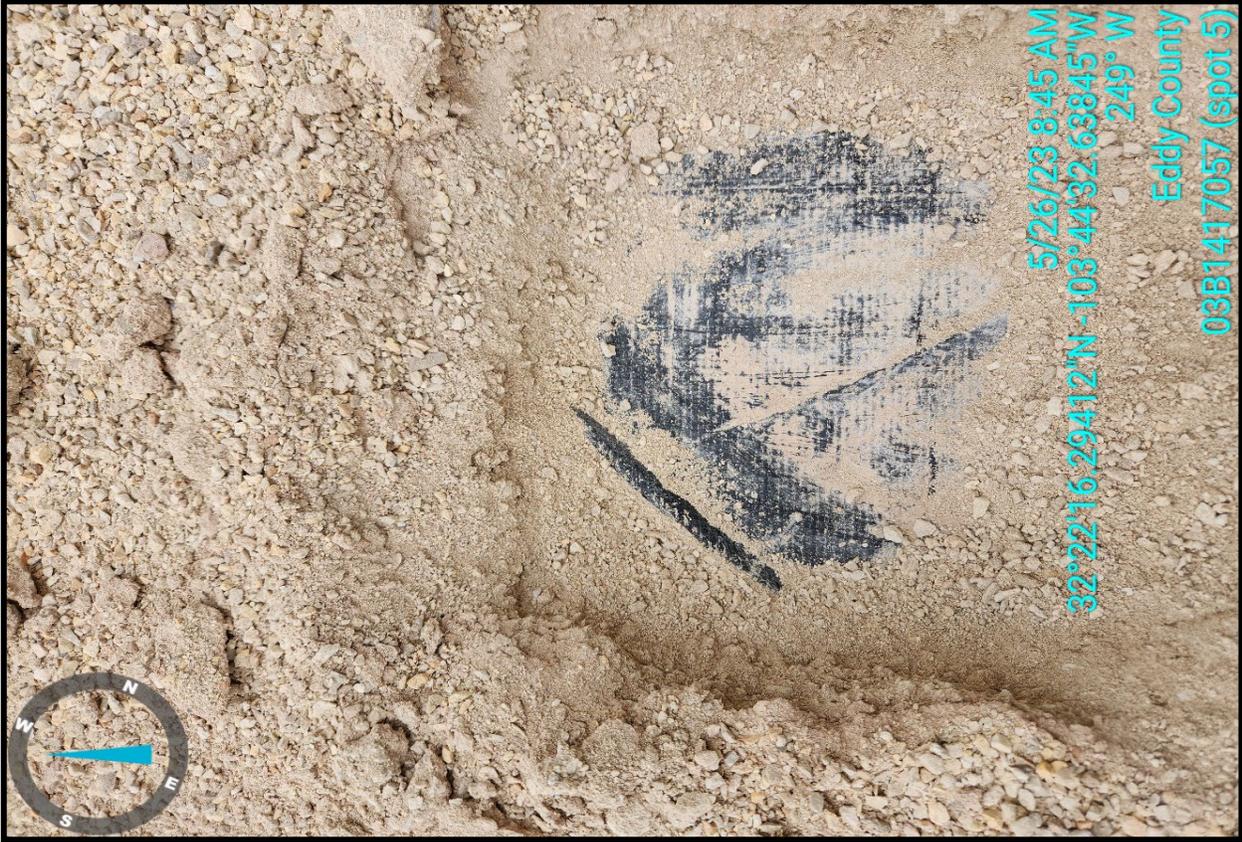
- Subsequent to sampling activities, a liner inspection was conducted to determine the integrity of the existing liner within the containment area. Based on visual inspection of multiple areas within the containment area, the liner remains intact and free of damage.

View of liner inspection on central and western portion of tank battery.

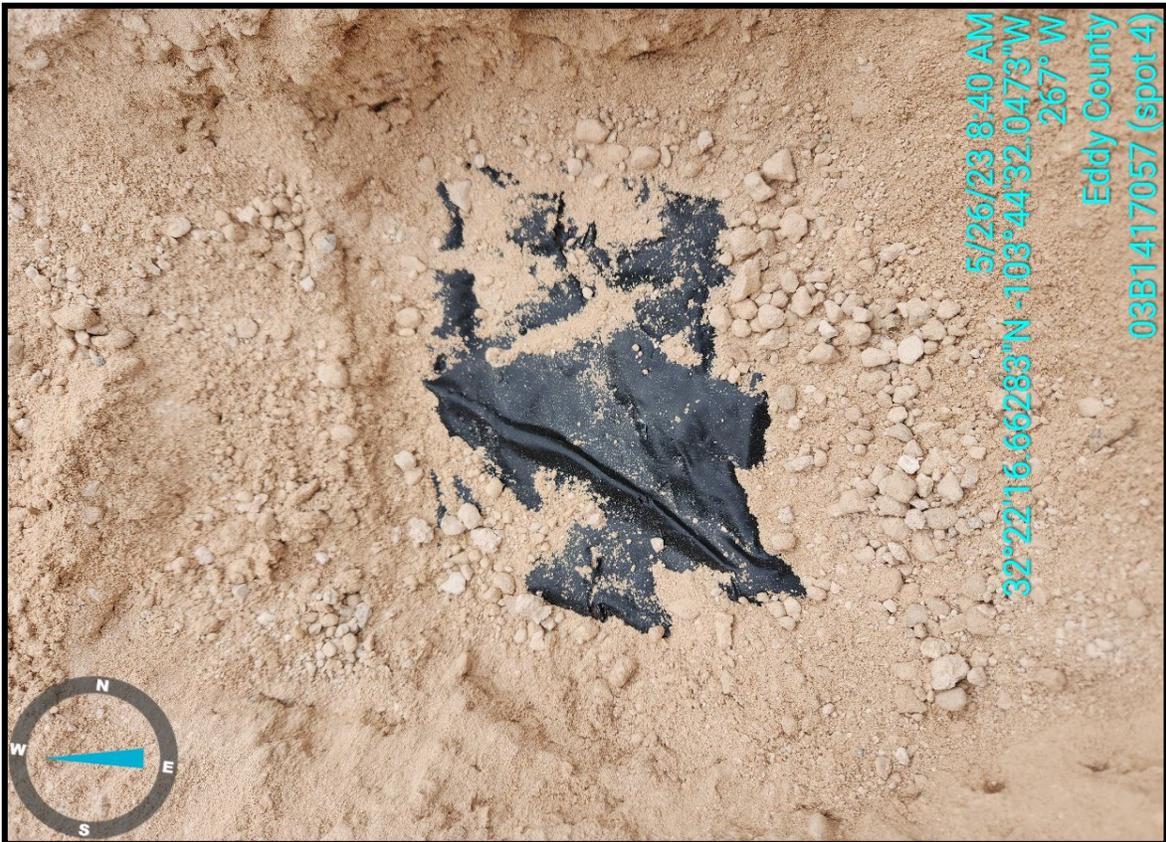
View of newly installed liner on eastern portion of tank battery.
