Incident ID	nAPP2205633098
District RP	
Facility ID	
Application ID

# CLOSURE REQUEST REPORT

**Dagger Lake Narwhal Pad  
Lea County, New Mexico  
Incident Number nAPP2205633098**

**Prepared For:  
Chevron USA, Inc.  
6301 Deauville Blvd.  
Midland, TX 79706**

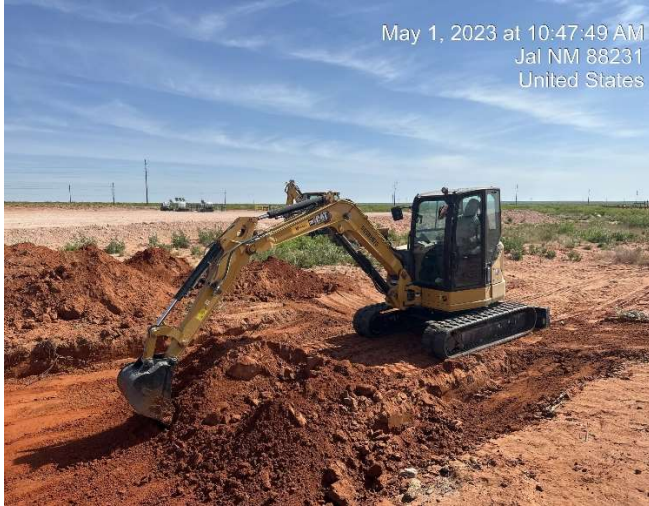
**Photograph 1****Date: 05/01/2023**

Description: Southwestern view of excavation activities

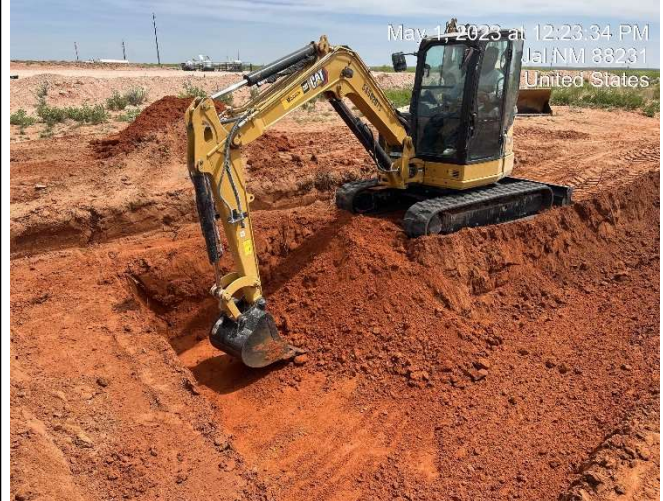
**Photograph 2****Date: 05/01/2023**

Description: Southwestern view of continued excavation activities

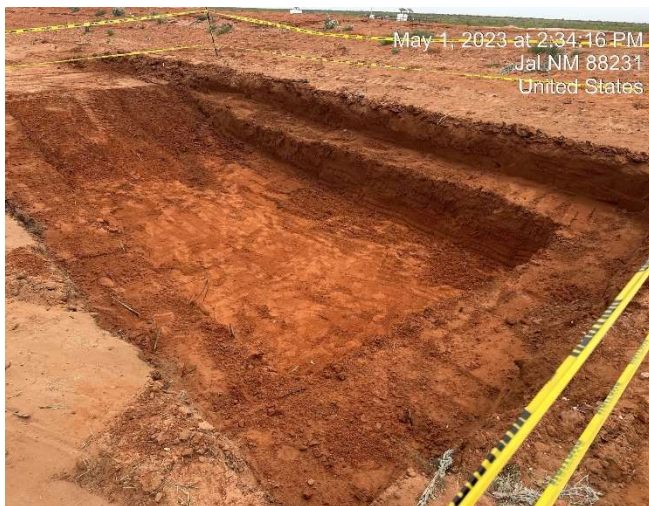
**Photograph 3****Date: 05/01/2023**

Description: Northwestern view of the final excavation extent

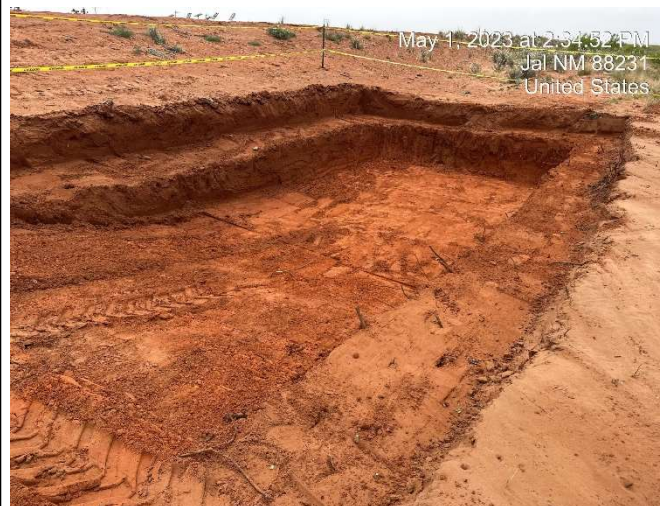
**Photograph 4****Date: 05/01/2023**

Description: Northeastern view of the final excavation extent

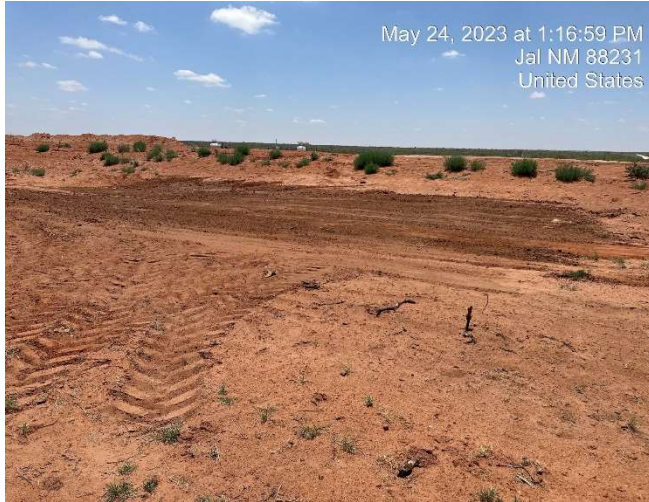
**Photograph 5****Date: 05/24/2023**

Description: Northern view of backfilled excavation

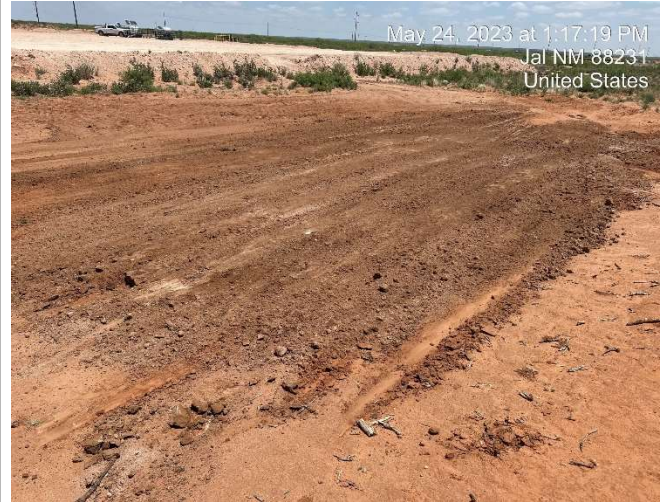
**Photograph 6****Date: 05/24/2023**

Description: Southwestern view of backfilled excavation

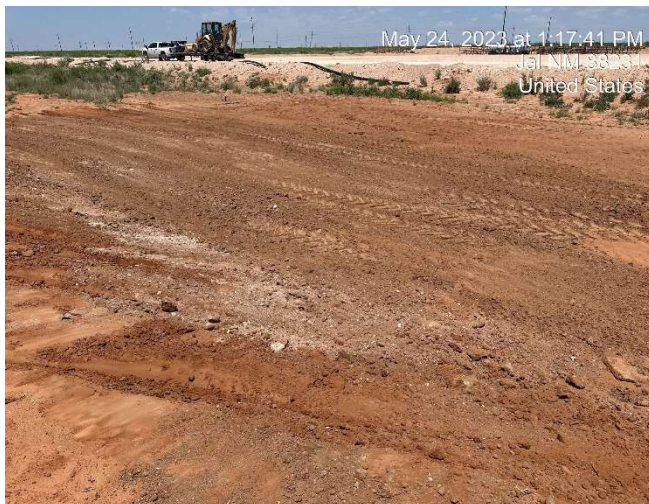
**Photograph 7****Date: 05/24/2023**

Description: Southeastern view of backfilled excavation

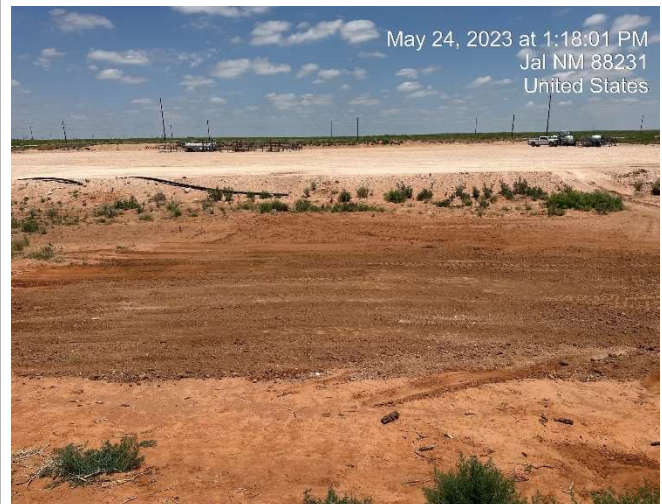
**Photograph 8****Date: 05/24/2023**

Description: Southern view of backfilled excavation
