December 20, 2023

**Re: Closure Request  
ConocoPhillips (Heritage COG Operating, LLC)  
Albatross State Com #002H FWKO Release  
Unit Letter B, Section 30, Township 18 South, Range 35 East  
Lea County, New Mexico  
Incident ID# NJXK1606034056**

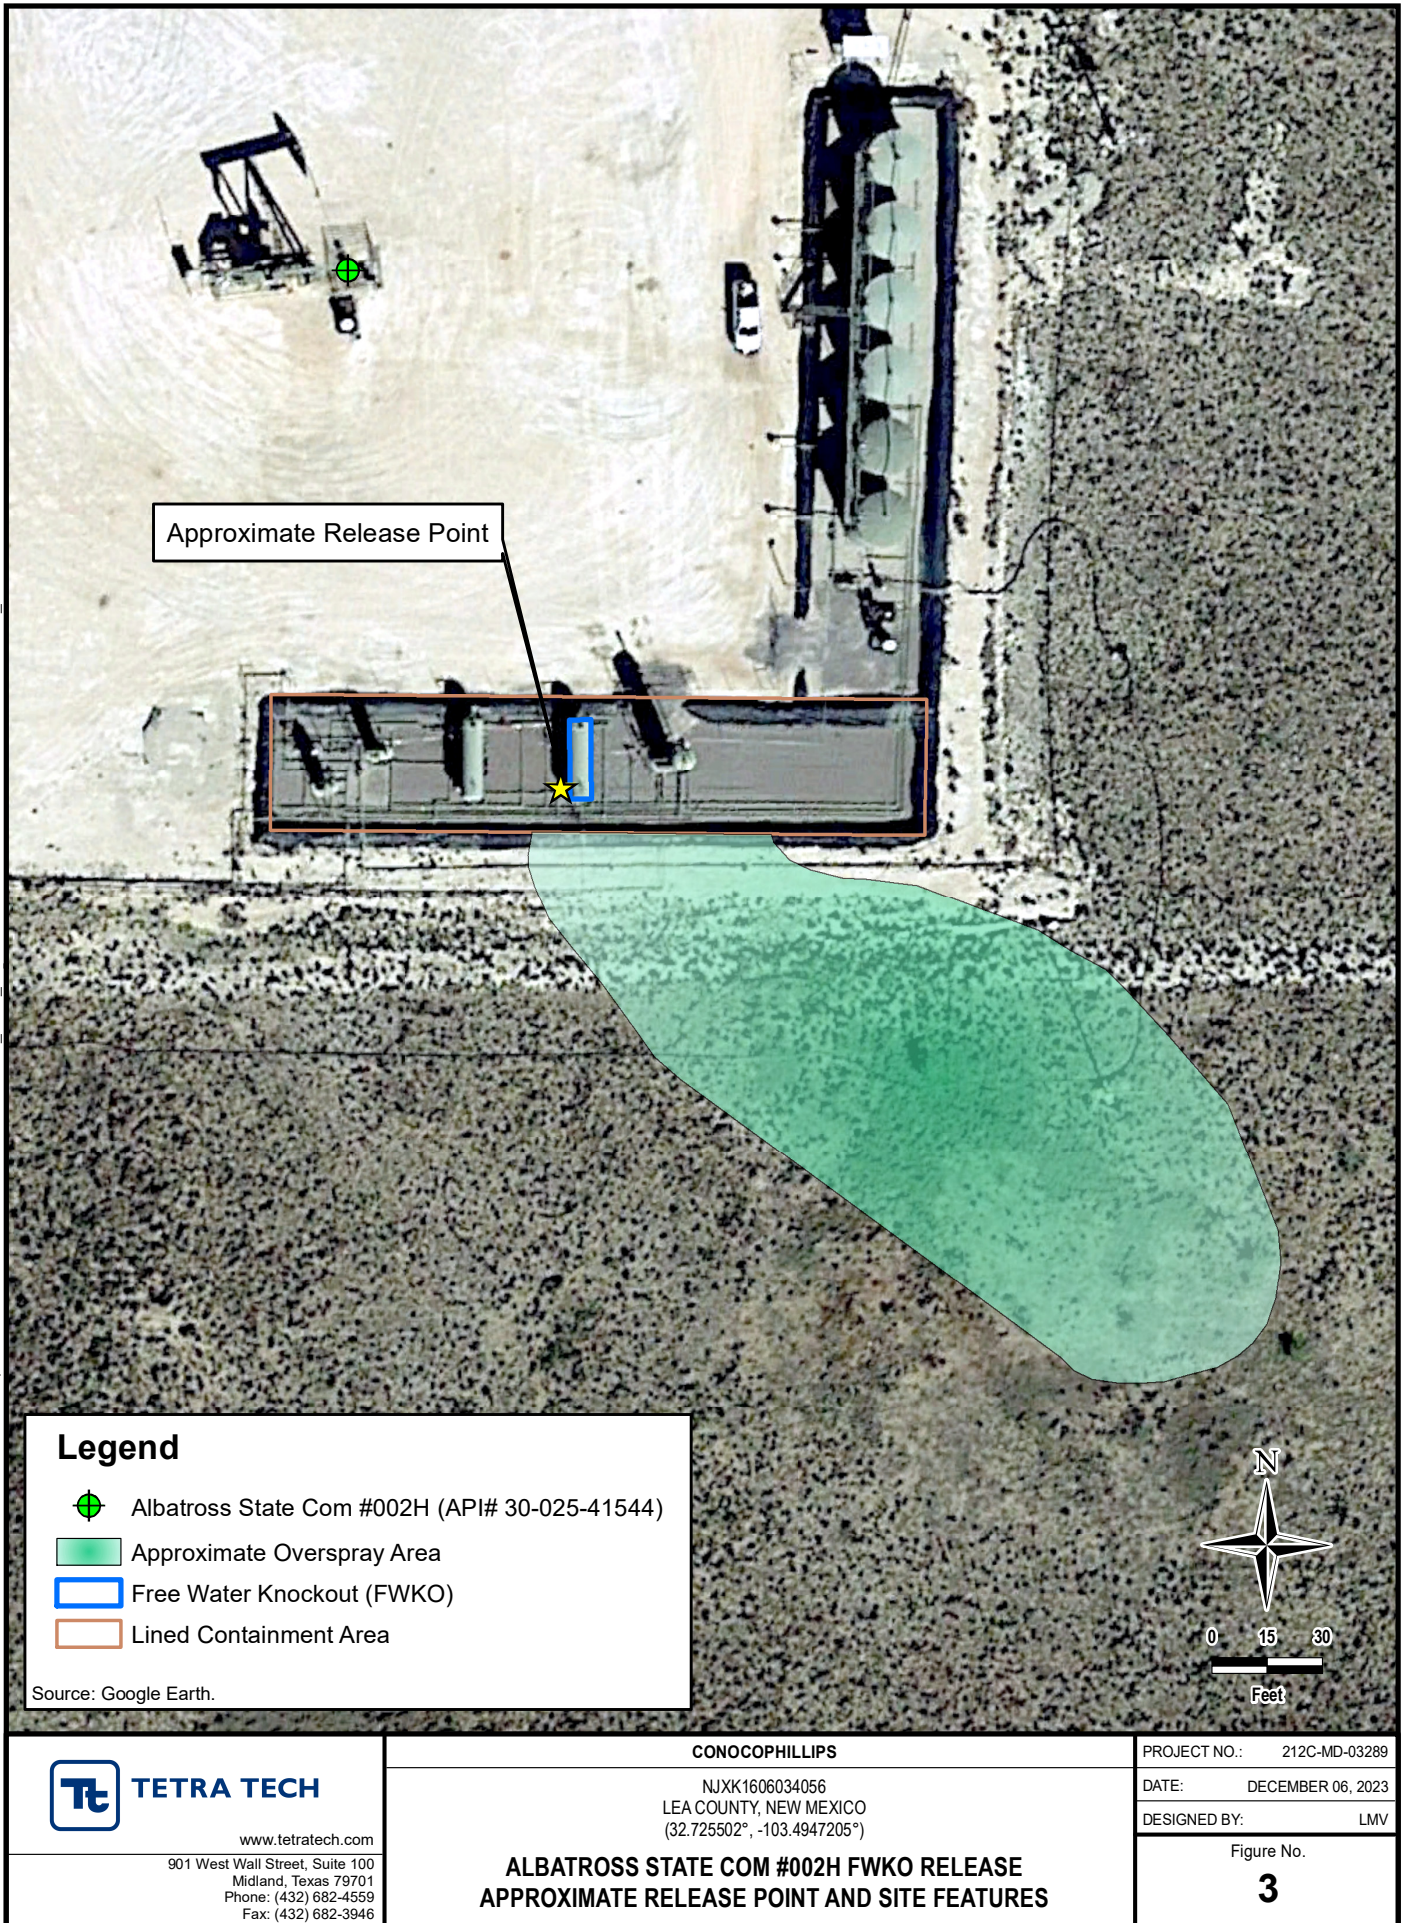
DOCUMENT PATH: C:\USERS\LISSA.VILLAMONEDRIVE - TETRA TECH\INC\DOCUMENTS\ILLINOIS\ALBATROSS\_002H\_FWKOMXD\FIGURE 3 RELEASE PT. & FEATURES\_ALBATROSS 2H.MXD

The release footprint was located within a lined containment area on the Albatross State Com #002H lease pad (API # 30-025-41544) with some overspray onto the pad and adjacent pasture, as presented in Figure 3. The NMOCD approved the initial C-141 on February 29, 2016, and subsequently assigned the Incident ID NJXK1606034056. The initial C-141 form is included in Appendix A.

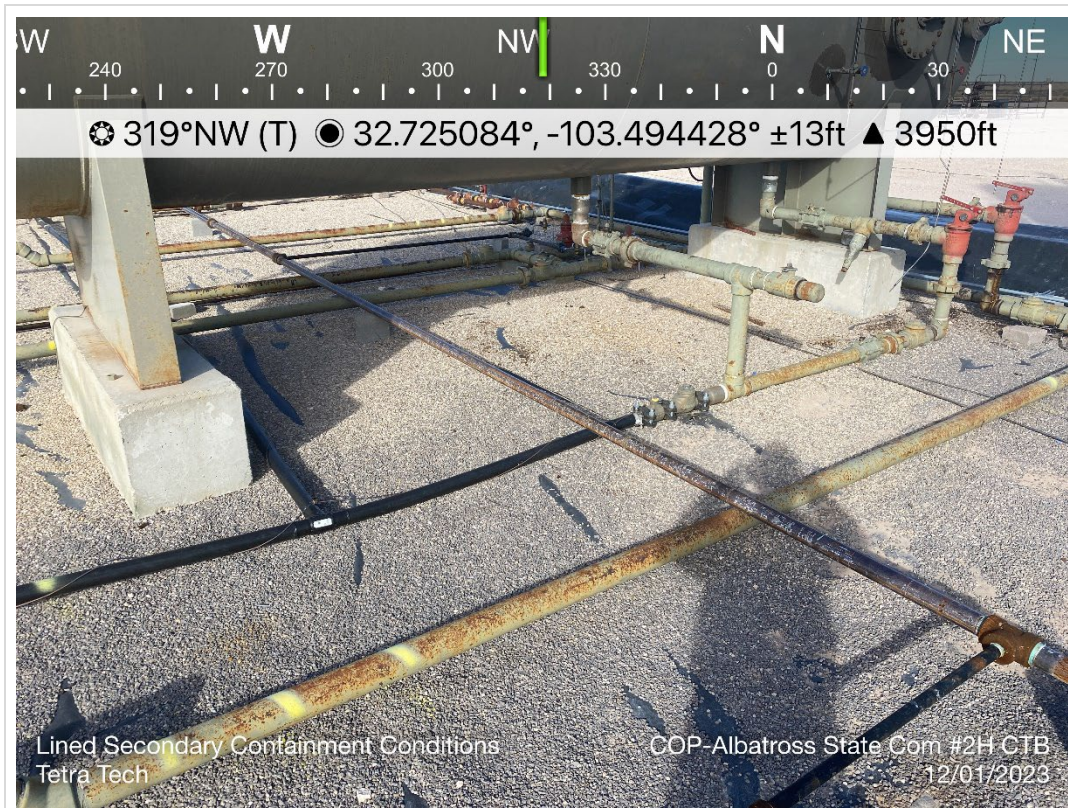
TETRA TECH, INC. PROJECT NO. 212C-MD-03289	DESCRIPTION	View northwest of approximate release area near FWKO inside lined secondary containment. Mass of surface pipelines.	5
	SITE NAME	Albatross State Com #002H Release	12/01/2023

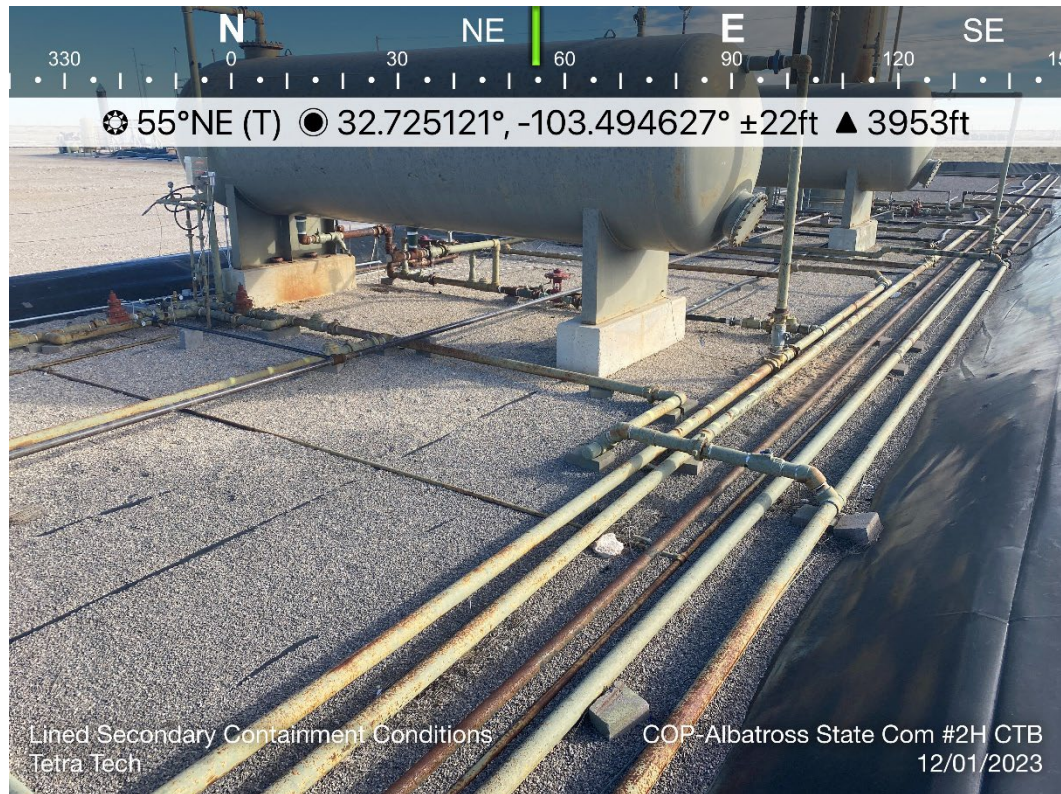
TETRA TECH, INC. PROJECT NO. 212C-MD-03289	DESCRIPTION	View east-northeast of approximate release area near FWKO inside lined secondary containment. Mass of surface pipelines.	6
	SITE NAME	Albatross State Com #002H Release	12/01/2023

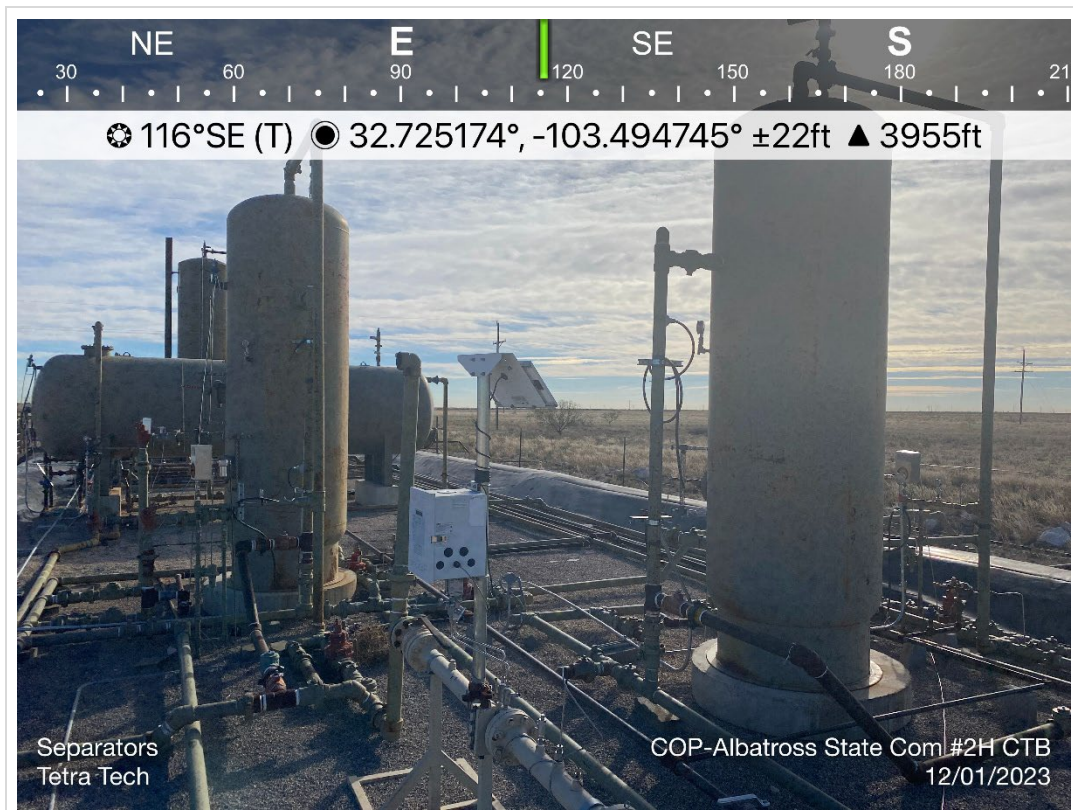
TETRA TECH, INC. PROJECT NO. 212C-MD-03289	DESCRIPTION	View east-southeast of approximate release area inside lined secondary containment. Mass of surface pipelines and separators.	7
	SITE NAME	Albatross State Com #002H Release	12/01/2023

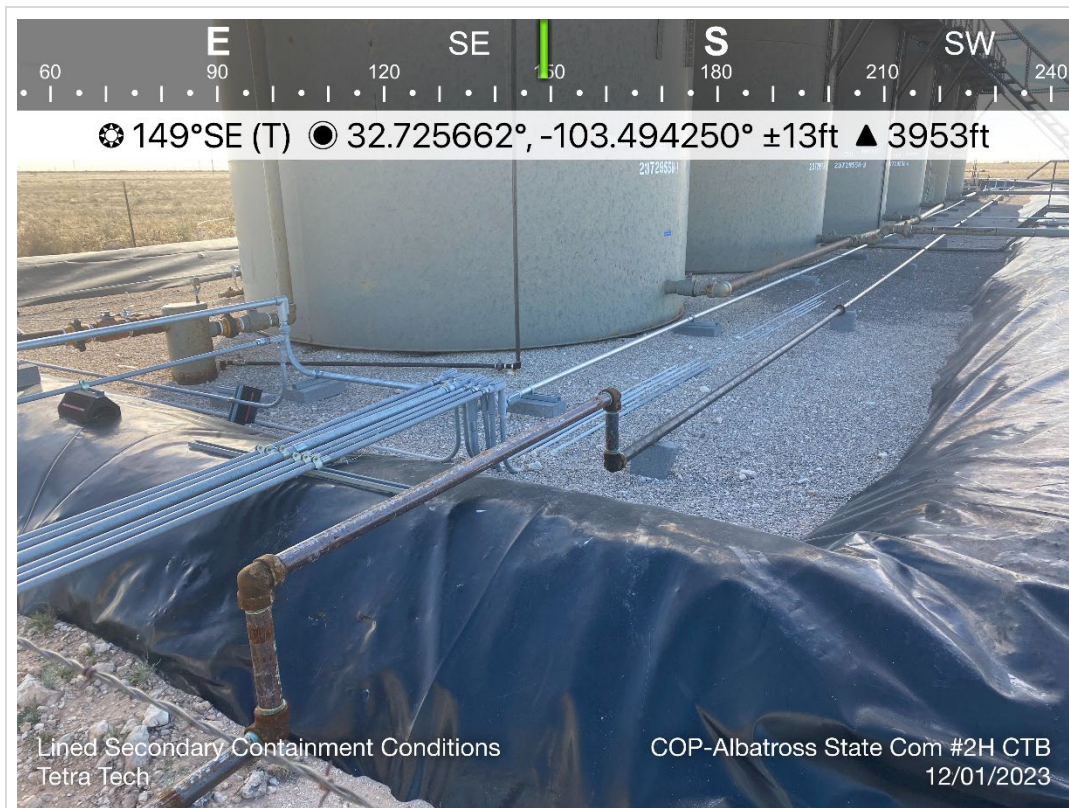
TETRA TECH, INC. PROJECT NO. 212C-MD-03289	DESCRIPTION	View south-southeast of lined secondary containment of tank battery and surface pipelines.	9
	SITE NAME	Albatross State Com #002H Release	12/01/2023

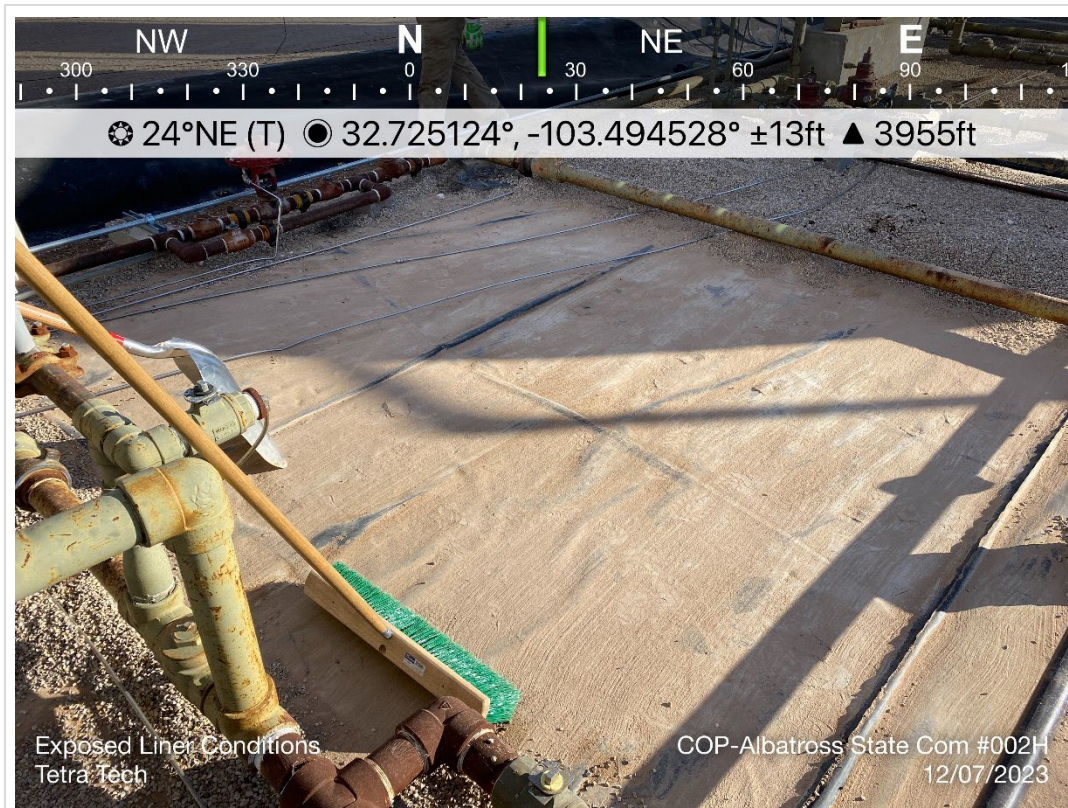
On December 7, 2023, Tetra Tech personnel performed an inspection of the liner within the secondary containment of the Albatross State Com #002H Battery. This work was completed to verify liner integrity. The clean base course/gravel material was carefully moved and/or extracted from the area surrounding the production equipment and the surrounding vicinity. The liner was observed to underlie the entirety of the tank battery secondary containment area. The liner was intact with no visible rips or tears and encompassed by a 2-foot-tall earthen berm. The liner extended up and over the berm and was anchored on the exterior. At the time of the inspection, the liner was intact and had the ability to contain the leak in question. Photographic documentation of the liner inspection is included in Appendix D.

TETRA TECH, INC. PROJECT NO. 212C-MD-03289	DESCRIPTION	View north-northeast of exposed liner conditions.	11
	SITE NAME	Albatross State Com #002H Release	12/07/2023

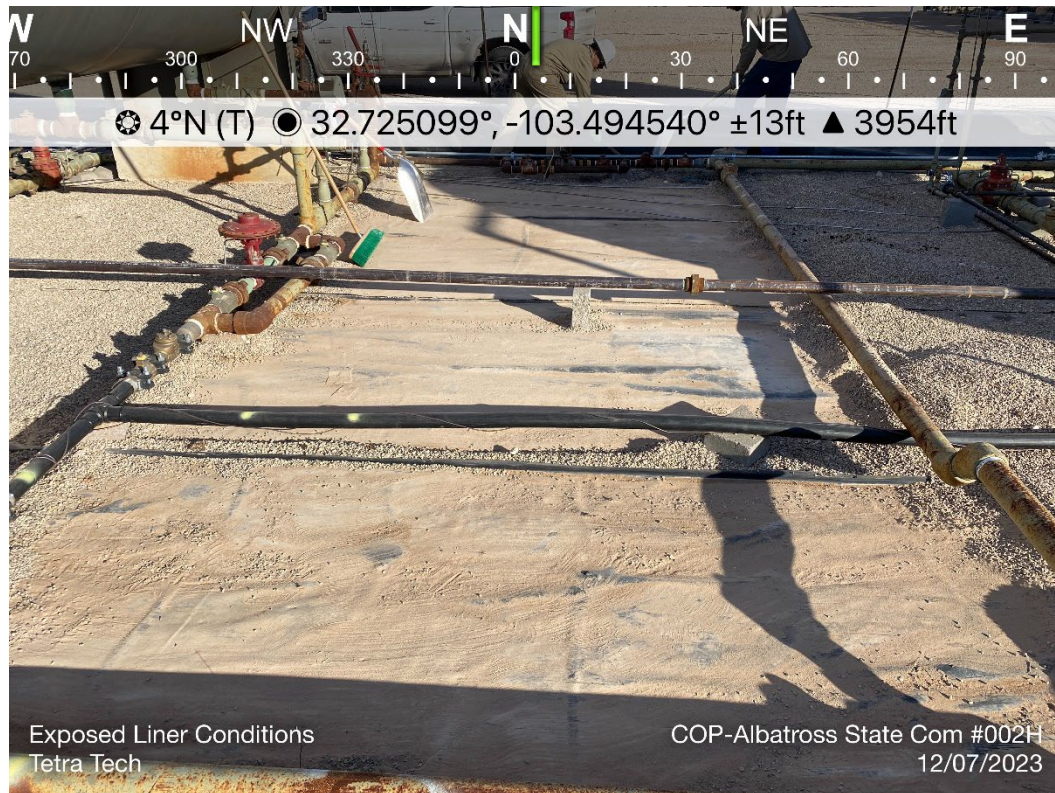
TETRA TECH, INC. PROJECT NO. 212C-MD-03289	DESCRIPTION	View north of exposed liner conditions.	12
	SITE NAME	Albatross State Com #002H Release	12/07/2023

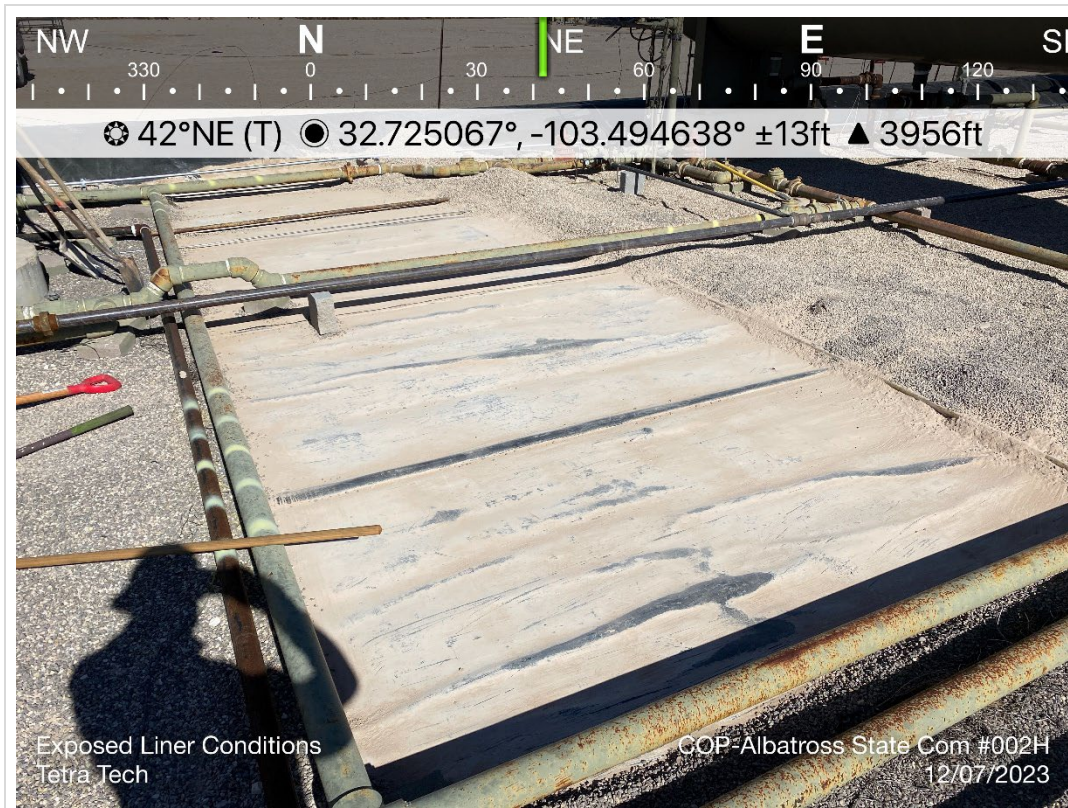
TETRA TECH, INC. PROJECT NO. 212C-MD-03289	DESCRIPTION	View northeast of exposed liner conditions.	13
	SITE NAME	Albatross State Com #002H Release	12/07/2023

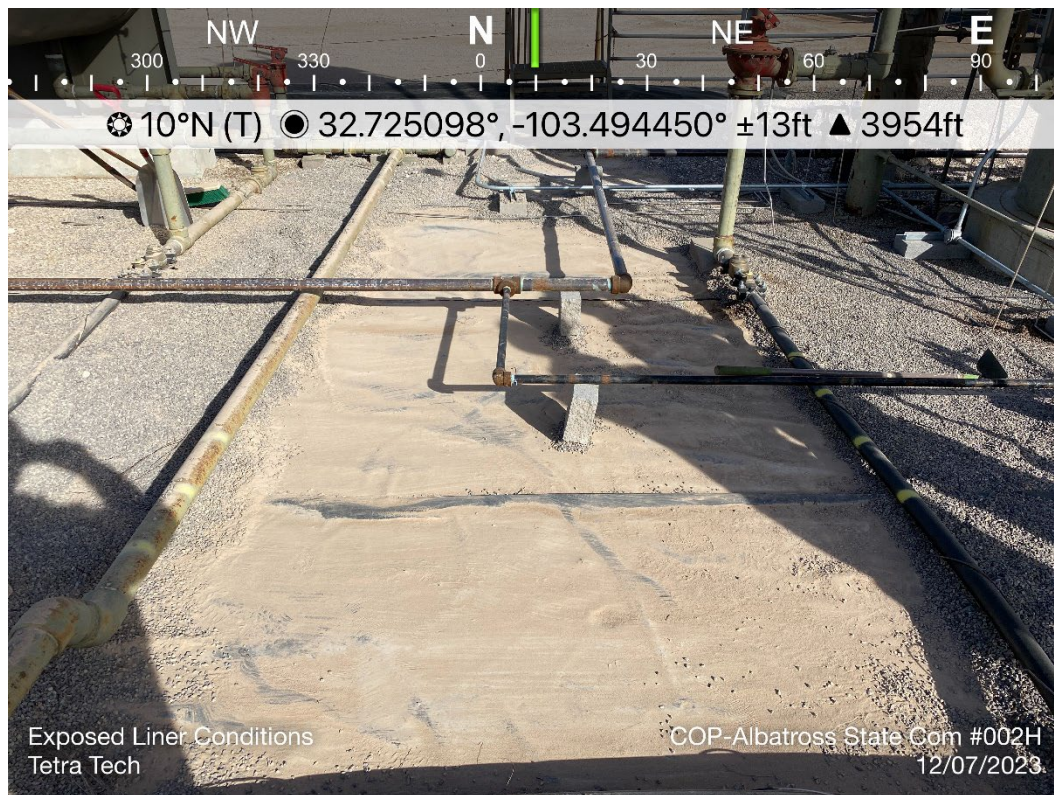
TETRA TECH, INC. PROJECT NO. 212C-MD-03289	DESCRIPTION	View north of exposed liner conditions.	14
	SITE NAME	Albatross State Com #002H Release	12/07/2023

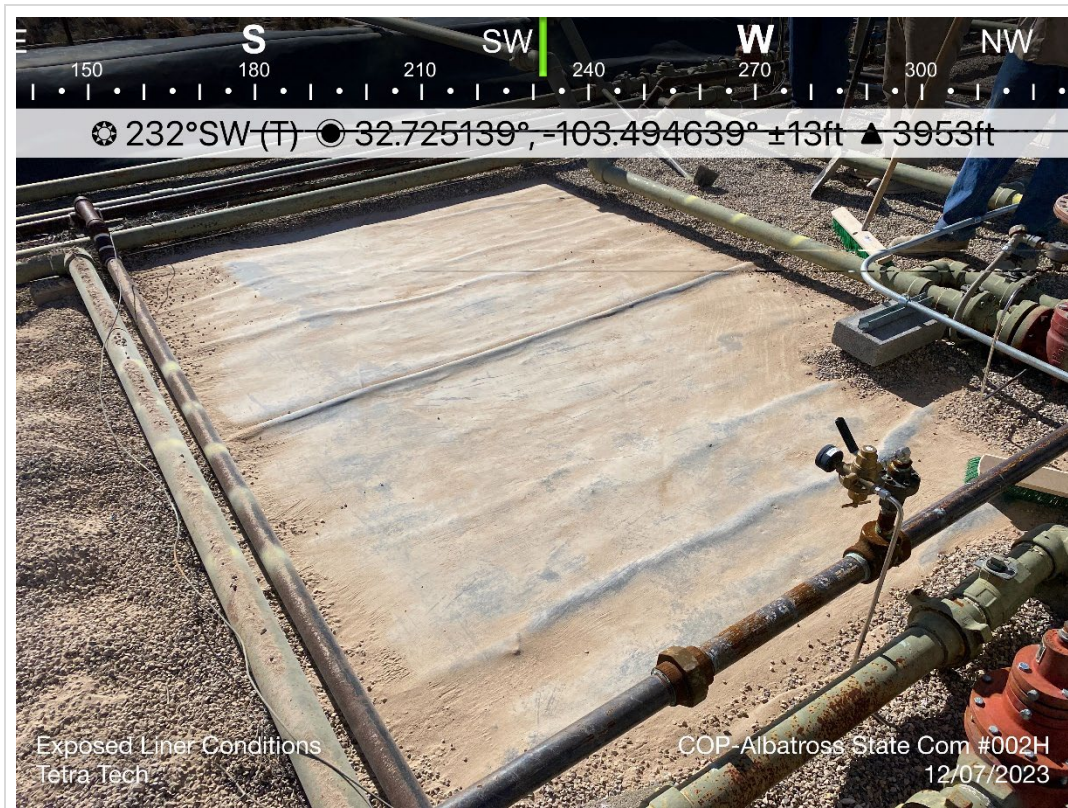
TETRA TECH, INC. PROJECT NO. 212C-MD-03289	DESCRIPTION	View southwest of exposed liner conditions.	15
	SITE NAME	Albatross State Com #002H Release	12/07/2023

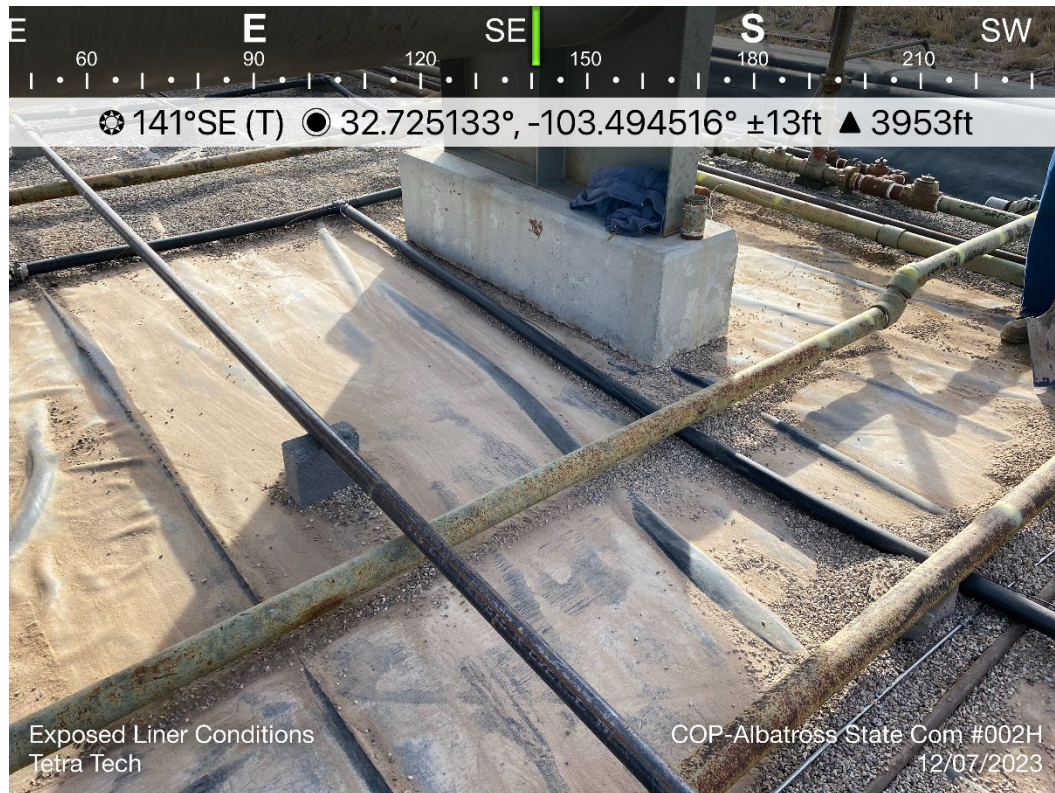
TETRA TECH, INC. PROJECT NO. 212C-MD-03289	DESCRIPTION	View southeast of exposed liner conditions directly beneath the FWKO unit.	18
	SITE NAME	Albatross State Com #002H Release	12/07/2023
