Frontier Field Services, LLC  
Cedar Breaks LH St. 1 6" Steel Line  
32.772122°, -103.948648°  
NMOCD Reference # nAPP2306238104  
Terracon Project # KH237028

RE: Release Investigation, and Closure Report  
Cedar Breaks LH St. 1 6" Steel Line  
Unit M, Section 2, Township 18 South, Range 30 East  
32.772122°, -103.948648°  
Eddy County, New Mexico  
Terracon Project No. KH237028

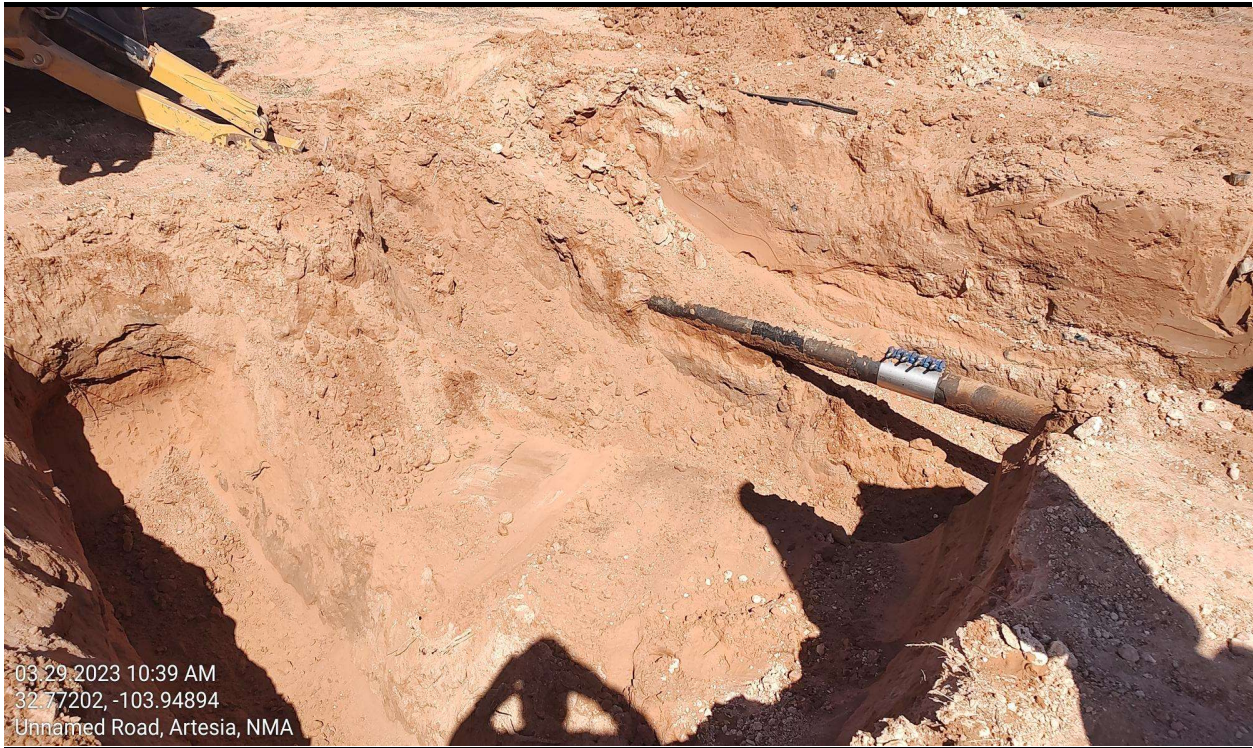
**PHOTO 1:** View of area before excavation

On March 29, 2023, Terracon mobilized to the site to perform soil remediation activities. Areas exhibiting visual impact were excavated to a depth of approximately 4 to 5 feet bgs.

Approximately 20 cubic yards of soil were excavated and stockpiled atop a polyethylene liner pending waste characterization and disposal under an approved Form C-138. Excavation efforts ceased based on the results of removing visual impacts. Excavated materials were disposed of at Lea Land Landfill.

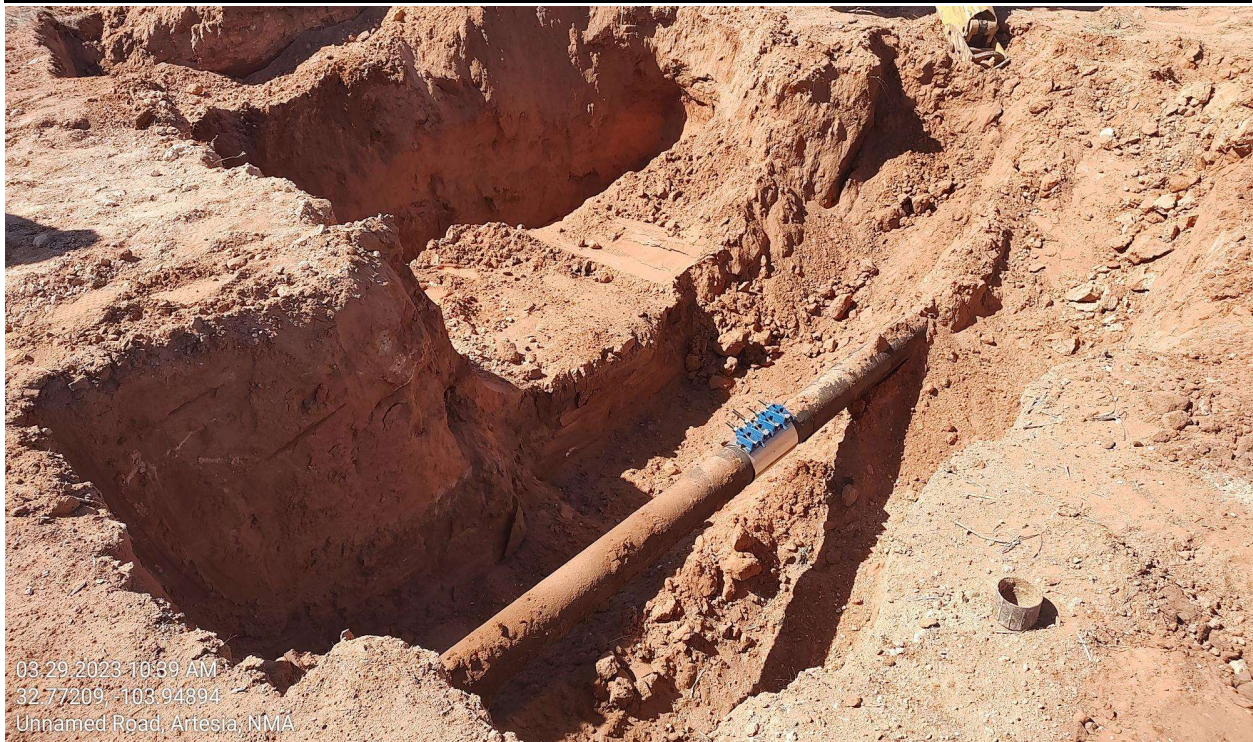
**PHOTO 2:** View of area after excavation

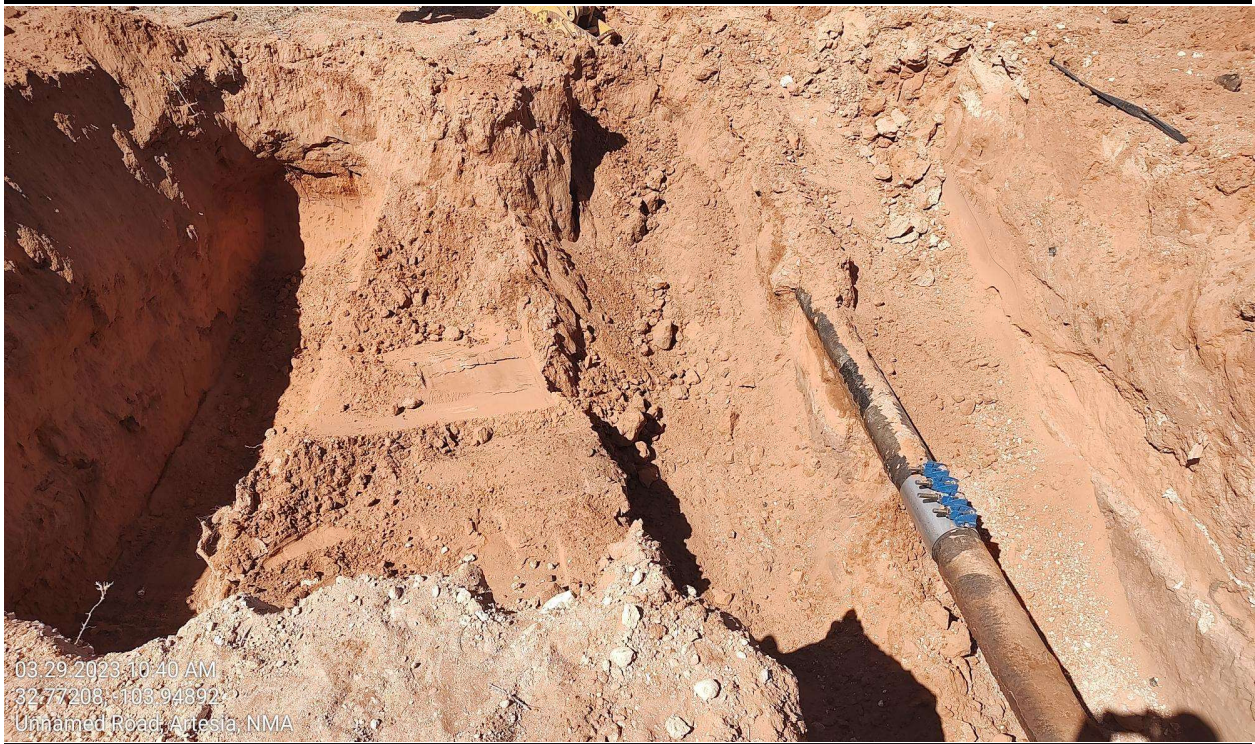
**PHOTO 3:** View of area after excavation
