## CLOSURE REPORT

**State Gas Com #3 (10/31/23)**  
Unit Letter J, S32 T31N R12W  
San Juan County, New Mexico

**New Mexico EMNRD OCD Incident ID No. NAPP2330435930**

Ensolum Project No. 05A1226294

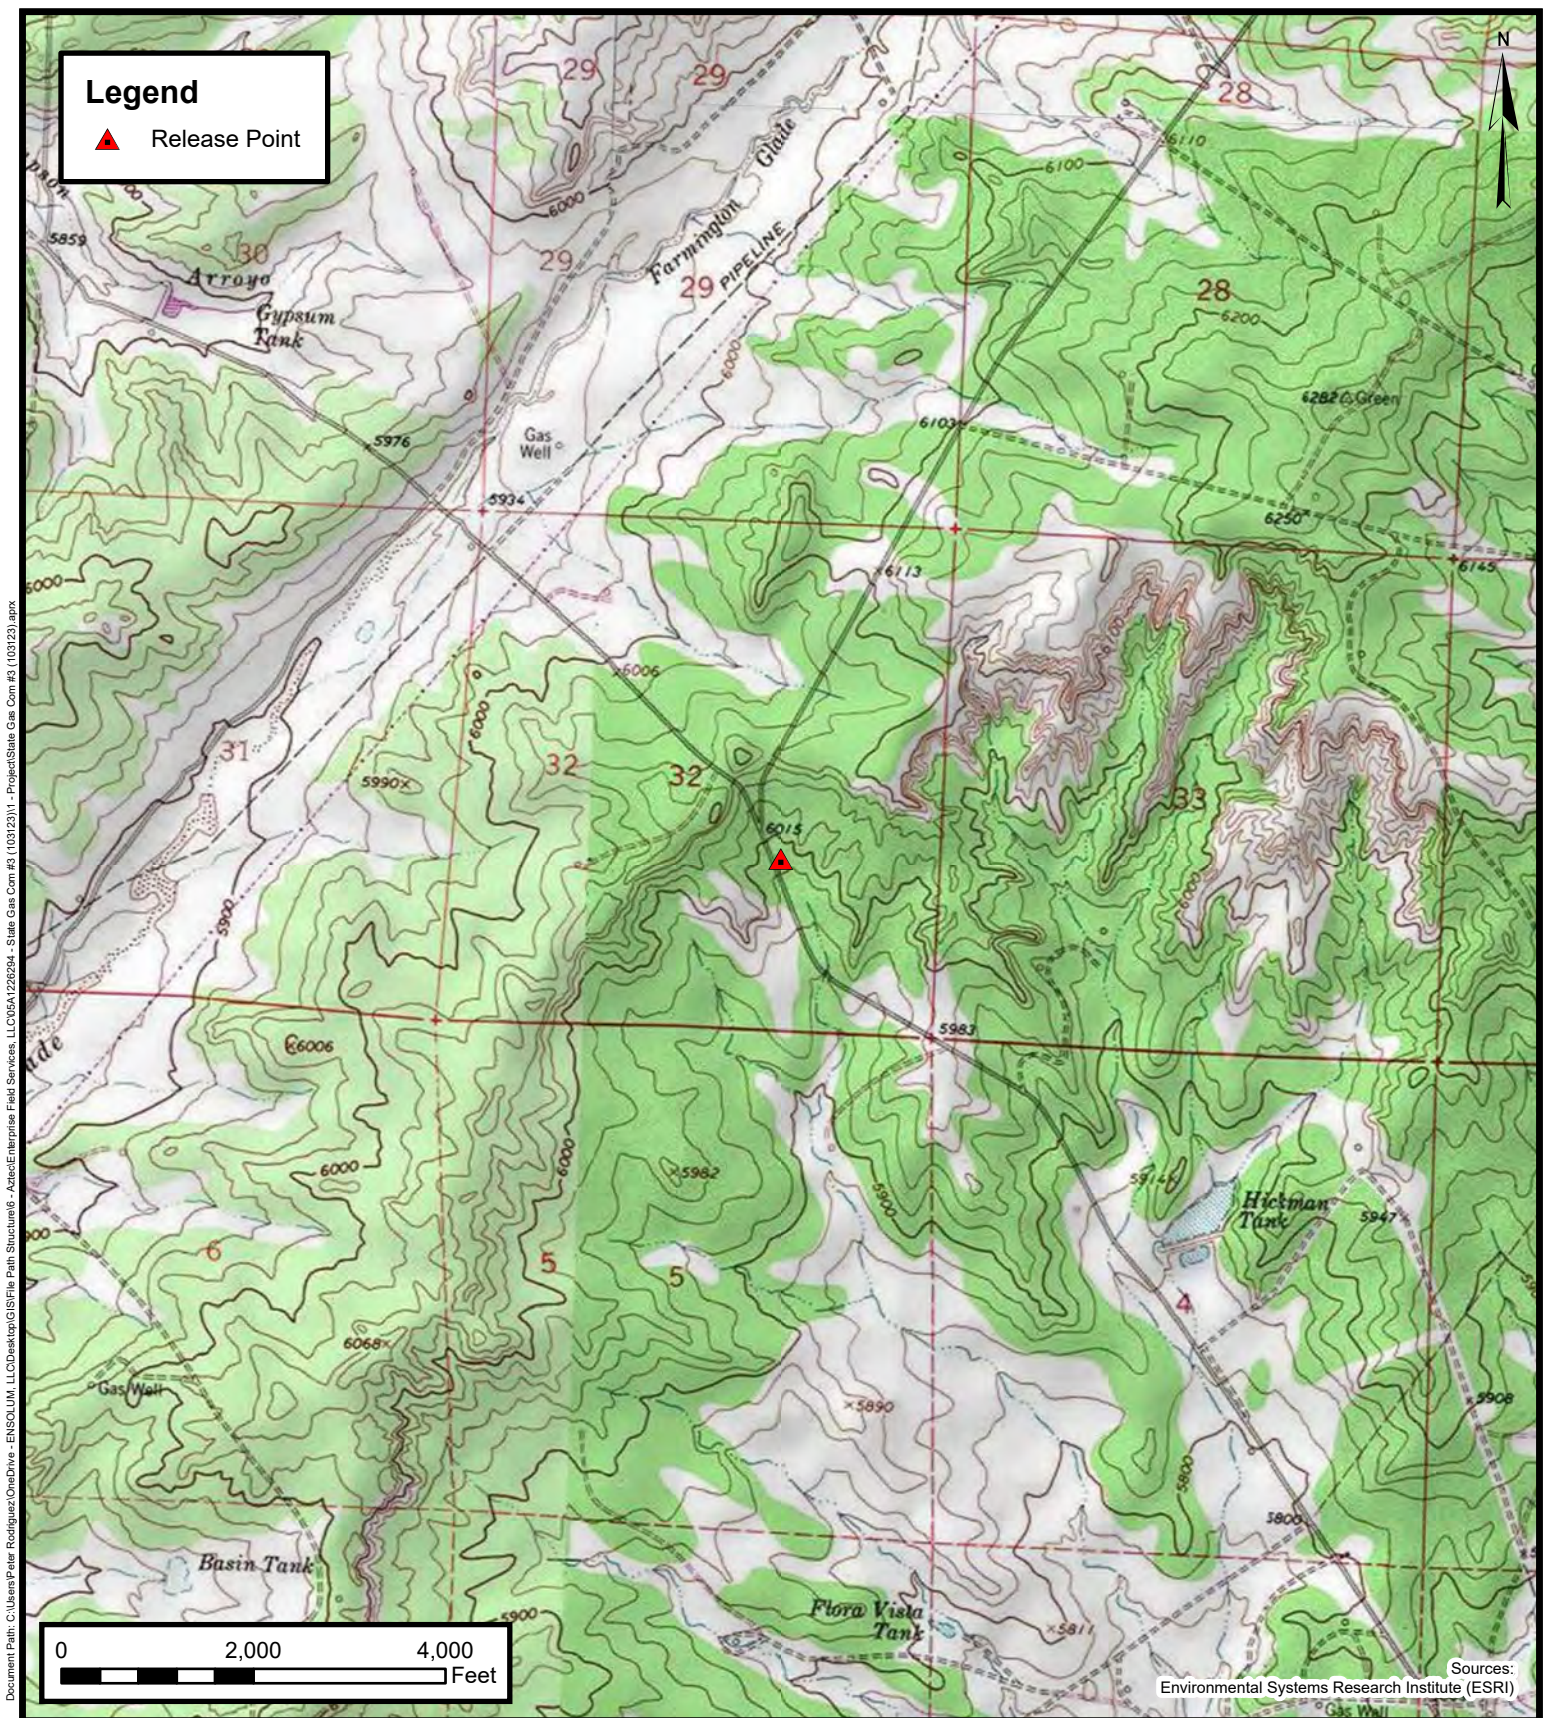
**FIGURE**  
**1**

## Topographic Map

A **Topographic Map** depicting the location of the Site is included as **Figure 1**, and a **Site Vicinity Map** is included as **Figure 2** in **Appendix A**.

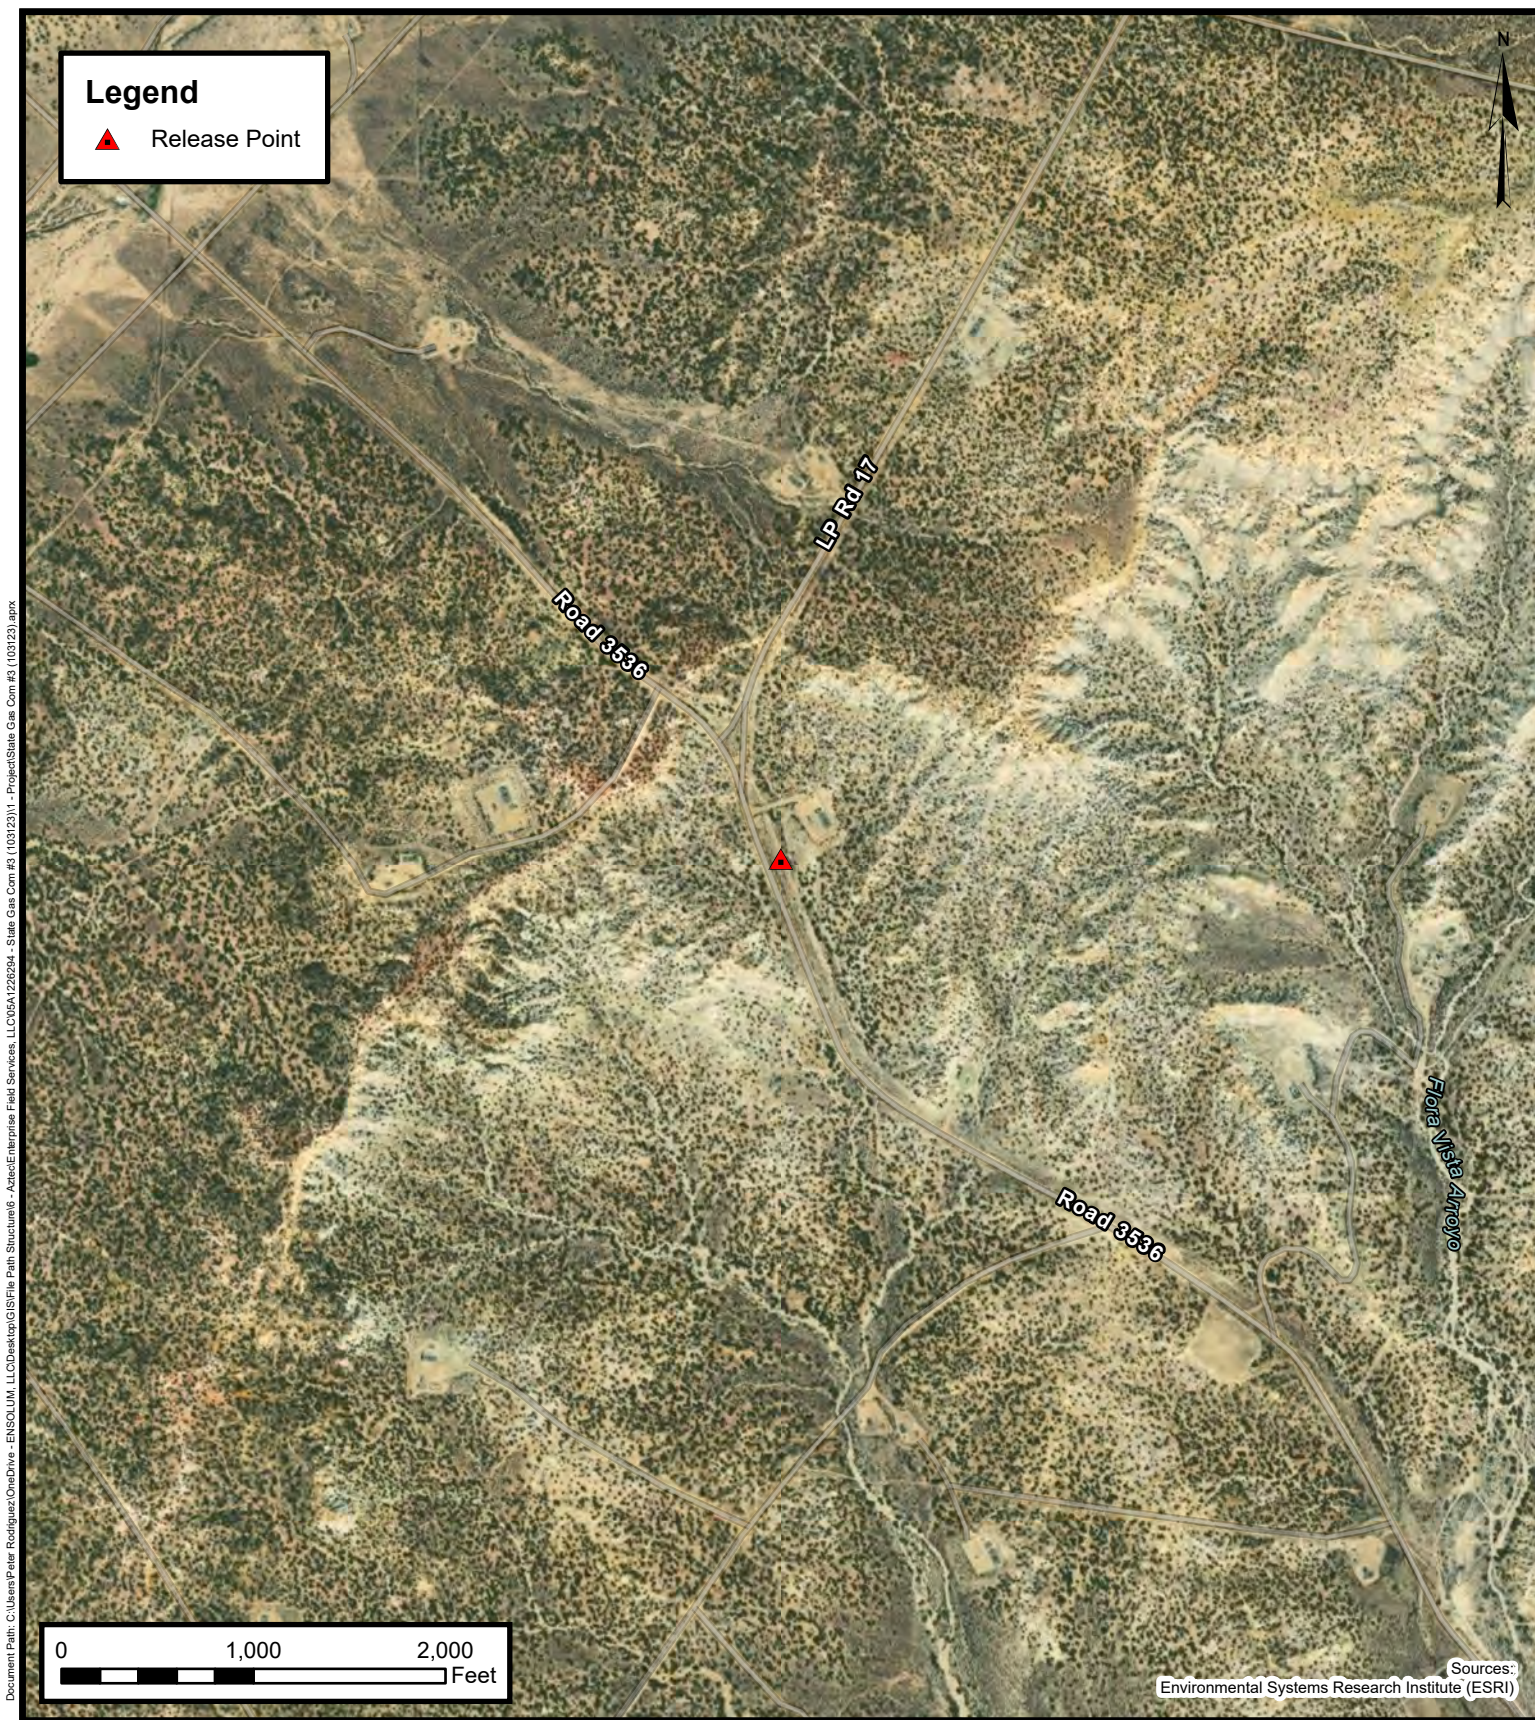
FIGURE

## Site Vicinity Map

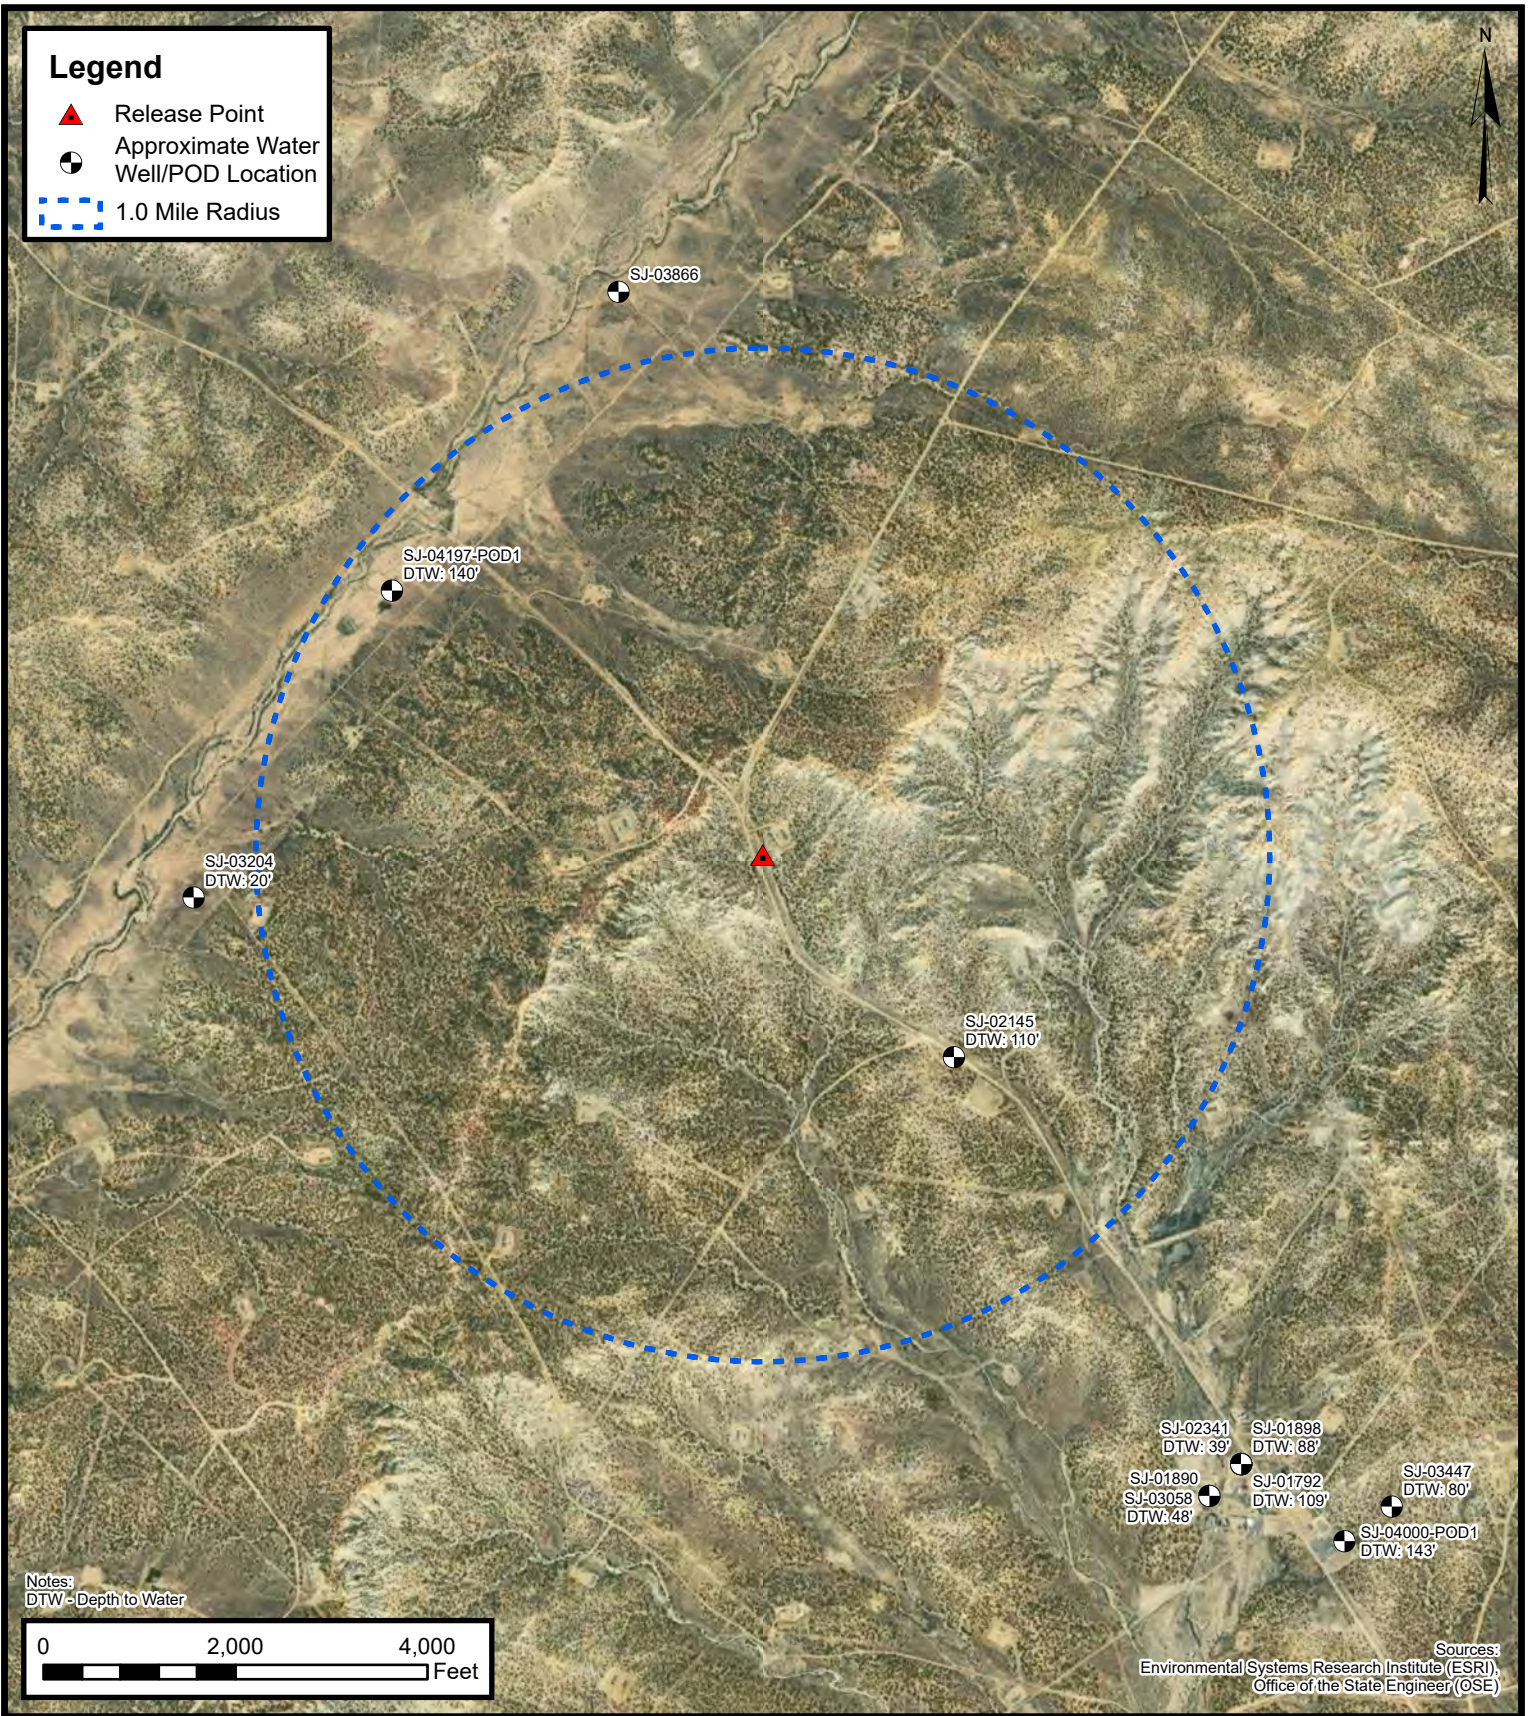
FIGURE  
**A**

## 1.0 Mile Radius Water Well/POD Location Map

- The NM Office of the State Engineer (OSE) tracks the usage and assignment of water rights and water well installations and records this information in the Water Rights Reporting System (WRRS) database. Water wells and other points of diversion (PODs) are each assigned POD numbers in the database (which is searchable and includes an interactive map). No PODs were identified in the same Public Land Survey System (PLSS) section as the Site. Numerous PODs were identified in the adjacent PLSS sections. The average depth to water for the PODs is 82 feet below grade surface (bgs). The closest POD (SJ-04197-POD1) is approximately 0.90 miles northwest of the site and approximately 70 feet lower in

elevation than the Site. The recorded depth to water for this POD is 140 feet bgs (**Figure A, Appendix B**). The OSE interactive map identifies POD SJ-02145 to be closer than POD SJ-04197, however, based on the PLSS information in the well record, the actual location is approximately 1.6 miles southeast of the Site.

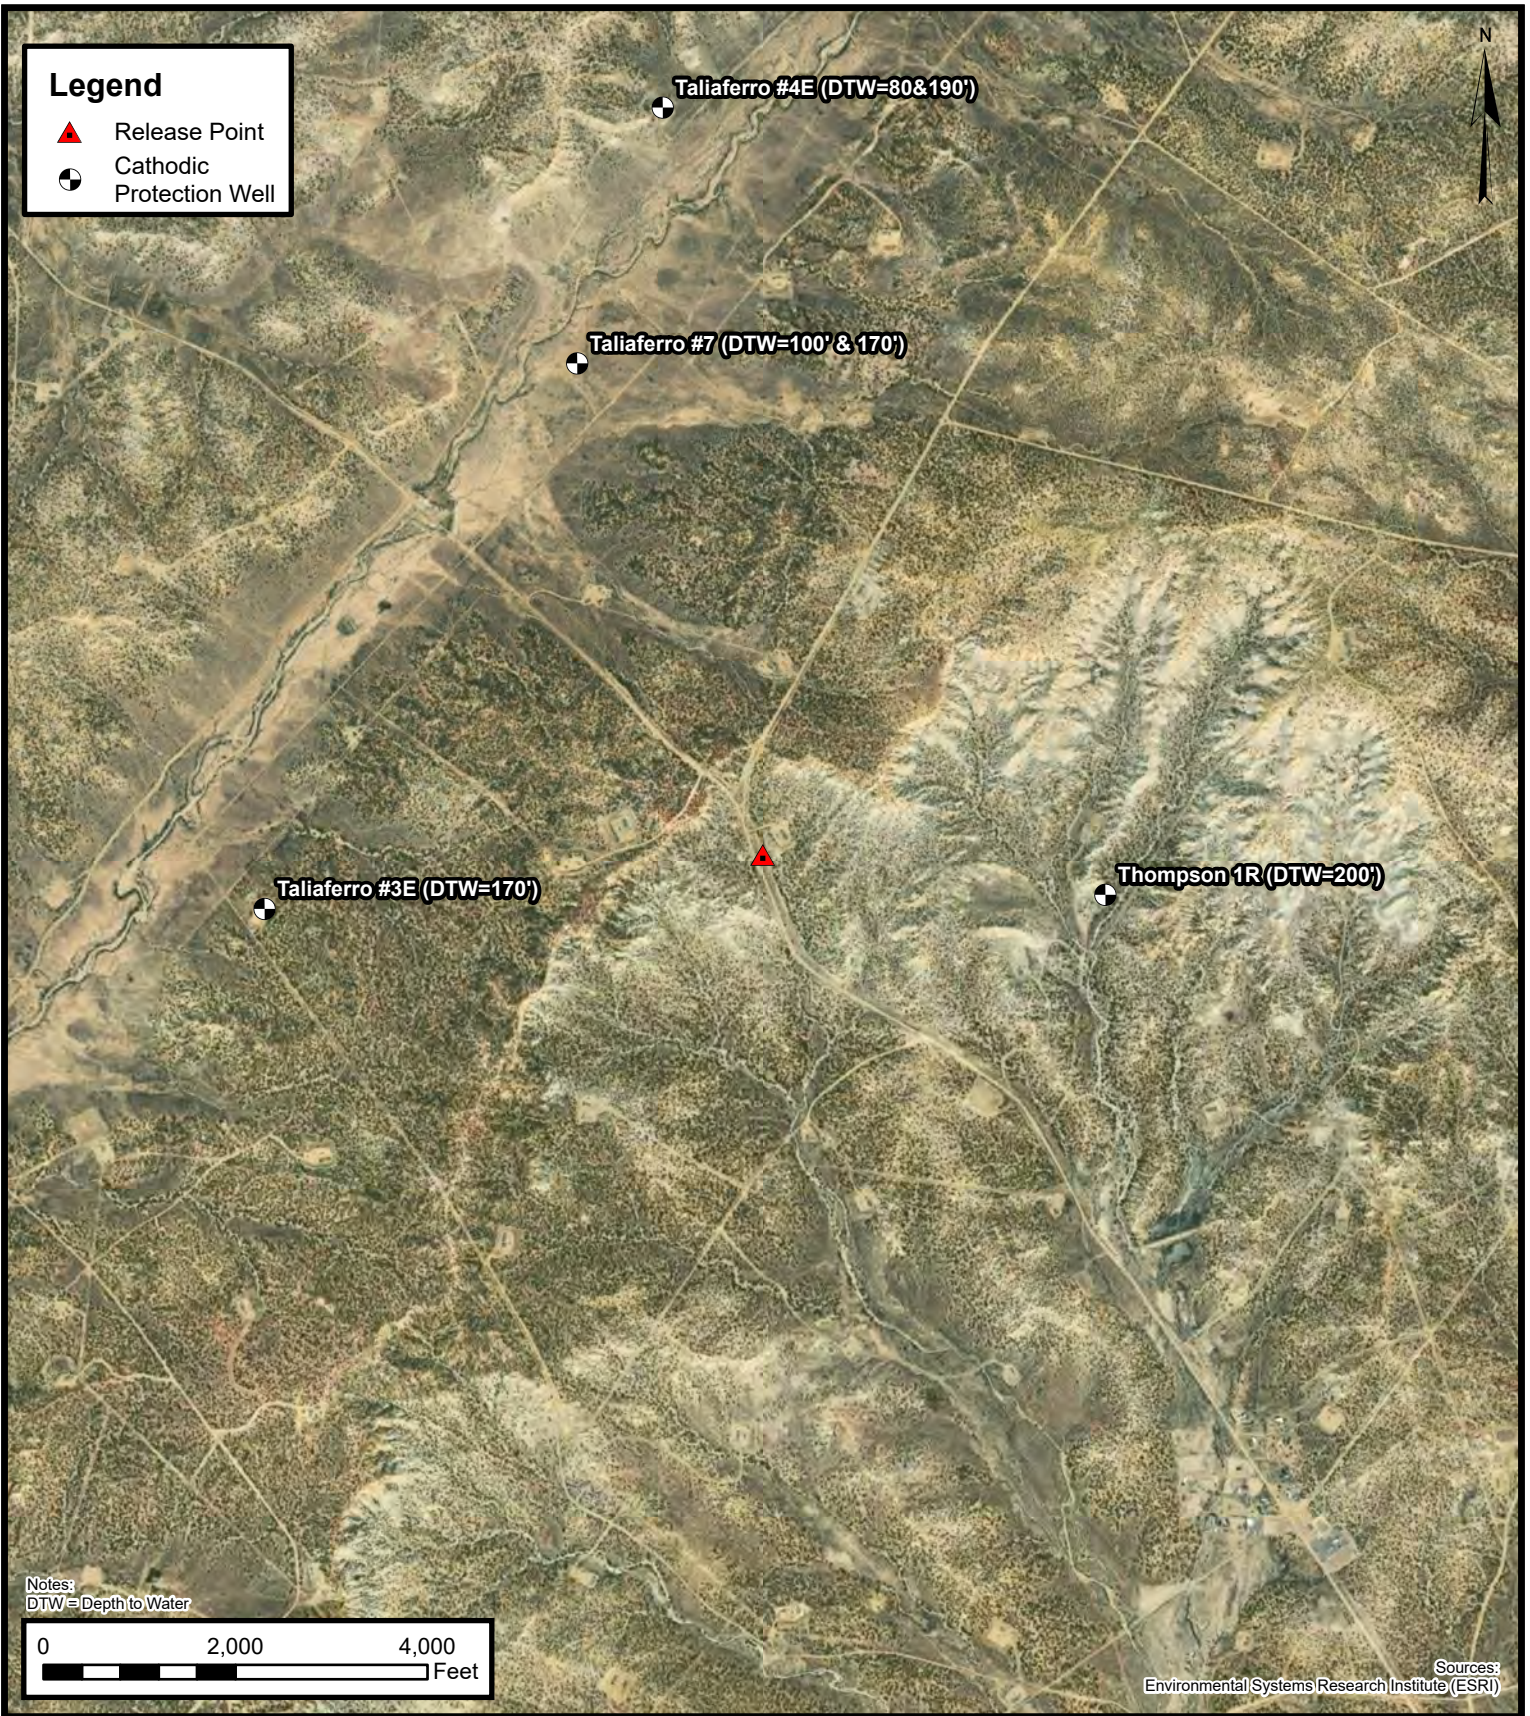
FIGURE  
**B**

## Cathodic Protection Well Recorded Depth to Water

- Four cathodic protection wells (CPWs) were identified in the NM EMNRD OCD imaging database in the adjacent PLSS sections. These CPWs are depicted on **Figure B (Appendix B)**. Documentation for the cathodic protection well located near the Thompson 1R production pad indicates a depth to water of 200 feet bgs. This cathodic protection well is located approximately 0.68 miles east of the Site and is approximately 48 feet lower in elevation than the Site. Documentation for the cathodic protection well located near the Taliaferro #3E production pad indicates a depth to water of approximately 170 feet bgs. This cathodic protection well is located approximately 0.99 miles southwest of the Site and is approximately 56 feet lower in elevation than the Site. Documentation for the cathodic protection well located near the Taliaferro #7 production pad indicates depths to water of approximately 100 and 170 feet bgs. This cathodic protection well is located approximately 1.04 miles northwest of the Site and is approximately 34 feet lower in elevation than the Site. Documentation for the cathodic protection well located near the Taliaferro #4E production pad indicates depths to water of approximately 80 and 90 feet bgs. This cathodic protection well is located approximately 1.48 miles northwest of the Site and is approximately 22 feet higher in elevation than the Site.

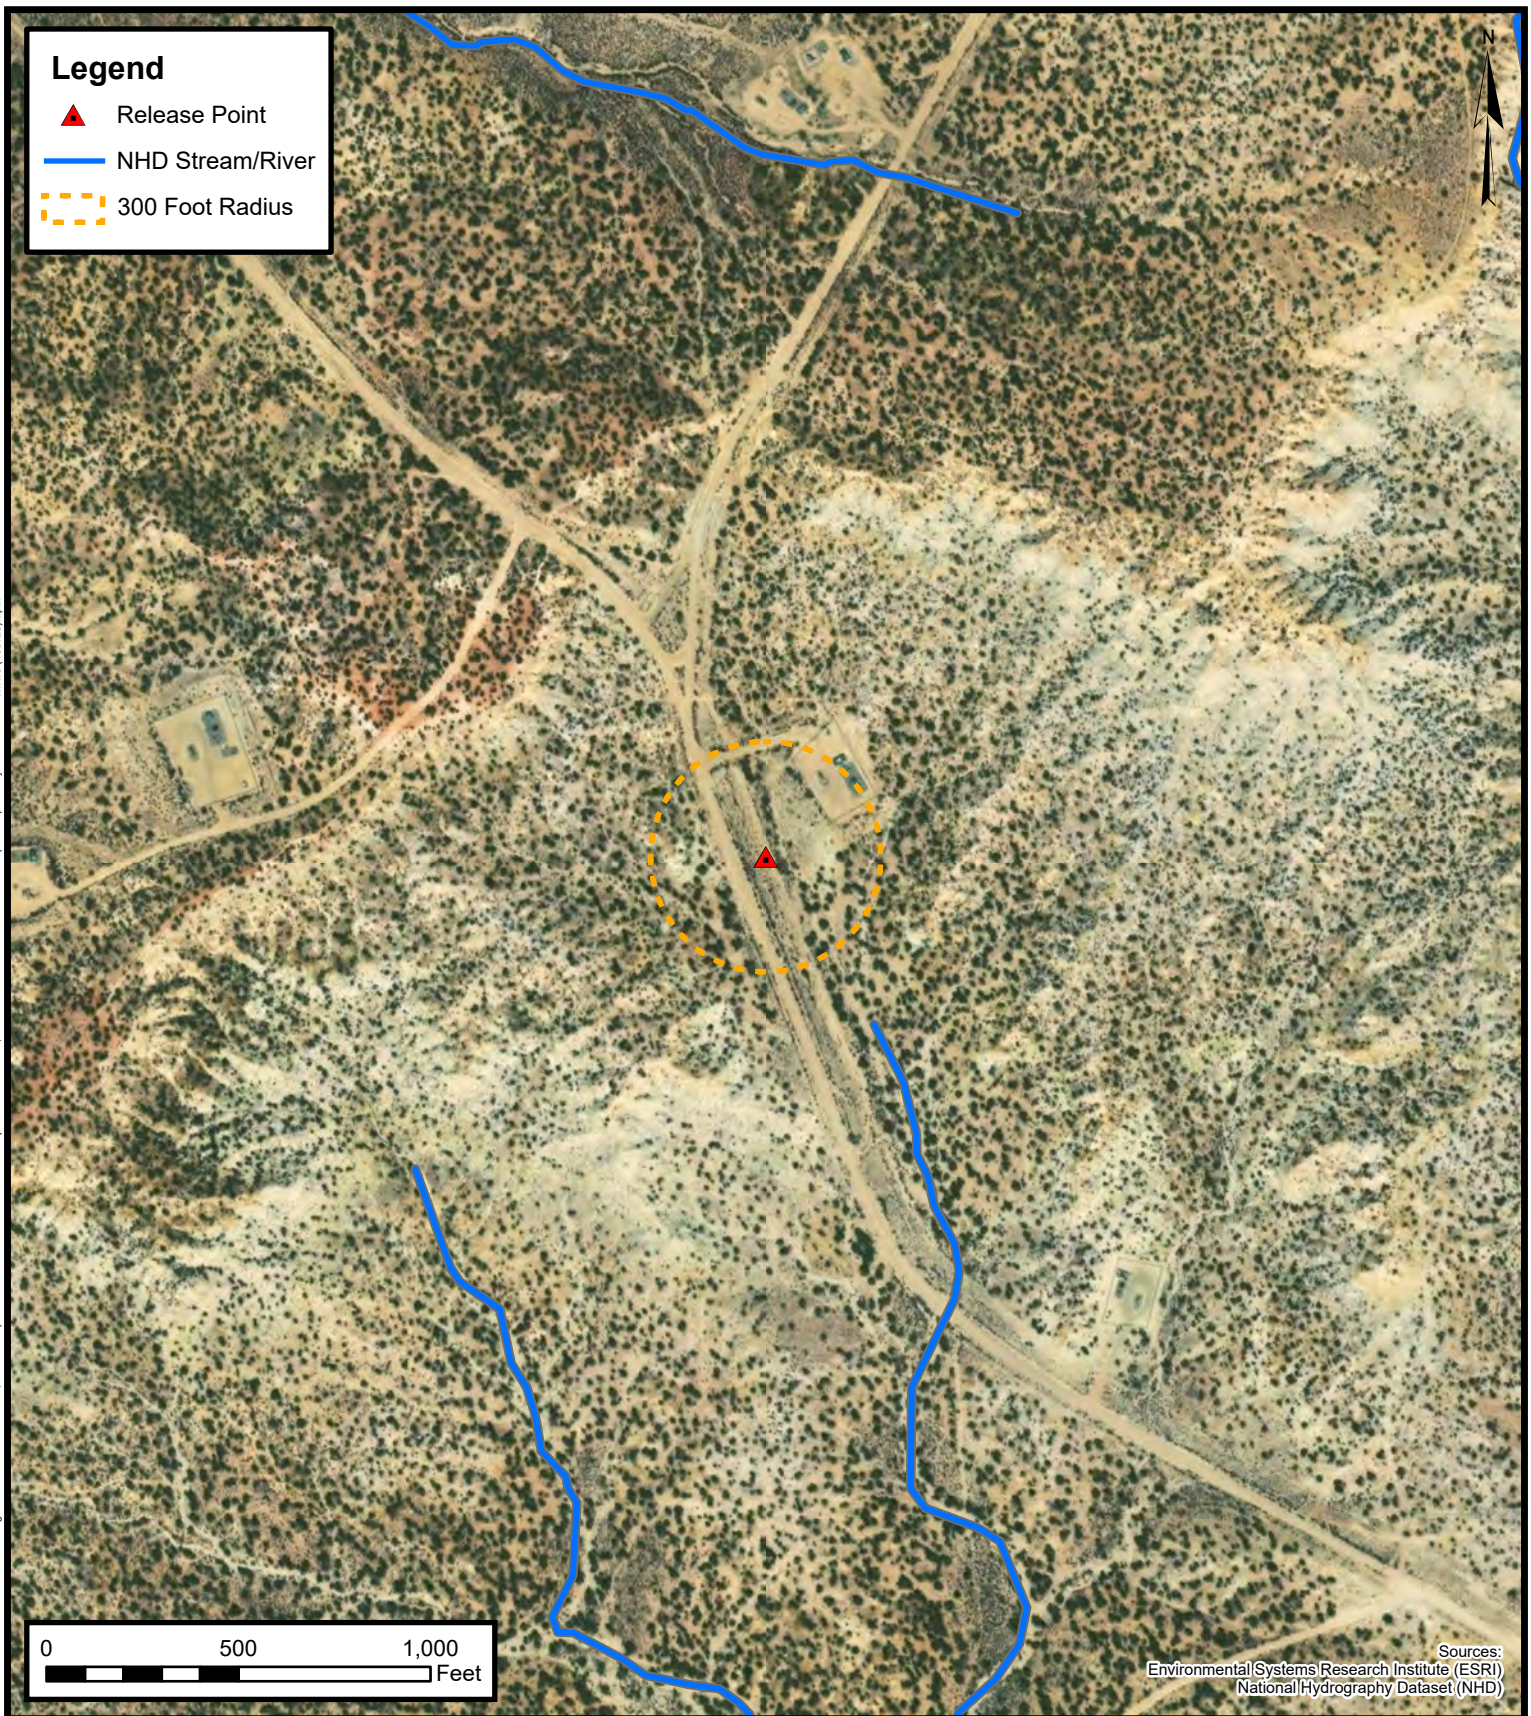
FIGURE  
**C**

### 300 Foot Radius Watercourse and Drainage Identification

- The Site is located within 300 feet of a NM EMNRD OCD-defined continuously flowing watercourse or significant watercourse (**Figure C, Appendix B**). The Site was approximately 35 feet from an ephemeral wash with regular high water flow marks.

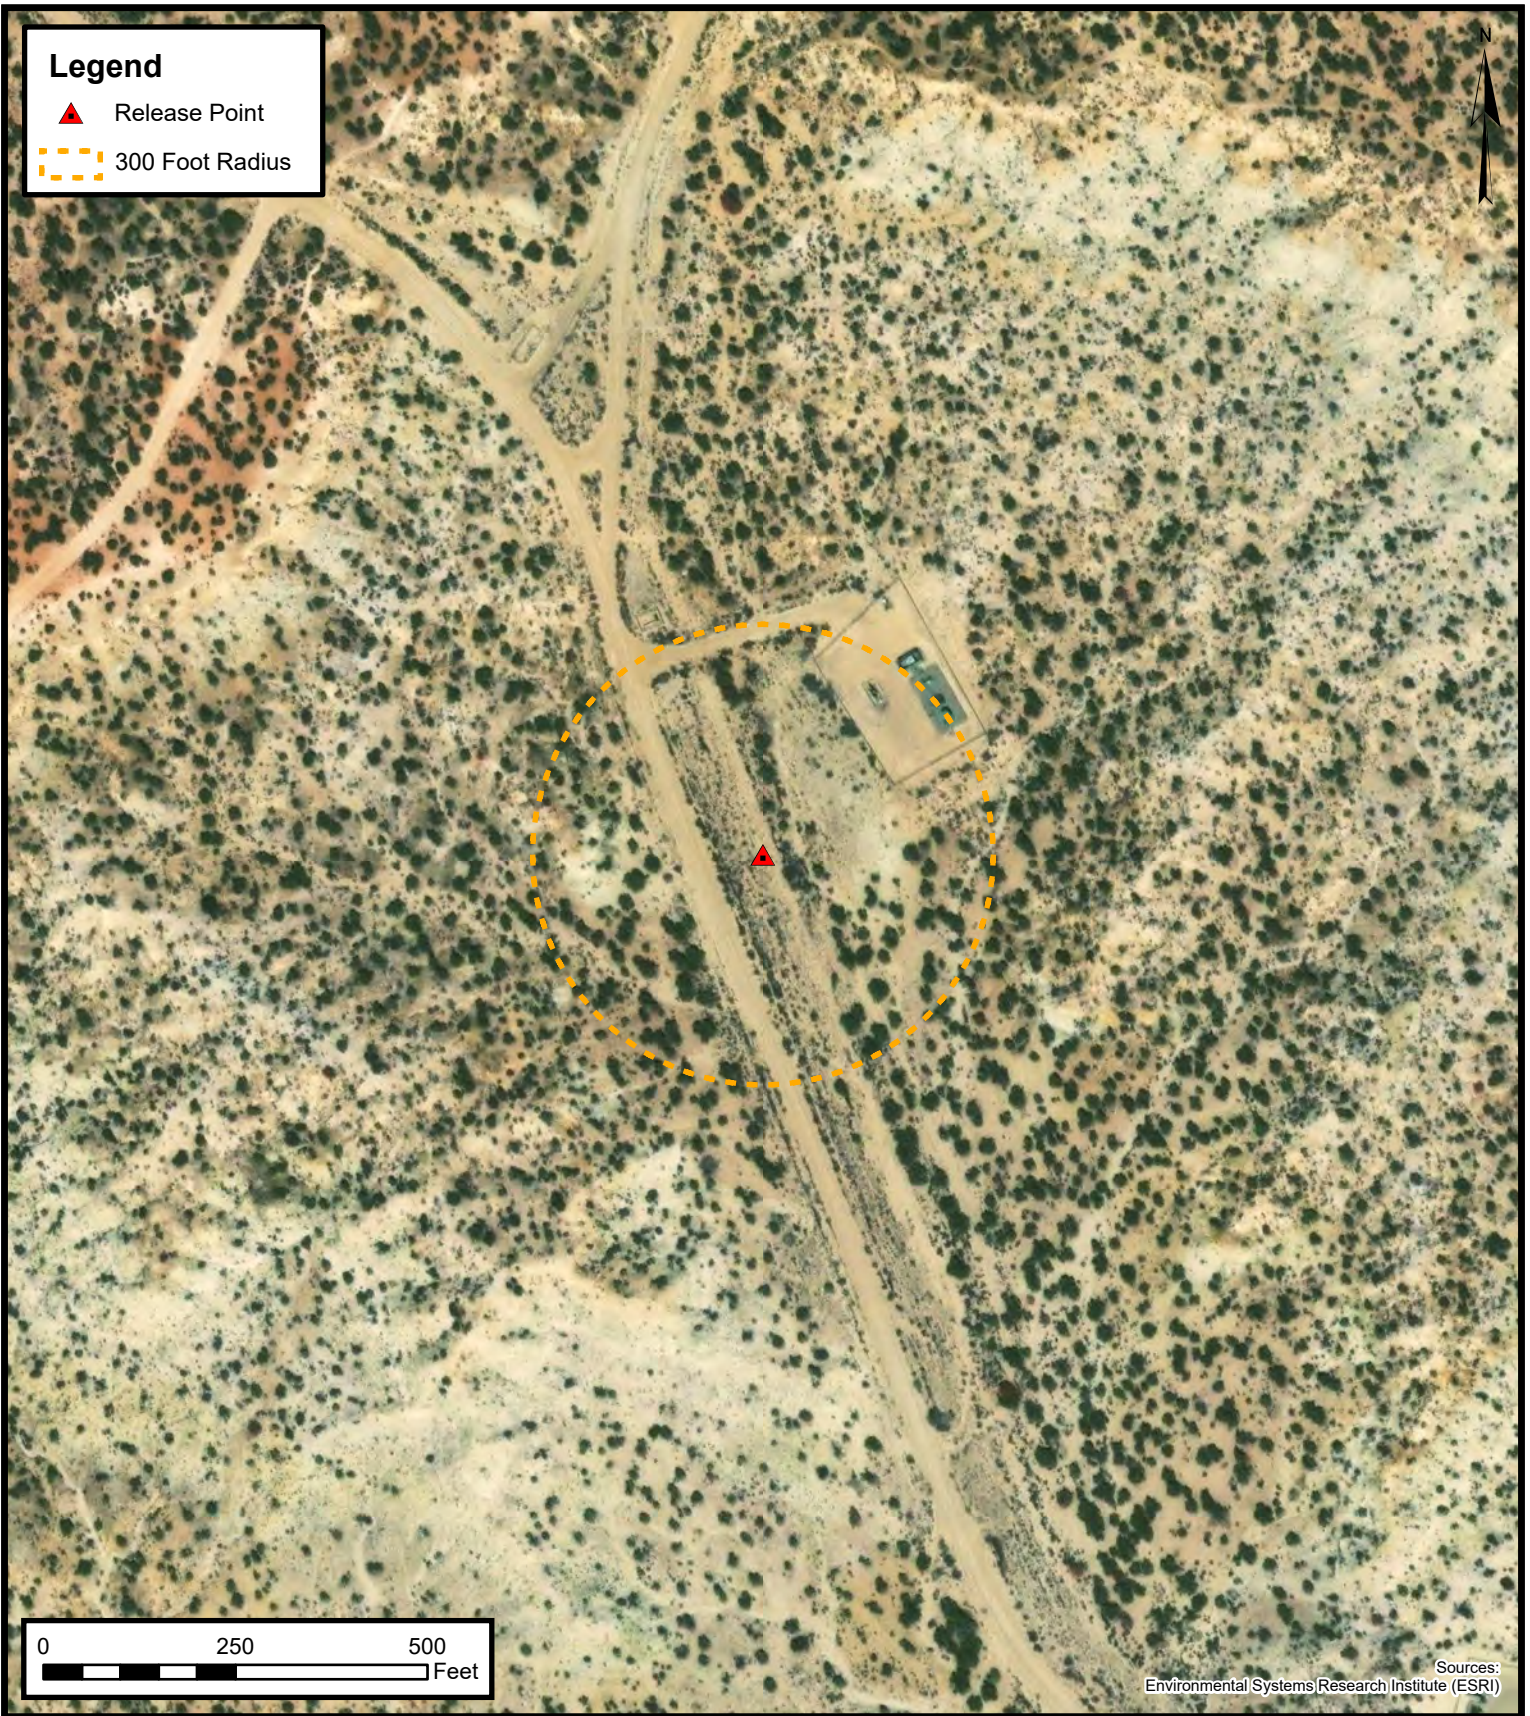
**FIGURE  
D**

### 300 Foot Radius Occupied Structure Identification

- The Site is not located within 200 feet of a lakebed, sinkhole, or playa lake.
- The Site is not located within 300 feet of a permanent residence, school, hospital, institution, or church (**Figure D, Appendix B**).

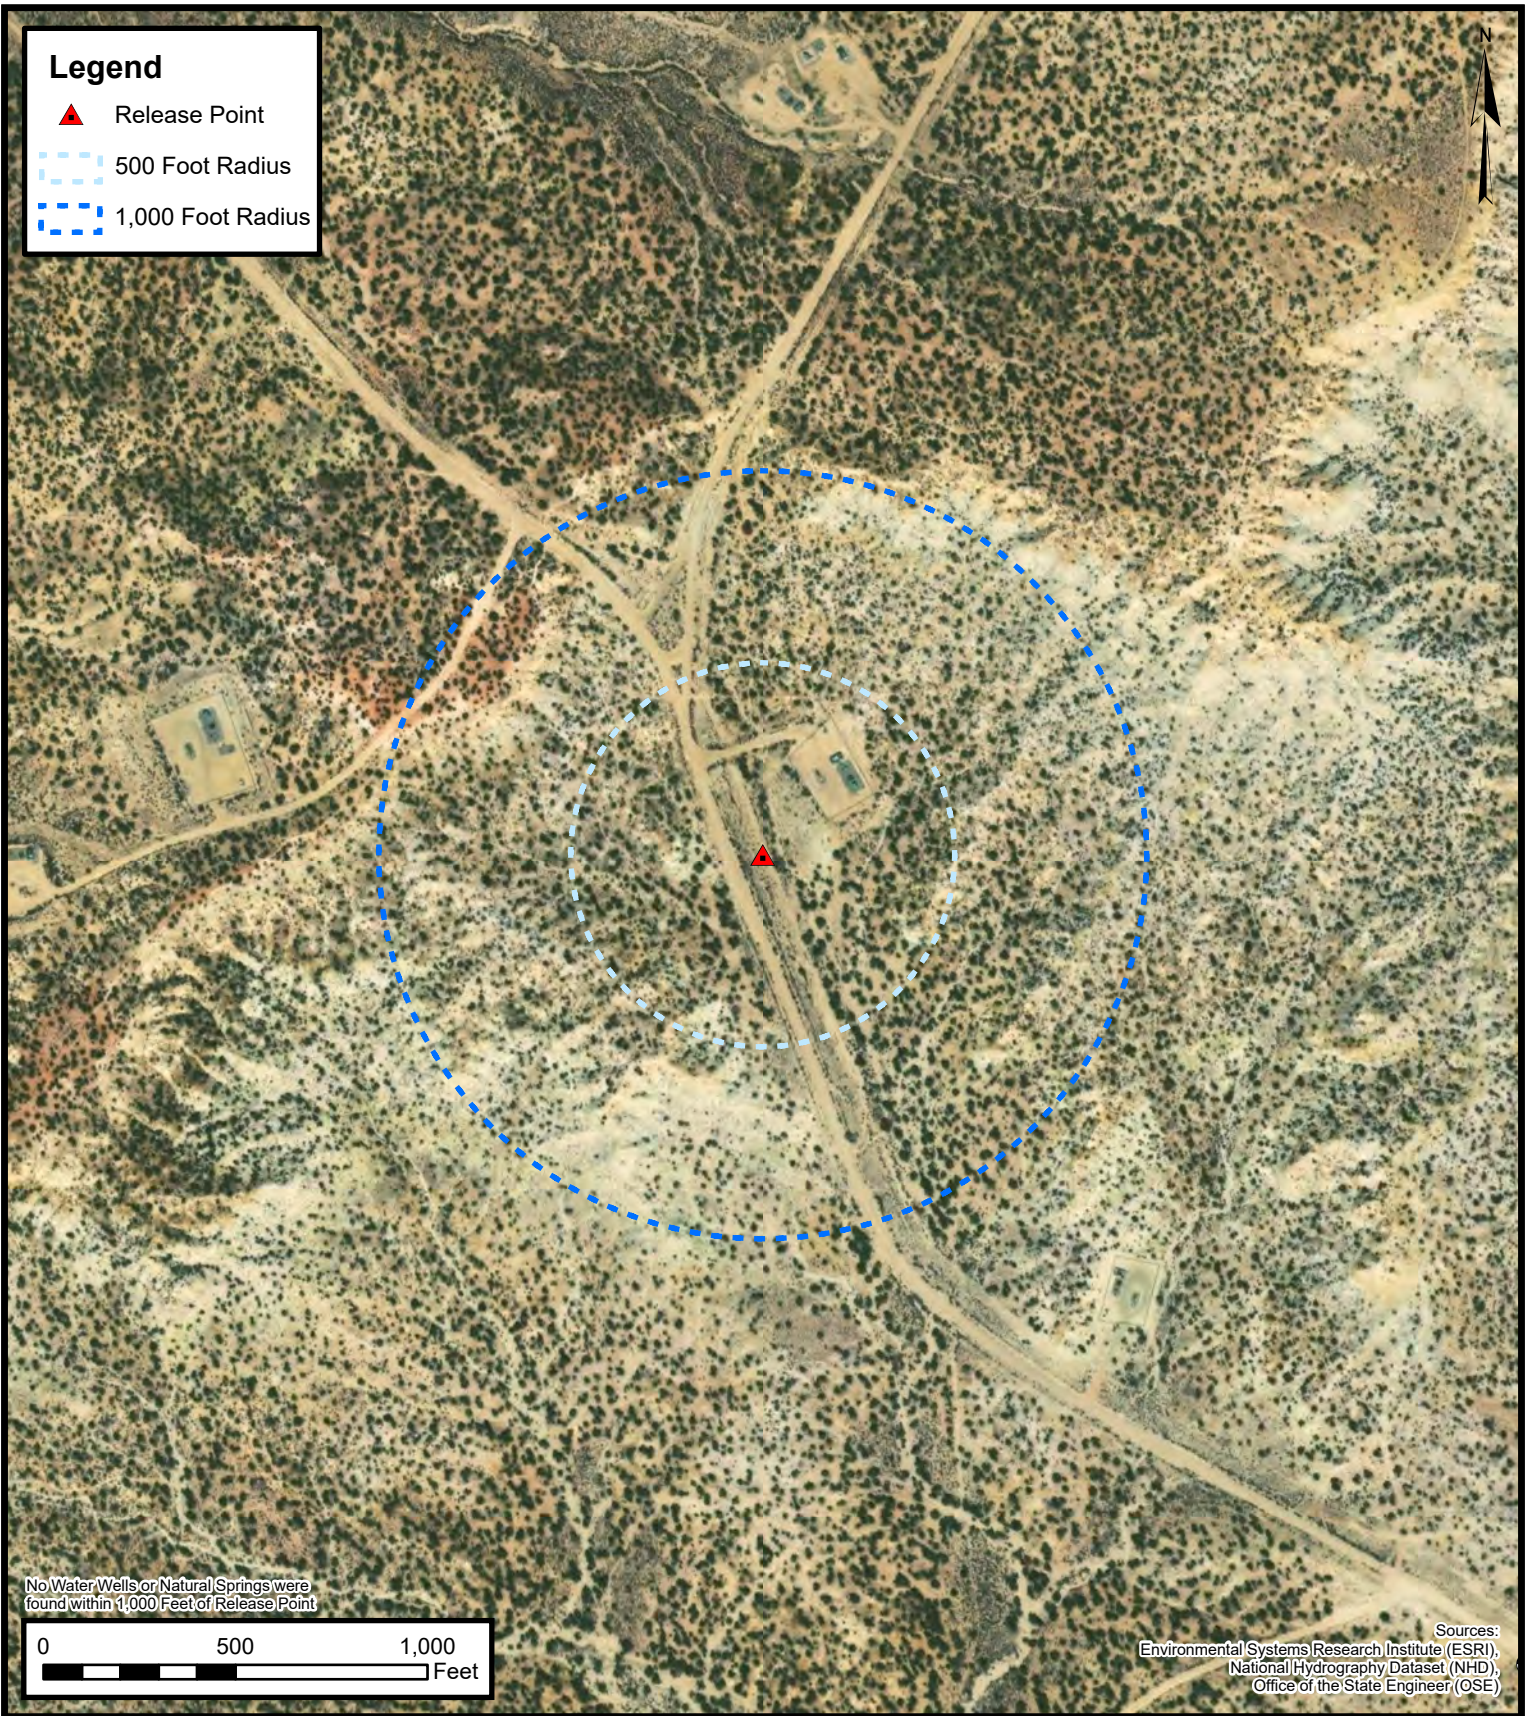
**FIGURE  
E**

**Water Well and  
Natural Spring Location**

- No springs, or private domestic freshwater wells used by less than five households for domestic or stock watering purposes were identified within 500 feet of the Site (**Figure E, Appendix B**).

- No freshwater wells or springs were identified within 1,000 feet of the Site (**Figure E, Appendix B**).
- The Site is not located within incorporated municipal boundaries or within a defined municipal fresh water well field covered under a municipal ordinance adopted pursuant to New Mexico Statutes Annotated (NMSA) 1978, Section 3-27-3.

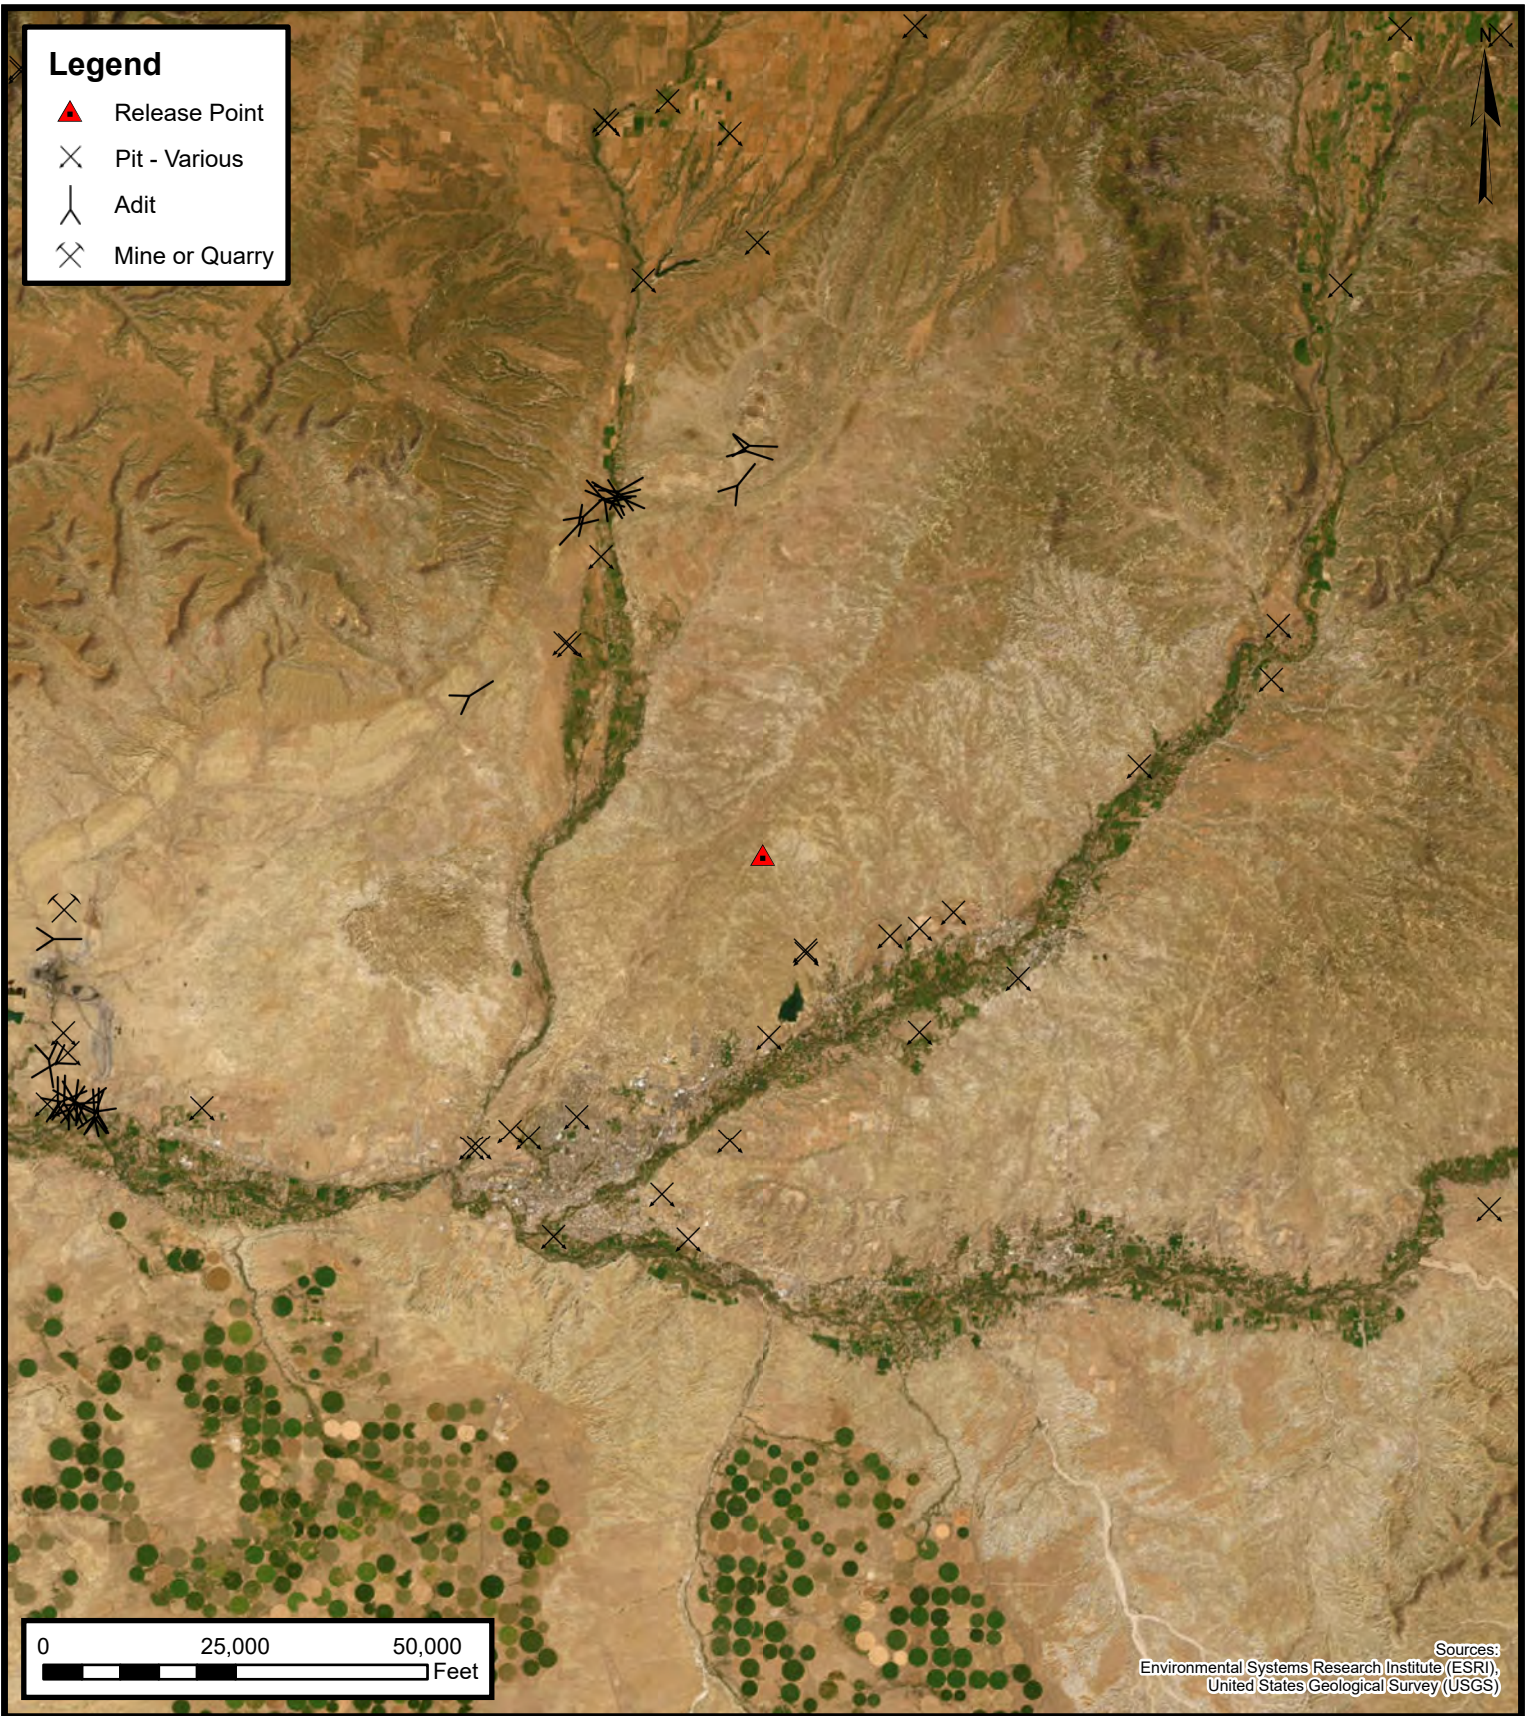
FIGURE  
**G**

## Mines, Mills, and Quarries

- Based on information identified in the NM Mining and Minerals Division's Geographic Information System (GIS) Maps and Mine Data database, the Site is not within an area overlying a subsurface mine (**Figure G, Appendix B**).
