## CLOSURE REPORT

**State Gas Com #3 (10/31/23)**  
Unit Letter J, S32 T31N R12W  
San Juan County, New Mexico

**New Mexico EMNRD OCD Incident ID No. NAPP2330435930**

Ensolum Project No. 05A1226294

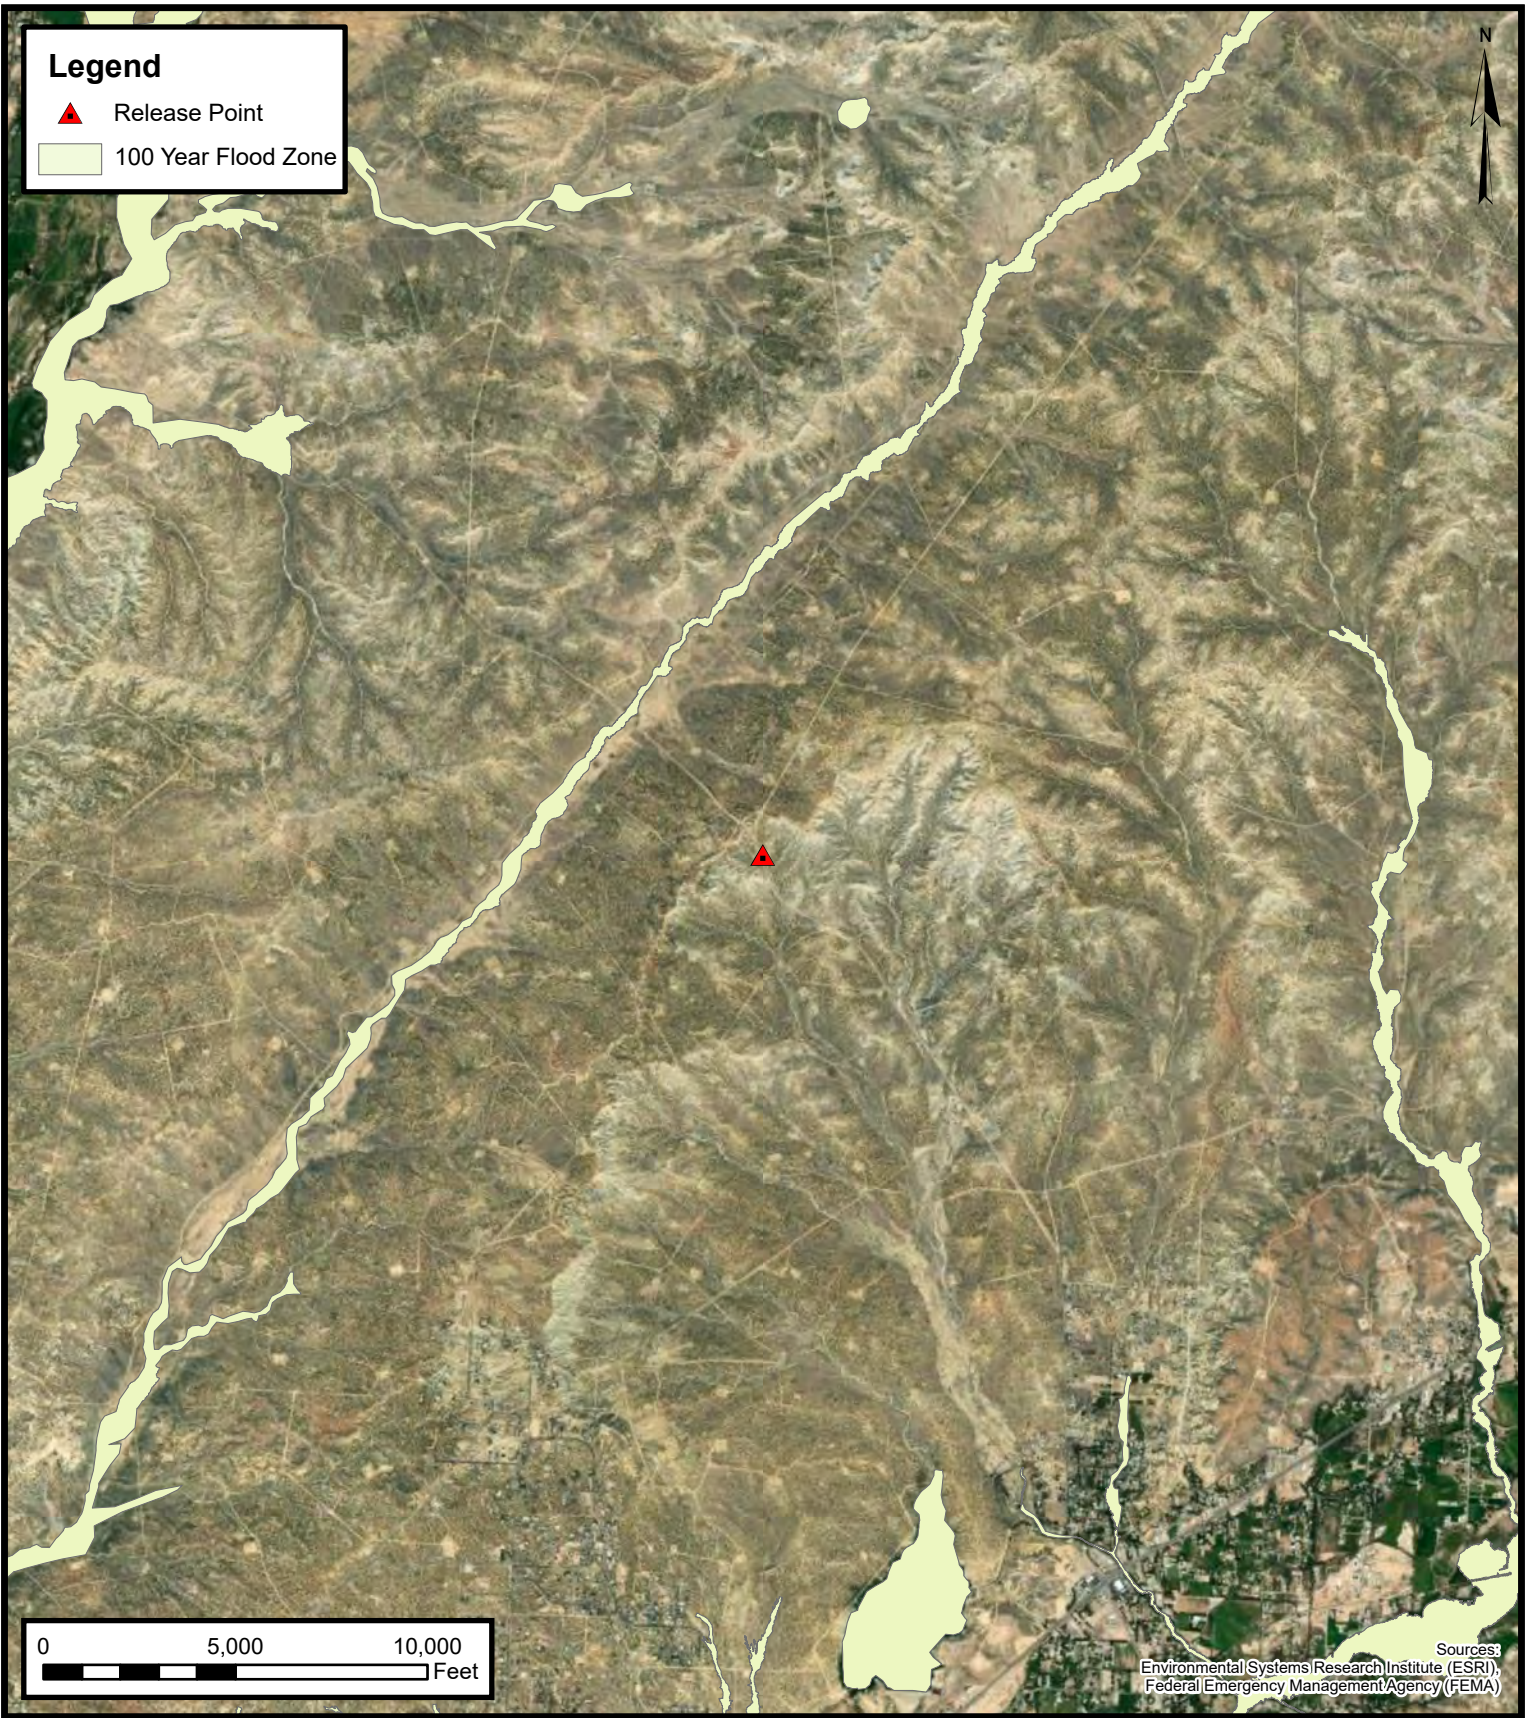
FIGURE  
H

## 100-Year Flood Plain Map

- Based on information provided by the Federal Emergency Management Agency (FEMA) National Flood Hazard Layer (NFHL) geospatial database, the Site is not within a 100-year floodplain (**Figure H, Appendix B**).

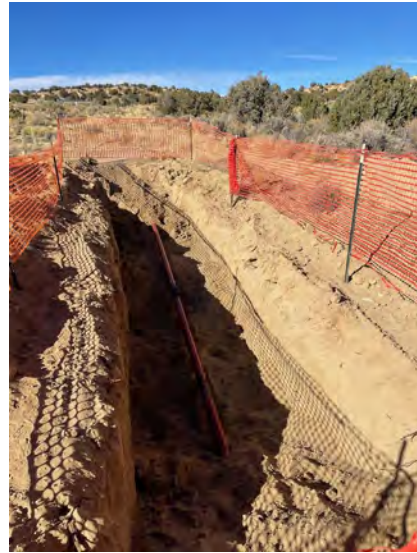
**Photograph 1**

Photograph Description: View of the in-process excavation activities.

The final excavation measured approximately 45 feet long and 12 feet wide at the maximum extents. The maximum depth of the excavation measured approximately 7 feet bgs. The flow path measured approximately 58 feet long and two feet wide at the maximum extents, with a depth of approximately six inches bgs. The lithology encountered during the completion of remediation activities consisted primarily of consolidated to unconsolidated silty sand underlain by shale.

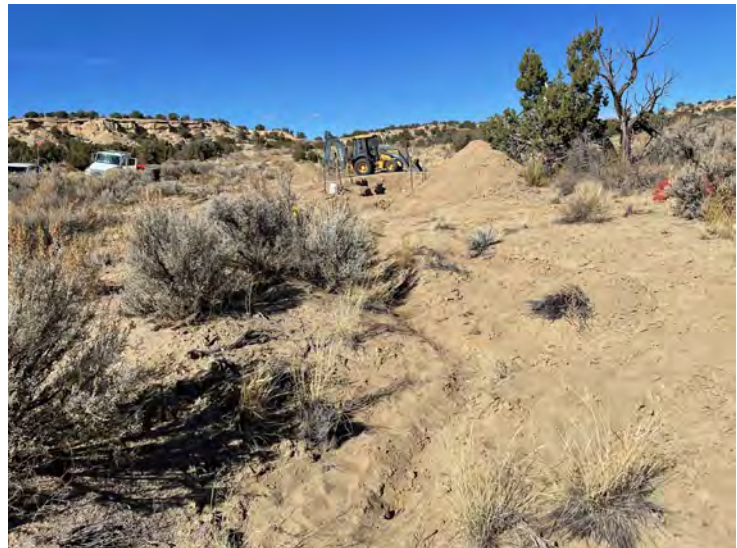
**Photograph 2**

Photograph Description: View of the hand-excavated flow path.

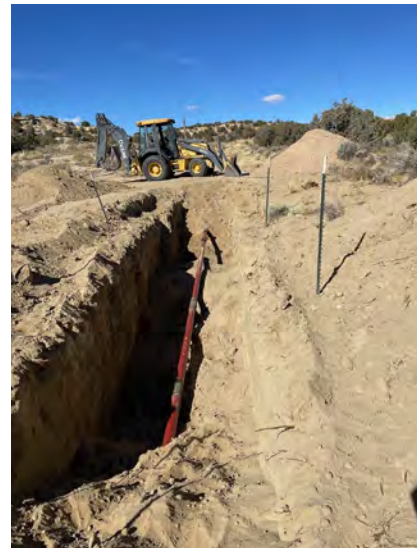
**Photograph 3**

Photograph Description: View of final excavation.

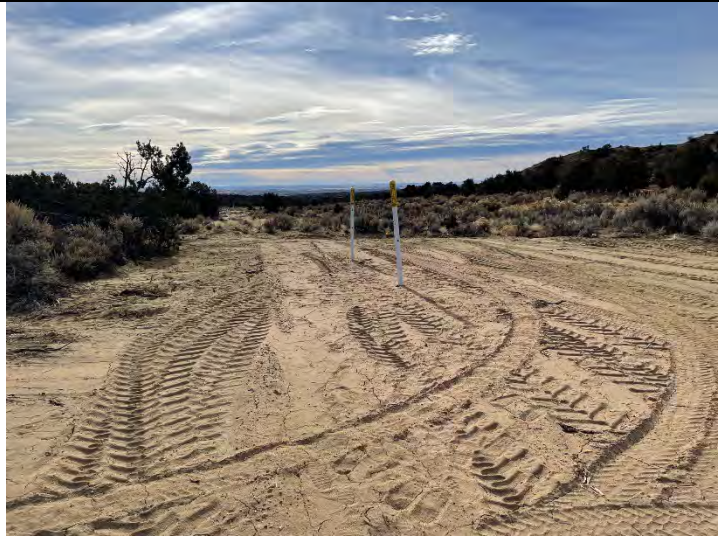
### Photograph 4

Photograph Description: View of the excavation after initial restoration.

The excavation was backfilled with imported fill and then contoured to the surrounding grade.
