February 5, 2024

**Re: REVISED Release Characterization and Work Plan
ConocoPhillips (Heritage COG Operating, LLC)
SRO State Com #018H Flowline Release
Unit Letter A, Section 17, Township 26 South, Range 28 East
Eddy County, New Mexico
Incident ID nAB1719137895
2RP-4288**

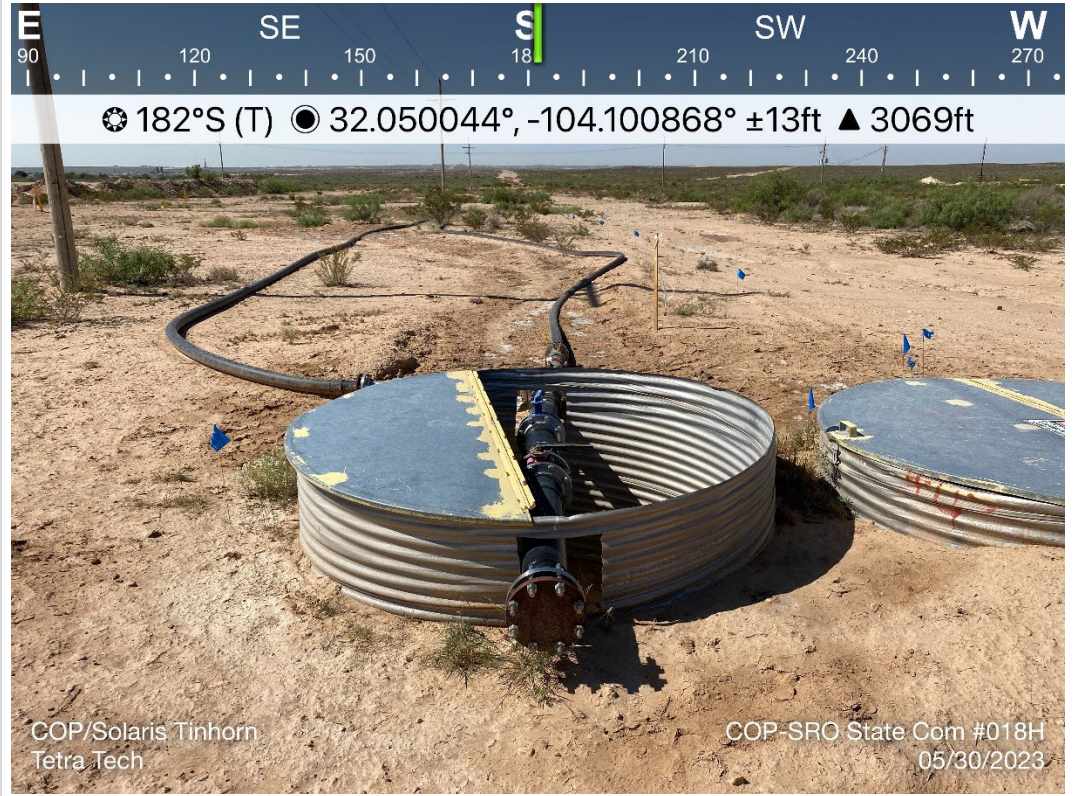
TETRA TECH, INC. PROJECT NO. 212C-MD-02826	DESCRIPTION	View south. Valve can and surface utilities. Release area with visible chloride staining.	2
	SITE NAME	SRO State Com #018H (nAB1719137895/ nAB1730649817)	5/30/2023

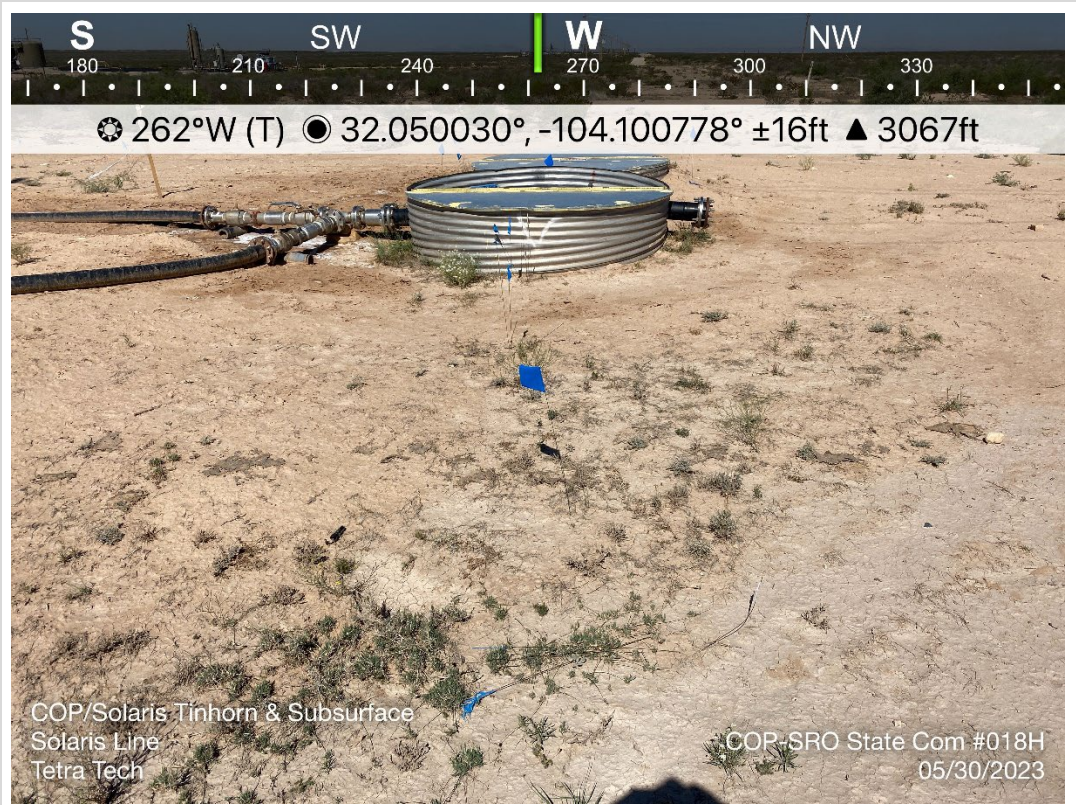
TETRA TECH, INC. PROJECT NO. 212C-MD-02826	DESCRIPTION	View west. Subsurface Solaris water line.	6
	SITE NAME	SRO State Com #018H (nAB1719137895/ nAB1730649817)	5/30/2023

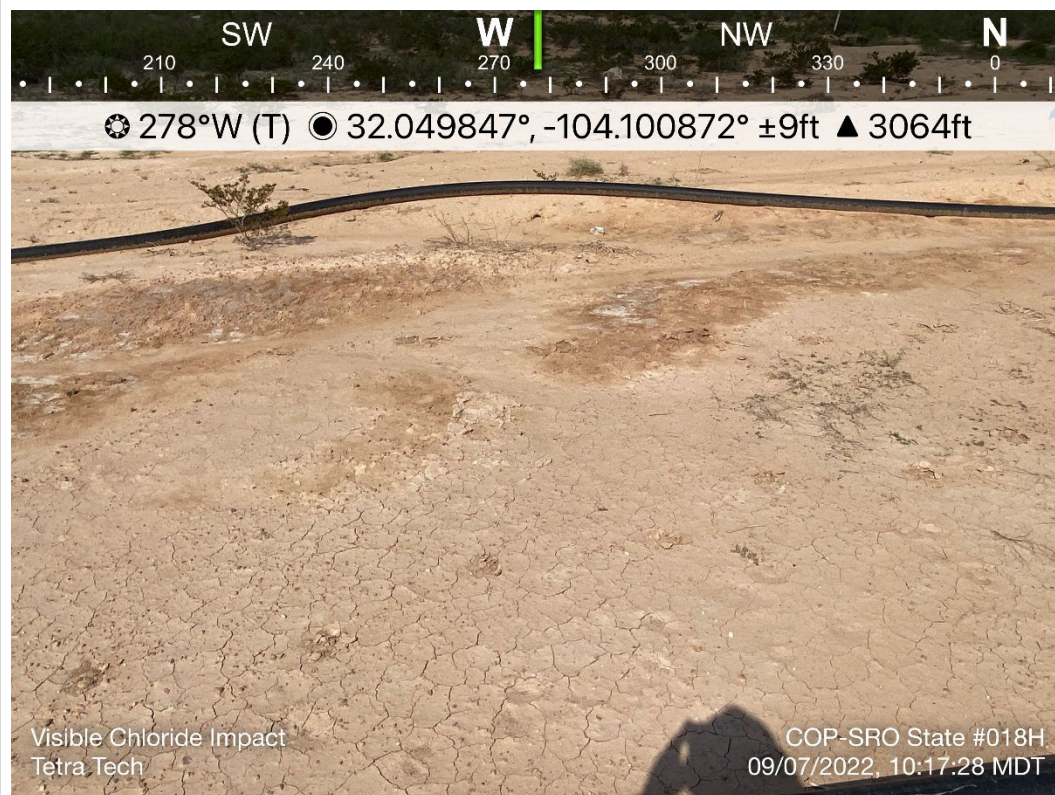
TETRA TECH, INC. PROJECT NO. 212C-MD-02826	DESCRIPTION	View west. Surface polyline and visible chloride staining.	12
	SITE NAME	SRO State Com #018H (nAB1719137895/ nAB1730649817)	9/7/2022
