February 5, 2024

**Re: REVISED Release Characterization and Closure Report
ConocoPhillips (Heritage COG Operating LLC)
SRO State Com #018H Flowline Release
Unit Letter A, Section 17, Township 26 South, Range 28 East
Eddy County, New Mexico
Incident ID nAB1730649817
2RP-4468**

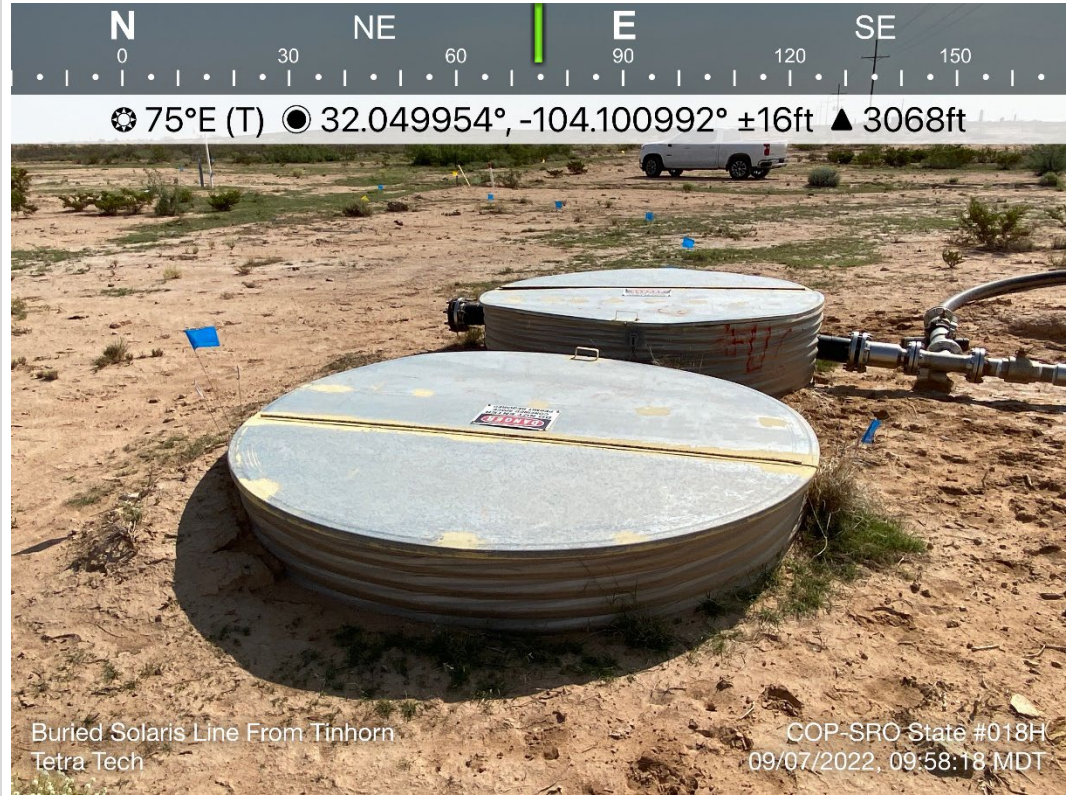
TETRA TECH, INC. PROJECT NO. 212C-MD-02826	DESCRIPTION	View of the Solaris valve cans.	2
	SITE NAME	SRO State Com #018H (nAB1730649817)	5/30/2023

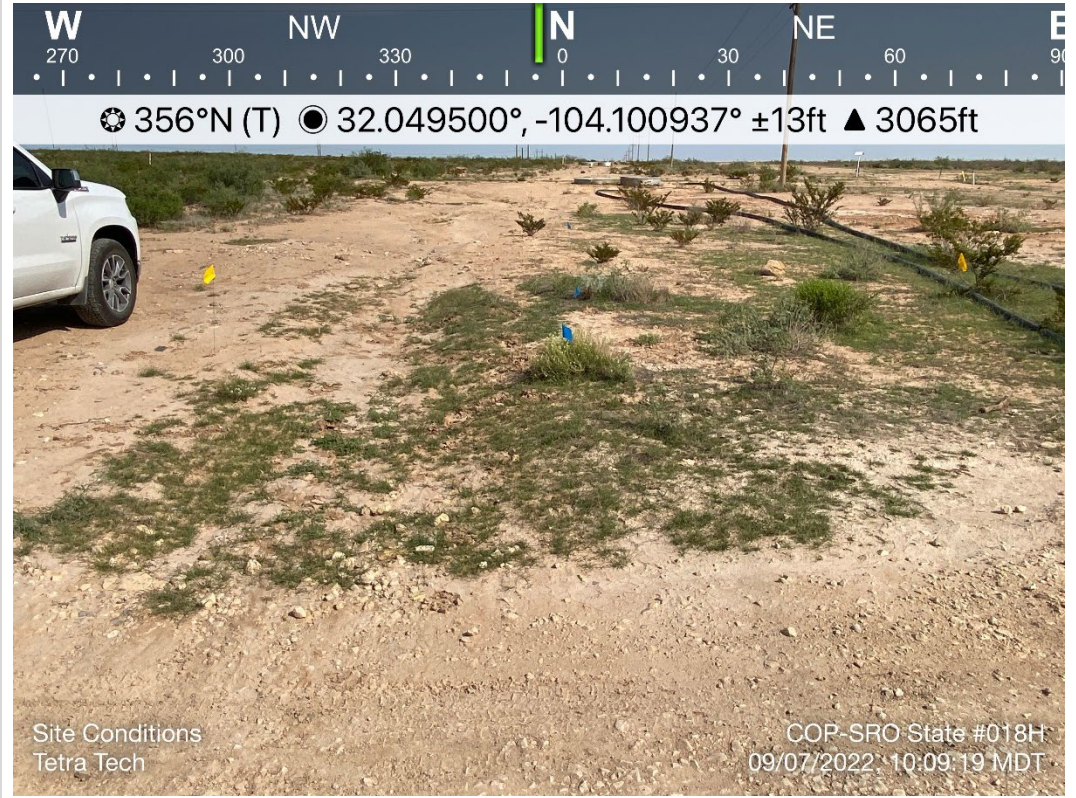
TETRA TECH, INC. PROJECT NO. 212C-MD-02826	DESCRIPTION	View north from southern end of release extent. Subsurface line markings and vegetation.	4
	SITE NAME	SRO State Com #018H (nAB1730649817)	9/7/2022

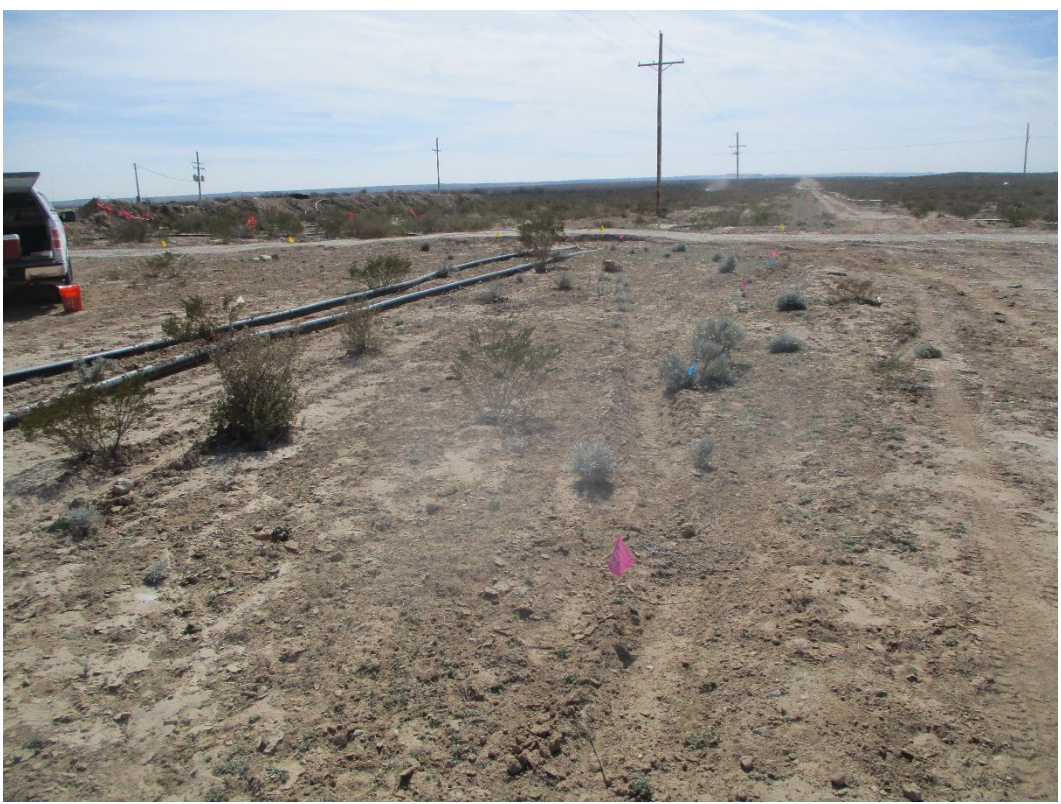
TETRA TECH, INC. PROJECT NO. 212C-MD-02826	DESCRIPTION	View south. Surface polylines, subsurface line markings and vegetation.	7
	SITE NAME	SRO State Com #018H (nAB1730649817)	2/13/2018

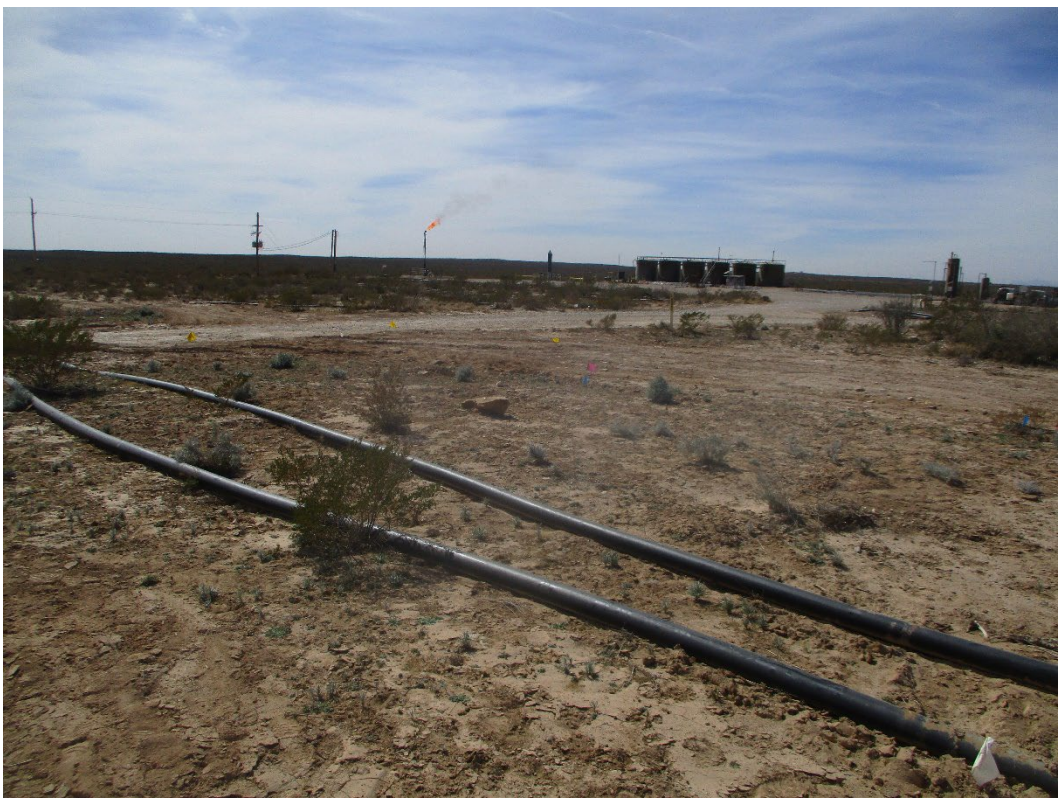
TETRA TECH, INC. PROJECT NO. 212C-MD-02826	DESCRIPTION	View southwest. Surface polylines, subsurface line markings, and vegetation	8
	SITE NAME	SRO State Com #018H (nAB1730649817)	2/13/2018
