**Re: Closure Request  
Mesa 8105 JVP #3H Produced Water Line  
Incident Number NRM2016045357  
Lea County, New Mexico**

BTA Oil Producers, LLC  
Closure Request  
Mesa 8105 JVP #3H Produced Water Line

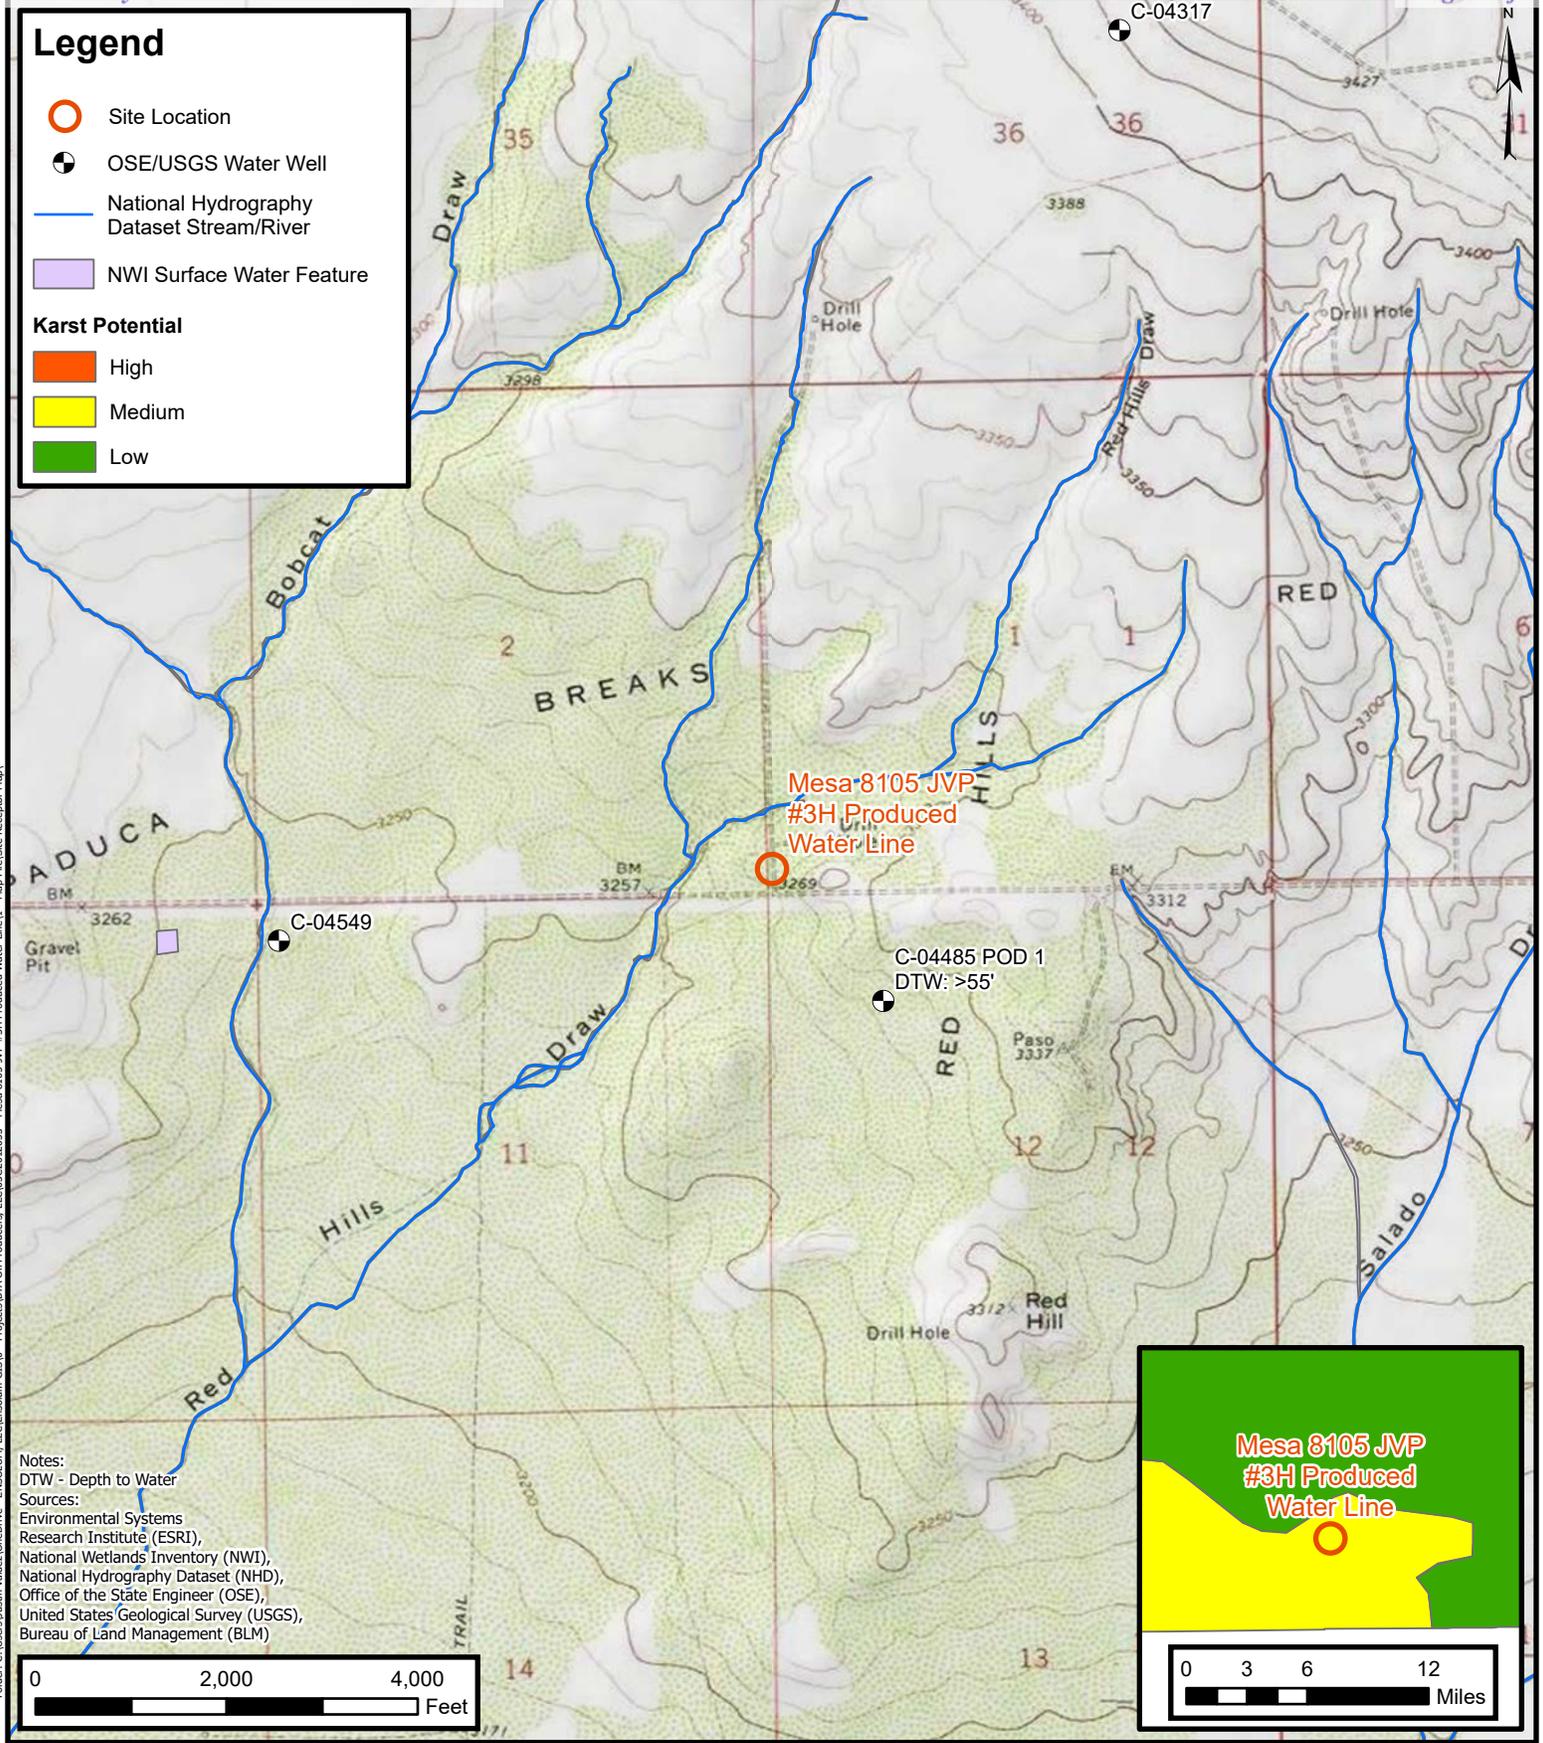
**FIGURE**  
**1**

The Site was characterized to assess the applicability of Table I, Closure Criteria for Soils Impacted by a Release, of Title 19, Chapter 15, Part 29 (19.15.29) of the New Mexico Administrative Code (NMAC). Results from the characterization desktop review are presented on page 3 of the Form C-141, Site Assessment/Characterization. Potential Site receptors are identified on Figure 1.

All wells used for depth to groundwater determination are presented on Figure 1. The associated well records are included in Appendix A.

The closest continuously flowing or significant watercourse is greater than 300 feet from the Site. The Site is greater than 200 feet from a lakebed, sinkhole, or playa lake and greater than 300 feet from an occupied residence, school, hospital, institution, church, or wetland. The Site is greater than 1,000 feet to a freshwater well or spring and is not within a 100-year floodplain or overlying a subsurface mine. The Site is not underlain by unstable geology (medium potential karst designation area). Site receptors are identified on Figure 1.

**Site Receptor Map**  
 BTA Oil Producers, LLC  
 Mesa 8105 JVP #3H Produced Water Line  
 Incident Number: NRM2016045357  
 Unit M, Sec 1, T26S, R32E  
 Lea County, New Mexico

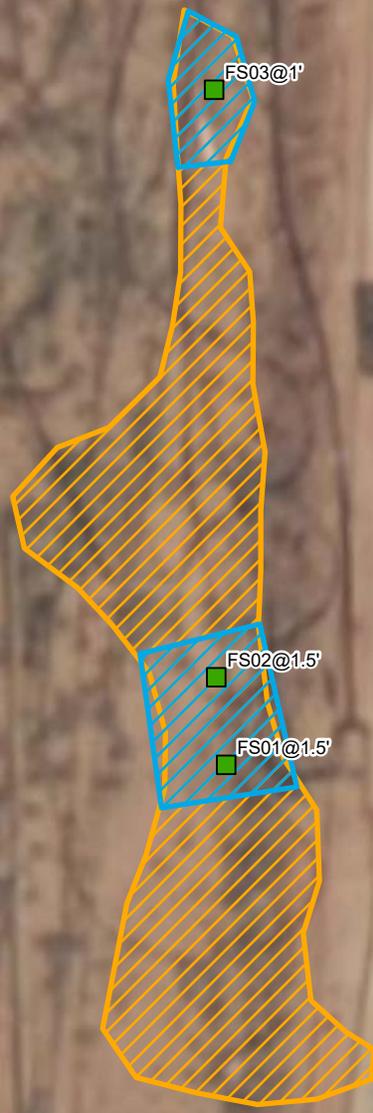
Following removal of impacted soil, 5-point composite soil samples were collected every 200 square feet from the floor and sidewalls of the excavation. The 5-point composite soil samples were collected by placing five equivalent aliquots of soil into a 1-gallon, resealable plastic bag and homogenizing the samples by thoroughly mixing. Composite soil samples FS01 through FS03 were collected from the floor of the excavation at depths ranging from 1-foot to 1.5 feet bgs. Due to the shallow depth of the excavation, soil from the excavation sidewalls was included in the floor samples. The soil samples were handled and analyzed as previously described. The excavation extent and excavation soil sample locations were mapped utilizing a handheld GPS unit and are depicted on Figure 3.

Laboratory analytical results for excavation floor samples FS01 through FS03 indicated all COC concentrations were compliant with the Site Closure Criteria and reclamation requirement. Laboratory analytical results are summarized in Table 1 and the complete laboratory analytical reports are included as Appendix D.

- Excavation Soil Sample in Compliance with Closure Criteria
- Excavation Extent
- Release Extent

Notes:  
Sample ID @ Depth Below Ground/Surface.

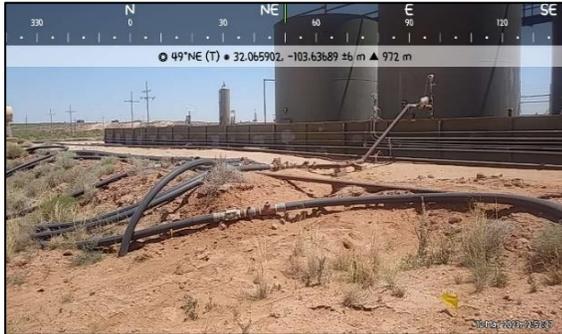
Photograph: 1 Date: 5/10/2023  
Description: Historical release area  
View: Northeast

On May 10, 2023, Ensolum personnel were at the Site to evaluate the release extent based on information provided on the Form C-141, the documented release extent, and visual observations. No visible indications of the historical release were observed. Nine assessment soil samples (SS01 through SS09) were collected within and around the documented release extent at a depth of approximately 0.5 feet bgs, to assess for the presence or absence of impacted soil. The soil samples were field screened for volatile organic compounds (VOCs) utilizing a calibrated photoionization detector (PID) and chloride using Hach® chloride QuanTab® test strips. The soil sample locations were mapped utilizing a handheld Global Positioning System (GPS) unit and are depicted on Figure 2. Photographic documentation was completed during the Site visit and a photographic log is included as Appendix B.

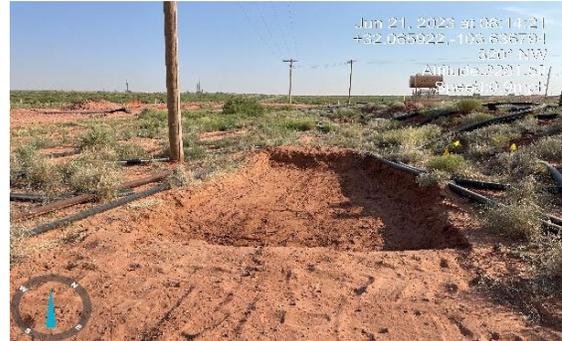
Photograph: 2 Date: 6/21/2023  
Description: Completed excavation  
View: Northwest

On June 20, 2023 and June 21, 2023, Ensolum personnel oversaw excavation of impacted soil from the release area as indicated by laboratory analytical results for assessment samples SS02 and SS03. Excavation activities were performed via hand shoveling, backhoe, and skidsteer to depths ranging from 1-foot to 1.5 feet bgs. To direct excavation activities, soil was field screened for VOCs and chloride as previously described. Photographic documentation is included in Appendix B.

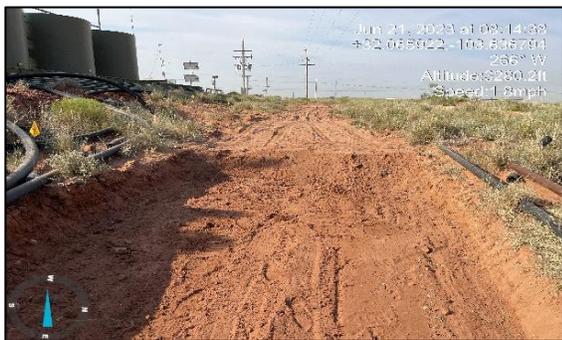
Photograph: 3 Date: 6/21/2023  
Description: Completed excavation  
View: West

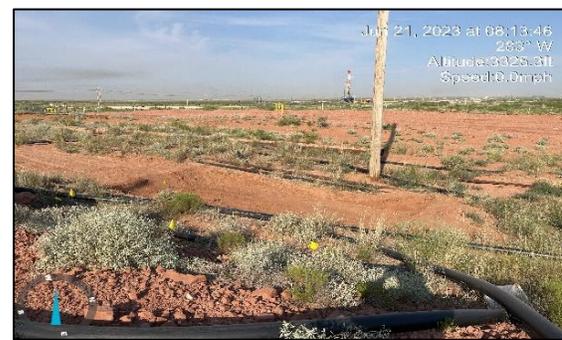
Photograph: 4 Date: 6/21/2023  
Description: Completed excavation  
View: West

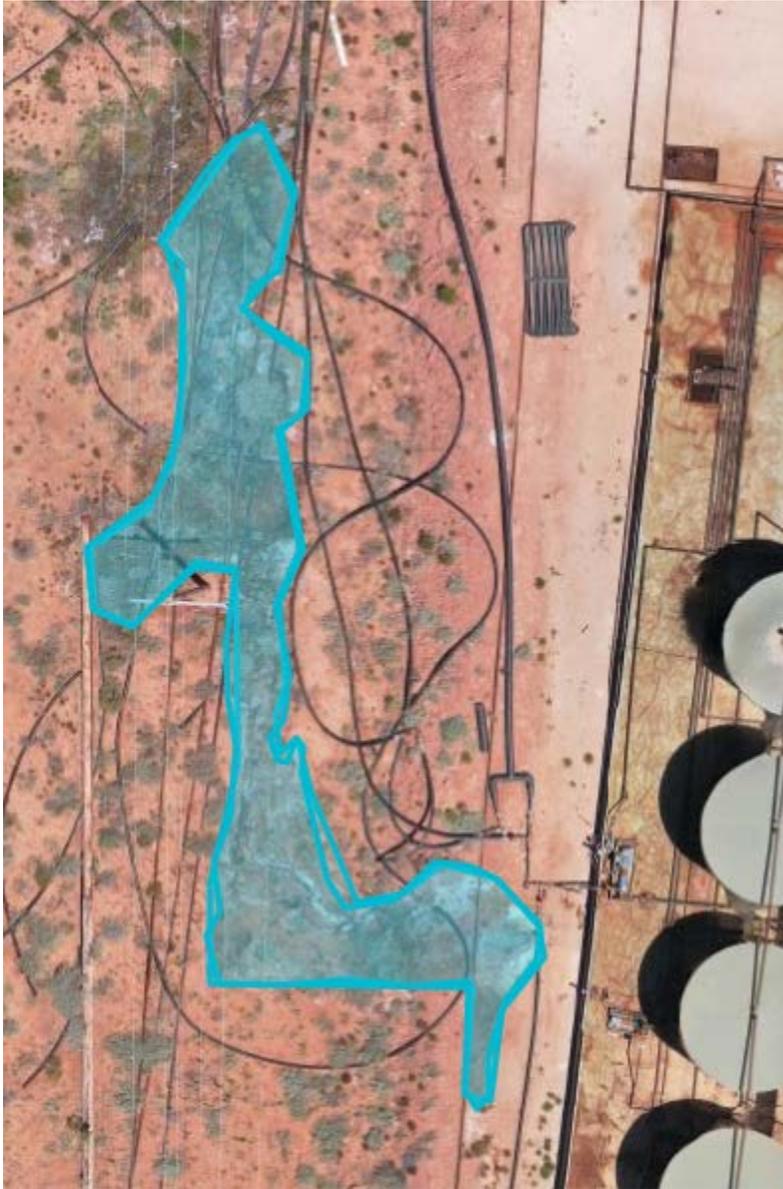
**Mesa #003H**  
**May 21, 2020**

The body of a check valve failed on the water flow line. This check valve was outside of secondary containment. As a result, 16 BBL of produced water was released from the raised location and down into a gully. Except in the area of the busted check valve, the produced water ran across the surface of the ground and soaked in. No water was recovered. Removal of the soil impacted by the produced water is nearly complete on the date of this filing. The produced water soaked into the soil about 6 inches deep.

**Location** Mesa B #003H  
**API #** 30-025-41290  
**Spill Date** 5/21/2020
