## CLOSURE REPORT

### **South Eddy Flare Fire**

**Unit H, S01, T25S, R30E  
32.160411° N, 103.827911° W  
Eddy County, New Mexico  
NMOCD Incident ID: nAPP2316528547**

August 11, 2023  
Ensolum Project No. 03B1226287

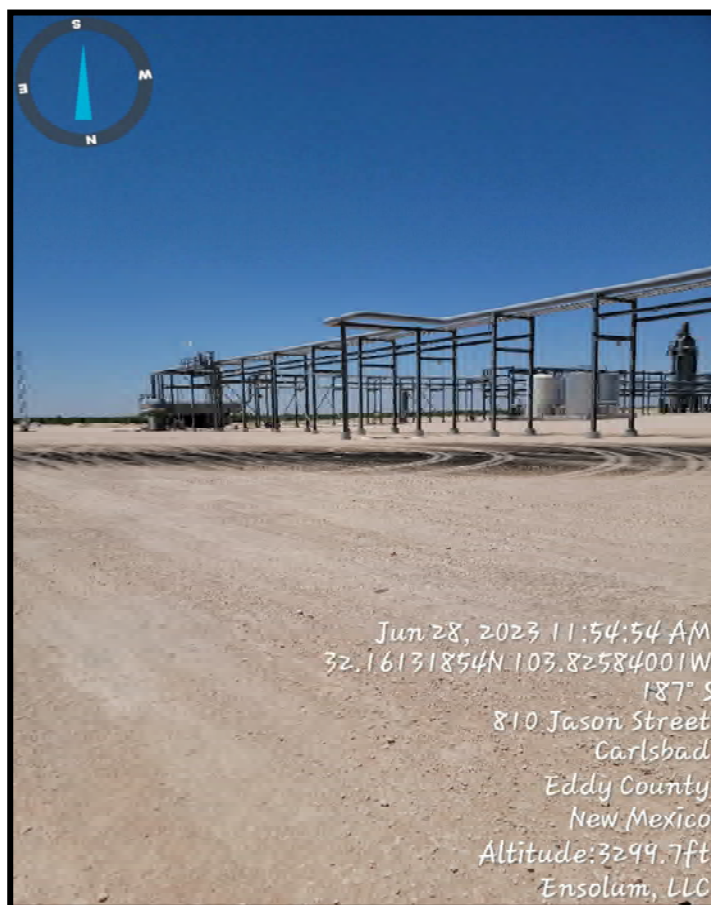
View of extent of impact during initial sampling activities, facing south.

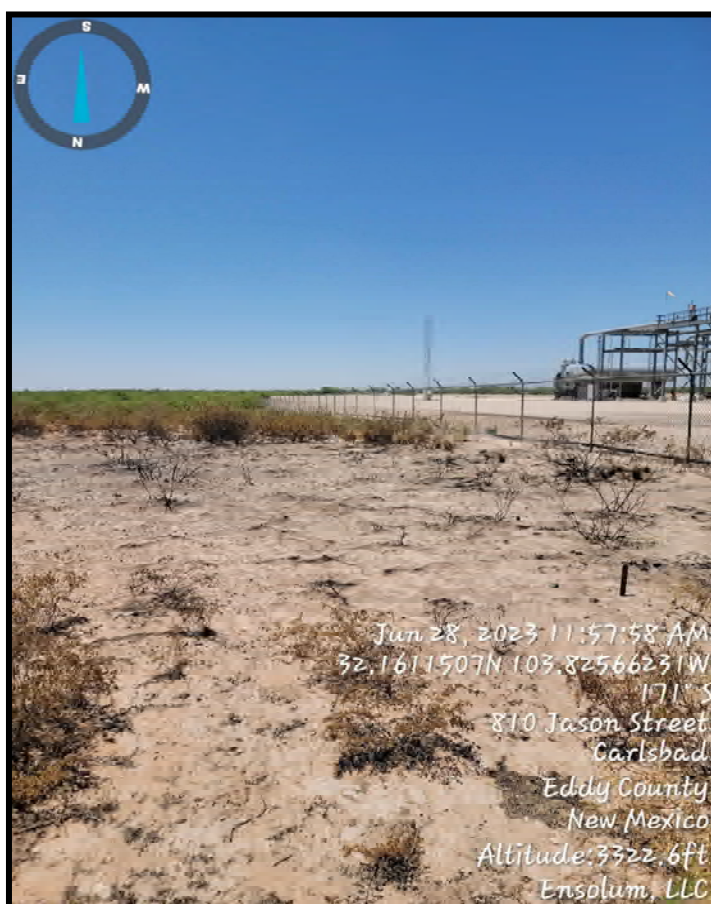
View of extent of impact on BLM land during initial sampling activities, facing south.

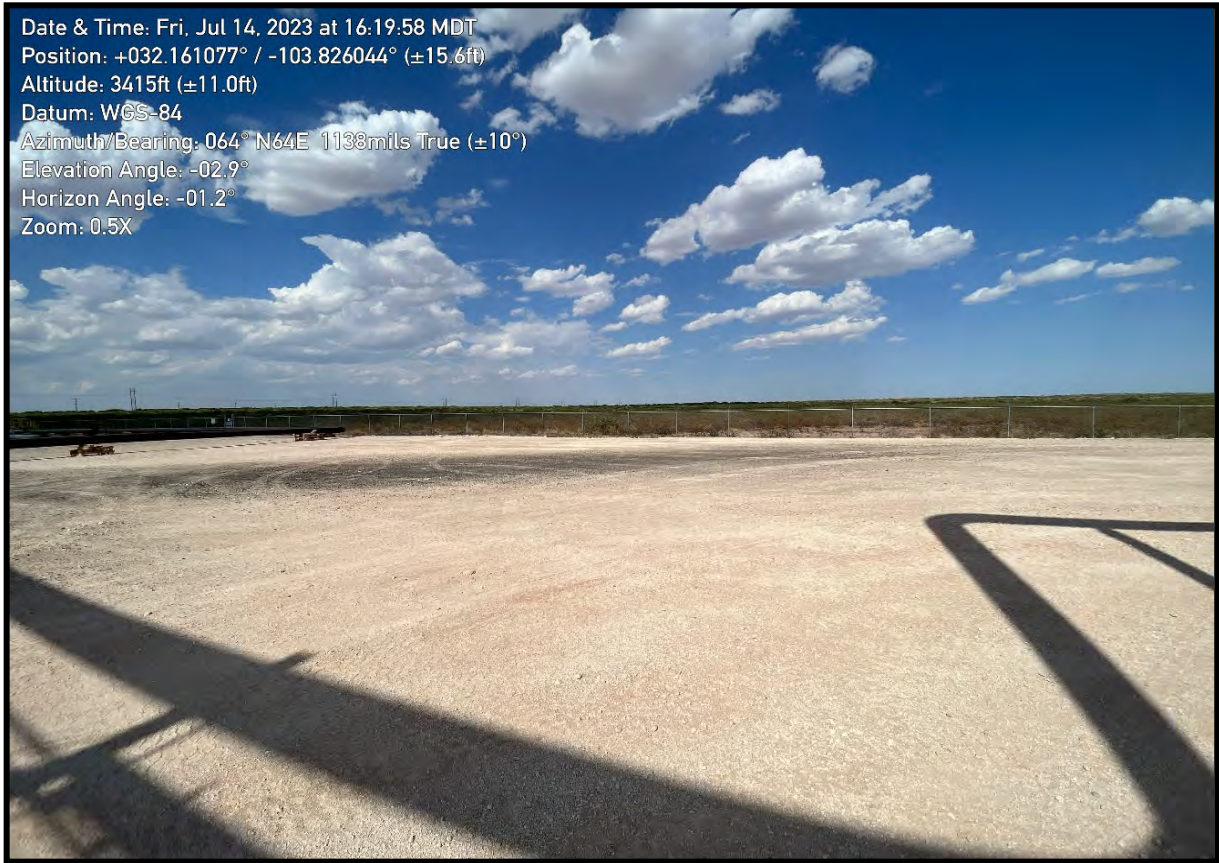
View of extent of impact during delineation sampling activities, facing northeast.
