Environmental Site Remediation Work Plan

Incident ID:	nAPP2326256394
RP Reference:	N/A
Site Location:	Boyd Y Water Transfer Line
Project #:	23E-05378
Phone #:	713.553.8320
Phone #:	575.988.1472

Characterization Schematic Boyd Y Water Transfer Line

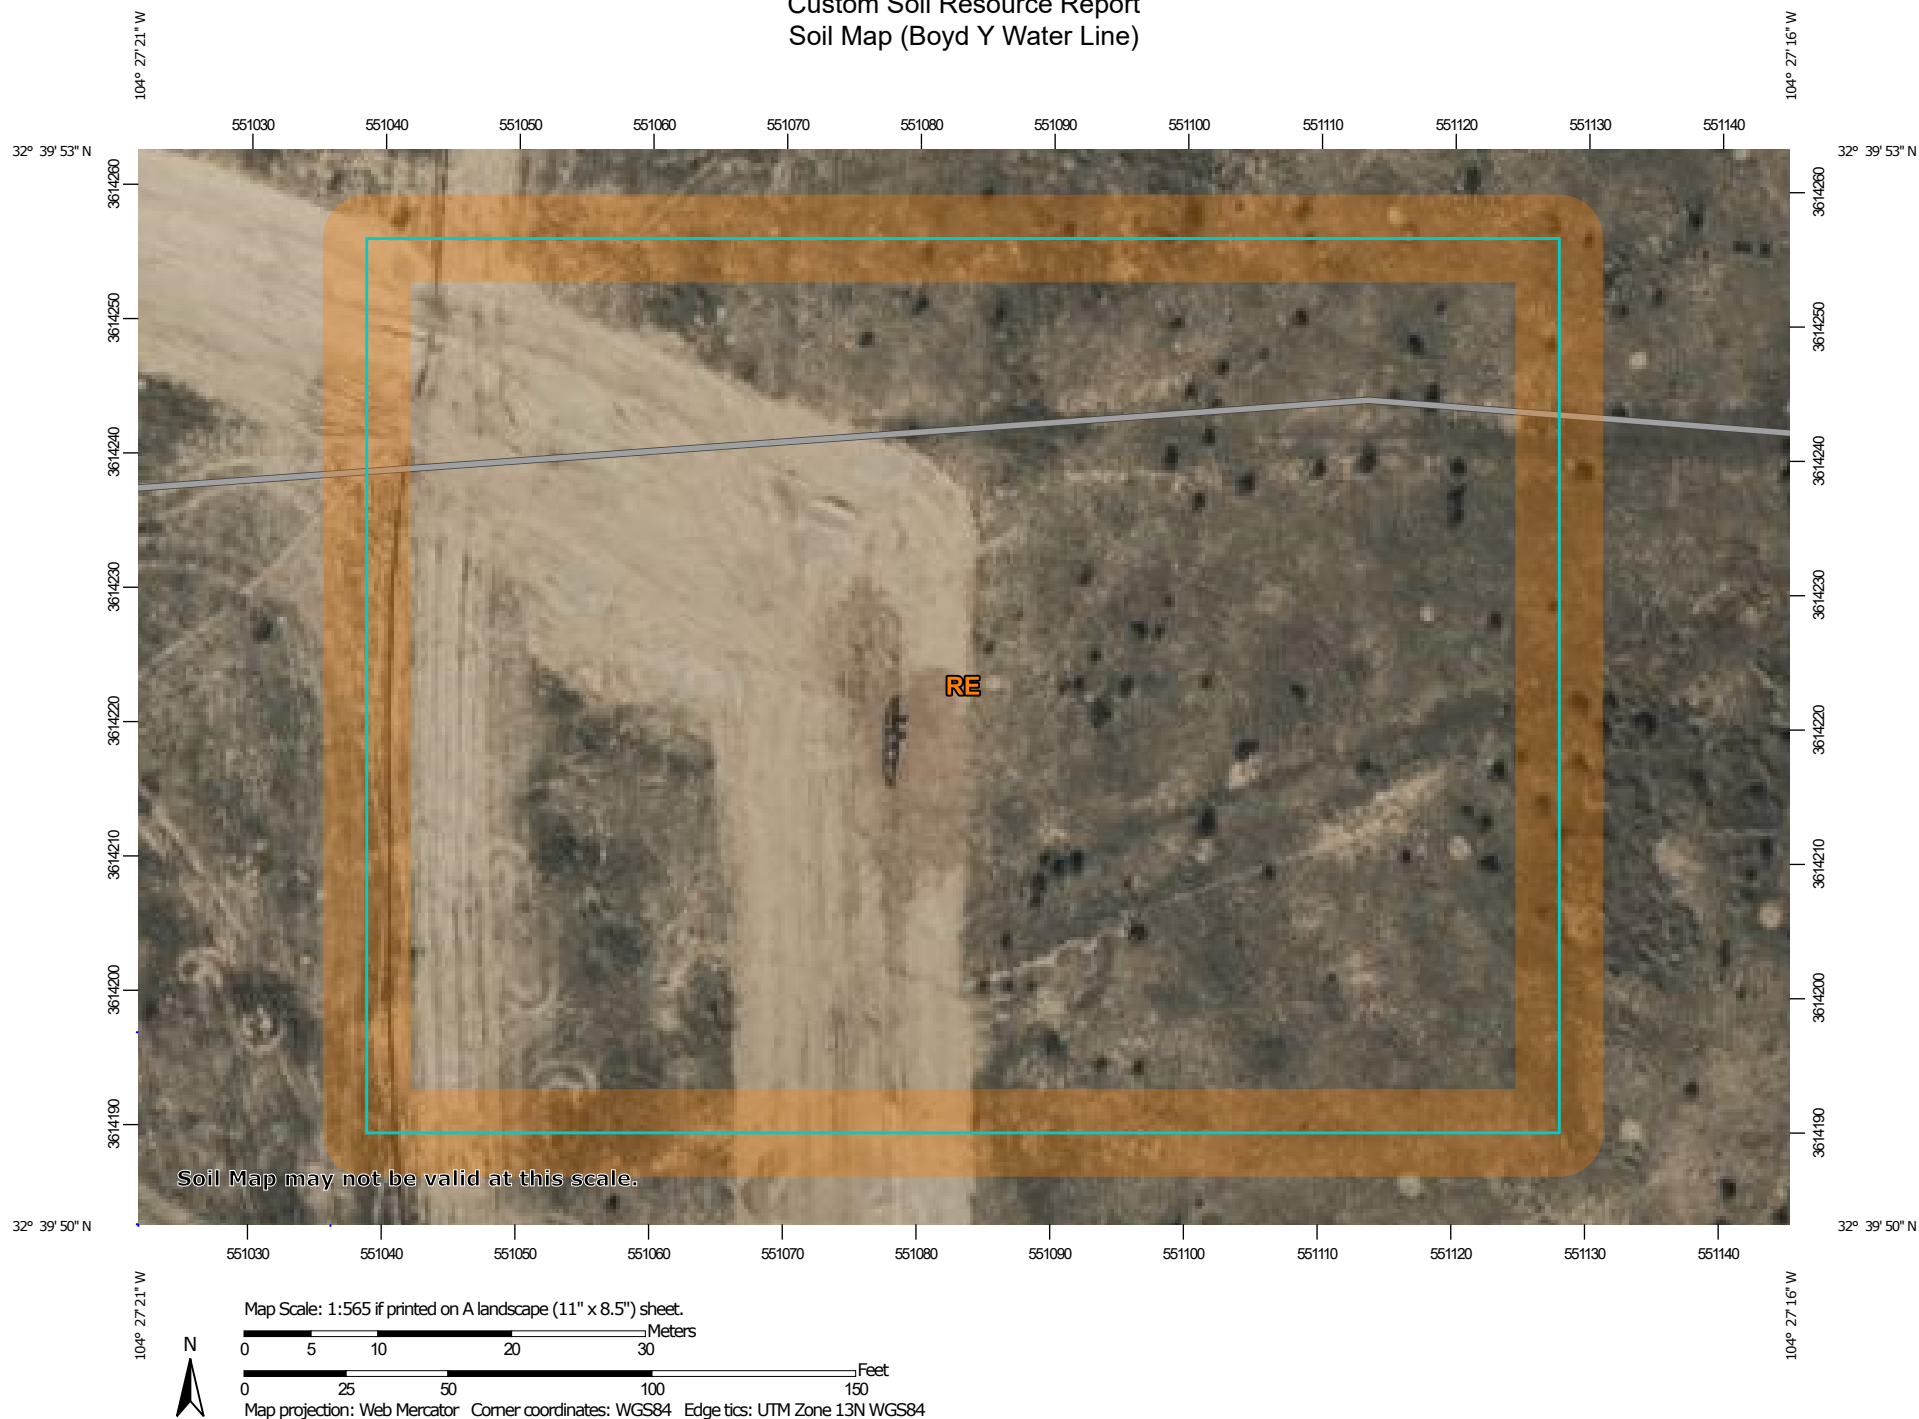
Custom Soil Resource Report
Soil Map (Boyd Y Water Line)

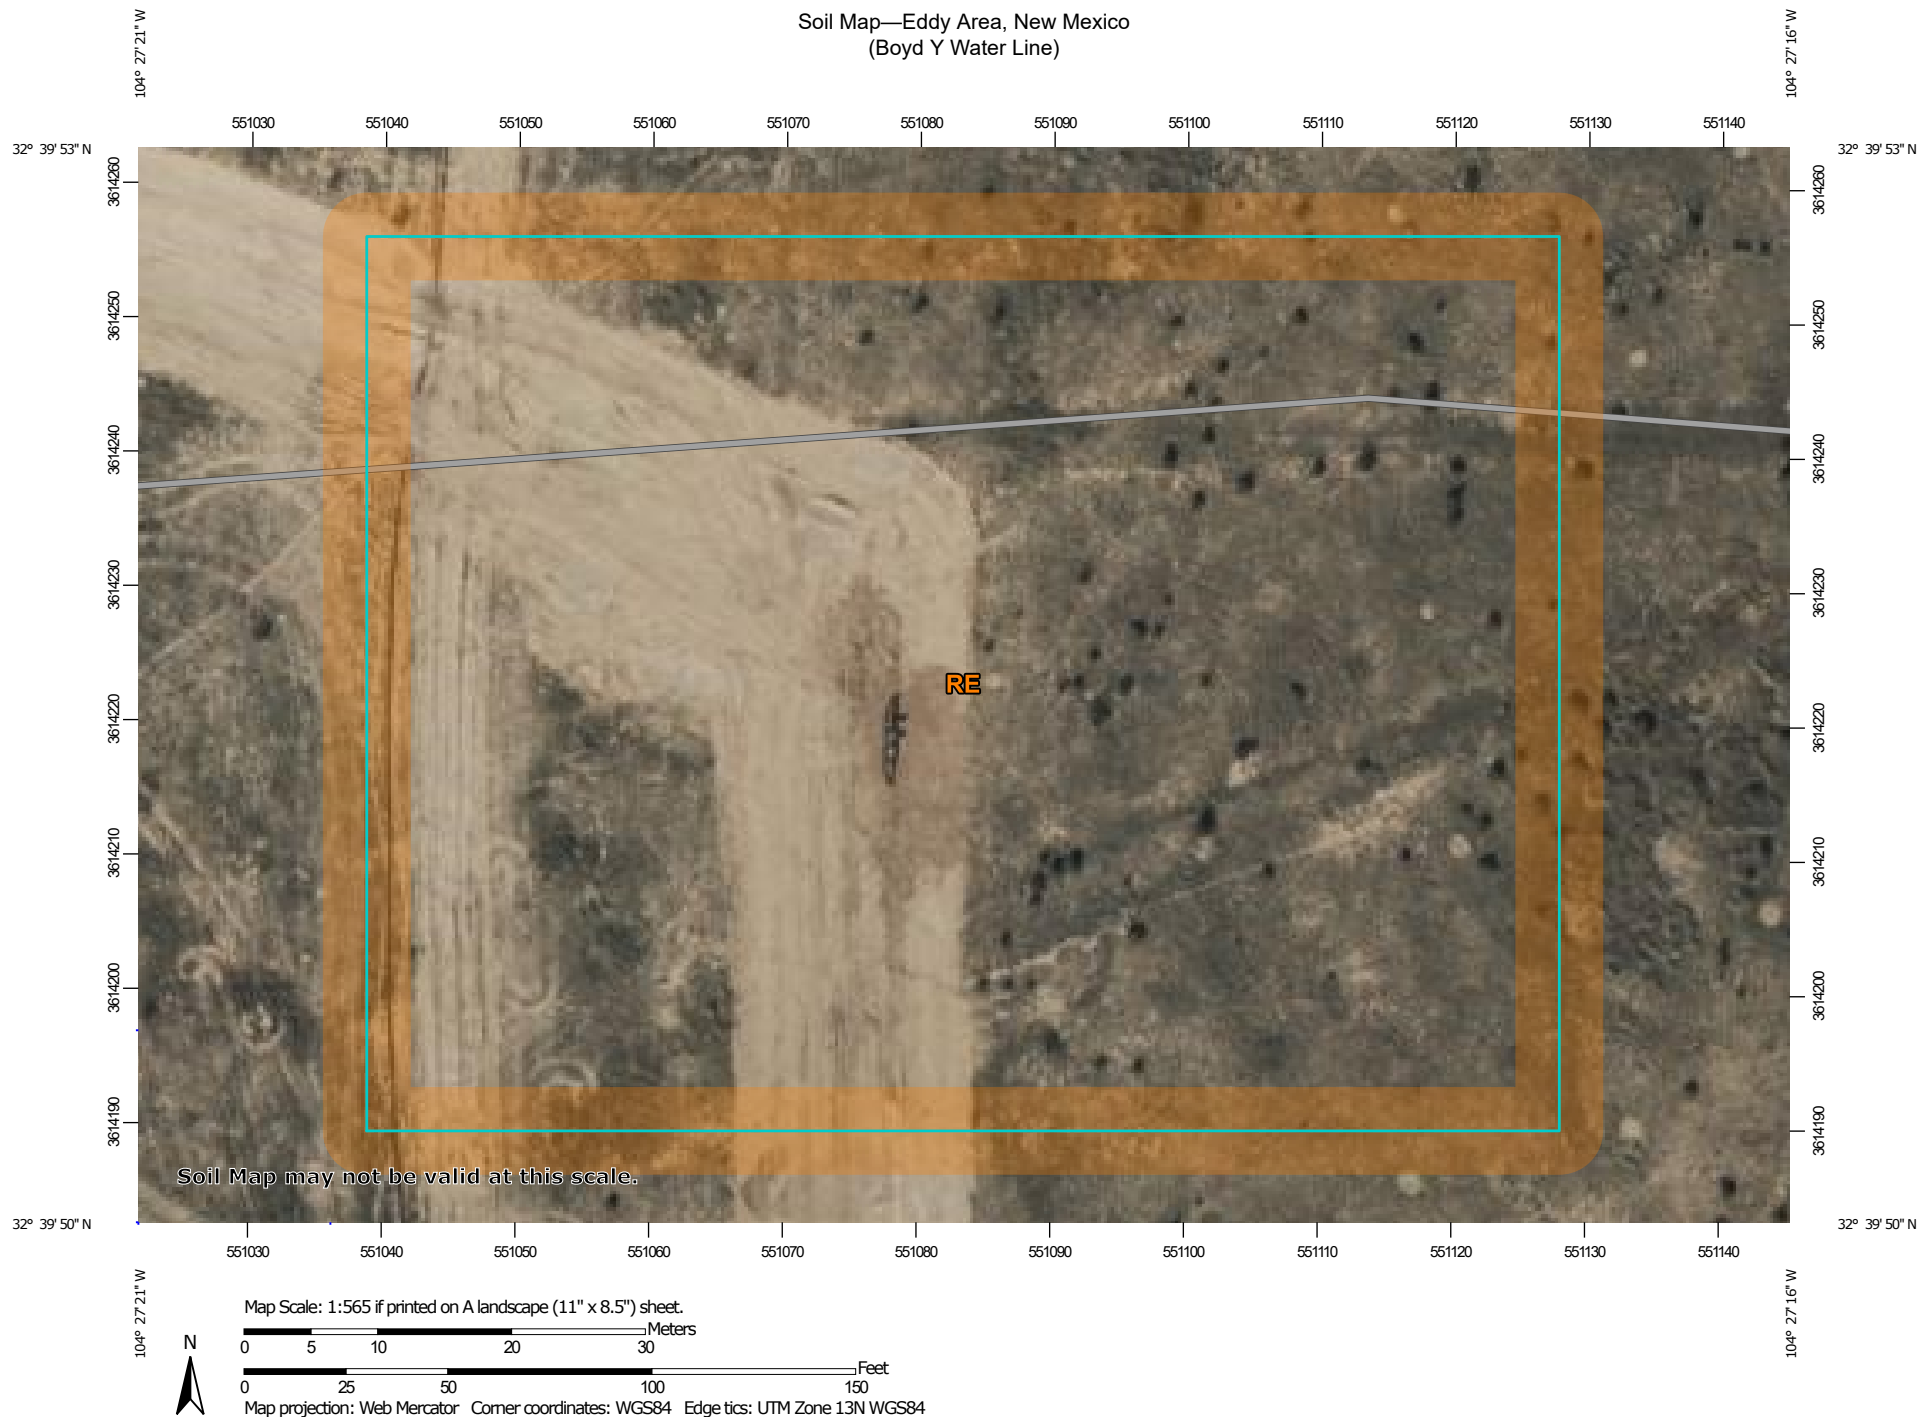
Soil Map—Eddy Area, New Mexico
(Boyd Y Water Line)

Map Unit Symbol	Map Unit Name	Acres in AOI	Percent of AOI
RE	Reagan-Upton association, 0 to 9 percent slopes	1.5	100.0%
Totals for Area of Interest		1.5	100.0%
