Remediation Plan

January 3, 2024

Re: Rhinewalt Battery
Case nAPP2328334367

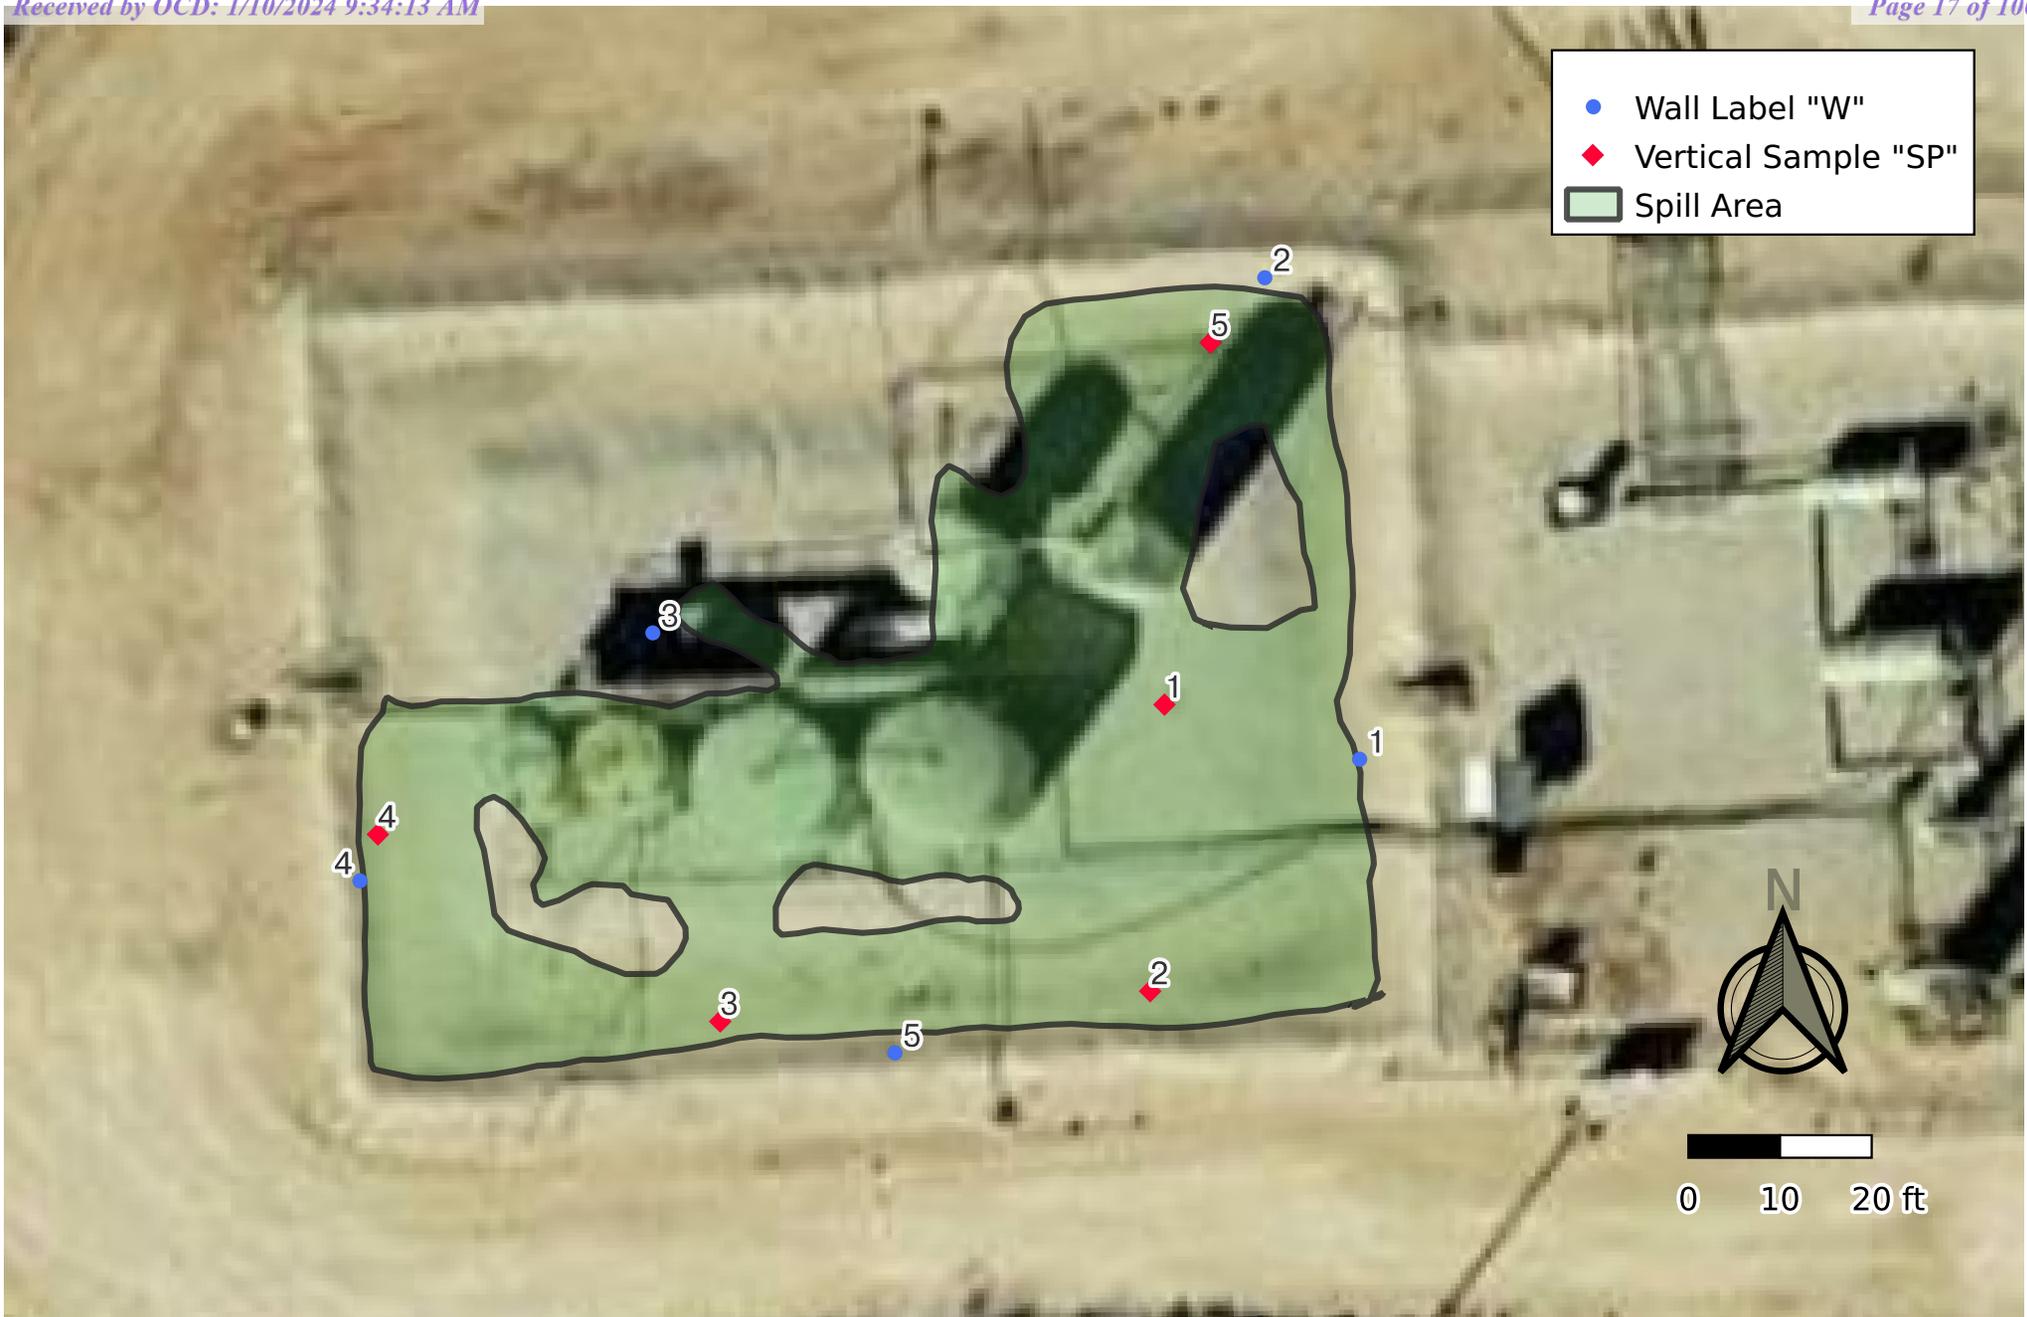
Sample Map

Discrete vertical and horizontal grab samples were collected to delineate the release on 11/13/2023. All samples collected were submitted to a commercial laboratory for analysis for Cl-, TPH, and BTEX. SP1 and SP5 TPH was above table one standards for releases 51-100 feet to groundwater. On 11/27/2023 SP1 and SP2 were advanced to 2 and 3 feet. All samples collected were submitted to a commercial laboratory for analysis of TPH and BTEX.

Apache Corporation proposes that the release area around SP5 be excavated to a depth of 3 feet and the remaining release area be excavated to a depth of 2 feet to extent possible due to the proximity of infrastructure. Final 5-point bottom and wall composite samples will be collected not to exceed 200 square feet. All samples collected will be submitted to a commercial laboratory for analysis of chloride (EPA 4500), TPH (8025), and BTEX (8021). All excavated material (300 yards) will be hauled to an OCD approved disposal facility. The excavation will be backfilled with clean imported caliche to restore the pad.
