GREEN WAVE 20 CTB 3

OCD incident # nAPP2331731081

Re: Site Assessment, Remediation, and Closure Report
Green Wave 20 CTB 3
API No: N/A
GPS: Latitude 32.03175646 Longitude -103.4937875
UL - F, 20, T26S, R34E
Lea County, NM
NMOCD Ref. No. NAPP2331731081

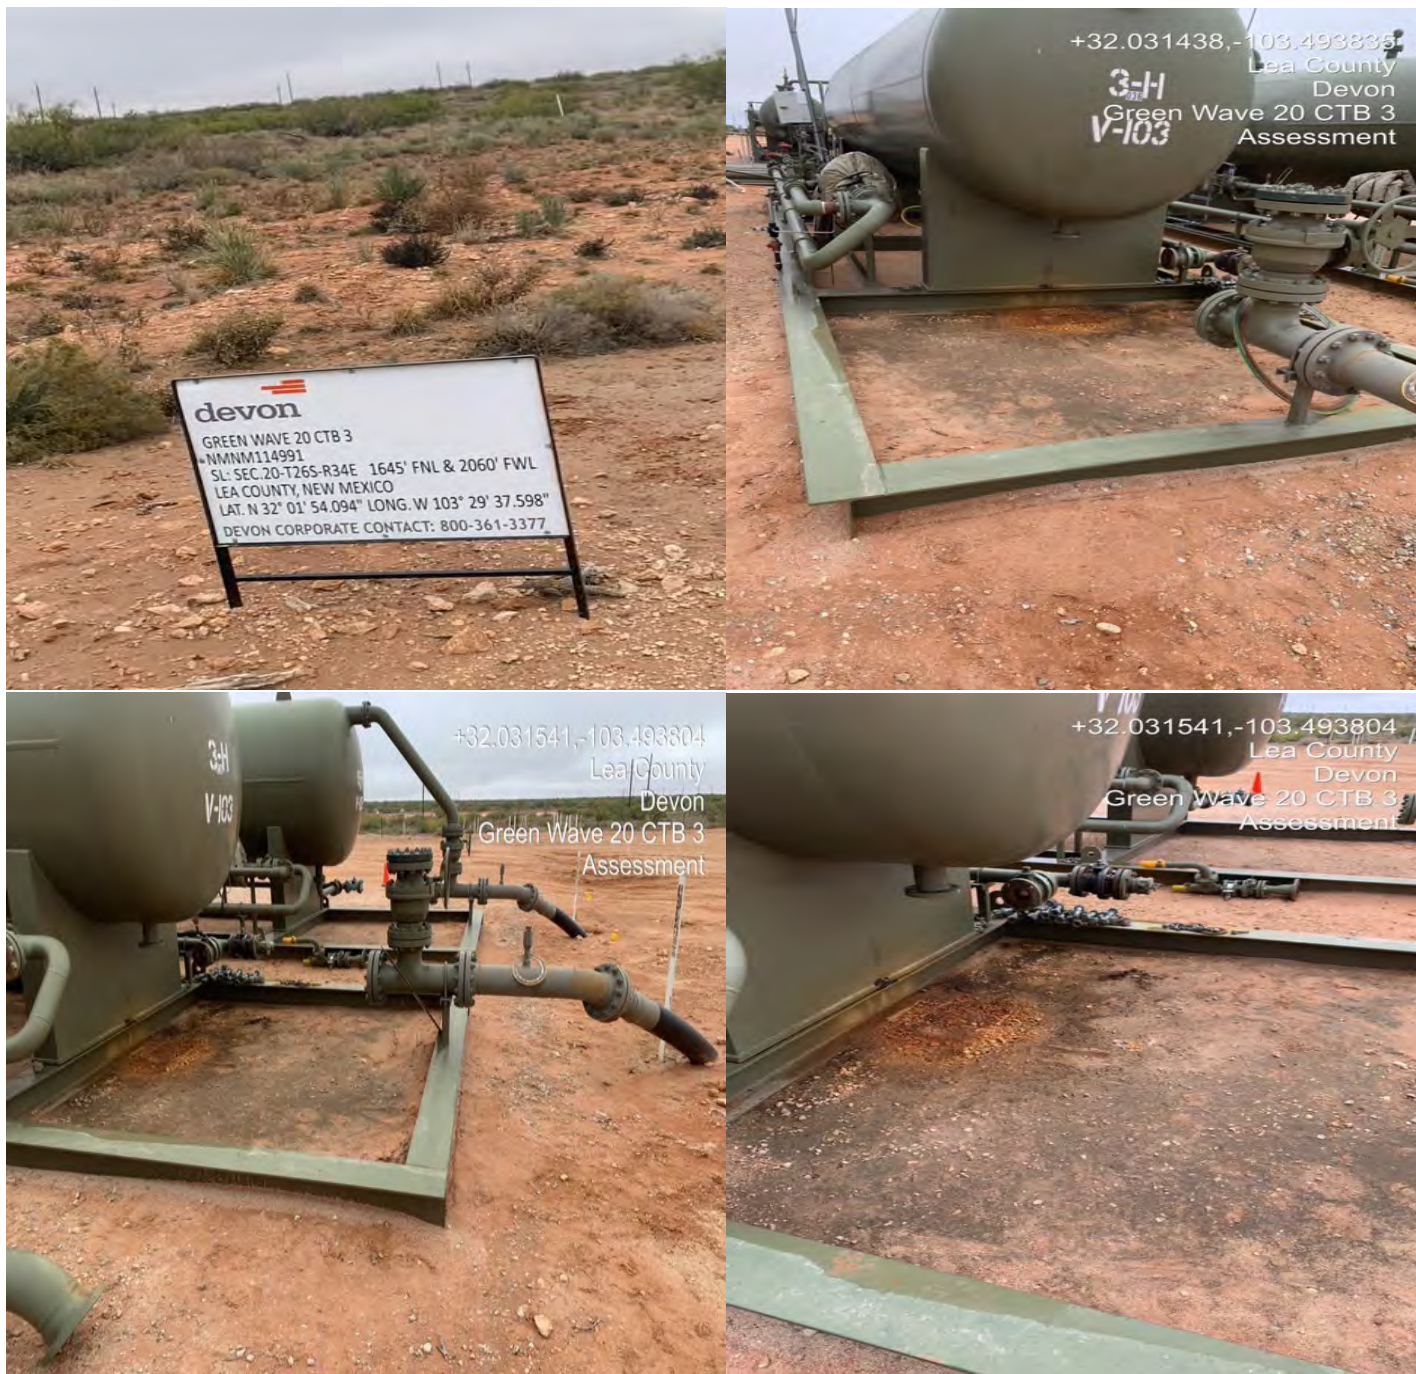
Assessment

On November 15, 2023, Pima mobilized personnel to the site to begin collecting soil samples from spill area. The laboratory results of this sampling event can be found in the following data table. A Site Map can be found in Figure 4.

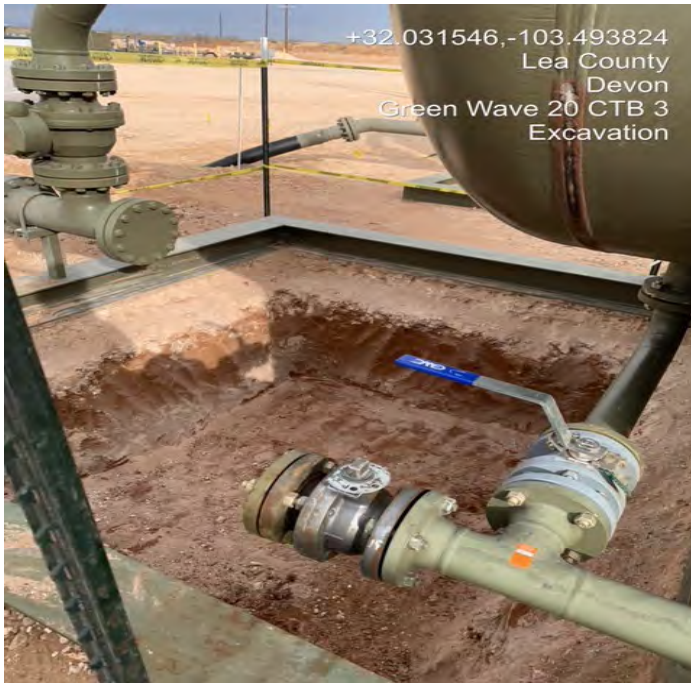
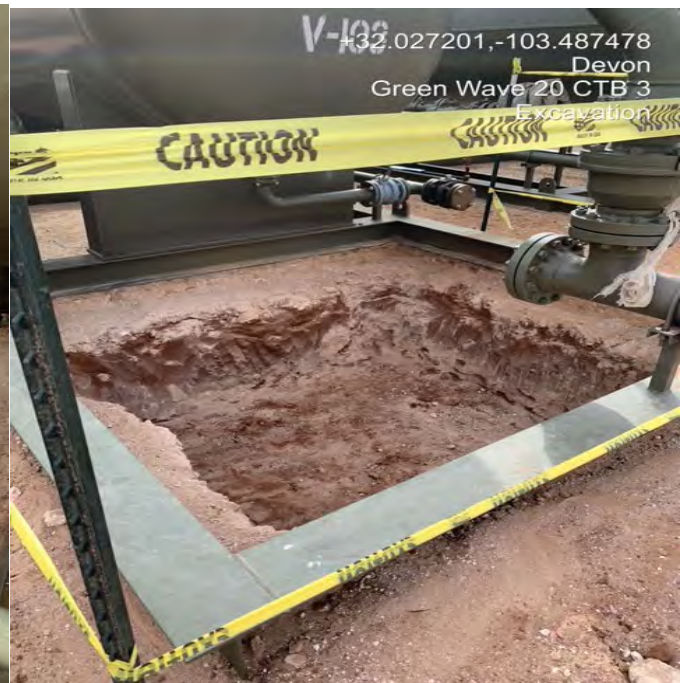
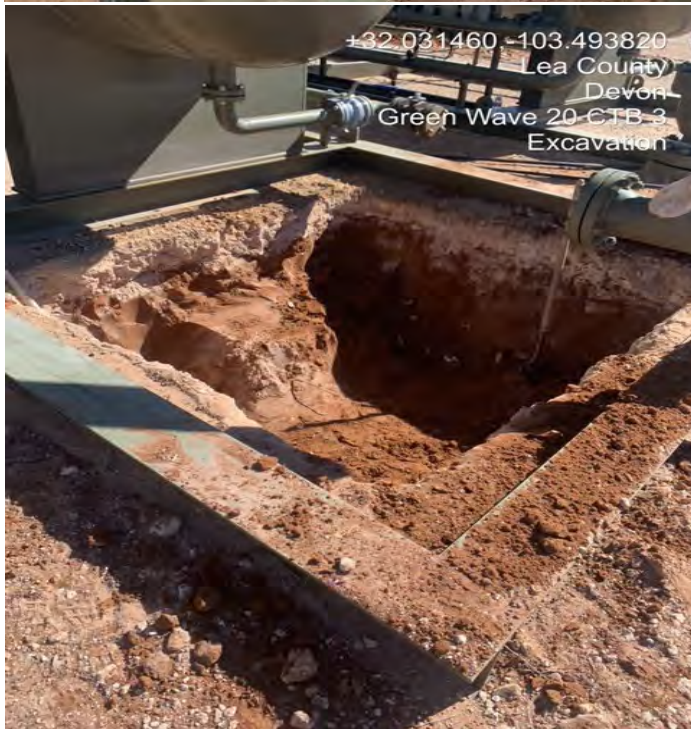
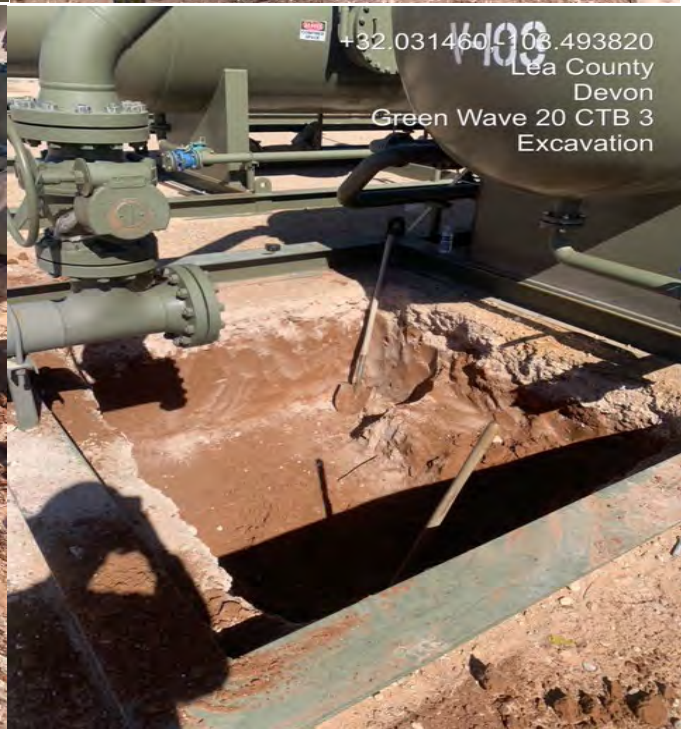
Excavation

On February 5, 2024, the Devon Construction Department mobilized personnel and equipment to begin immediate remediation activities. They began excavating the area to a depth of 3' BGS. The contaminated soil of 8 cubic yards was hauled to an approved, lined disposal facility and clean backfill material was brought in.

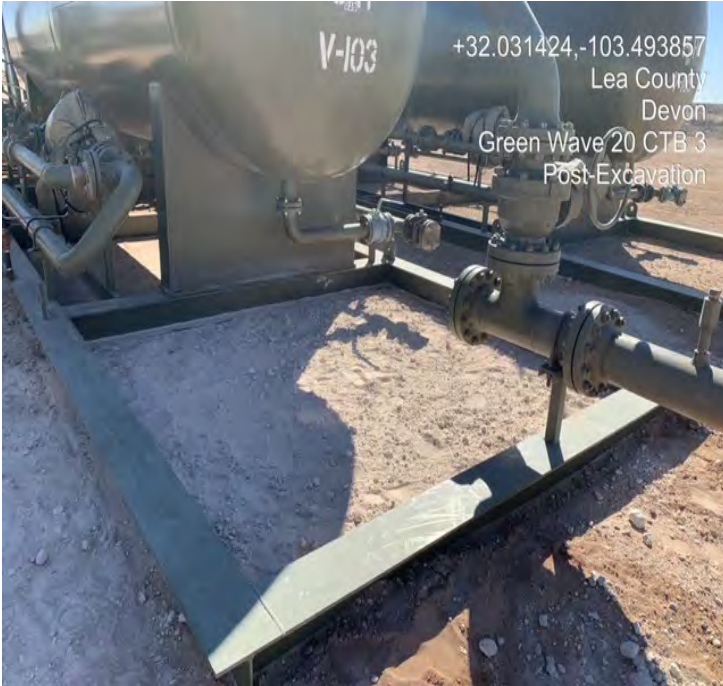
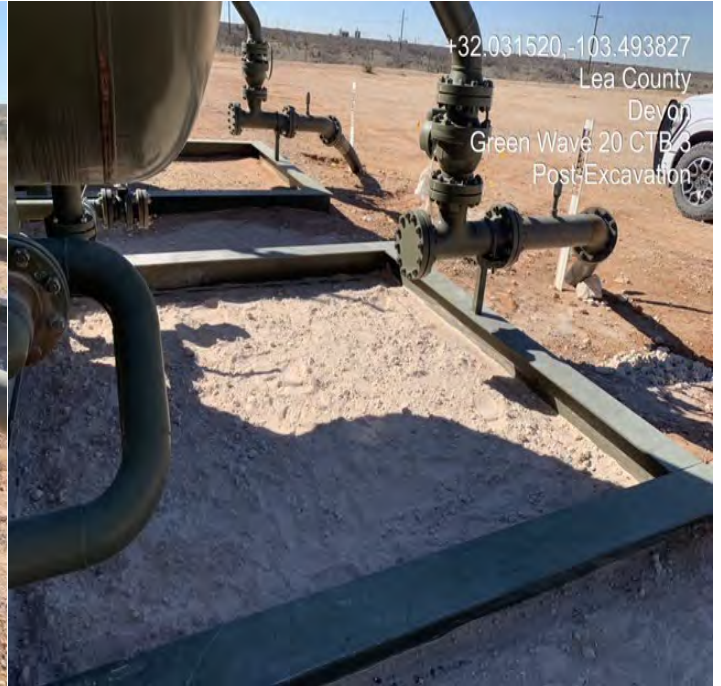
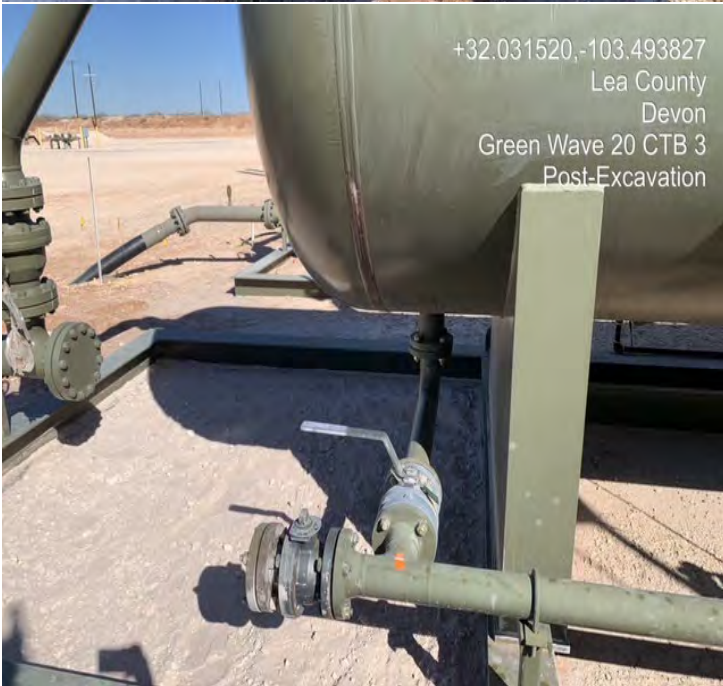
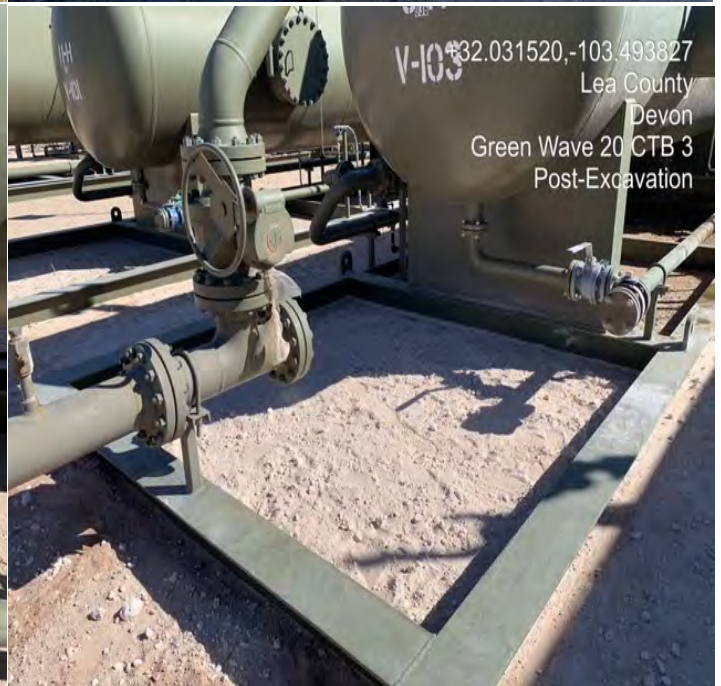
Post Excavation

Based on the sample results, the bottoms and sidewalls were below NMOCD Closure Criteria 19.15.29 NMAC. The contaminated material was sufficiently removed then transported to an NMOCD approved disposal site. The excavation was then backfilled with clean like material, machine compacted and returned to its previous state. See Appendix D for Photographic Documentation.
