Remediation Summary and Closure Request

**FAE II Operating, LLC
Moberly #10 CTB
Lea County, New Mexico
Unit Letter "M", Section 21, Township 26 South, Range 37 East
Latitude 32.025402 North, Longitude 103.171975 West
NMOCD Incident # nAPP2313634226**

December 2023

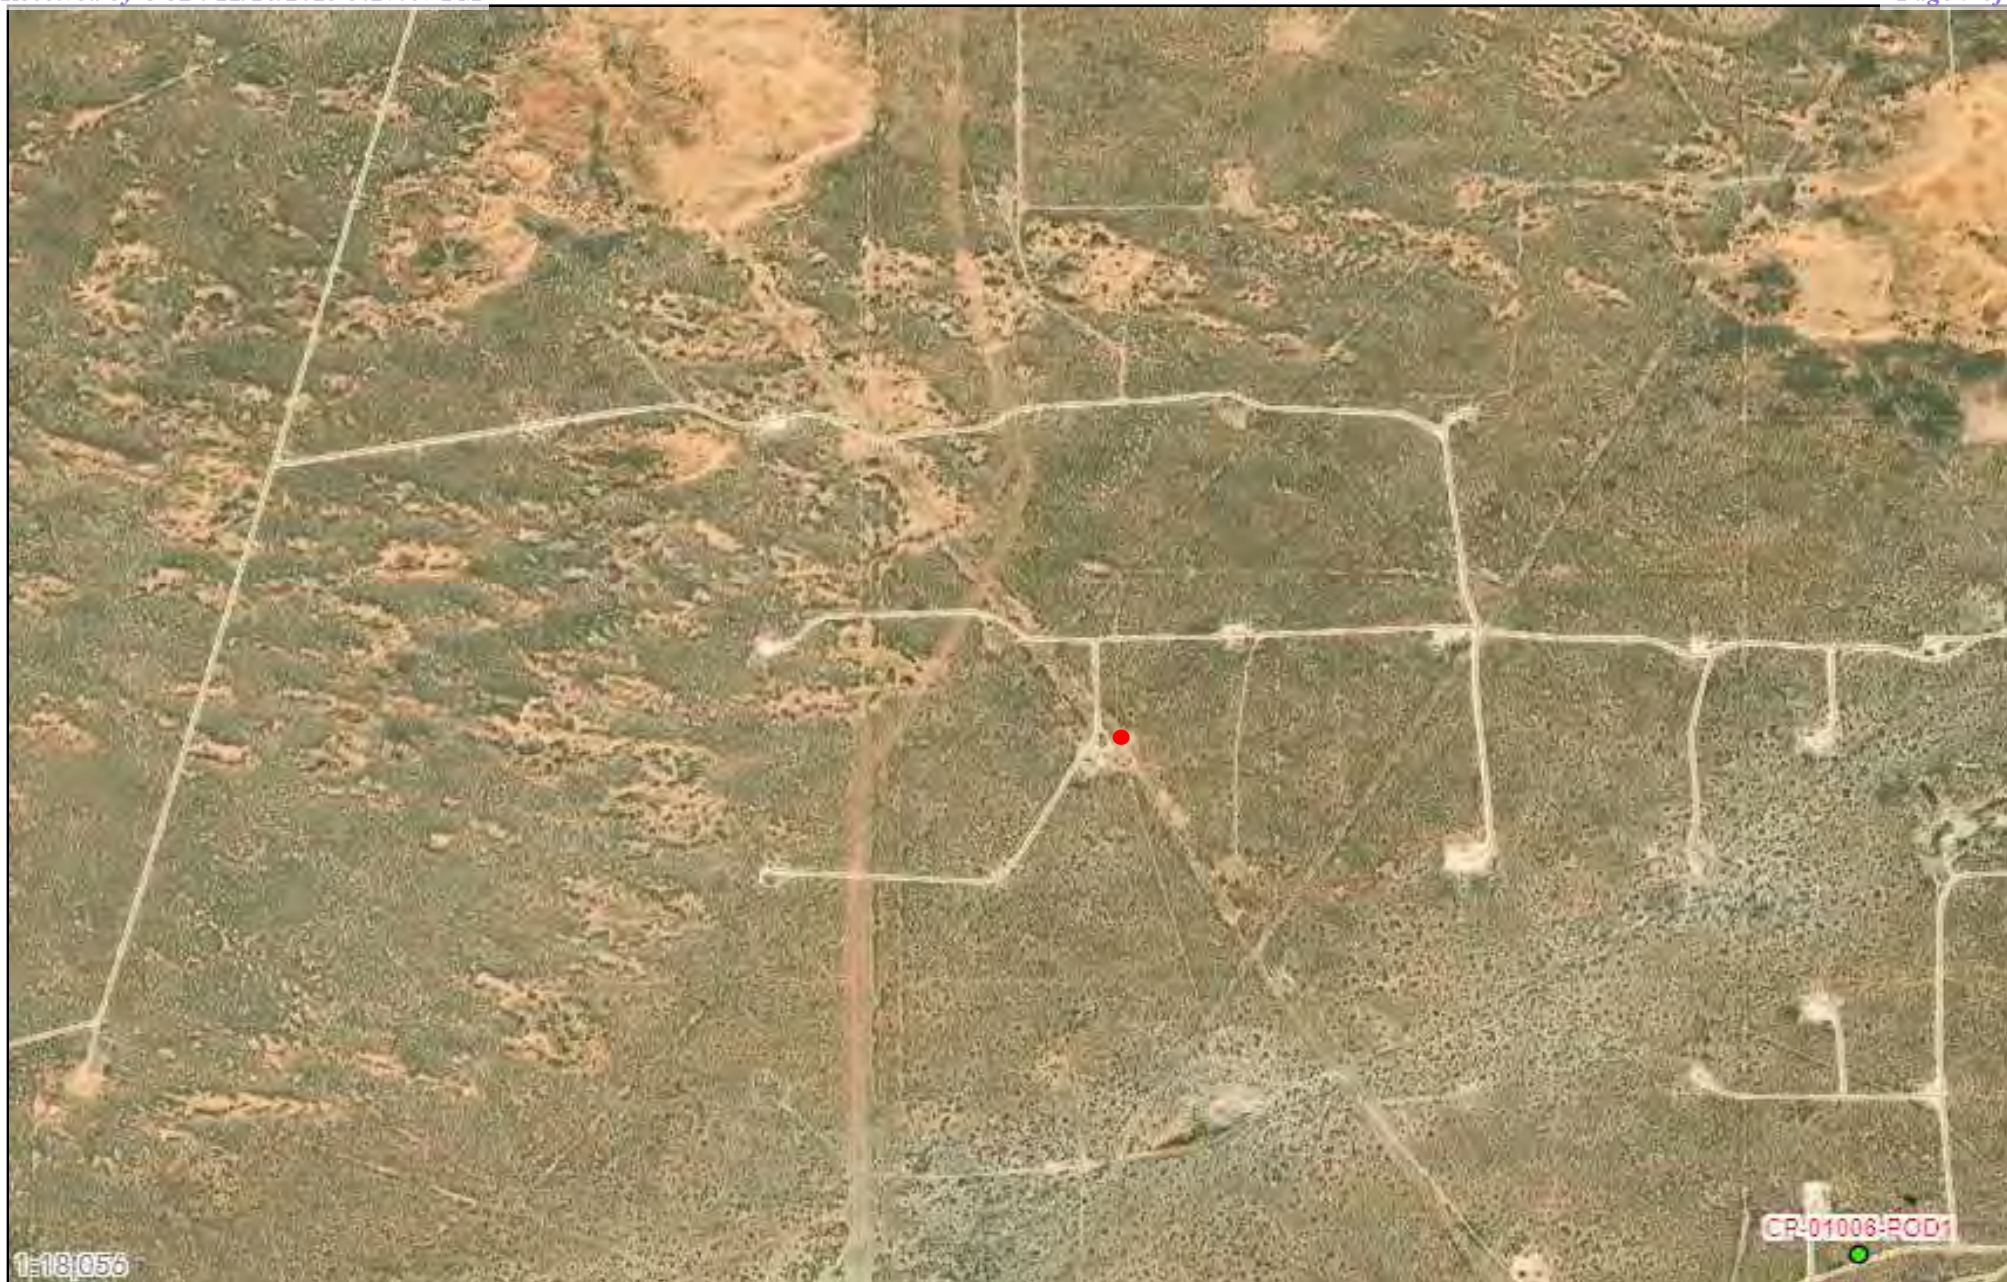
**Figure 2**

A search of the New Mexico Office of the State Engineer (NMOSE) and United States Geological Survey (USGS) groundwater databases was completed in an effort to determine the horizontal distance to known water sources within a half mile radius of the Release Site. Approximate depth to groundwater was determined using maintained and published water well data. Karst mapping indicates the site is located in a Karst designated area. Karst and Wetland Maps are provided as Attachment I. Depth to groundwater information is provided as Attachment IV and the results are depicted on Figures 2 & 3.

OSE POD Locations Map
FAE II Operating, LLC
Moberly #10 CTB
GPS: 32.024992, -103.172194
Lea County

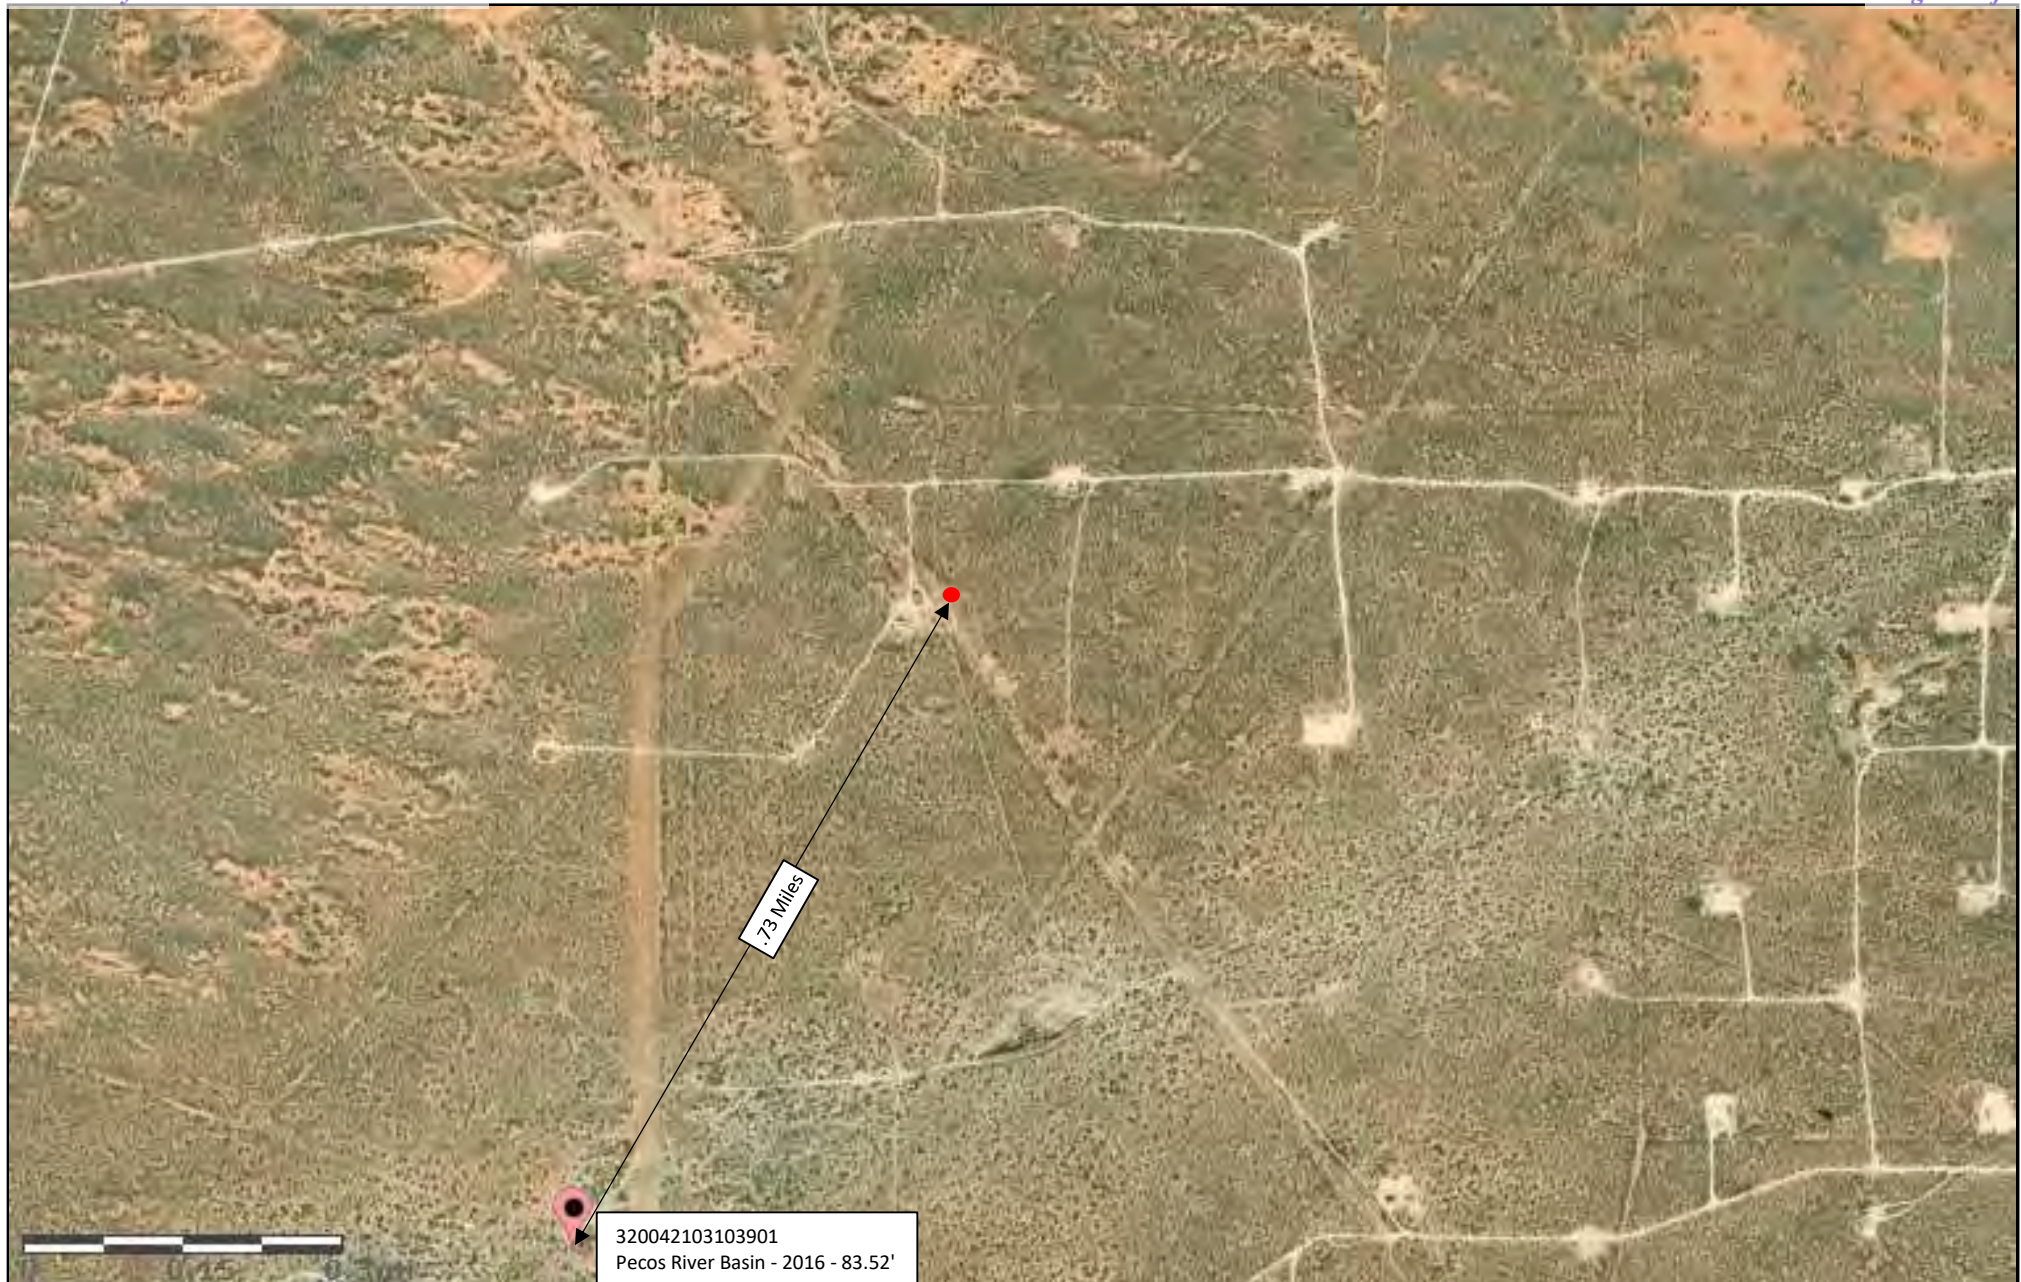
**Figure 3**

One water well was located in the vicinity of the release area. USGS well 320042103103901 was located .73 miles southwest of the location. Gauging in 2016 indicated depth to water of approximately 83.52 feet bgs. However, as the release occurred within a Karst designated area, the site was remediated according to the strictest NMOCD Closure Criteria. Utilizing this information, the NMOCD Closure Criteria for the Site were determined as follows:

USGS Well Locations Map
FAE II Operating, LLC
Moberly #10 CTB
GPS: 32.025402, -103.171975
Lea County

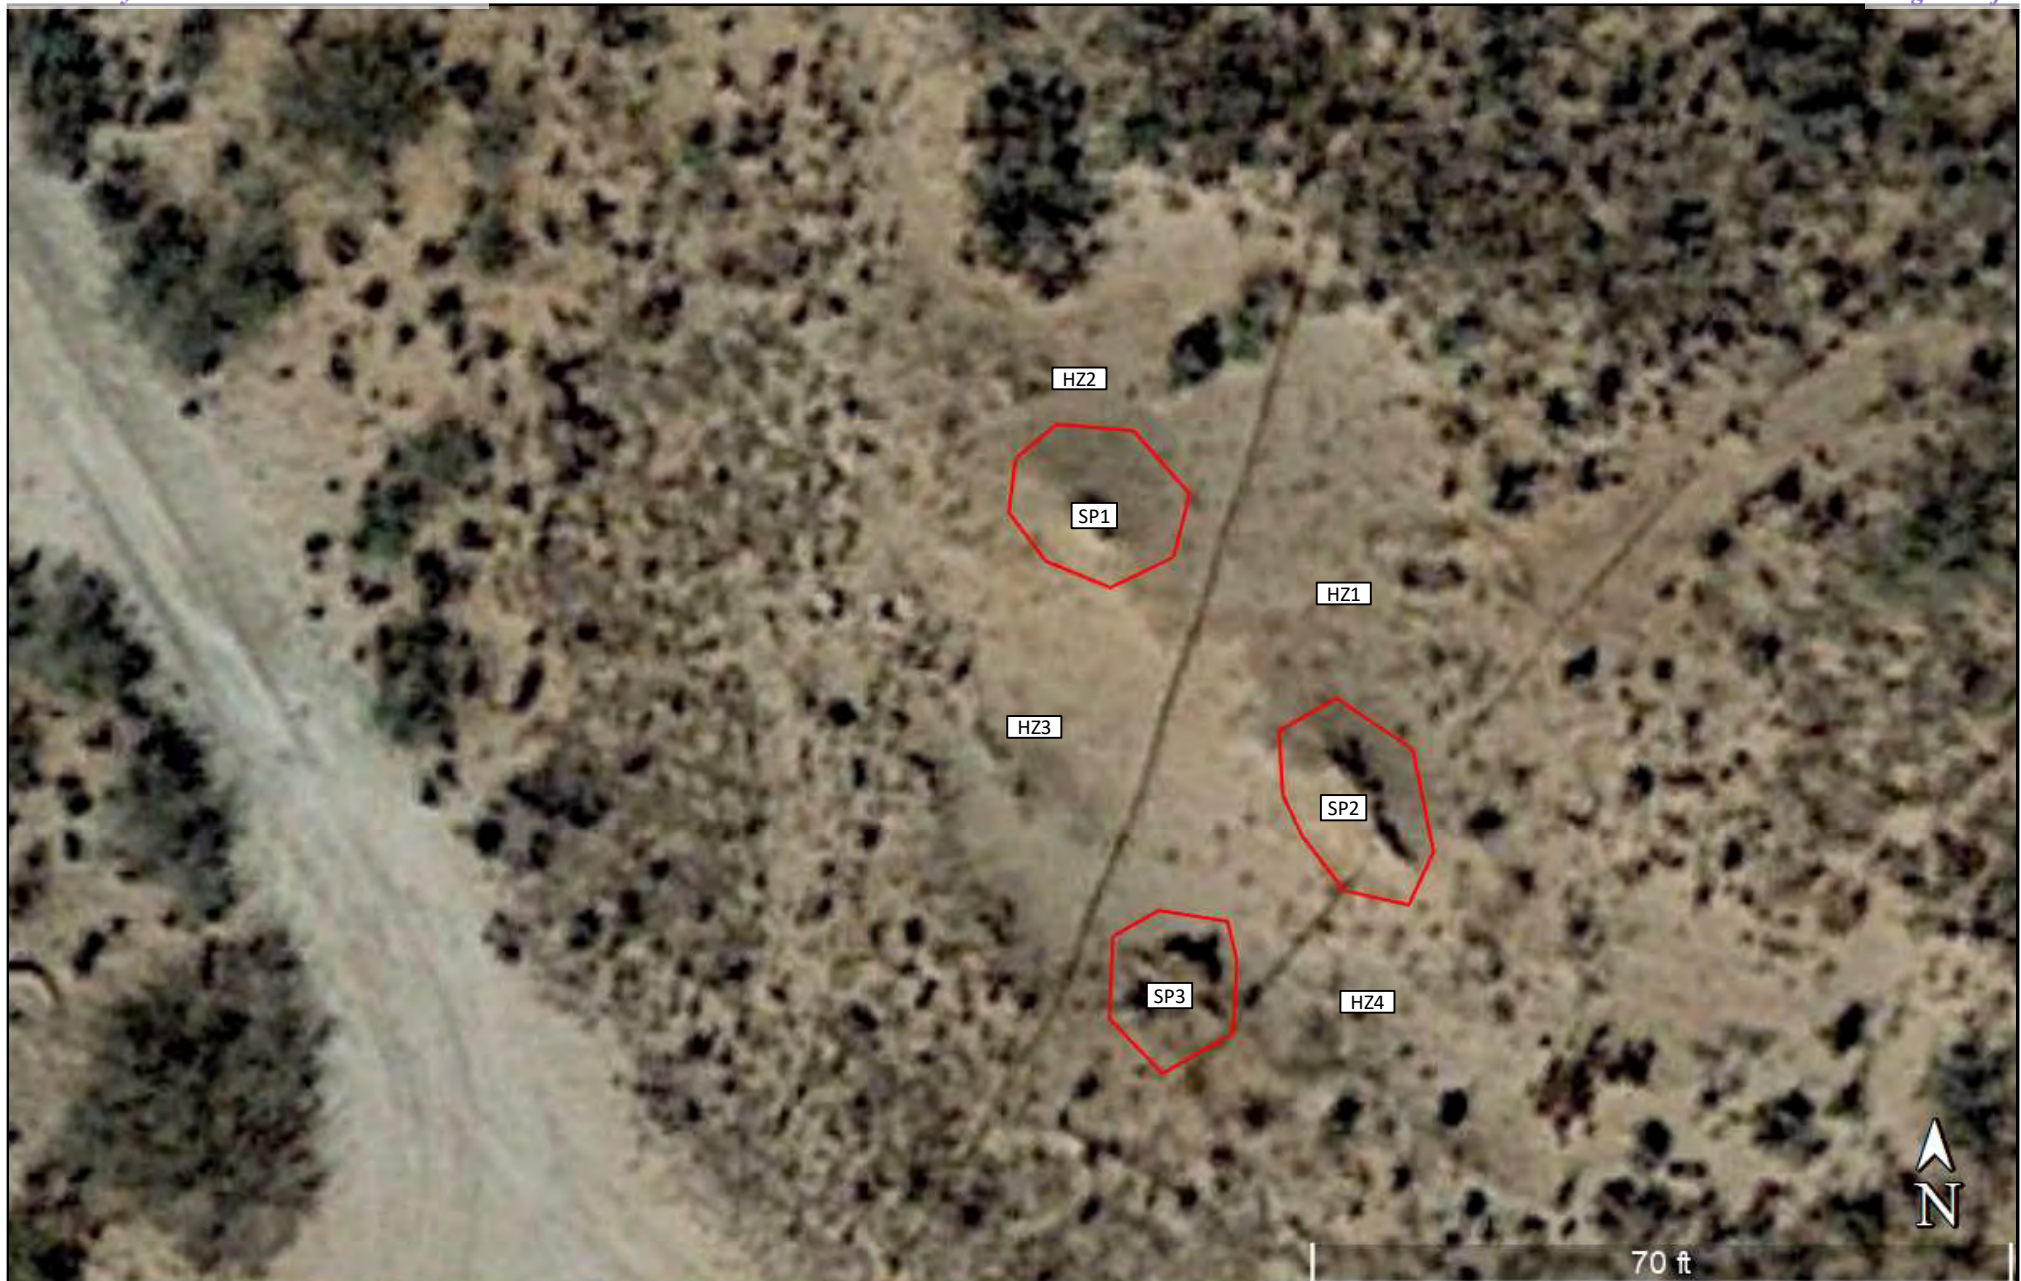
**Figure 4**

On October 12, 2023, Hungry Horse conducted an initial site assessment consisting of photographing, mapping, and sampling the contaminated soil piles. During sampling, hand augered test bores were advanced into the contaminated soil piles in an effort to determine the extent of contamination. These sample locations are identified by SP designation. On October 19, 2023, hand augered sample bores were advanced along the outside edges of the contaminated soil piles in an effort to determine the horizontal extent of contamination, if any. These sample locations are identified by HZ designation. During the advancement of the hand augered sample bores, soil samples were collected and field screened for the presence of chloride concentrations utilizing a Hach Quantab® chloride test kit.

Based on field observations and field test data noted above and provided in Attachment IV, fourteen representative soil samples were selected for laboratory analysis. Delineation soil samples SP1 through SP3, HZ1 through HZ4, were submitted to the laboratory for analysis of BTEX, TPH, and chloride. Laboratory analytical results indicated contaminant concentrations were below the NMOCD Closure Criteria in each of the submitted samples, with the exception of SP1 at Surface, which exhibited TPH concentrations in excess of NMOCD Closure Criteria.

Delineation Sample Map
FAE II Operating, LLC
Moberly #10 CTB
GPS: 32.024992, -103.172194
Lea County

A Delineation Sample Map and Excavation Sample Map are provided as Figure 4 and Figure 5, respectively. A Summary of Soil Sample Laboratory Analytical Results is provided as Table 1 and Laboratory Analytical Reports are provided as Attachment V.

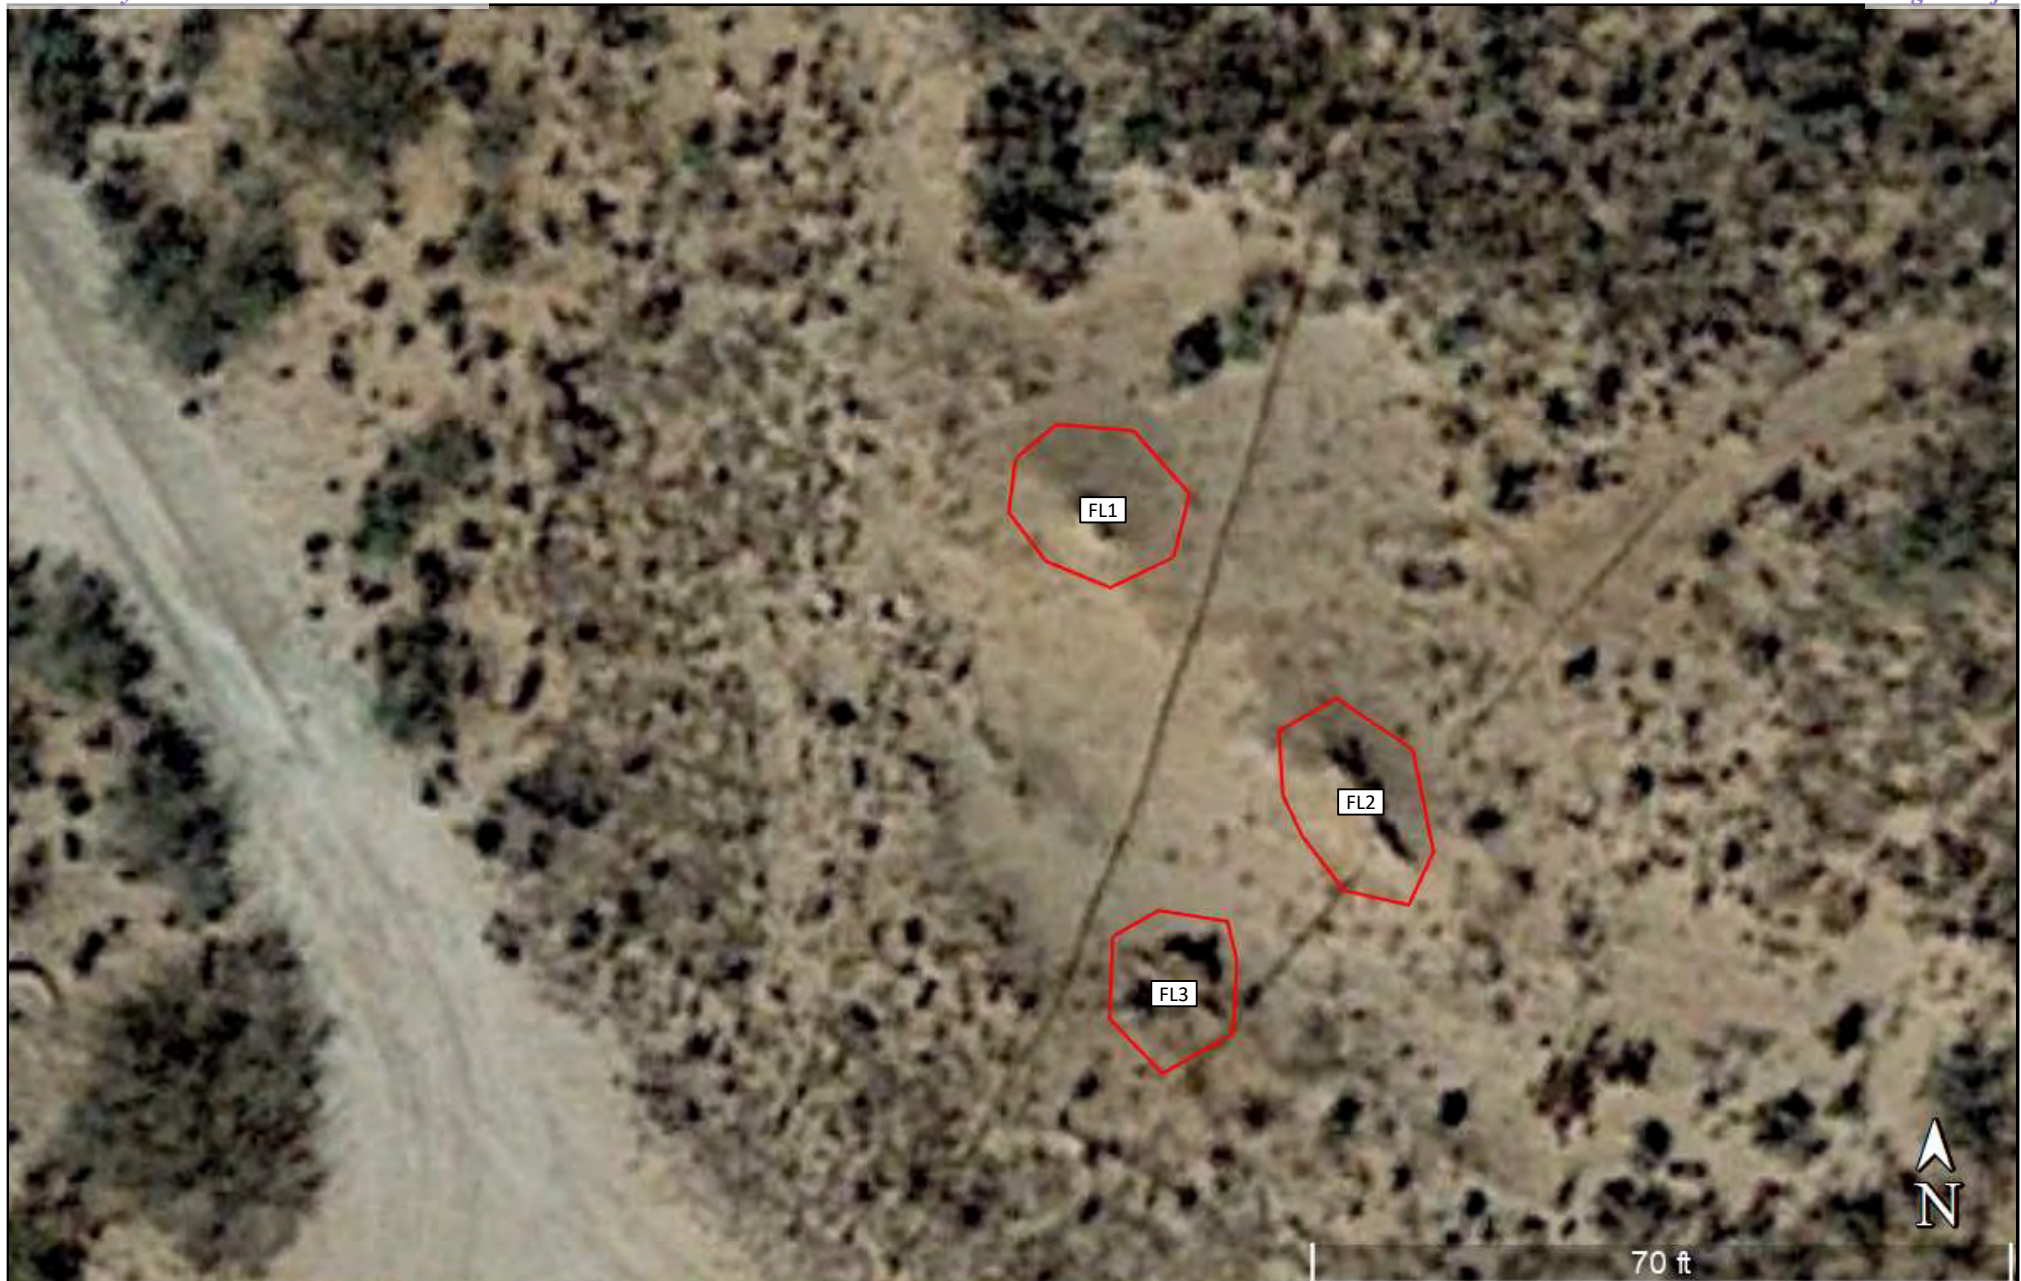
**Figure 5**

On December 1, 2023, three composite confirmation soil samples were collected from the area exposed after the removal of the contaminated soil piles; every 200 square feet. Soil samples FL1 through FL3 were submitted to the laboratory for analysis of BTEX, TPH, and chloride. Laboratory analytical results indicated contaminant concentrations were below the NMOCD Closure Criteria in each of the submitted samples.

The affected areas measured approximately two hundred square feet each. During remediation activities approximately 18 cubic yards of impacted soil were excavated and hauled to an NMOCD approved disposal facility.

Excavation Sample Map
FAE II Operating, LLC
Moberly #10 CTB
GPS: 32.024992, -103.172194
Lea County

Based upon laboratory analytical results from confirmation soil samples, the excavated area was backfilled with locally sourced, clean, non-impacted soil. The area was contoured to achieve erosion control and preserve surface water flow.
