SHARBO 2 FLOWLINE RELEASE

Remediation Action Plan Addendum

NMOCD Incident No. nAPP2316539496
UL "H", Sec. 18, T23S, R32E
32.3064450°, -103.7064010°
Lea County, New Mexico

November 7, 2023

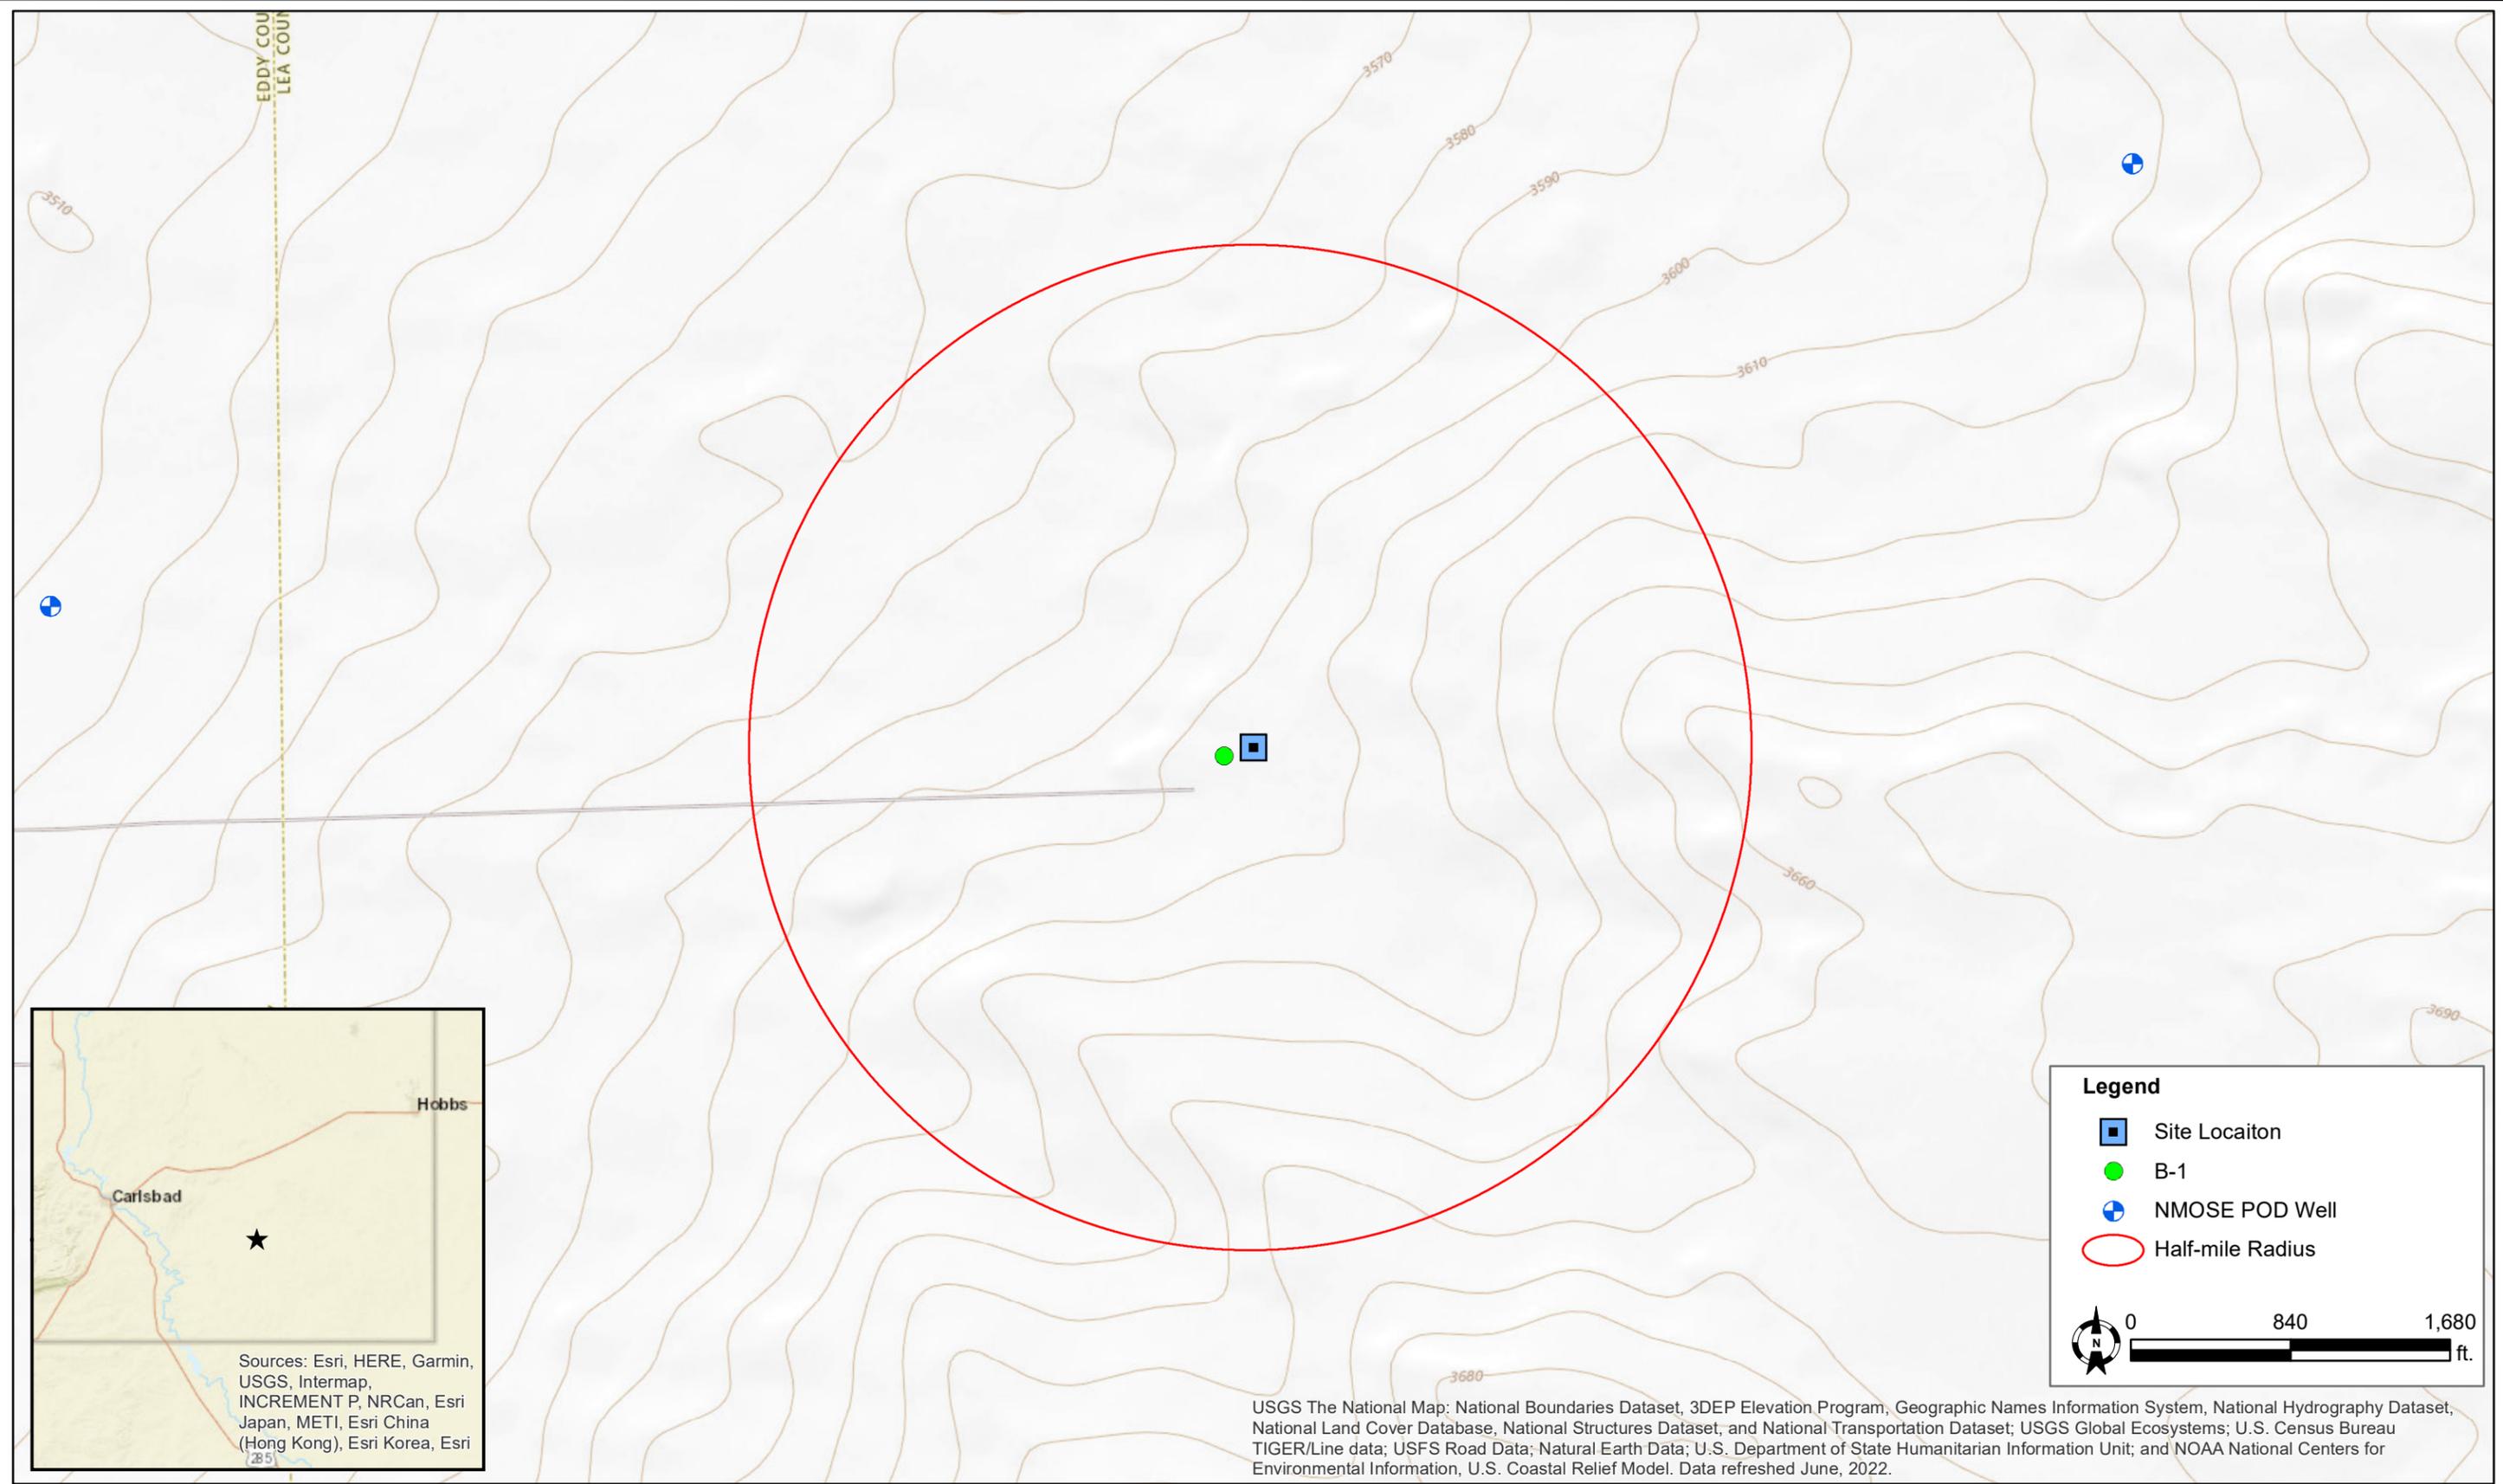
Figure
1

Site Location & Characteristics
Map

The site is located in Unit Letter "H", Section 18, Township 23 South, Range 32 East in Lea County, New Mexico. The release occurred from the Sharbo 2 Flowline, a poly produced water pipeline. The release occurred on BLM property. A site location map can be found attached as Figure 1.

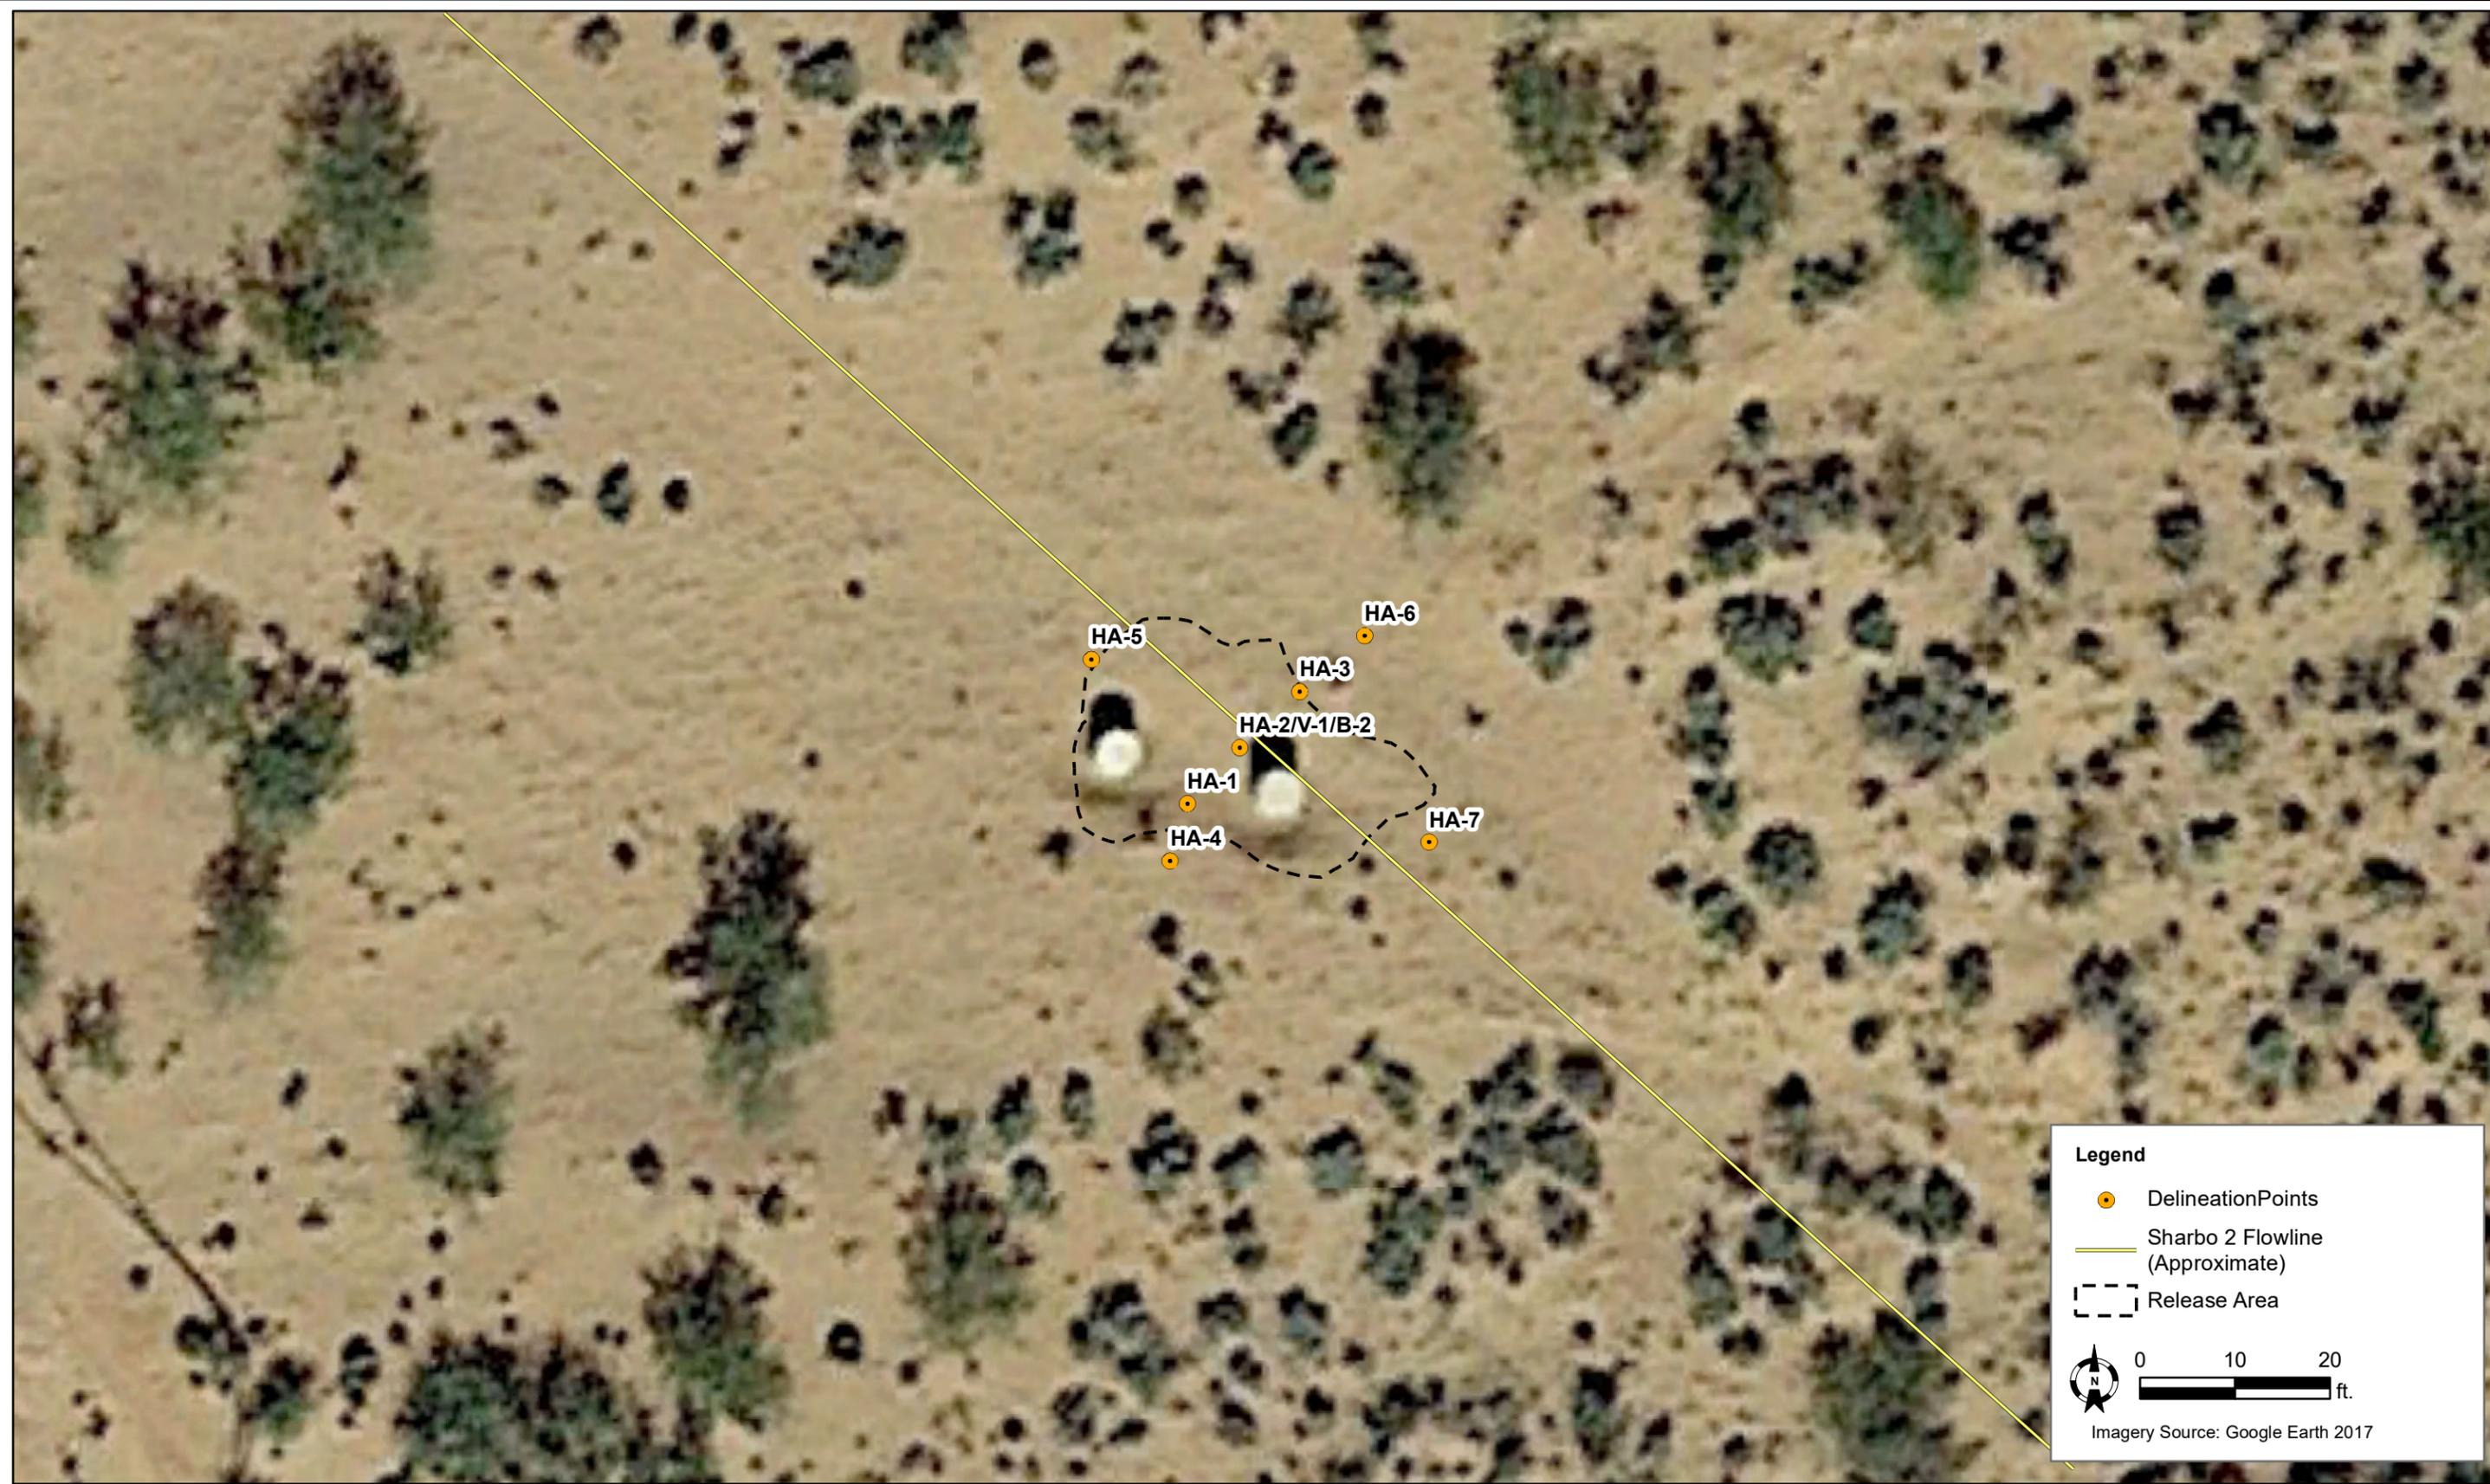
Delineation Overview Map

Field screening and laboratory analytical results are summarized on Table 1 and laboratory analytical reports are included as Appendix C. The attached Figure 2 illustrates the observed release area and location of soil borings and the vertical delineation trench.

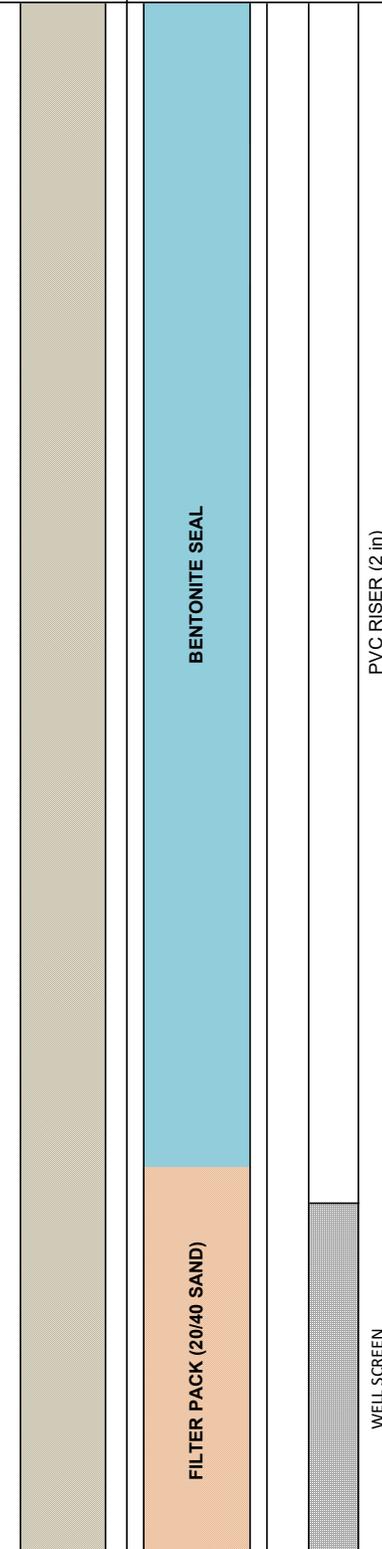
Driller:	HCI Drilling	
Drilling Method:	6" Air Rotary	
Start Date:	10/3/2023	
End Date:	10/3/2023	Company: Foundation Energy Project Name: Sharbo 2 Flowline Well ID: MW-1 Project Consultant: Tasman
Comments: Soil samples were collected from drill cuttings at specified intervals. DRAFTED BY: Laura Flores TD = 102 ft GW = 98 ft		Location: Unit H, Section 18, T23S, R32E Lat: Not yet surveyed County: Lea Long: Not yet surveyed State: NM

Depth (feet)	Chloride field tests	LAB (mg/kg)	PID (ppm)	Description	Lithology	Well Construction
0 ft				Sand		
5 ft						
10 ft						
15 ft						
20 ft						
25 ft				Sand with gravel		
30 ft						
35 ft				Sand		
40 ft				Sand with gravel		
45 ft						
50 ft				Sand		
55 ft						
60 ft						
65 ft				Sand with gravel		
70 ft						
75 ft						
80 ft						
85 ft						
90 ft						
95 ft						
100 ft						
105 ft				Total Depth @ 102 ft
