# **Liner Inspection and Closure Request**

BTA Oil Producers, LLC

Mesa Dolphin

NMOCD Incident # nAPP2328328023

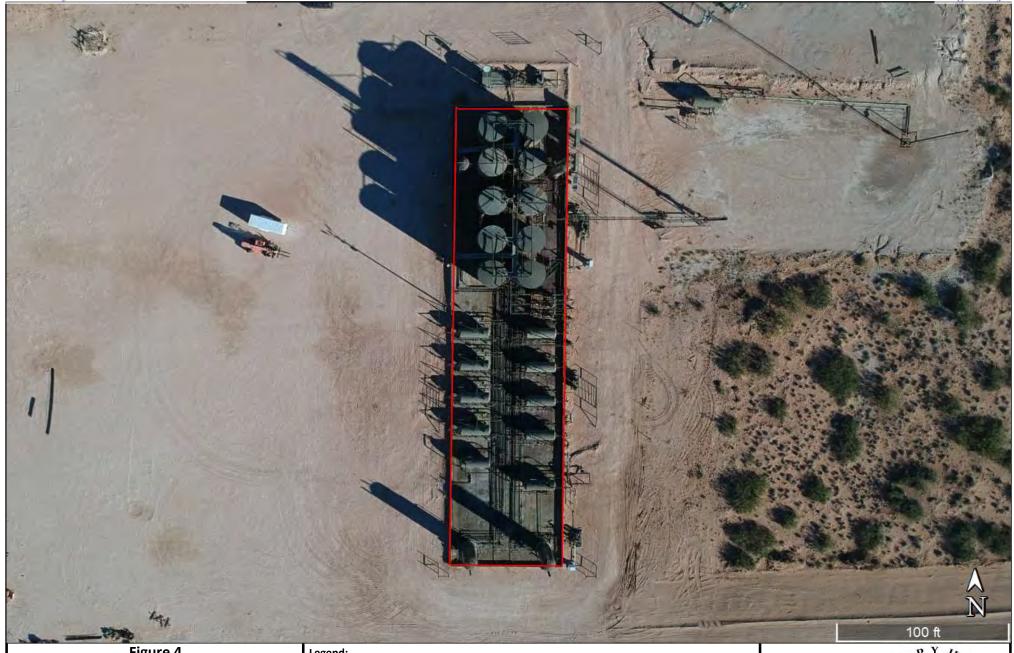
## Figure 4

Liner Inspection Map BTA Oil Producers, LLC Mesa Dolphin GPS: 32.06383, -103.65153

Release Within Lined Containment Area

On November 20, 2023, Hungry Horse personnel arrived on location to inspect the liner. The liner and metal containment were thoroughly inspected form edge to edge, as well as around the tanks and process equipment installed on the liner itself (reference Attachment III – Site Photographs). The liner was found to be in place, intact, with no visible, breaks, or tears. There was no evidence of the release escaping the metal containment area. A completed Liner Inspection Form is attached as Attachment V.
