**RE: Northeast Blanco Unit 400A Site Closure
San Juan County, New Mexico**

Cottonwood Consulting LLC (Cottonwood), on behalf of Simcoe LLC (Simcoe), is submitting a closure report for the above ground storage tank (AST) release at the Northeast Blanco Unit #400A well site (API #30-045-33467).

Project Map
Northeast Blanco Unit #400A
Simcoe LLC

NEBU #400A
Photographic Log
Simcoe LLC

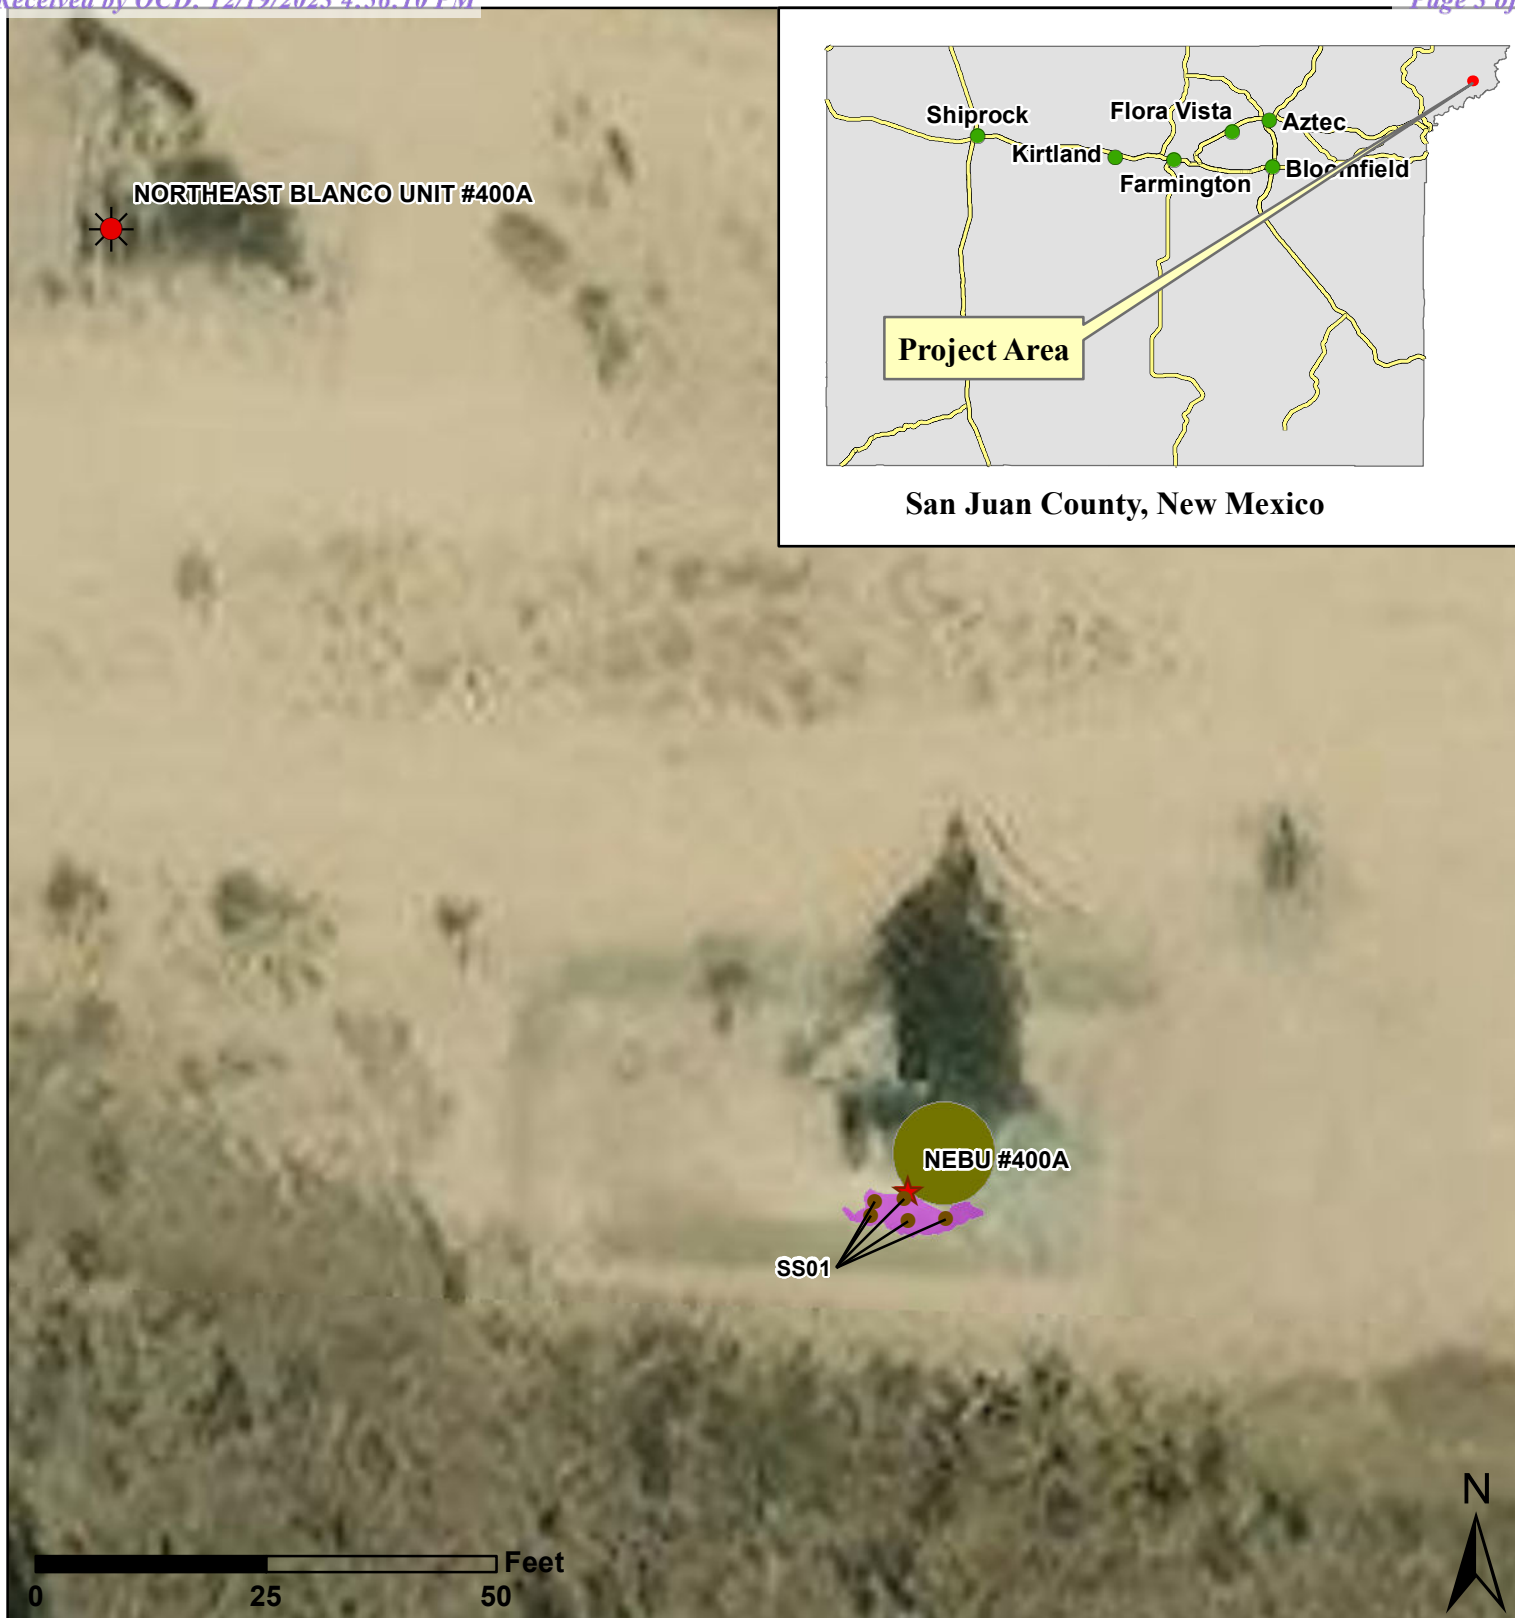
FIGURE 1

Notes: SS01 collected 12/7/2023 as a 5-point composite sample.

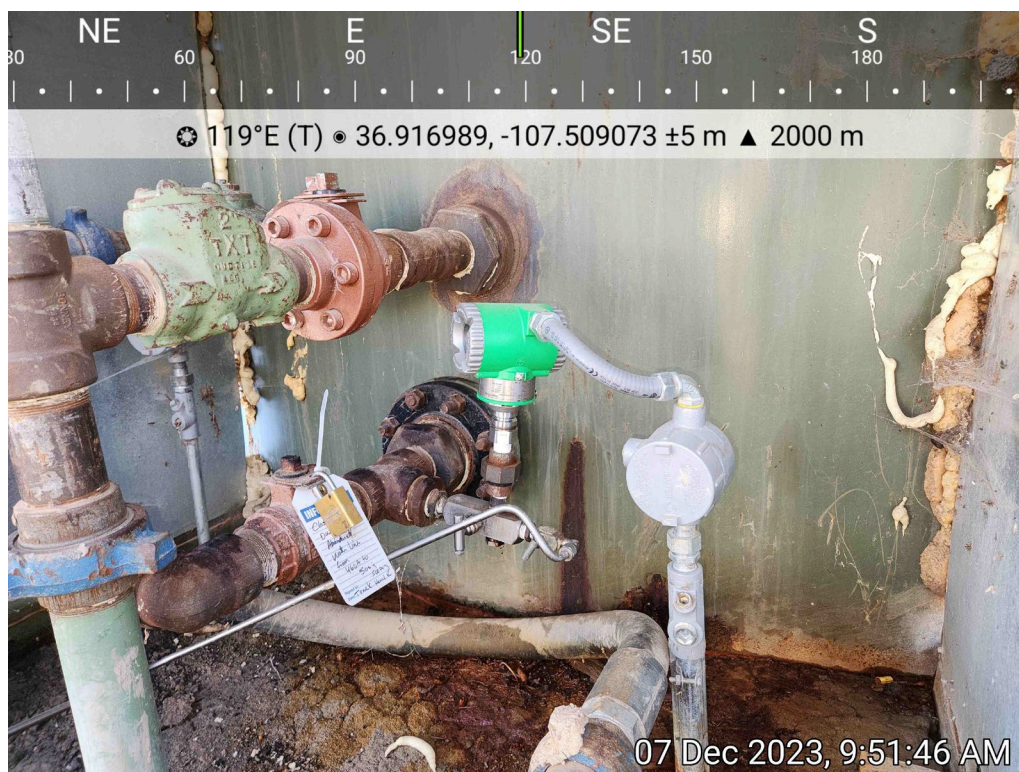
Photo 2: NEBU #400A point of release 12/7/2023.

On December 2, 2023, Simcoe discovered a produced water release from a pinhole at a 500-barrel produced water AST at the NEBU #400A during routine inspection operations. Simcoe immediately pulled the water from the tank and stopped the release. The release was caused by corrosion and the AST is no longer in use. A New Mexico Oil Conservation Division (NMOCD) Notice of Release was submitted to the NMOCD and the project was assigned Incident ID nAPP2333849051.

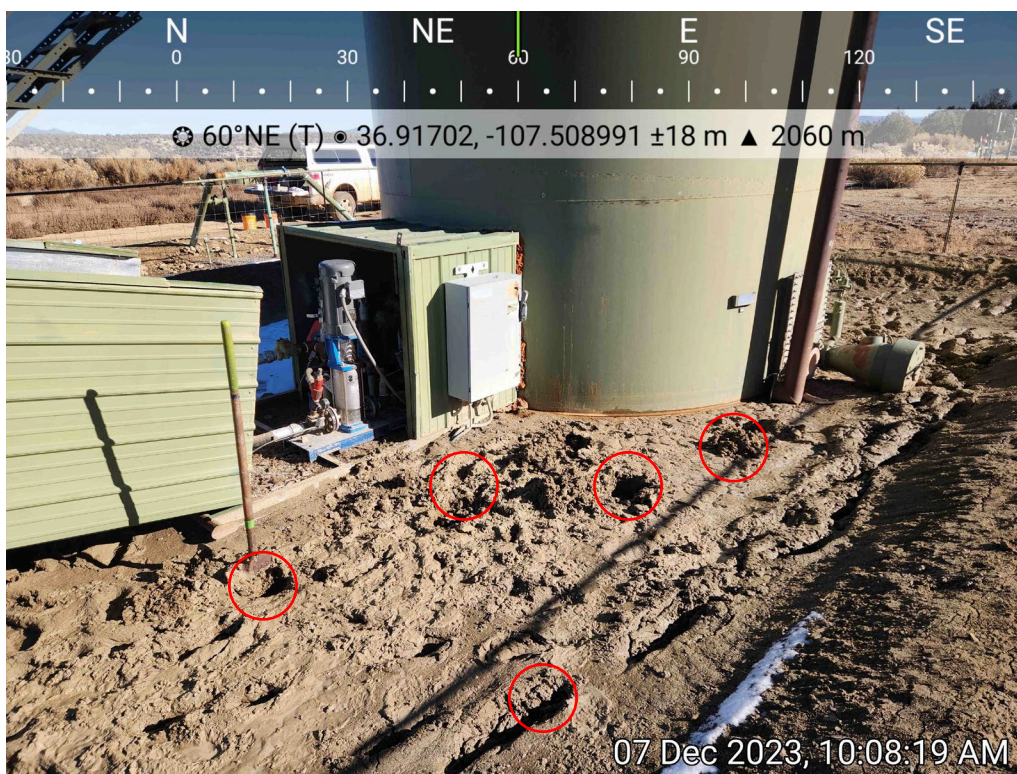
Photo 3: SS01 is a five-point composite sample collected from the wet area, 12/7/2023.

Chloride, BTEX, and TPH levels were below the NMOCD standard; see Table 1 for a summary of the sample results. Appendix A is a photographic log documenting site conditions during sampling and laboratory results are included in Appendix B.

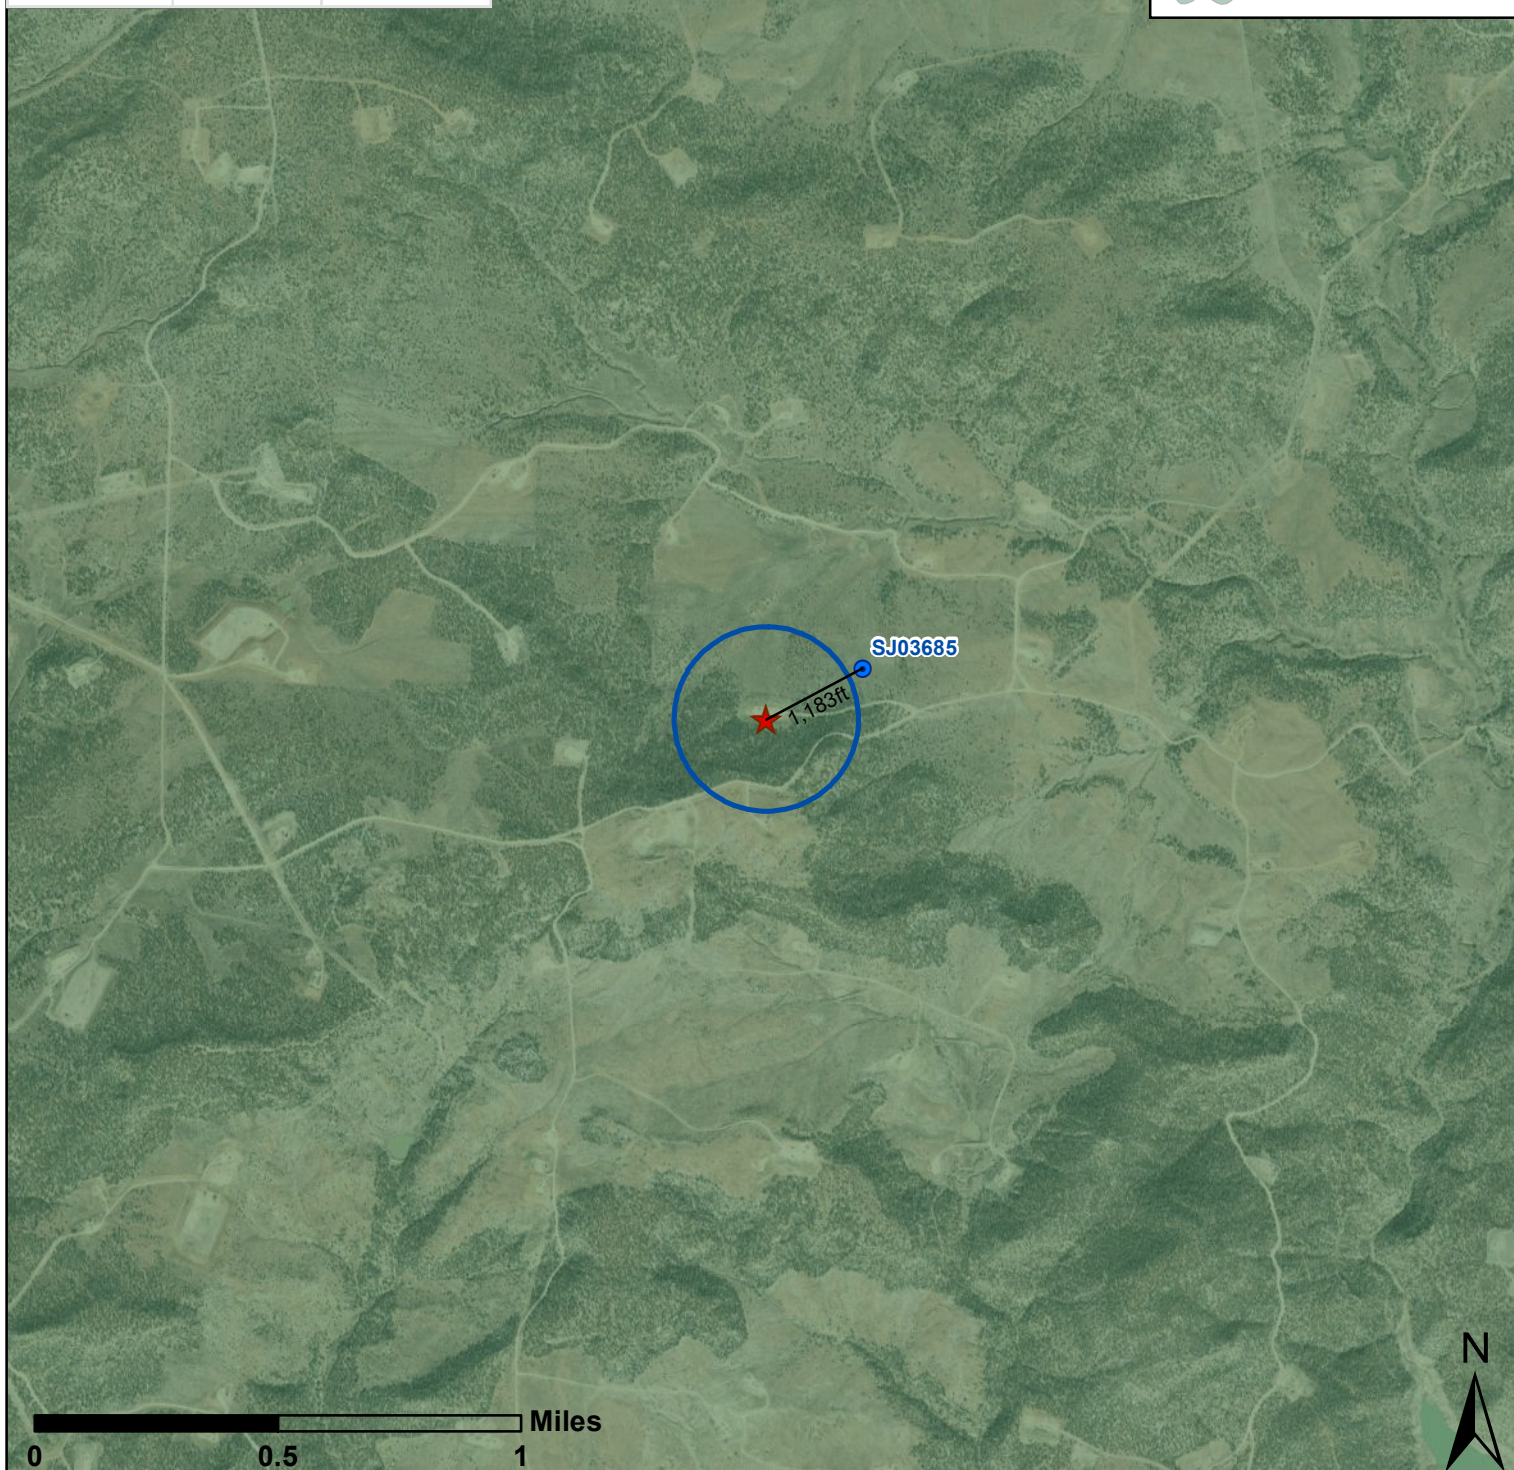
Figure 1
Depth to Groundwater Map
Northeast Blanco Unit #400A
Simcoe LLC

POD Number	Well Depth (ft bgs)	Water Depth (ft bgs)
03685	460	310

Notes: Water well data from the New Mexico Office of the State Engineer. Surficial geology data from the 1997 USGS Geologic Map of New Mexico. ESRI Aerial Imagery date 10/29/2022.

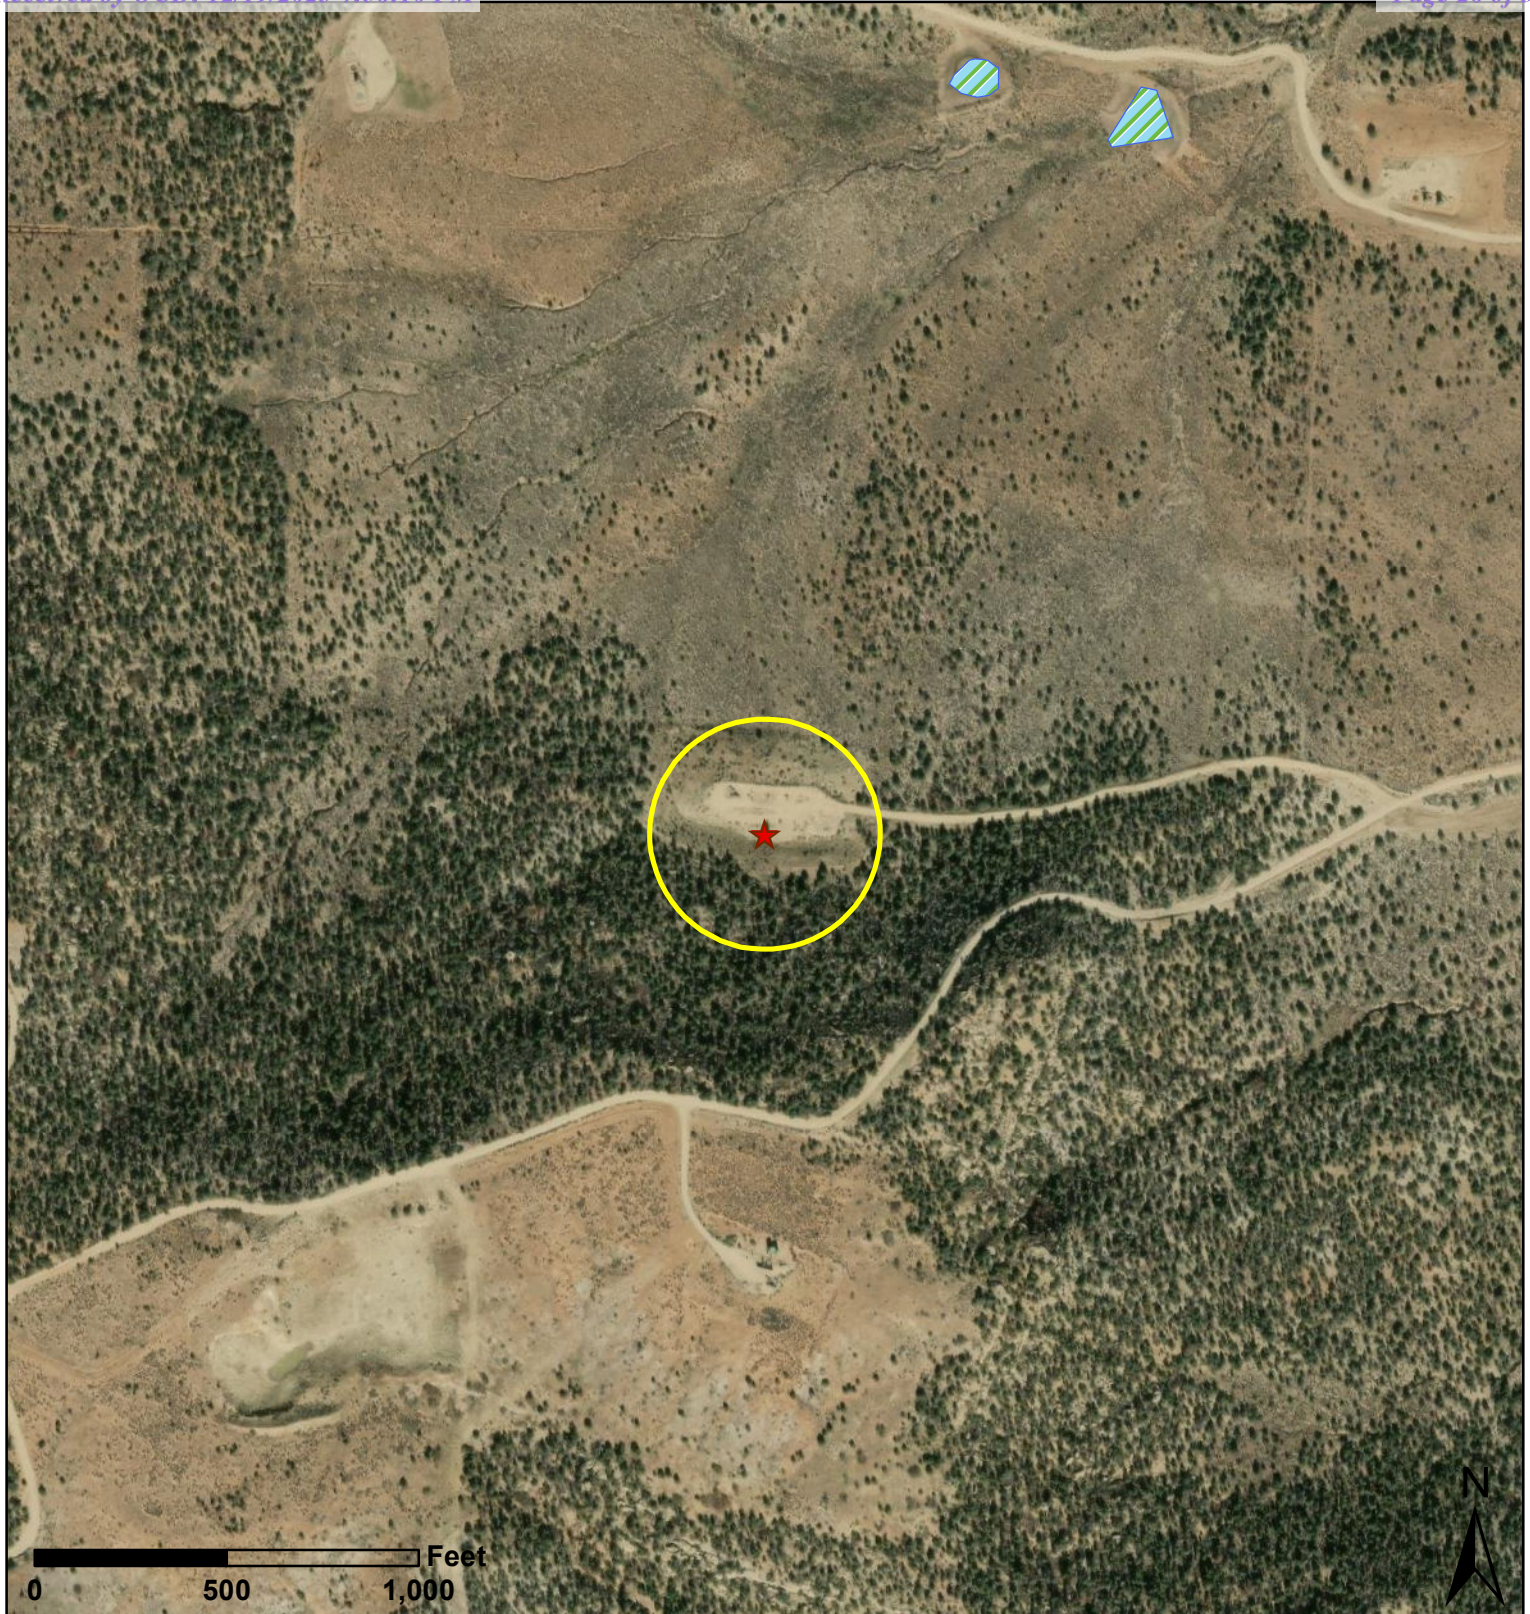
Figure 5
Proximity to Wetlands Map
Northeast Blanco Unit #400A
Simcoe LLC

Notes: Wetland data from the National Hydrography Dataset. ESRI Aerial Imagery date 10/29/2022.

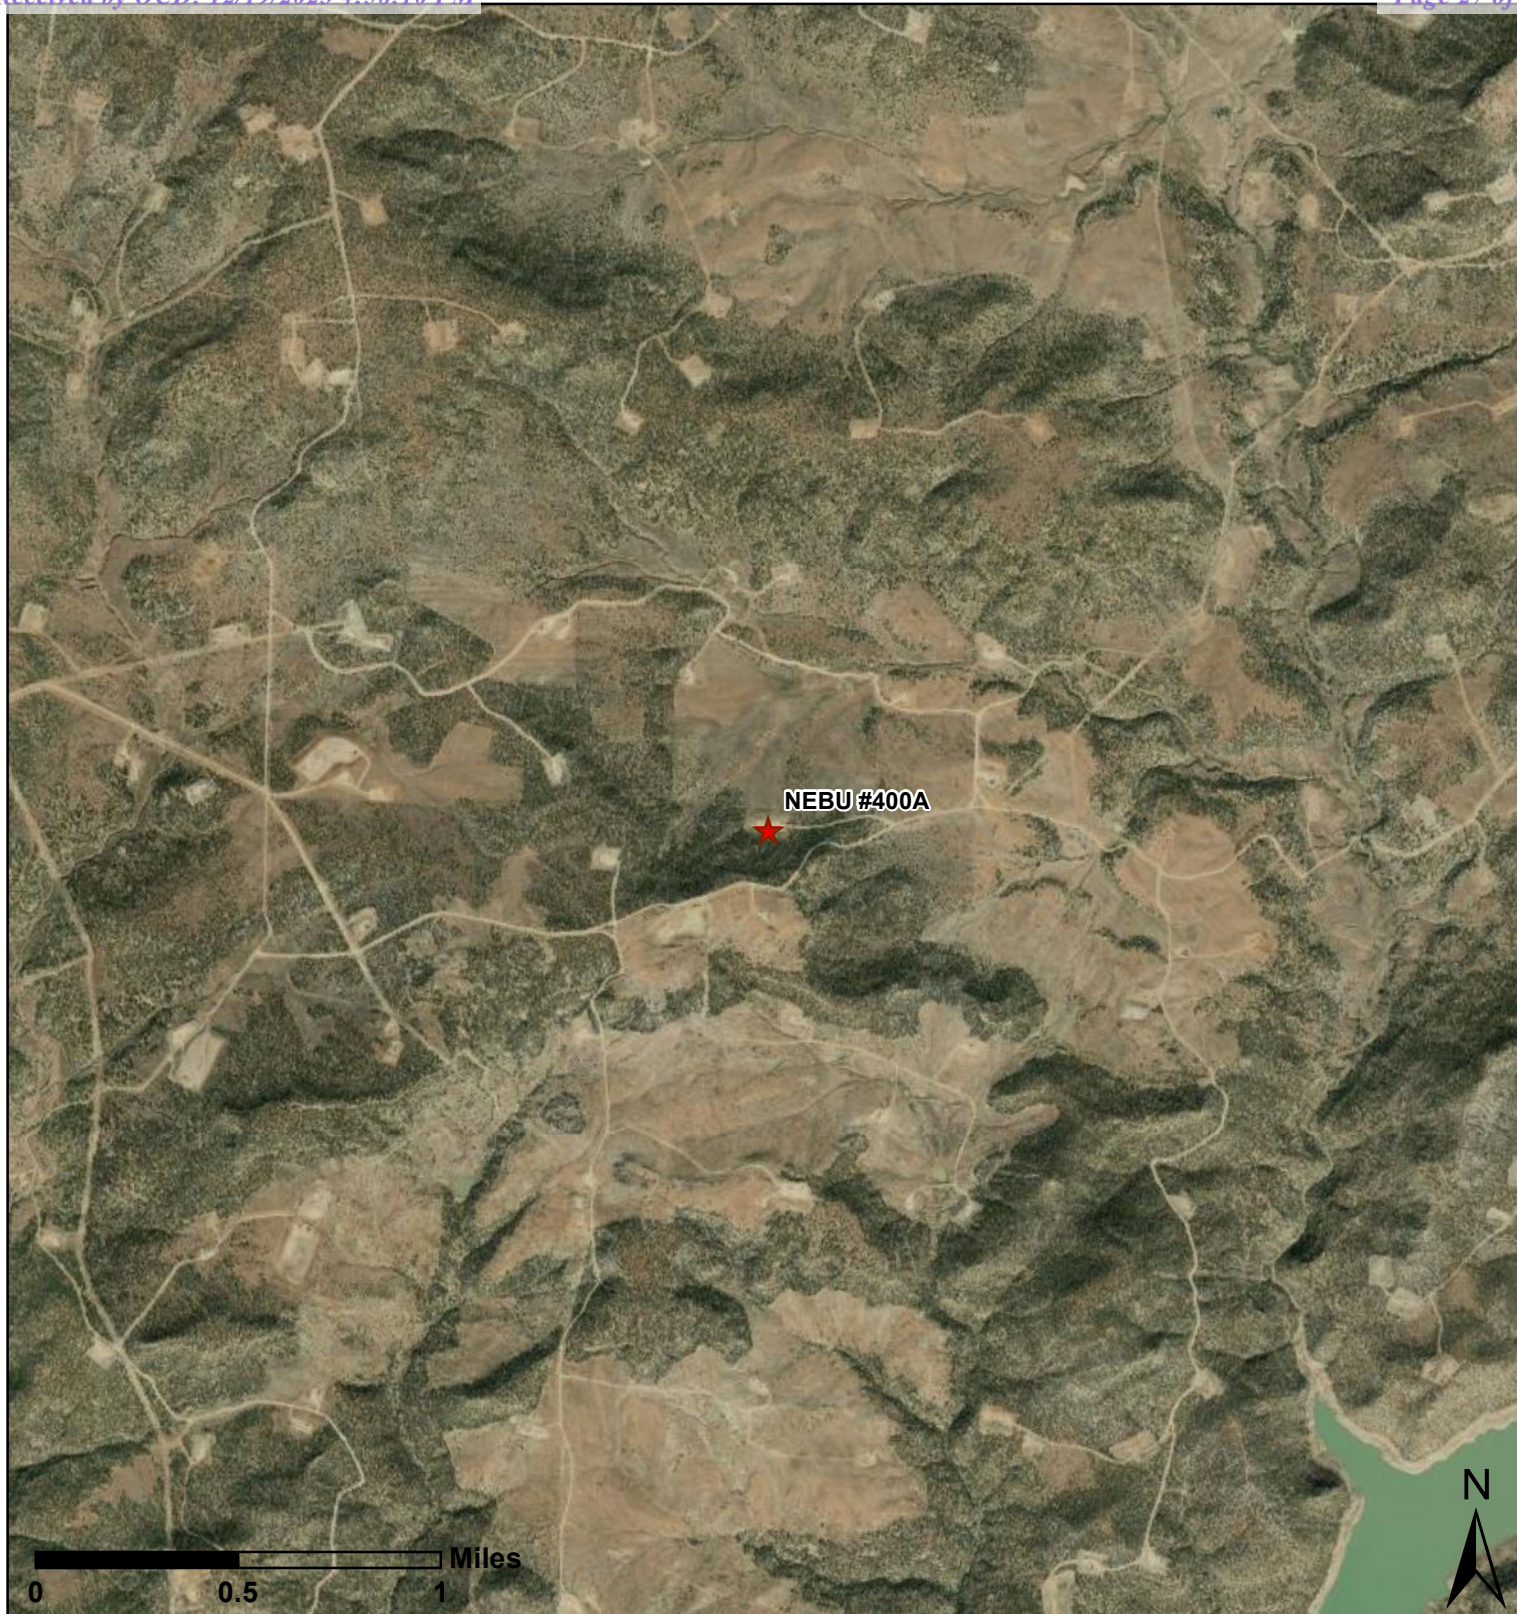
Figure 6
Proximity to Mines Map
Northeast Blanco Unit #400A
Simcoe LLC

Notes: Mine data from the New Mexico Mining and Minerals Division. ESRI Aerial Imagery date 10/29/2022.

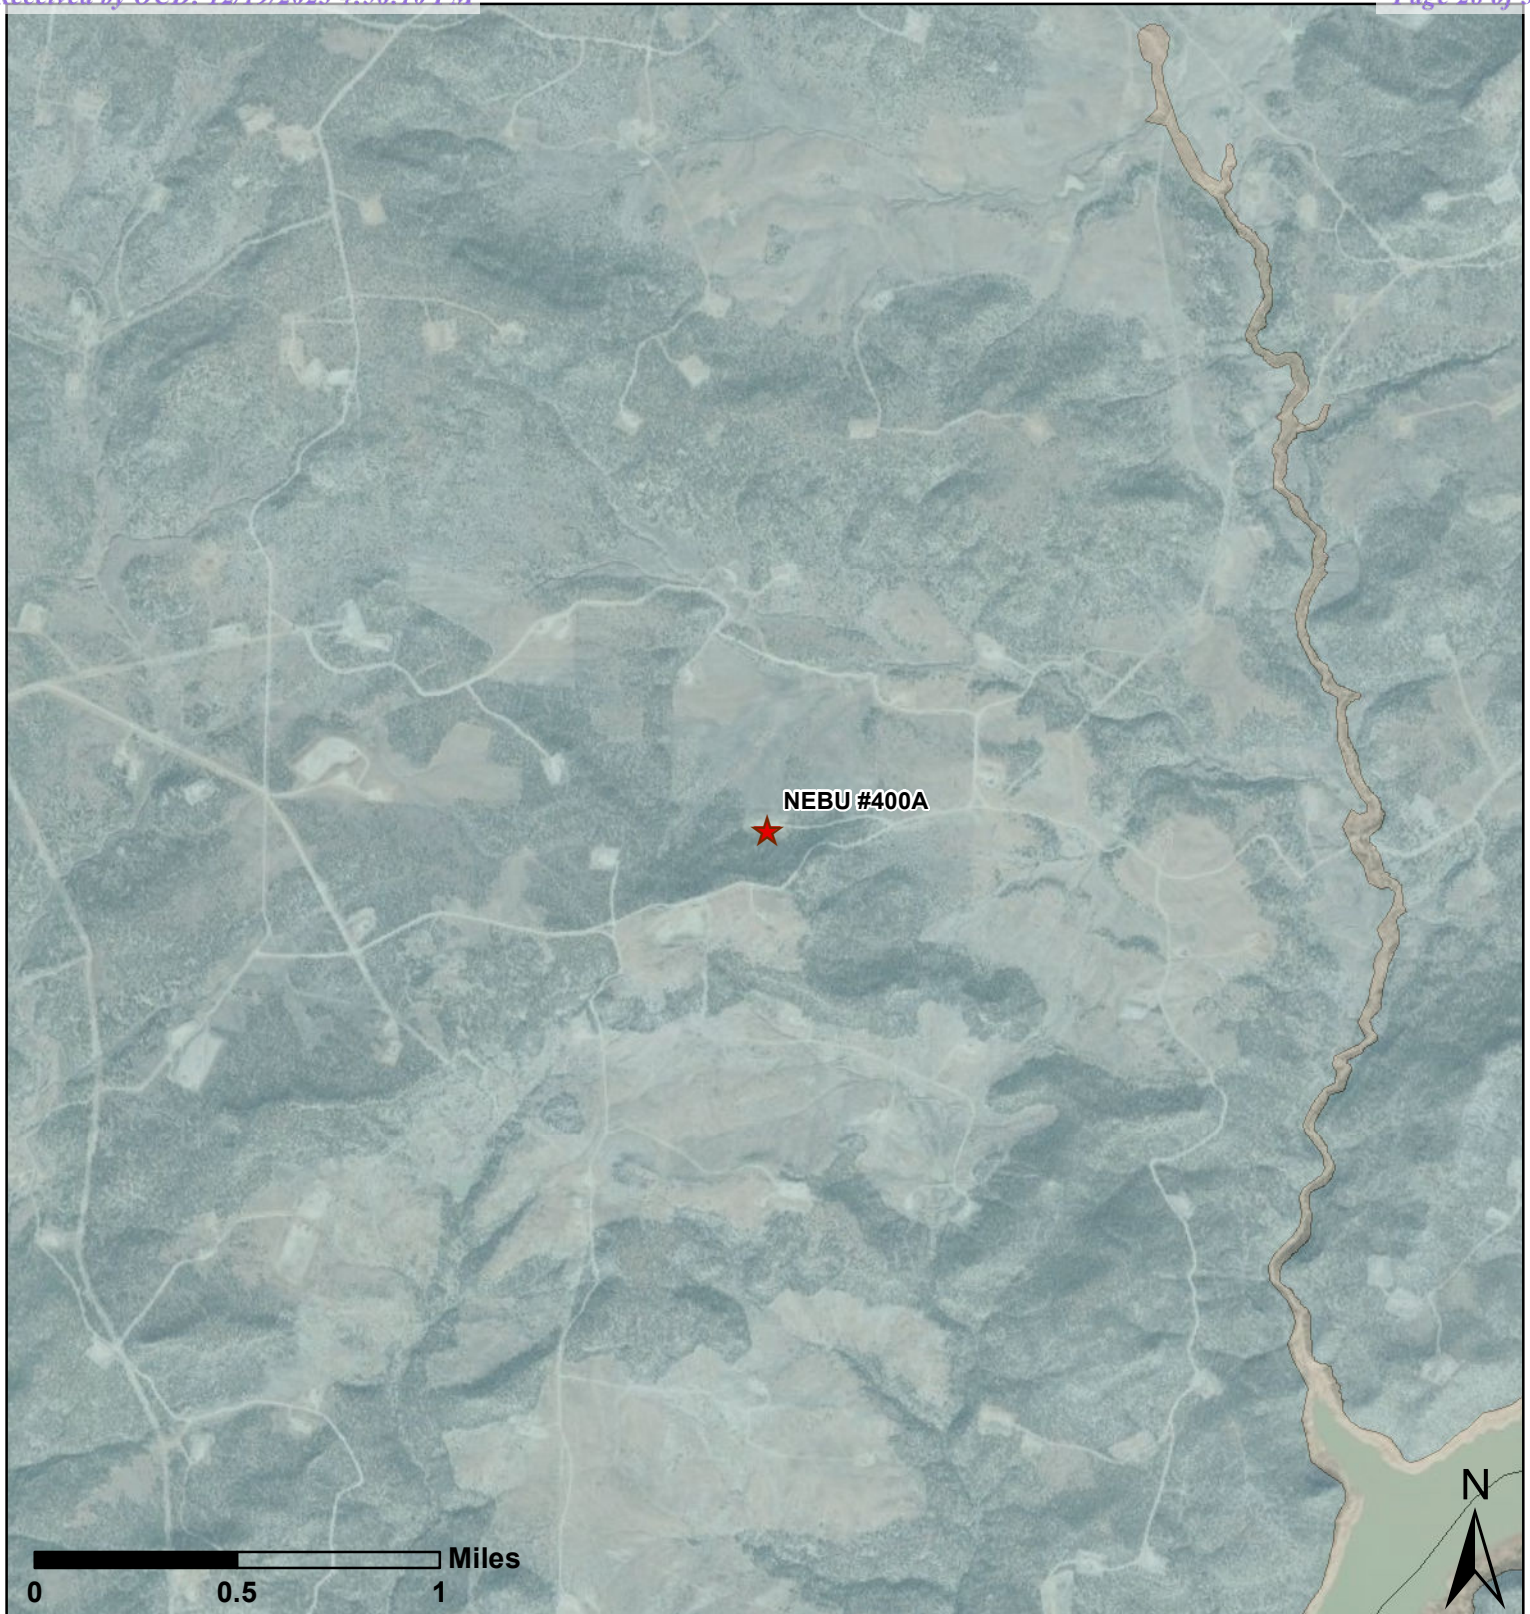
Figure 7
Proximity to Floodplains Map
Northeast Blanco Unit #400A
Simcoe LLC

Notes: Floodplain data from the Federal Emergency Management Agency. ESRI Aerial Imagery date 10/29/2022.
