February 1, 2021

SUBJECT: Remediation Closure Report for the Tomcat 17 Battery Release (NRM2024747616), Lea County, New Mexico

Tomcat 17 Battery Closure Report
February 1, 2021

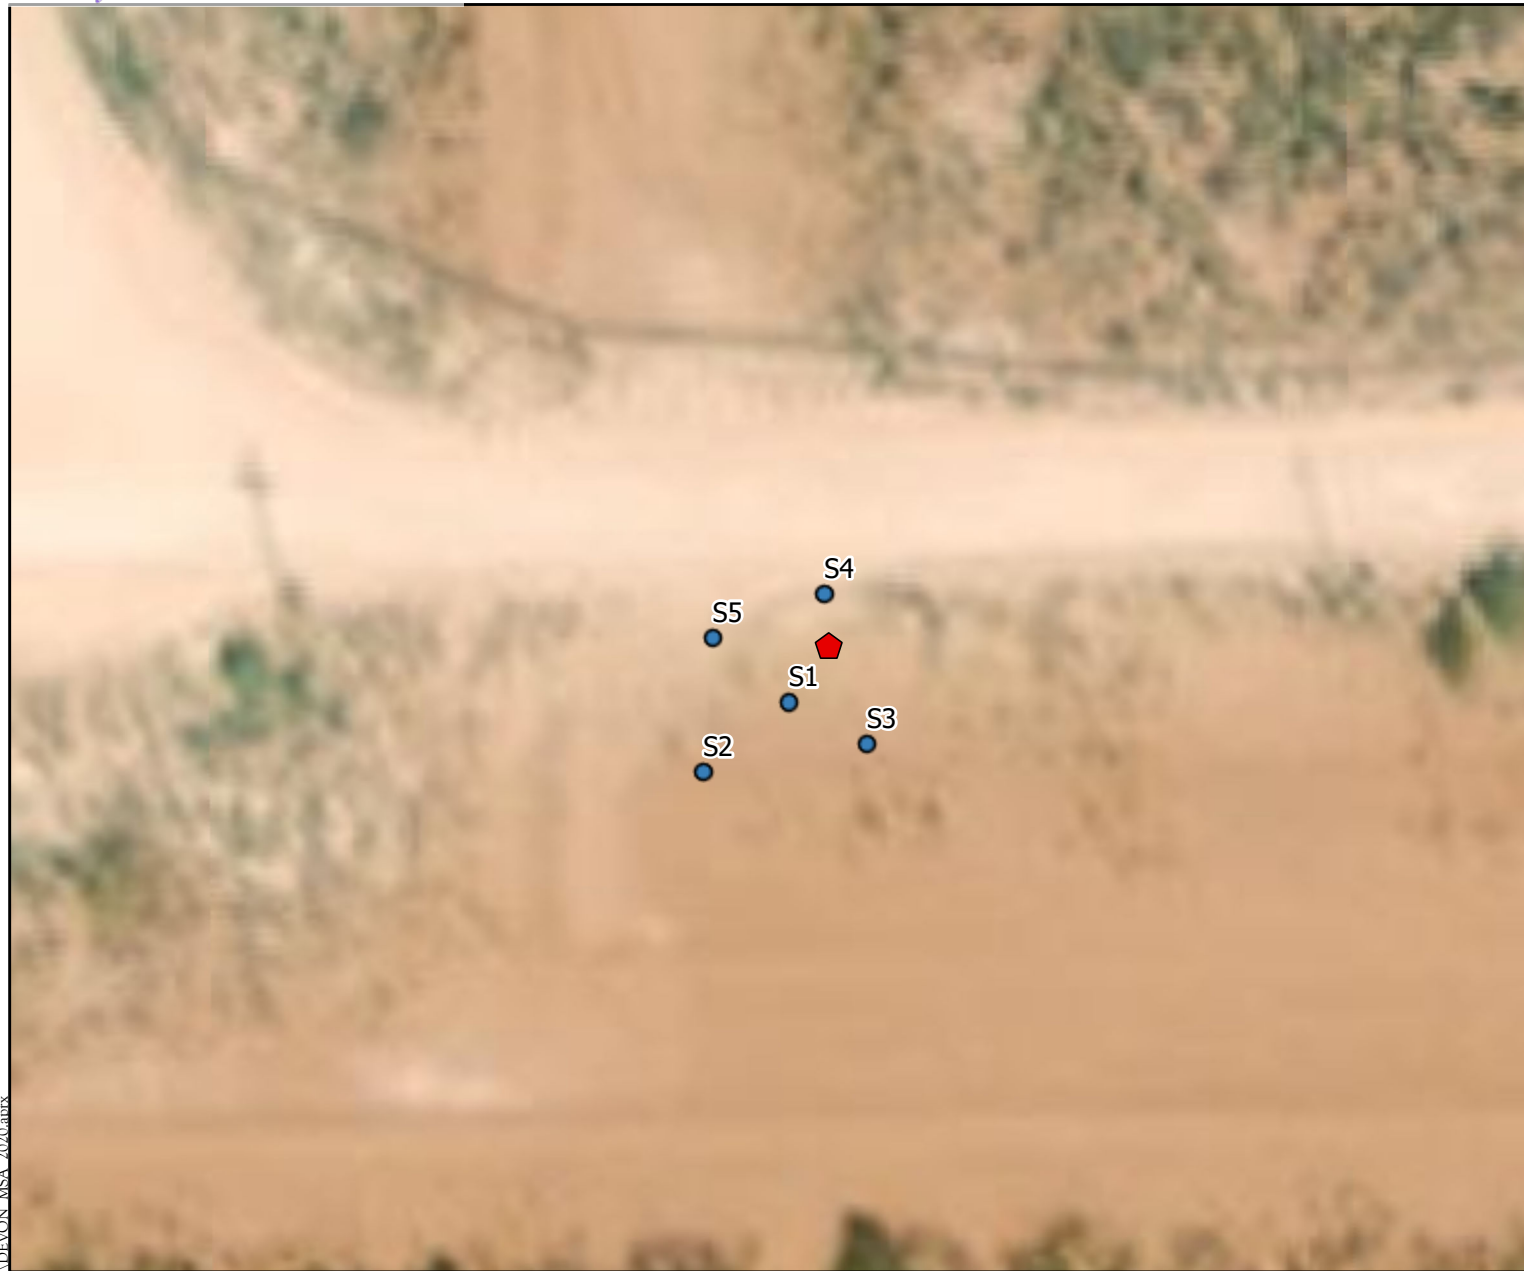
Figure 3

A total of five sample locations (S1 – S5) were investigated using a hand-auger, from surface level to a depth of one foot bgs. A minimum of two samples were collected at each sampling location and field-screened using the methods above. A total of ten samples were collected for laboratory analysis for total chloride using EPA Method 300.0; benzene, toluene, ethylbenzene and total xylenes (BTEX) using EPA Method 8021B; and motor, diesel and gasoline range organics (MRO, DRO, and GRO) by EPA Method 8015D.

Site and Sample Location Map
Tomcat 17 Battery - Devon Energy Production Company
UL: G S: 26 T: 25S R: 34E, Lea County, New Mexico
