RE: Liner Inspection and Closure Report
Bradley 8 Fee Battery
API No. N/A
GPS: Latitude 32.66870 Longitude -104.40690
UL- N, Section 8, Township 19S, Range 26E
NMOCD Reference No. NAPP2331050245

Spur Energy Partners (Spur) has contracted Pima Environmental Services, LLC (Pima) to perform a liner inspection and prepare this closure report for the release of produced water that happened on the Bradley 8 Fee Battery (Bradley). An initial C-141 was submitted on November 6, 2023, and can be found in Appendix B. This incident was assigned Incident ID NAPP2331050245 by the New Mexico Oil Conservation Division (NMOCD).

Liner Inspection

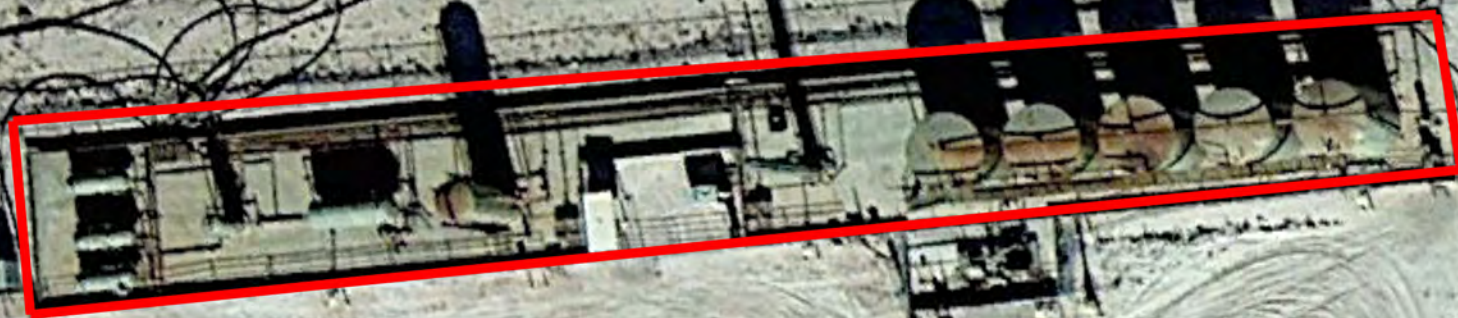
Spur Energy
API:30-015-39811
Eddy County, NM
Site Map

A Site Map can be found in Figure 4.

Lined Containment

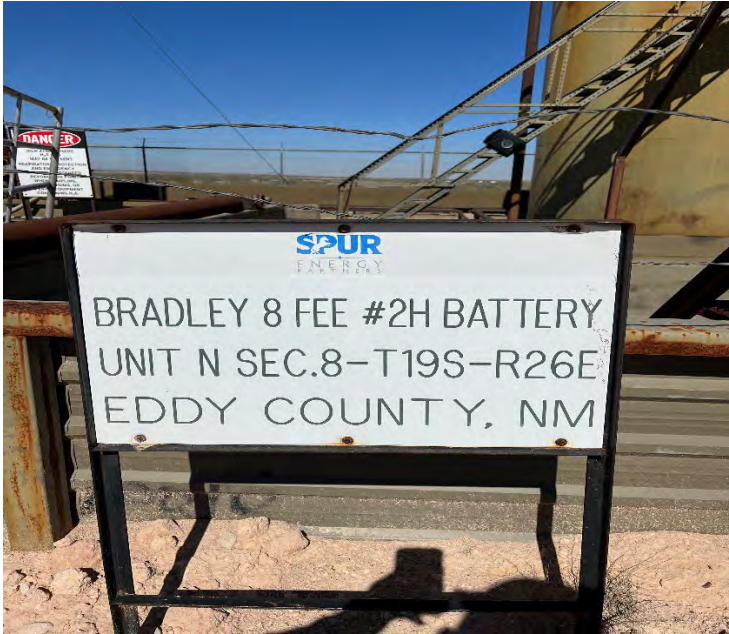
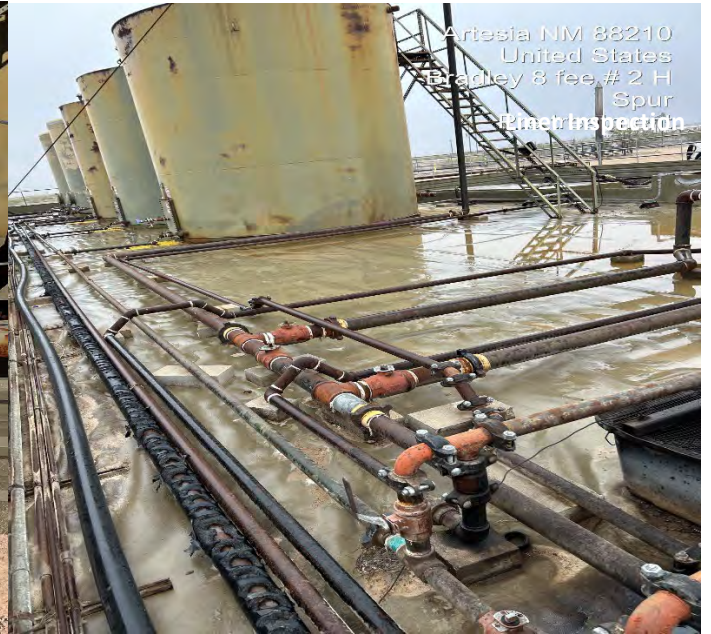
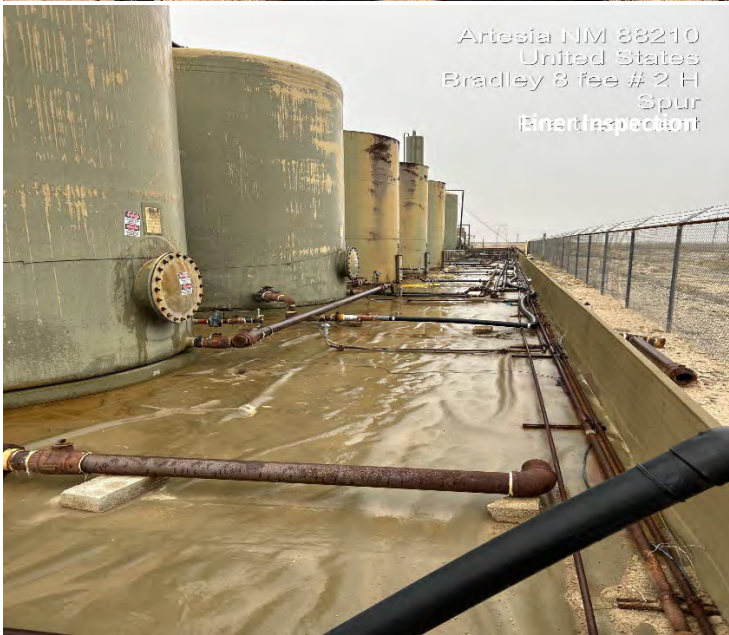
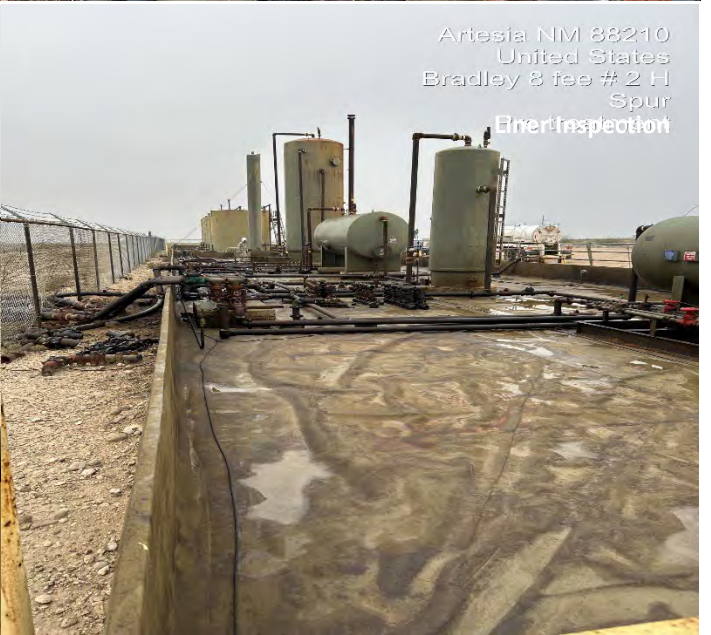
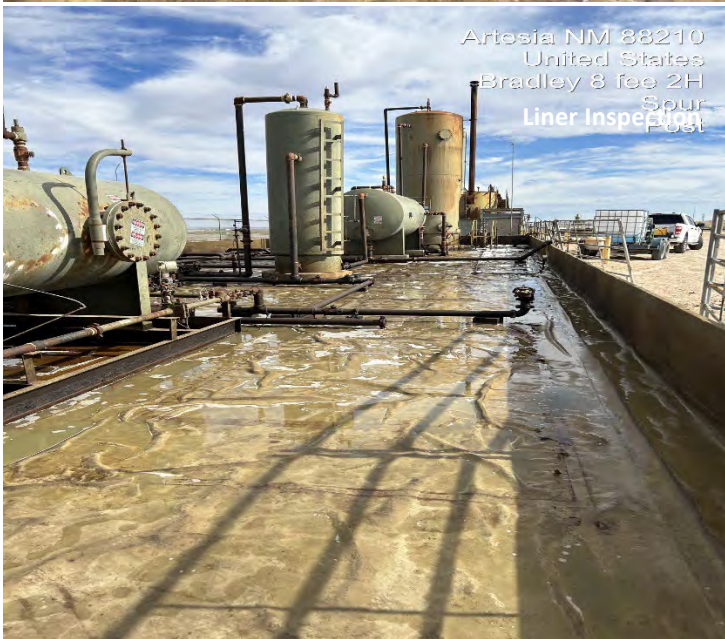
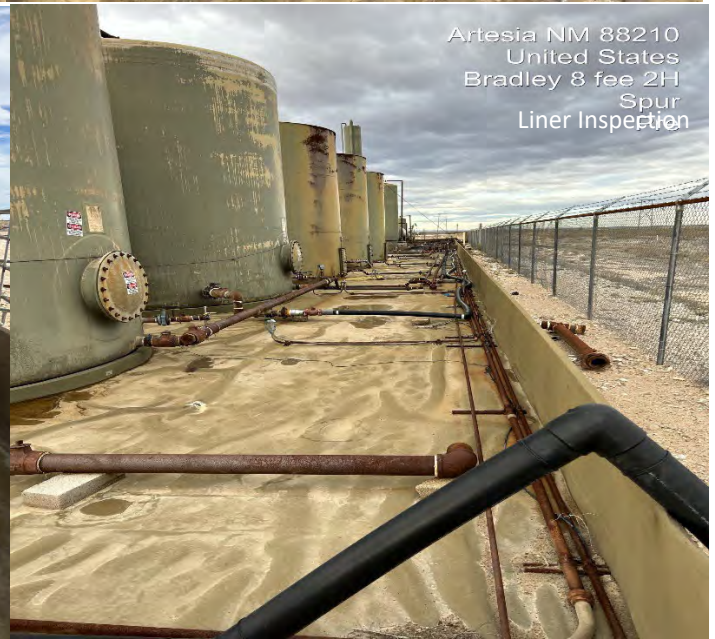
On November 17, 2023, after sending the 48-hour notification via email, Pima Environmental conducted a liner inspection at this location. We concluded that this liner and containment maintained its integrity and was able to retain the fluids. The liner inspection form and photographic documentation can be found in Appendix C.

Visualization	Yes	No	Comments
Is there a tear in the liner?		X	
Are there holes in the liner?		X	
Is the liner retaining any fluids?	X		The inspection images of the liner reveal residual fluid resulting from the remediation event involving power washing.
Does the liner have integrity to contain a leak?	X
