Re: Fourth Quarter 2023 – SVE System Update

San Juan 28-6 #31
Rio Arriba County, New Mexico
Hilcorp Energy Company
NMOCD Incident Number: NVF1816655680

Ensolum, LLC (Ensolum), on behalf of Hilcorp Energy Company (Hilcorp), presents this *Fourth Quarter 2023 – SVE System Update* report summarizing the soil vapor SVE system performance at the San Juan 28-6 #31 natural gas production well (Site) located in Section 28, Township 28 North, Range 6 West in Rio Arriba County, New Mexico (Figure 1). This report summarizes Site activities performed in October, November, and December 2023. The report is submitted either annually or biannually, the New Mexico Oil Conservation Division (NMOCD).

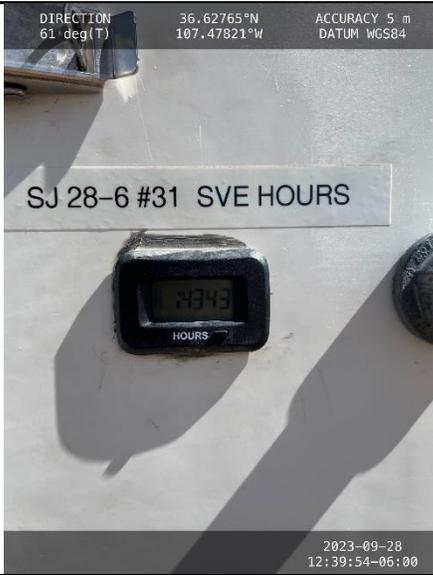
<p>Photograph 1</p> <p>Runtime meter taken on September 28, 2023 at 12:39 PM Hours = 14,343</p>
