Remediation Summary & Soil Closure Request

Mewbourne Oil Company

Perro Loco 22 B3OB Fed Com #1H

NMOCD Reference No. nAPP2333538592

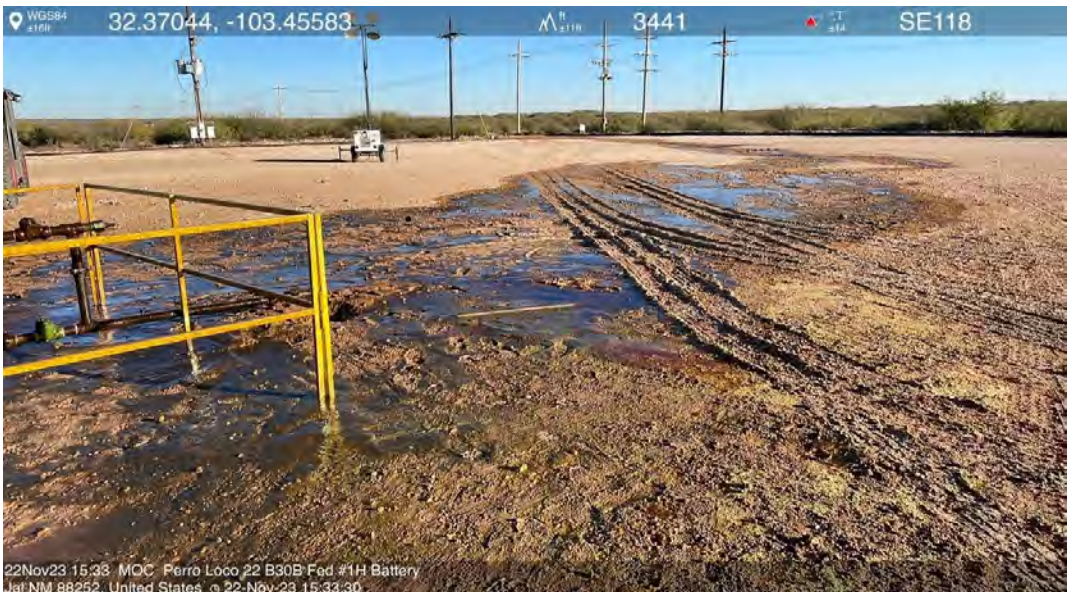
Photo Number: 2

<p>22Nov23 15:33 MOC Perro Loco 22 B30B Fed #1H Battery Jaf NM 88252, United States 22-Nov-23 15:33:30</p>
Photo Direction: East-Southeast	
Photo Description: View of the affected area.

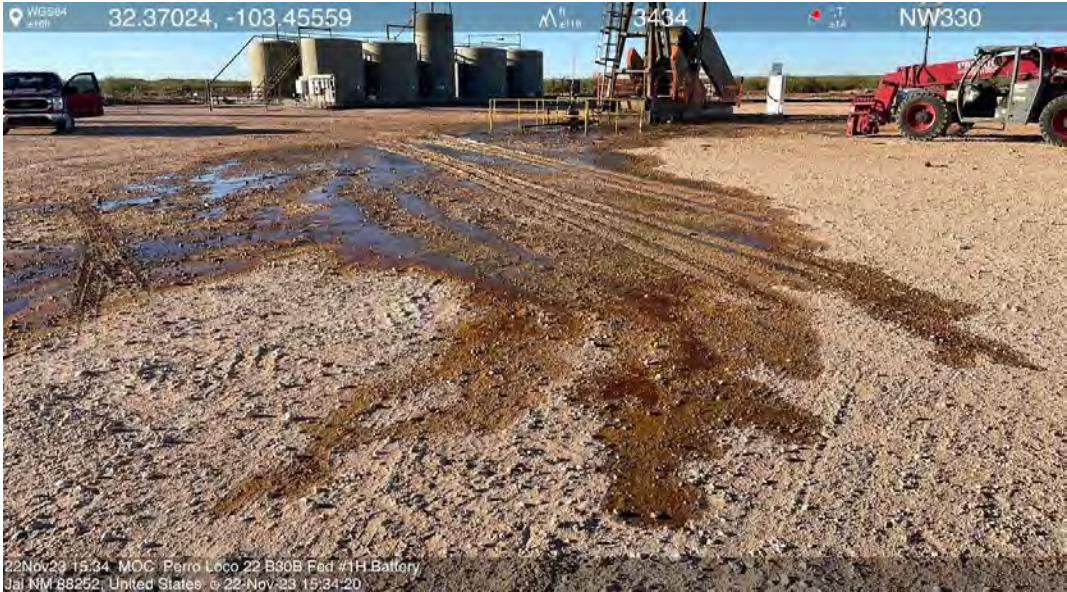
Photo Number: 3

Photo Direction: North-Northwest	
Photo Description: View of the affected area.

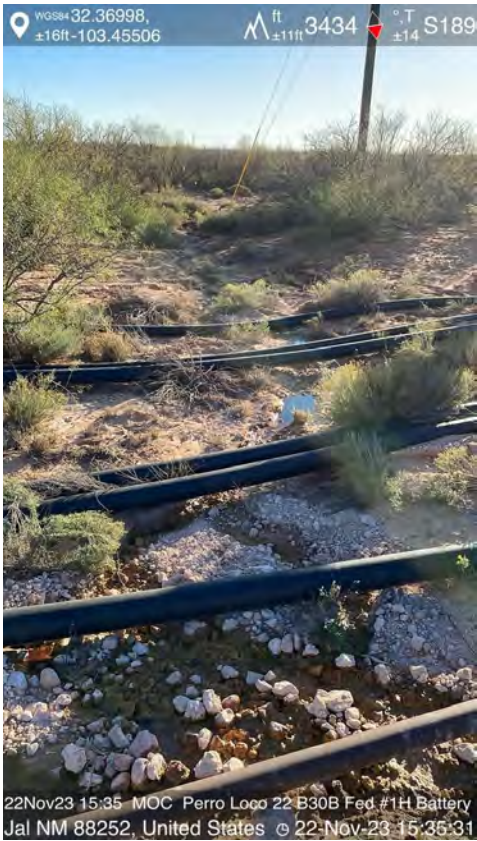
Photo Number: 5

<p>22Nov23 15:35 MOC Perro Loco 22 B30B Fed #1H Battery Jal NM 88252, United States © 22-Nov-23 15:35:31</p>
Photo Direction: South	
Photo Description: View of the affected area.

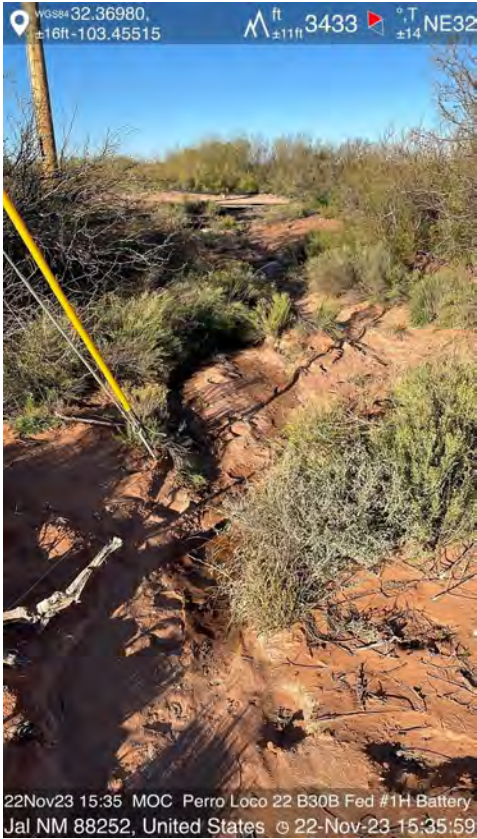
Photo Number: 6

<p>22Nov23 15:35 MOC Perro Loco 22 B30B Fed #1H Battery Jal NM 88252, United States © 22-Nov-23 15:35:59</p>
Photo Direction: North-Northeast	
Photo Description: View of the affected area.

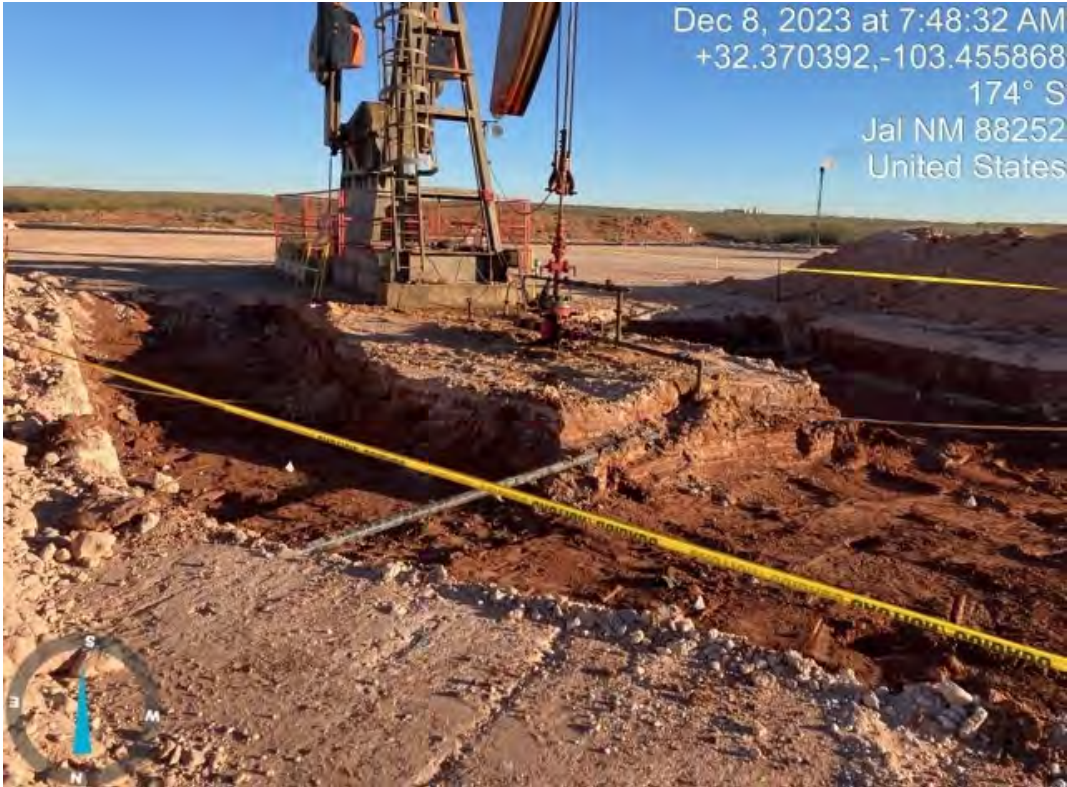
Photo Number: 7

Photo Direction: South	
Photo Description: View of the excavated area.

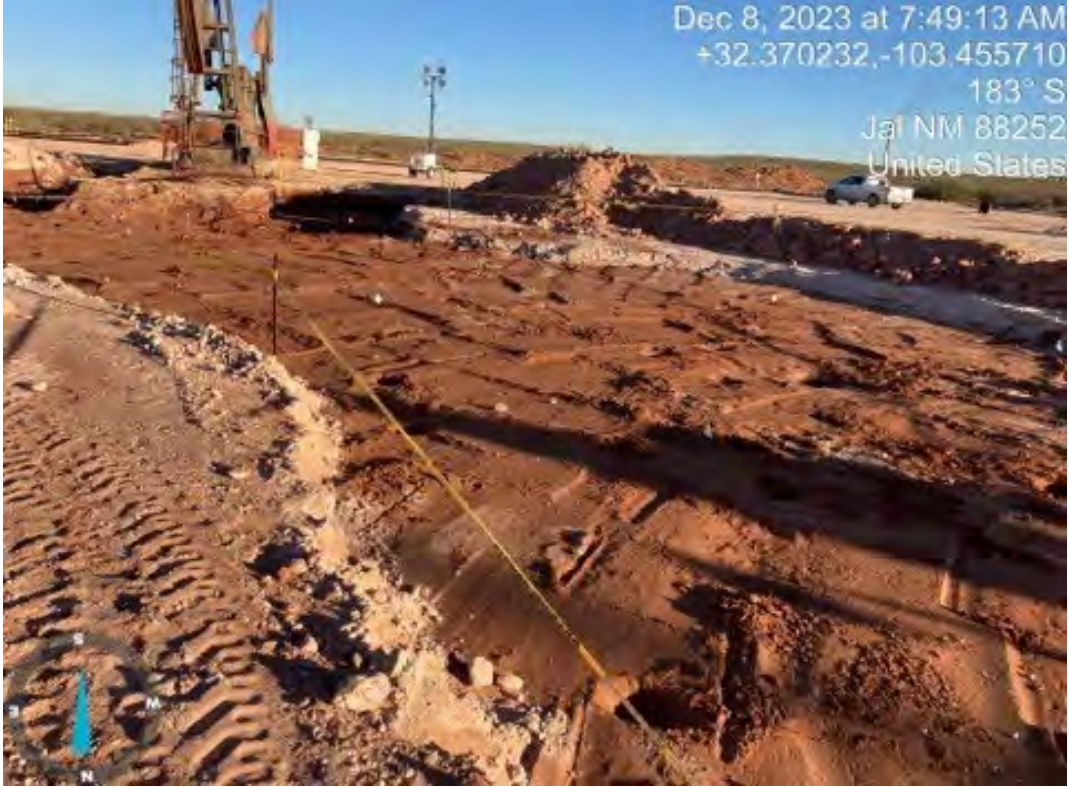
Photo Number: 9

<p>Dec 8, 2023 at 7:49:13 AM +32.370232,-103.455710 183° S Jal NM 88252 United States</p>
Photo Direction: South	
Photo Description: View of the excavated area.

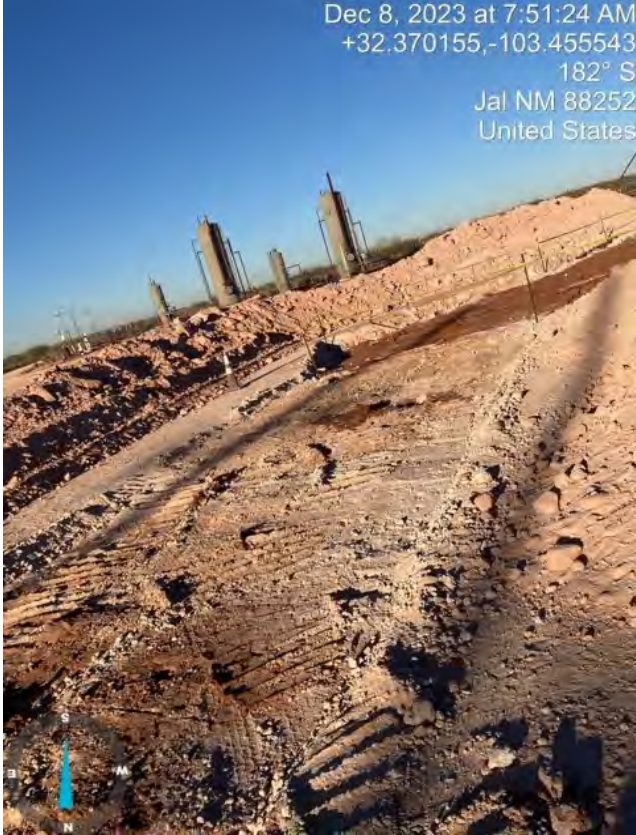
Photo Number: 10

<p>Dec 8, 2023 at 7:51:24 AM +32.370155,-103.455543 182° S Jal NM 88252 United States</p>
Photo Direction: South	
Photo Description: View of the excavated area.
