**Re: Updated Remediation Work Plan**

San Juan 27-5 Unit 111  
Rio Arriba County, New Mexico  
Hilcorp Energy Company  
NMOCD Incident Number: NAPP2300554747

Hilcorp Energy Company  
Updated Remediation Work Plan  
San Juan 27-5 Unit 111

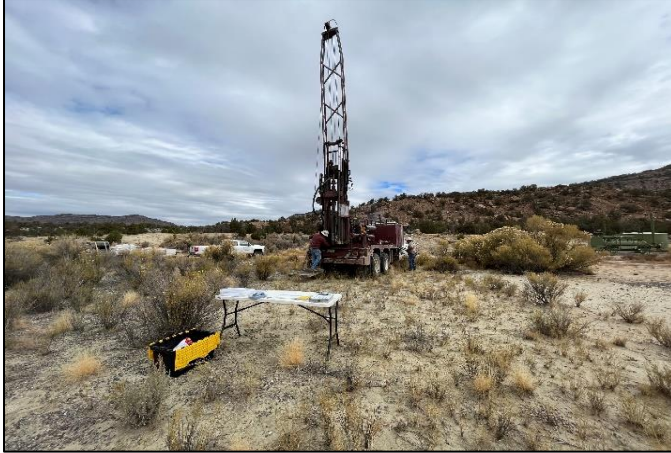
Photograph: 1                      Date: 11/16/2023  
Description: Drilling boring BH08  
View: North

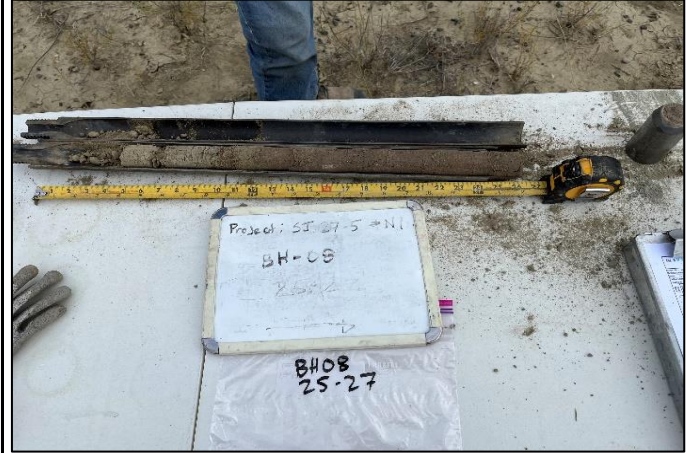
Photograph: 2                      Date: 11/16/2023  
Description: Impacted interval at 25 to 27 feet depth  
View: Boring BH08

Concentrations of TPH as a combination of GRO+DRO exceeding the NMOCD Table I Closure Criteria were detected in samples collected from borings BH08 (at depths of 25 to 27 feet bgs) and BH09 (at depths of 33 to 35 feet bgs). Additionally, total BTEX concentrations exceeded the NMOCD Table I Closure Criteria in sample BH09(33-35). TPH as a combination of GRO+DRO and BTEX concentrations were compliant with NMOCD Table I Closure Criteria in samples collected above and below these impacted intervals in borings BH08 and BH09. In addition, concentrations of constituents of concern (COC) were compliant with the NMOCD Table I Closure Criteria in all other analyzed samples collected during the November 2023 delineation effort. A summary of the November 2023 analytical results is presented on Table 1 (including previously collected data) and depicted on Figure 2. Complete laboratory reports are attached in Appendix C. Photographs collected during Site work are included in Appendix D.

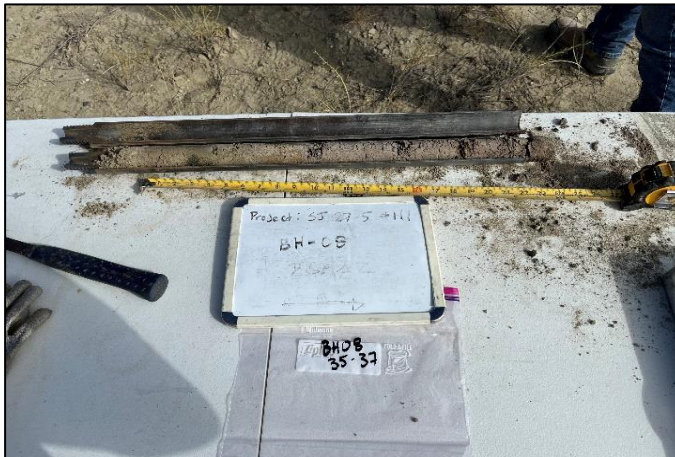
Photograph: 3                      Date: 11/16/2023  
Description: Siltstone at terminus of boring  
View: Boring BH08

Based on the depths at which COC concentrations exceeded the applicable Closure Criteria (near the terminus of each boring and directly above the bedrock units), it appears the released fluids predominantly migrated vertically below the center of the secondary containment and then travelled along the bedding plane of the bedrock unit to the west. Although the terminal soil sample previously collected from boring BH05 at 24 feet to 26 feet bgs contained COC concentrations exceeding the Closure Criteria, it is unlikely soil impacts have migrated into the underlying bedrock. As such, it is assumed impacts in this area are likely contained above the bedrock unit, as indicated by the data collected from borings BH01, BH06, BH08, and BH09.

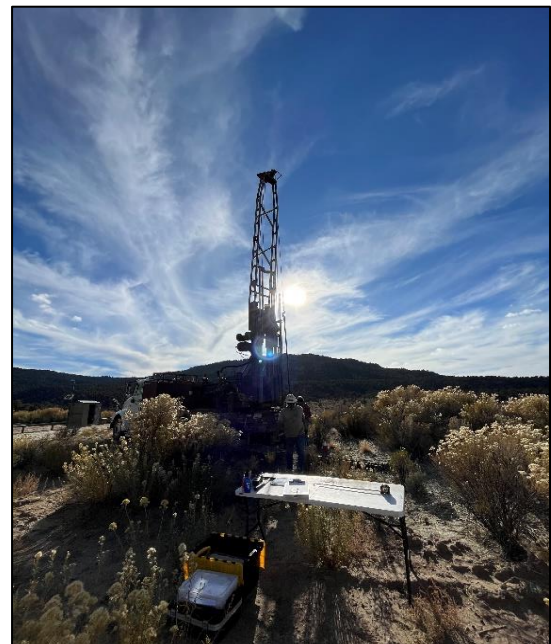
Photograph: 4                      Date: 11/16/2023  
Description: Drilling boring BH10  
View: South
