> RE: Spur Energy Partners, LLC Conoco 8 St 4 Tank Battery NMOCD Reference No. nAPP2308835013 UL/ O Sec. 8, T17S, R29E API No. 30-015-39882 GPS: 32.8452, -104.0935

Etech Environmental & Safety Solutions (Etech), on behalf of Spur Energy Partners, LLC, has prepared this *Amended Remediation and Liner Inspection Summary* for the release at the Conoco 8 St 4 Tank Battery location. The site is located approximately 17 miles east of Artesia, NM, in Unit Letter O, Section 8, Township 17 South, Range 29 East. The GPS coordinates of the site are: 32.8452, -104.0935. A "Site Location Map" is provided as Attachment #1.

## Photographic Log

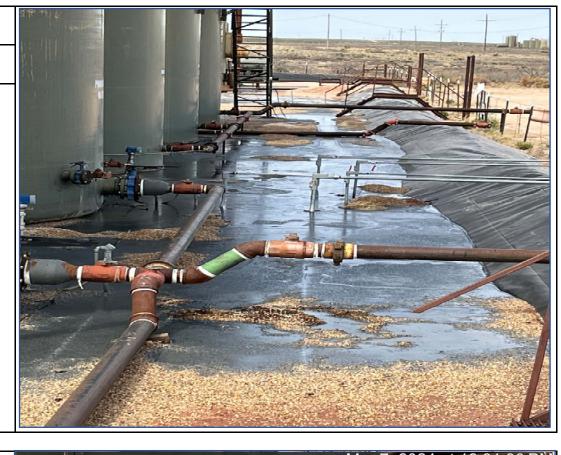
#1

West

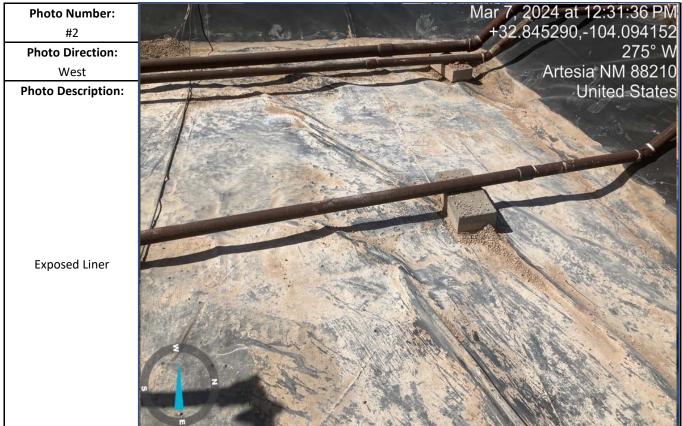
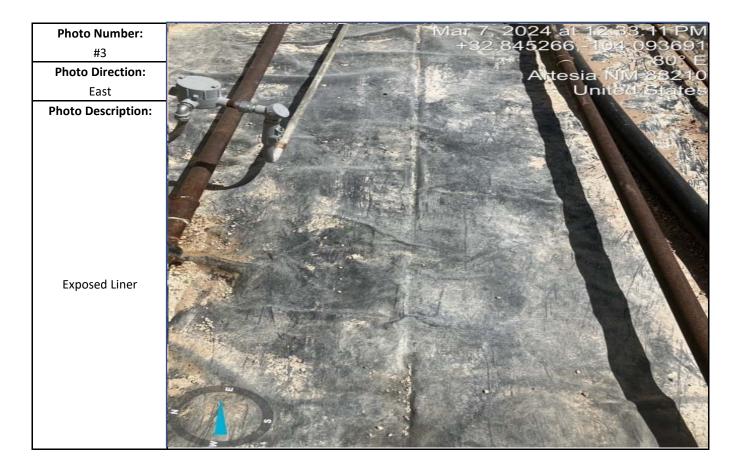
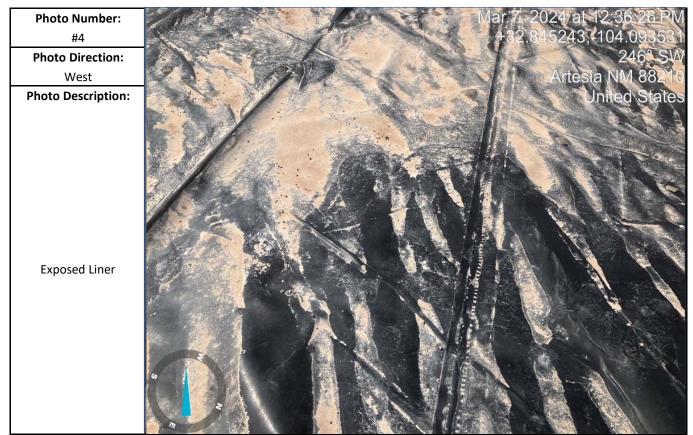
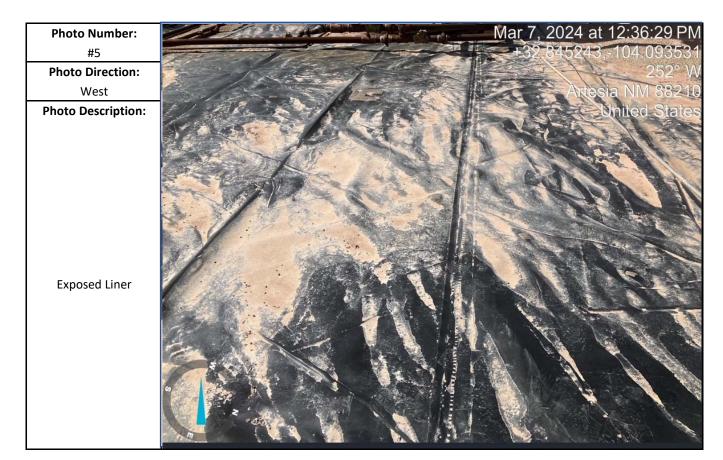
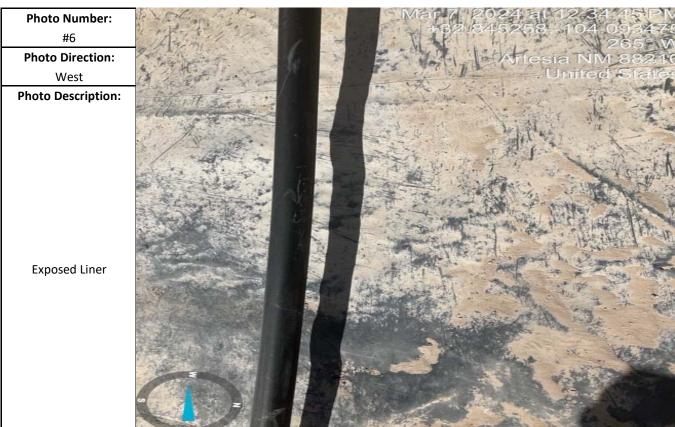
Beginning on March 4, 2024, Etech performed an additional liner inspection. All material was removed from the liner and stockpiled prior to inspecting the liner. Additional photgraphs were taken to show the liner inspection was done without having any material present. After inspection and verification of liner integrity, the previously removed material was placed back on the liner.

Based on observations made by Etech personnel during the course of inspection activities, it was determined that the integrity of the liner is adequate, and the liner is performing as intended. The attached photgraphs of the liner show the integrity of the liner has not been compromised. Therefore, Etech believes no further action is necessary at this time. A "Liner Integrity Inspection Report" is provided as Attachment 2. A "Photographic Log" is provided as Attachment 3.
