Mesquite Booster Line

nAPP2325073485

**Re: Closure Report
Mesquite Booster Line
Devon Energy Production Company
Site Location: Unit N, S33, T23S, R33E
Lat 32.255789°, Long -103.578829°
Lea County, New Mexico
Incident ID: nAPP2325073485**

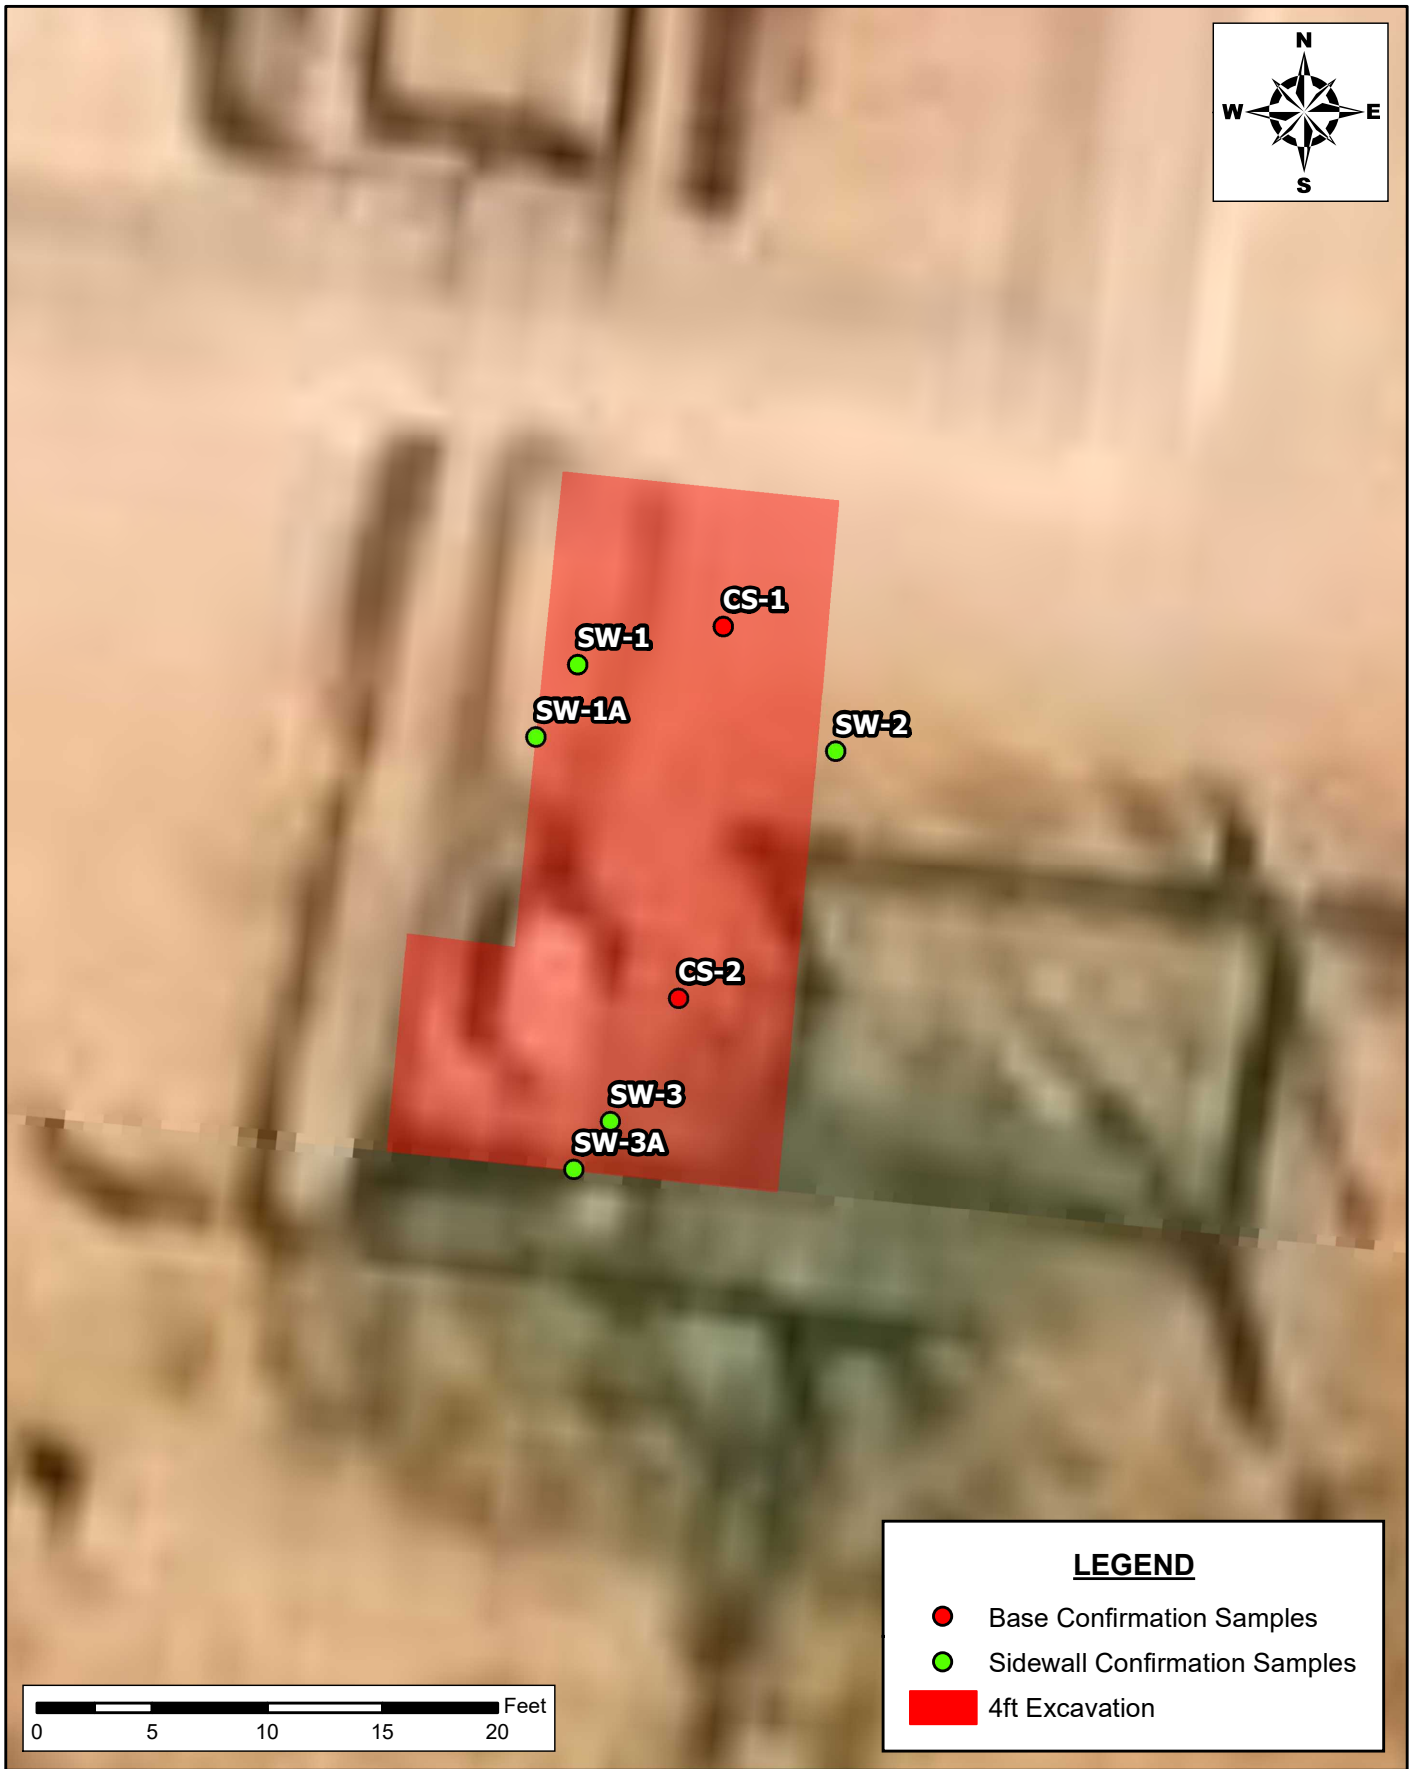
Based on the analytical results, Devon proceeded with remediation activities at the Site to include the excavation and disposal of impacted soils above the regulatory limits. The release areas of V-1 were excavated to four (4) ft bgs based on the delineation samples results shown in Table I. A final excavation map with confirmation sample locations is shown in Figure 4.

Complete analytical results for all confirmation samples are presented in Table 2 and the final excavation map with confirmation sample locations is shown in Figure 4.

- Base Confirmation Samples
- Sidewall Confirmation Samples
- 4ft Excavation

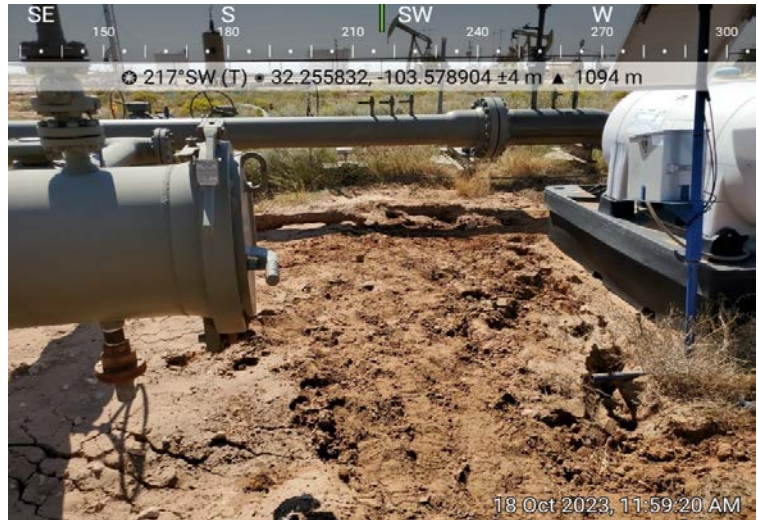
Description:
Area of Concern.

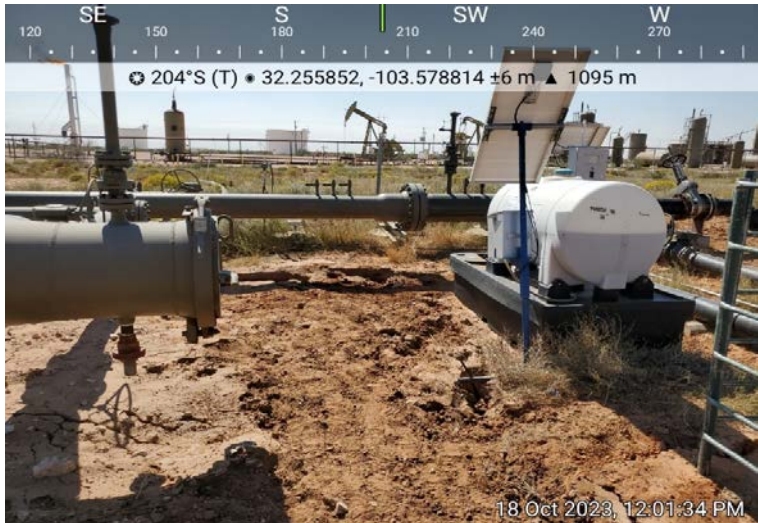
**Photograph No. 2**

Description:
Area of Concern.

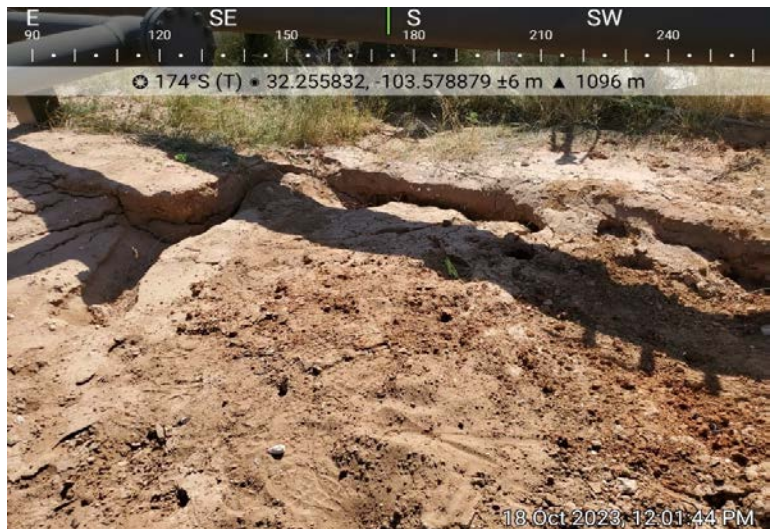
**Photograph No. 3**

Description:
Area of Concern.

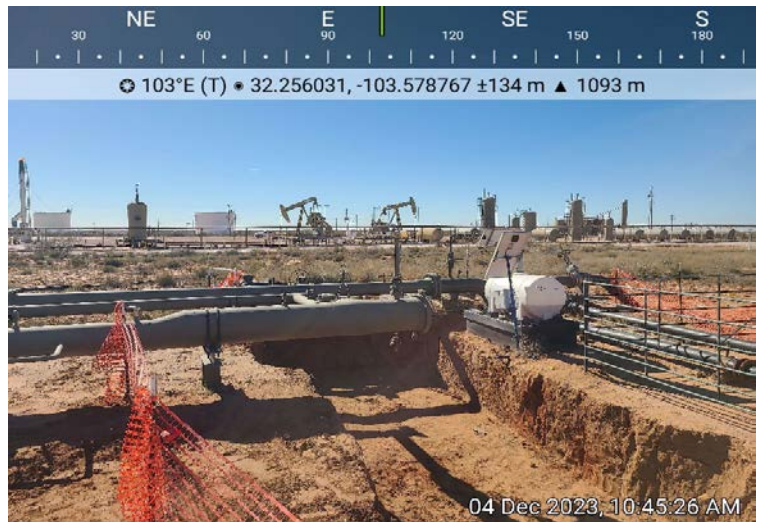
Description:
Area of Excavation.

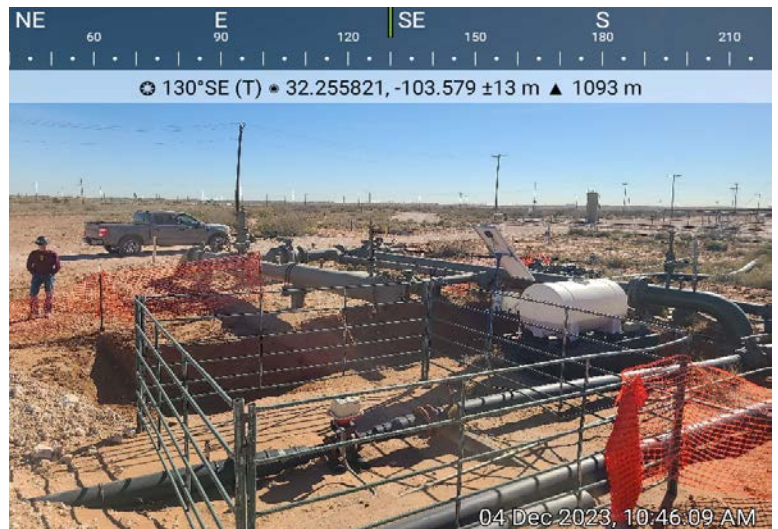
**Photograph No. 6**

Description:
Area of Excavation.

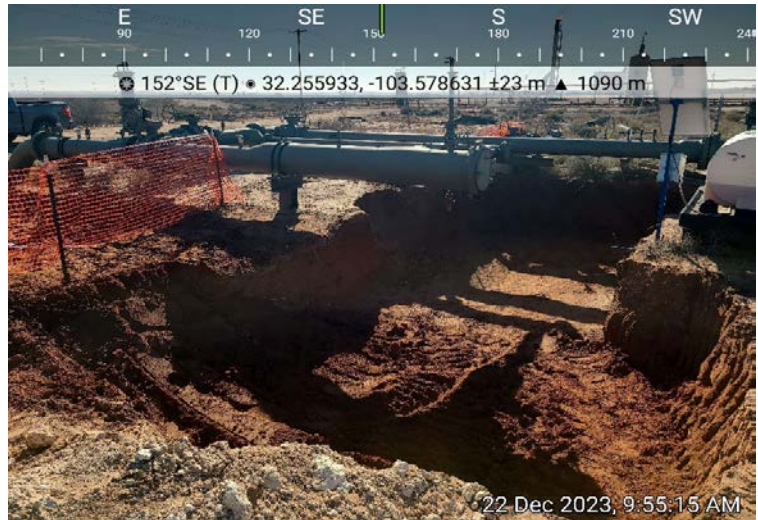
Photograph No. 7

Description:
Area of Excavation.

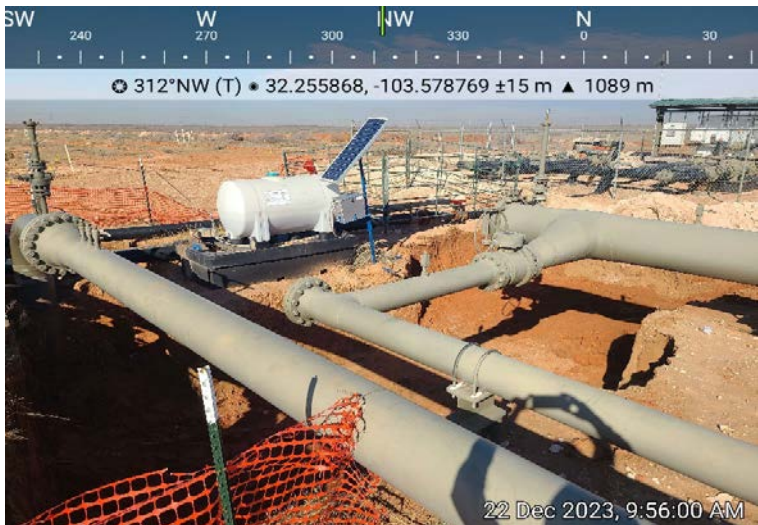
**Photograph No. 8**

Description:
Area of Excavation.

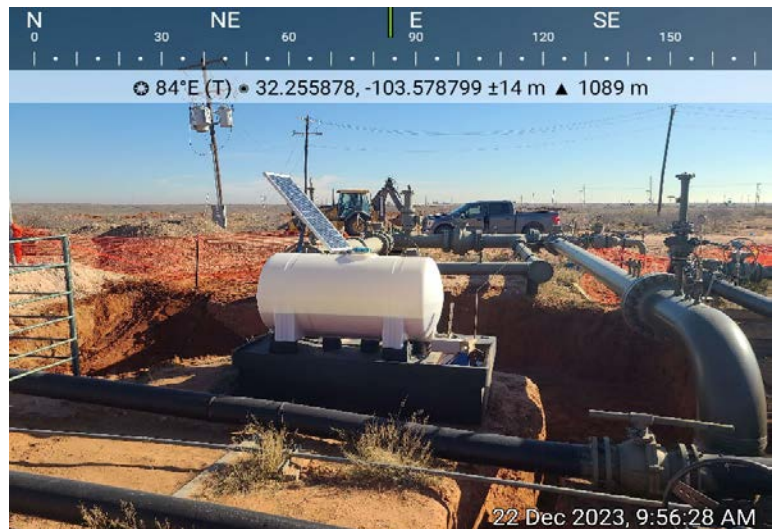
**Photograph No. 9**

Description:
Area of Excavation.
