## CLOSURE REPORT

**Canyon Largo #57 (09/26/23)**  
Unit Letter D, S31 T25N R6W  
Rio Arriba County, New Mexico

**New Mexico EMNRD OCD Incident ID No. NAPP2327027386**

Ensolum Project No. 05A1226276

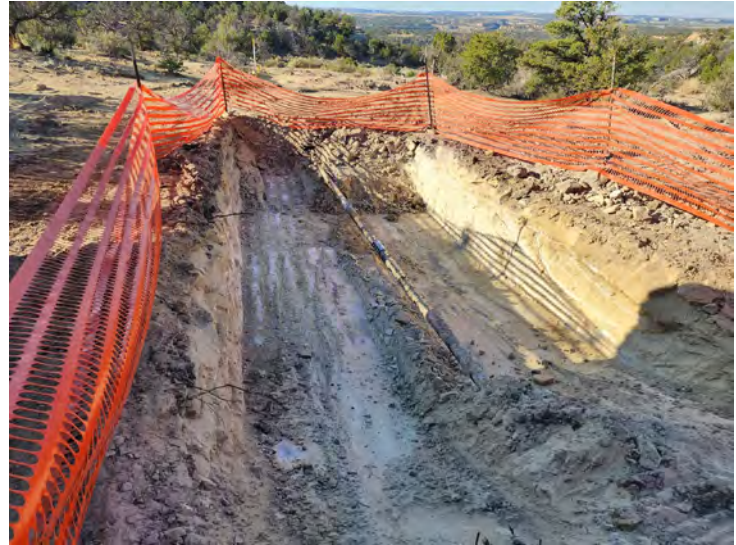
**Photograph 1**

Photograph Description: View of the final excavation.

The final excavation measured approximately 30 feet long and 8 feet wide at the maximum extents. The maximum depth of the excavation measured approximately four feet bgs. The lithology encountered during the completion of remediation activities consisted primarily of sandstone.

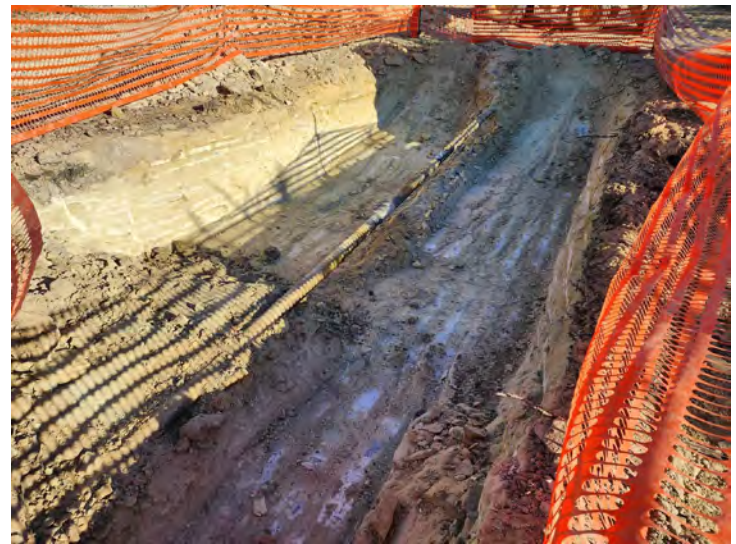
**Photograph 2**

Photograph Description: View of the final excavation.

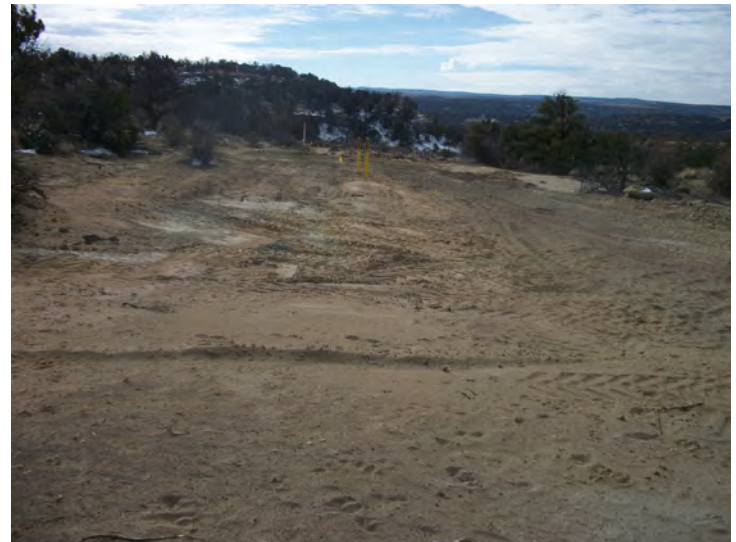
**Photograph 3**

Photograph Description: View of the site after initial restoration.

The excavation was backfilled with imported fill and then contoured to the surrounding topography.
