## Release Assessment and Closure

Poseidon CTB

Facility ID: [fAPP2126032846] Poseidon CTB

Vertex File Number: 24E-00245

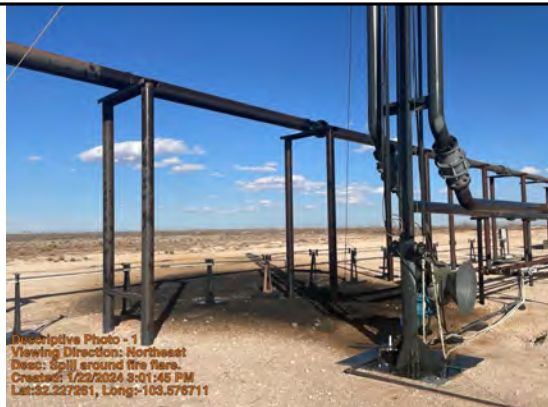
Viewing Direction: Northeast

Spill around fire flare.

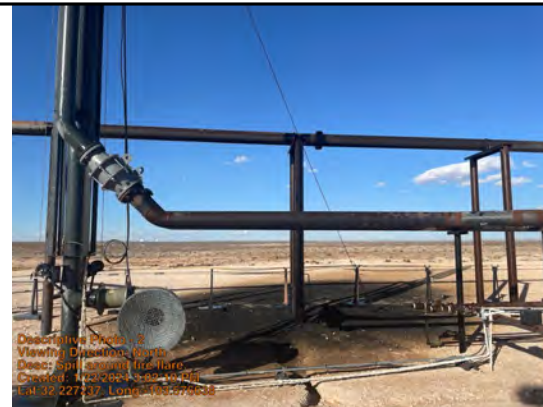
Viewing Direction: North

Spill around fire flare.

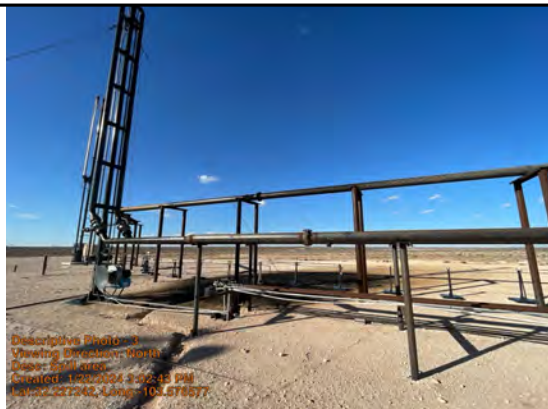
Viewing Direction: North

Spill area.

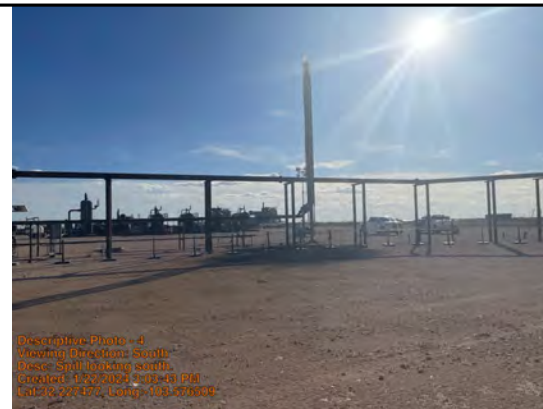
Viewing Direction: South

Spill looking south.

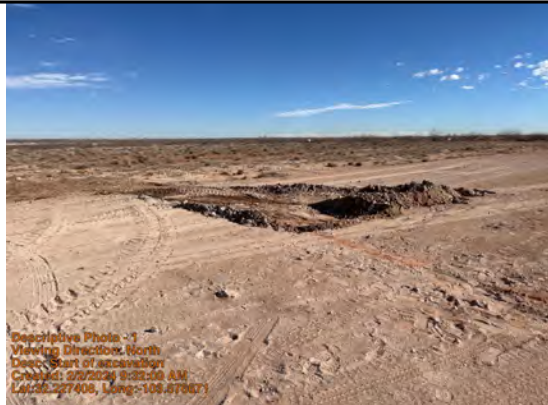
Viewing Direction: North

Start of excavation

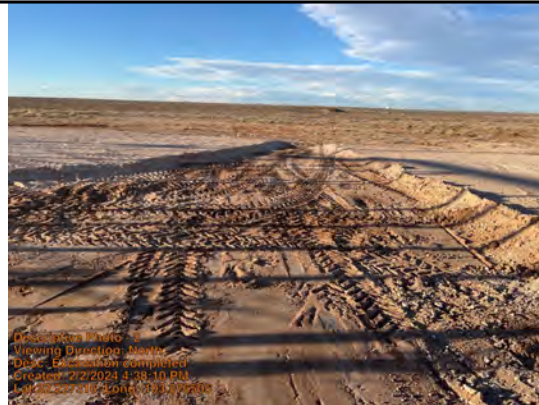
Viewing Direction: North

Excavation completed

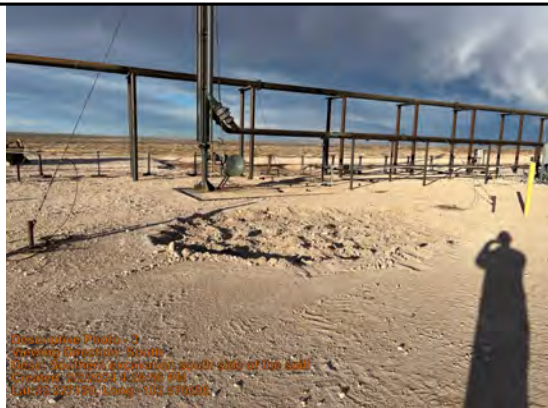
Viewing Direction: North

Southern excavation south side of the spill,

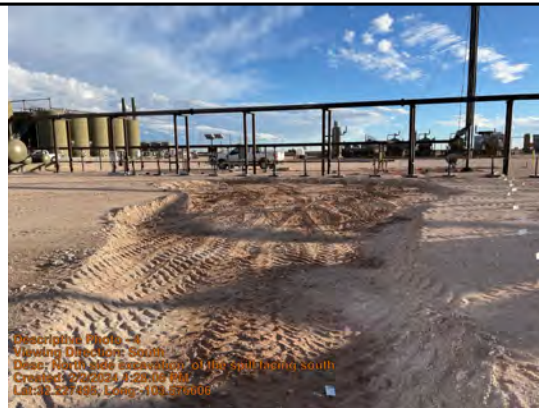
Viewing Direction: South

North side excavation of the spill facing south

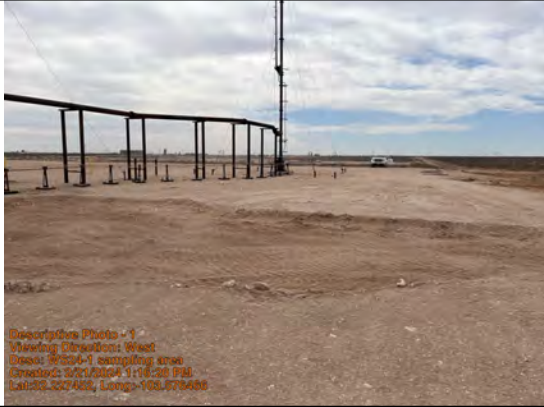
Viewing Direction: West

WS24-1 sampling area

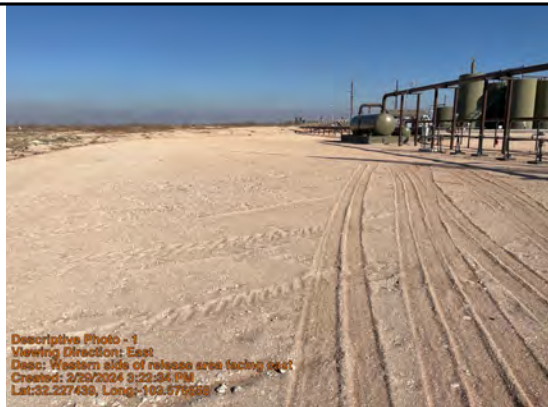
Viewing Direction: East

Western side of release area facing east

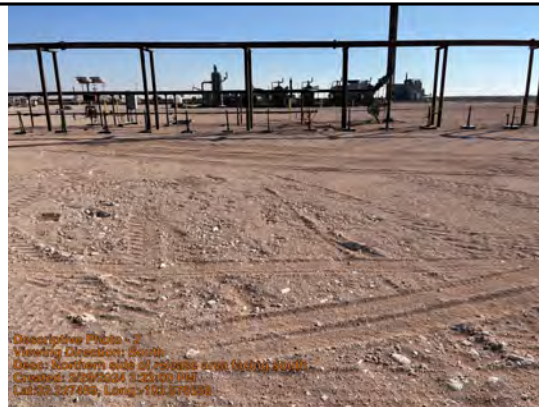
Viewing Direction: South

Northern side of release area facing south

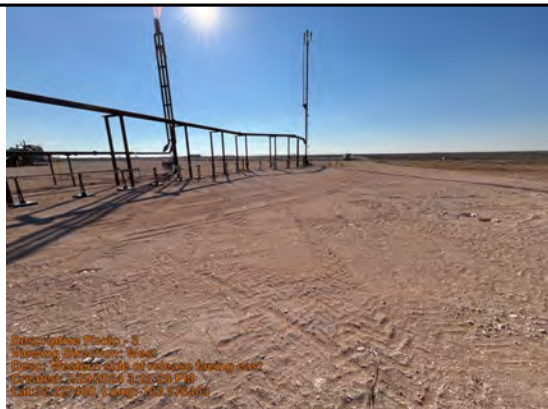
Viewing Direction: West

Western side of release area facing east

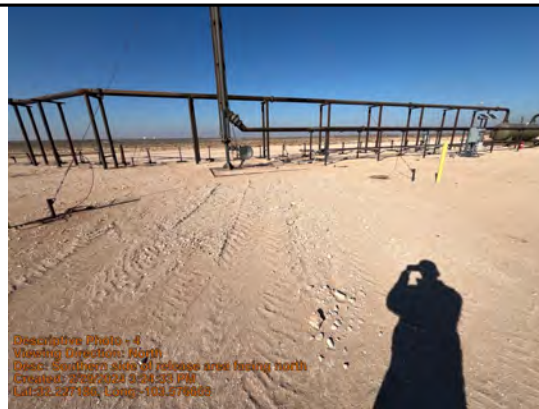
Viewing Direction: North

Southern side of release area facing north
