Report Type: Closure Report nAPP2313632890

Site:	Delek NexGen Lost Tanks Line					
Company:	Solaris Water Midstream, LLC					
Section, Township and Range	Unit L1	Sec. 02	T 22S	R 32E		
Lease Number:						
County:	Lea County					
GPS:	32.42776°			-103.65408°		
Surface Owner:	Private					
Mineral Owner:						
Directions:	From intersections of Red Rd & Mills Ranch Rd, head North on Red Rd and follow for 3.34 miles. Turn right (east) onto lease road, follow for 1.31 miles. Turn right (south) onto lease road, follow for 1.14 miles. Turn right (south) onto lease road and follow for 0.45 miles. Turn left (east) onto lease road and follow for 3.49 miles. Turn left (north) onto lease road and follow for 2.90 miles. Site on west side of lease road.

**RE: Closure Report
Solaris Water Midstream
Delek NexGen Lost Tanks Line
Lea County, New Mexico
nAPP2313632890**

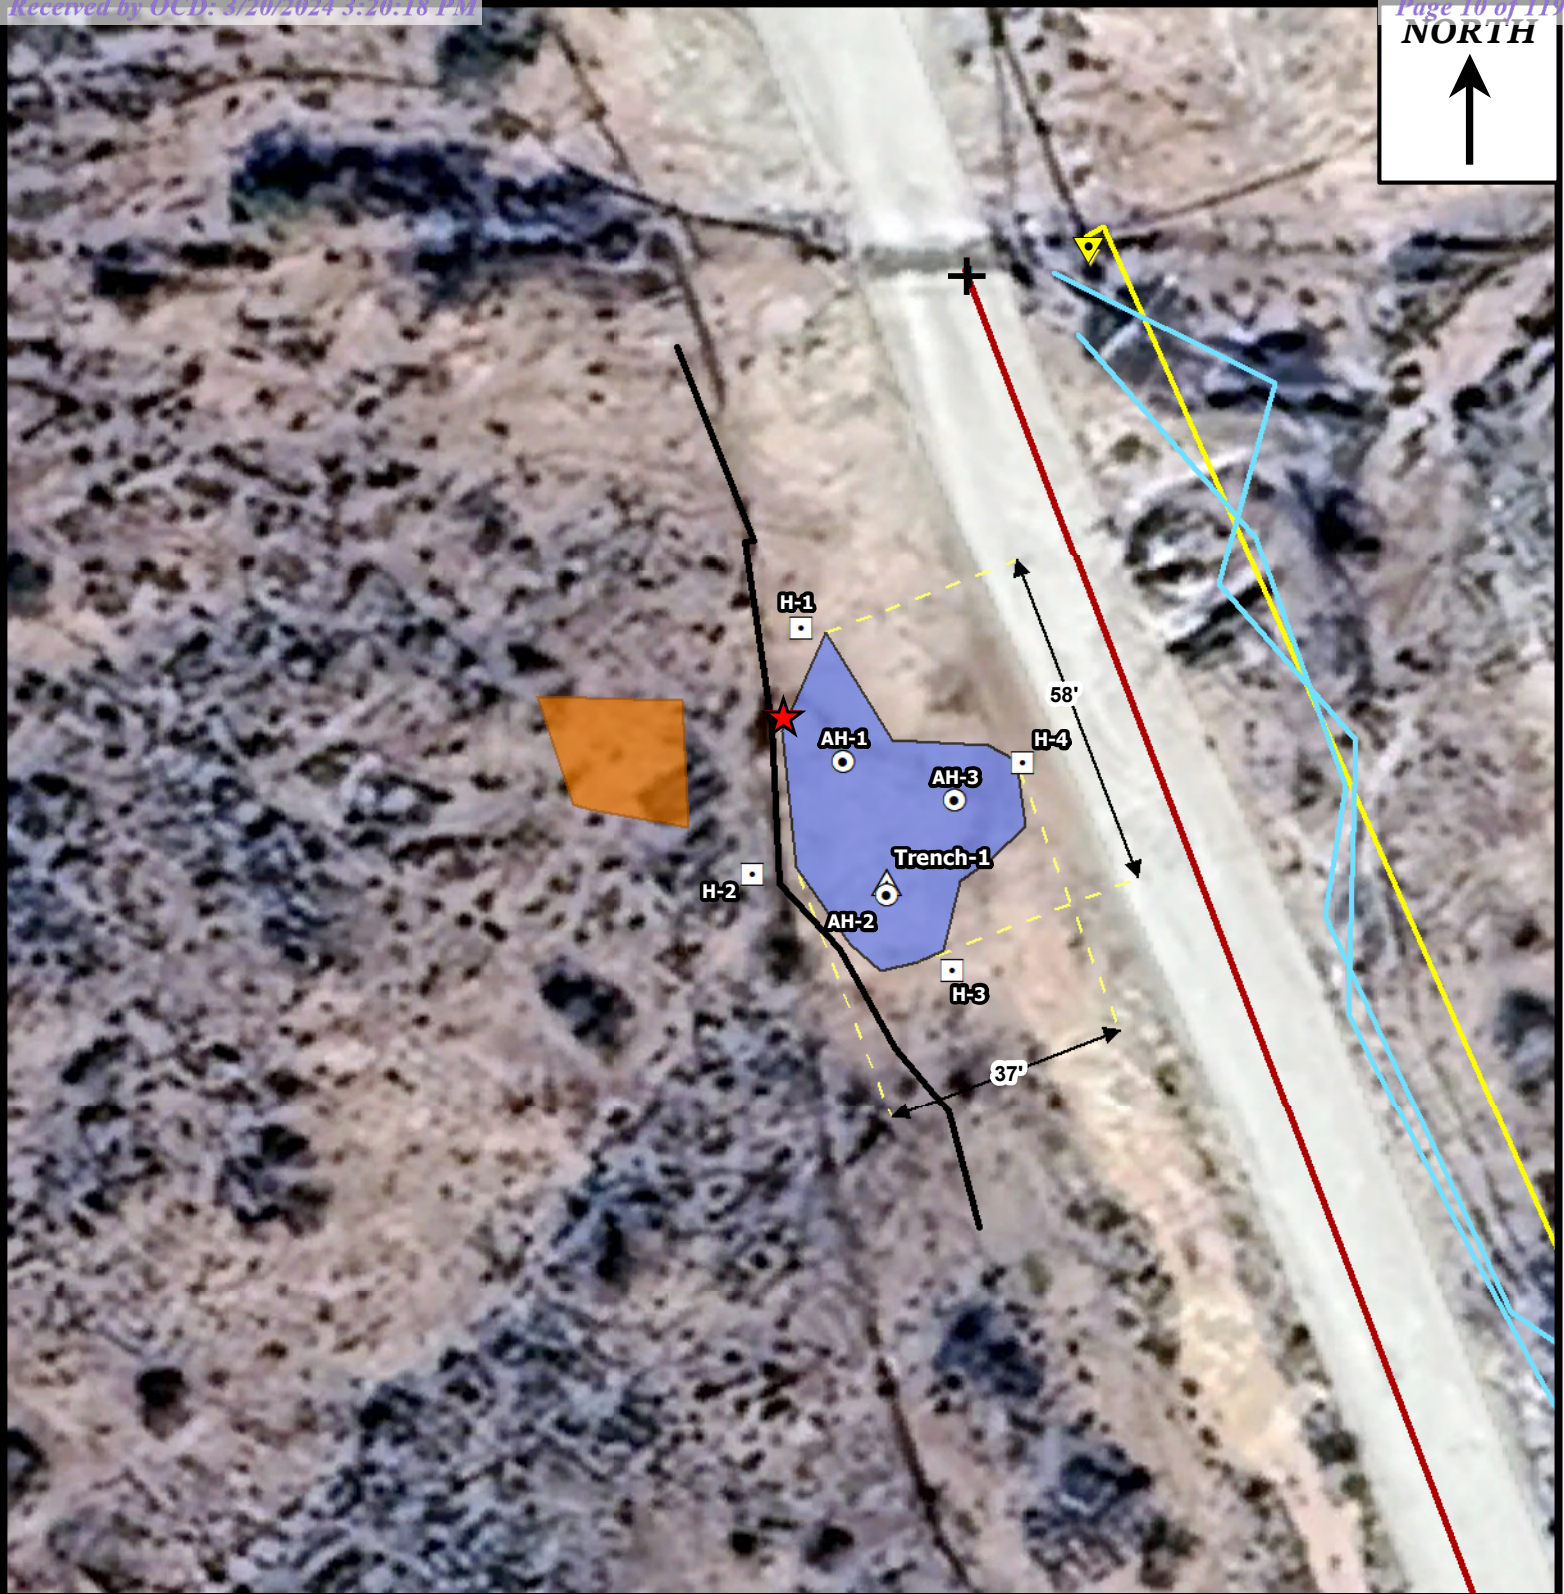
Name: Figure 3 - Lost Tanks

Referring to Table 1, auger holes (AH-1, AH-2 and AH-3) indicated chloride concentrations above RRALs with concentrations ranging from 2,440 mg/kg to 4,720 mg/kg at depths ranging from surface to 3.5 ft bgs. None of the auger holes (AH-1 through AH-3) indicated TPH or BTEX concentrations above laboratory detection limits. Additionally, horizontal borings (H-1 through H-4) indicated chloride, benzene, BTEX, and TPH concentrations below RRALs. Vertical delineation of chloride concentrations was not found in the auger (AH-2) due to auger refusal, however, delineation of chloride concentrations was found in auger holes (AH-1 and AH-3) at depths 4.0 ft bgs and 1.0 ft bgs, respectively.

Referring to Table 1, delineation trench (T-1) indicated BTEX and TPH concentrations below laboratory detection limits. However, chloride concentrations above RRALs were indicated in trench (T-1), with concentrations ranging from 1,260 mg/kg to 5,150 mg/kg, at depths ranging from surface to 12 ft bgs. Additionally, vertical delineation of chloride concentrations was found at 13 ft bgs.

- ★ RELEASE POINT
- ▽ ELECTRICAL POST LOCATION
- ⊕ CATTLE GUARD LOCATION
- △ TRENCH LOCATION
- ⊙ AUGERHOLE SAMPLE LOCATION
- HORIZONTAL SAMPLE LOCATION
- SURFACE POLY LINE (NOT IN USE)
- OVERHEAD POWER LINES
- SURFACE POLY LINE
- MAIN ROAD
- WATER RELEASE EXTENT
- OLD CATTLE GUARD

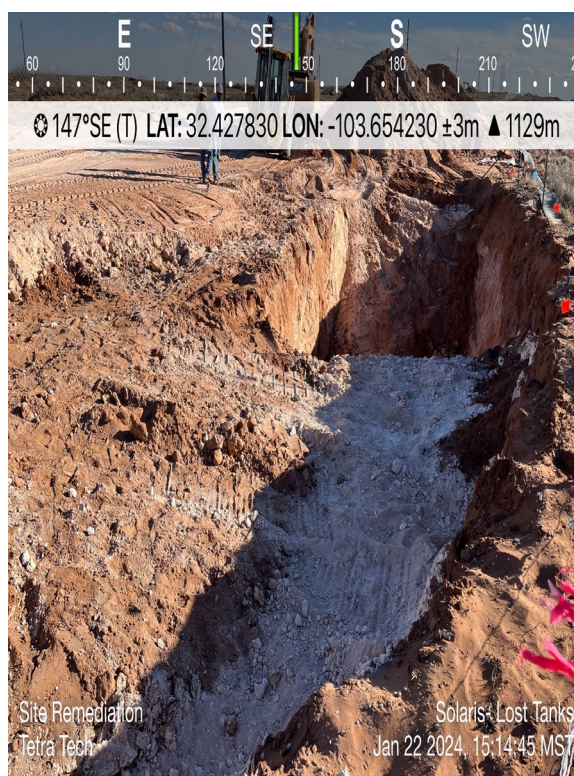
View of Remediation Activities – View Southeast

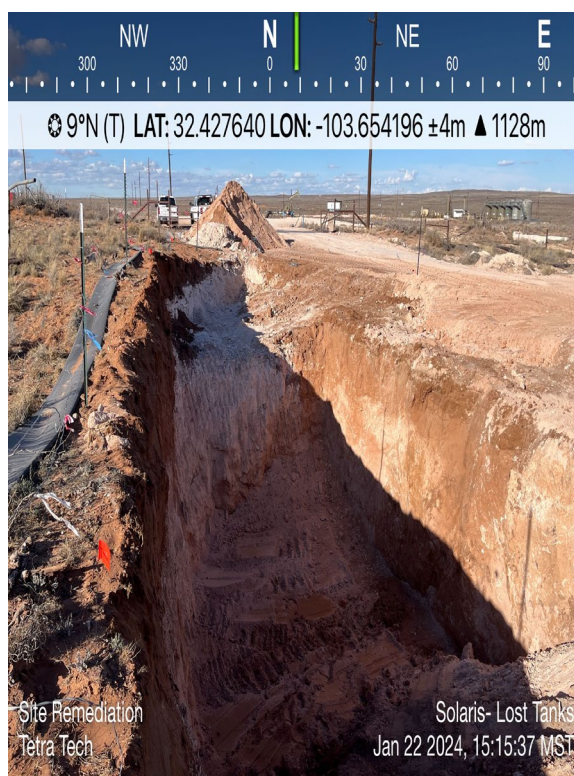
View of Remediation Activities – View North
