**RE: Liner Inspection and Closure Report  
C 17 State CTB  
API No: 30-015-44534  
GPS : Latitude 32.308862 Longitude -104.205363  
UL- A, Section 17, Township 23S, Range 27E  
Eddy County, NM  
NMOCD Reference No. NAPP2328635425**

Devon Energy Production Company (Devon) has contracted Pima Environmental Services, LLC (Pima) to perform a liner inspection and prepare this closure report for a produced water release that happened at the C 17 State CTB (C 17). This incident was assigned Incident ID:NAPP2328635425, by the New Mexico Oil Conservation Division (NMOCD).

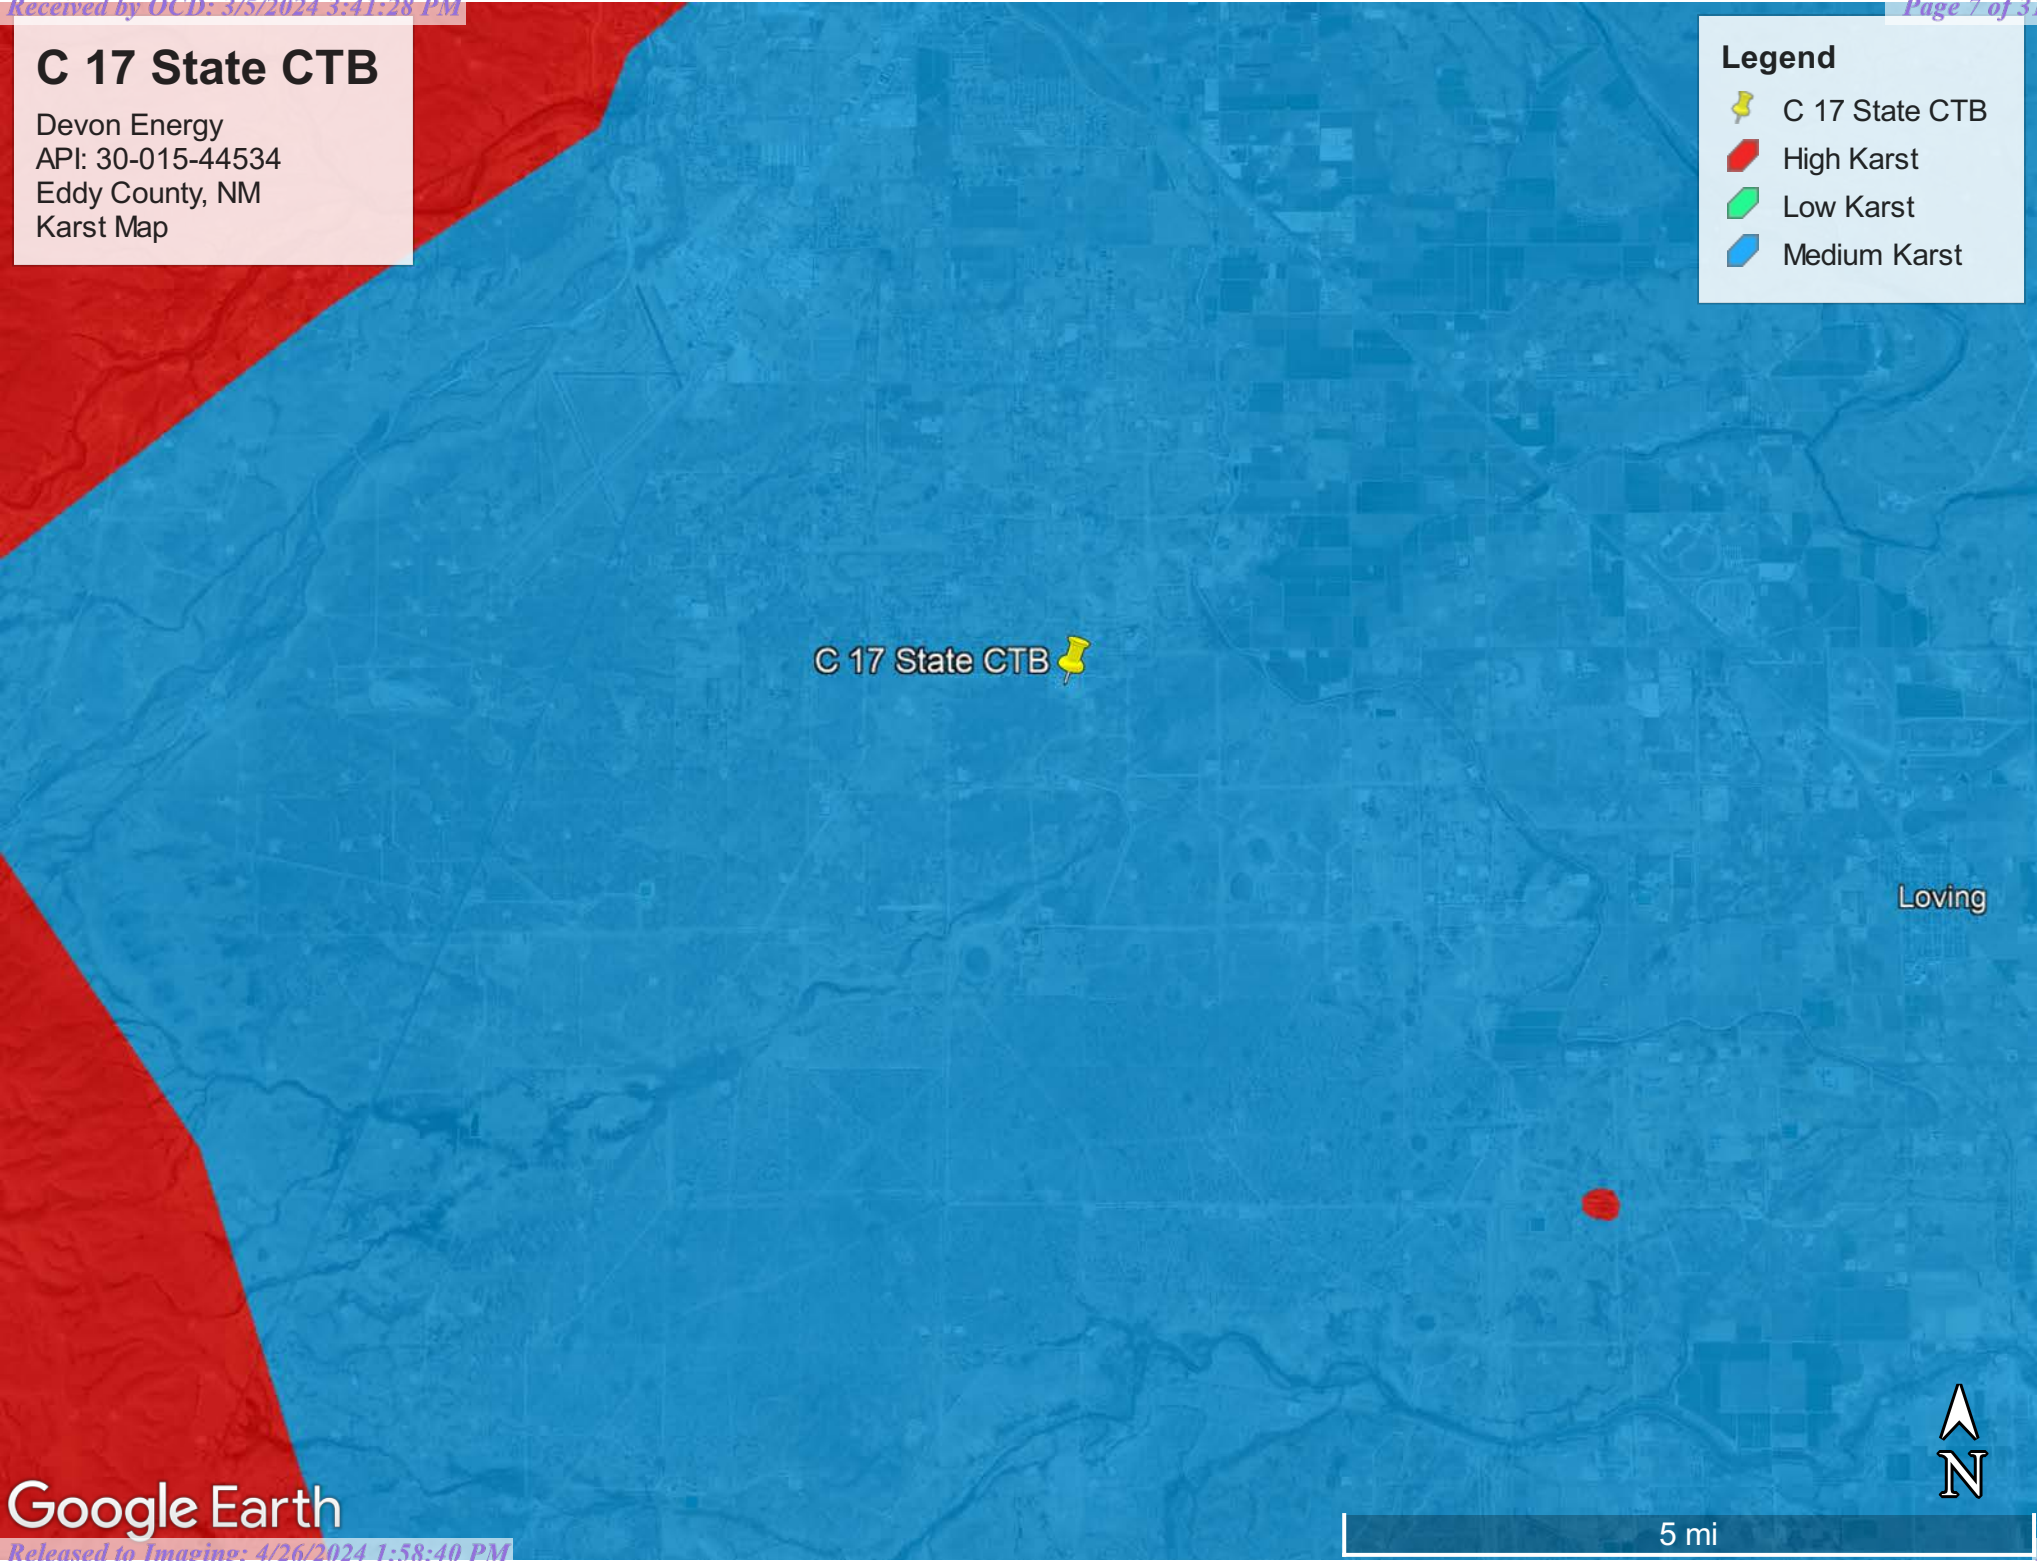
Devon Energy  
API: 30-015-44534  
Eddy County, NM  
Karst Map

Based upon New Mexico Office of the State Engineer well water data, depth to the nearest groundwater in this area is 150 feet below grade surface (BGS). According to the United States Geological Survey well water data, depth to the nearest groundwater in this area is 95 feet BGS. See Appendix A for referenced water surveys. The C 17 is in a medium karst area (Figure 3). A Topographic Map can be found in Figure 2.

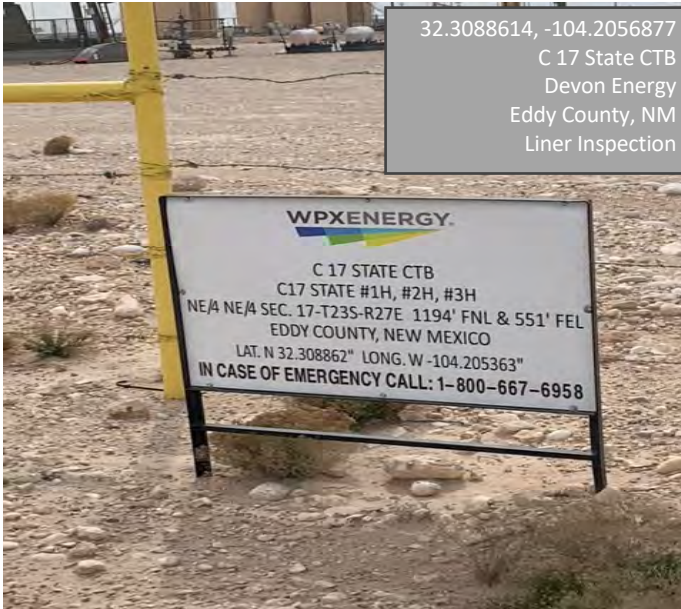
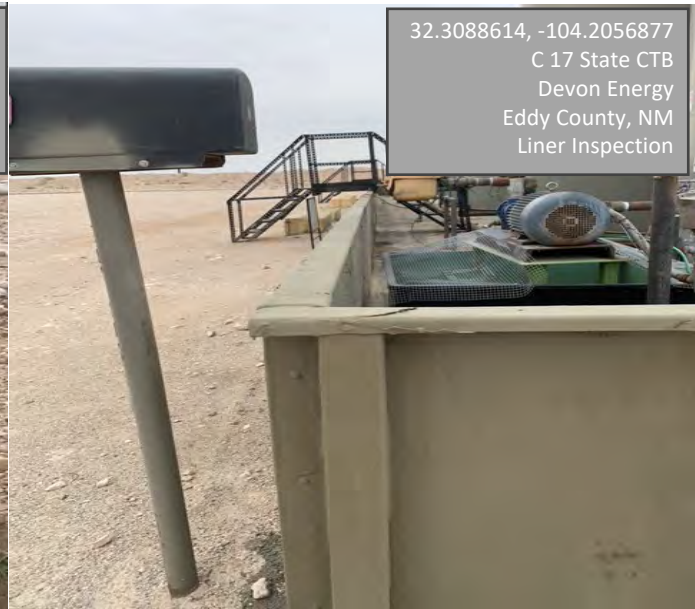
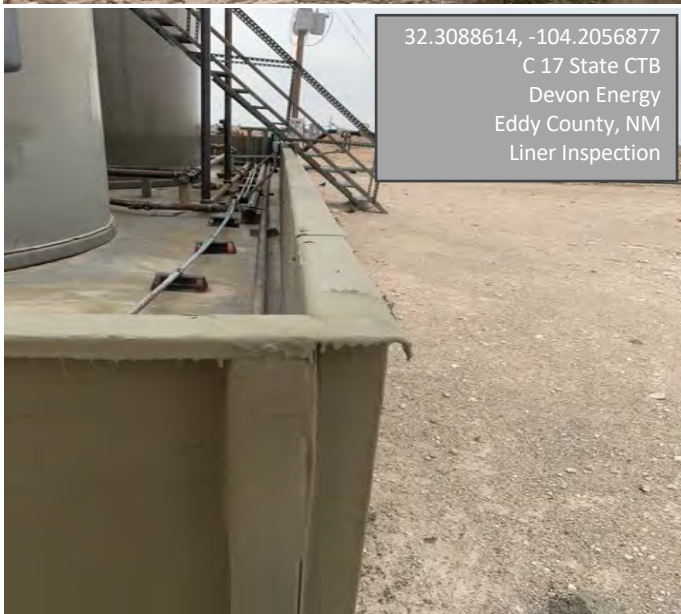
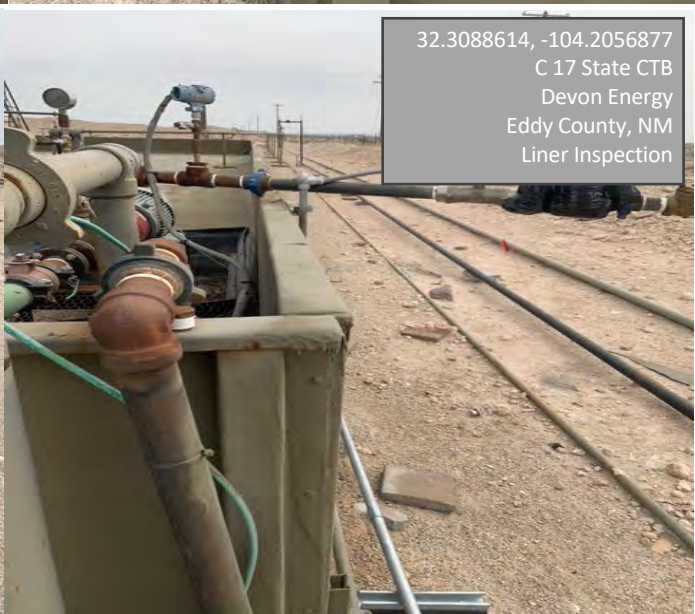
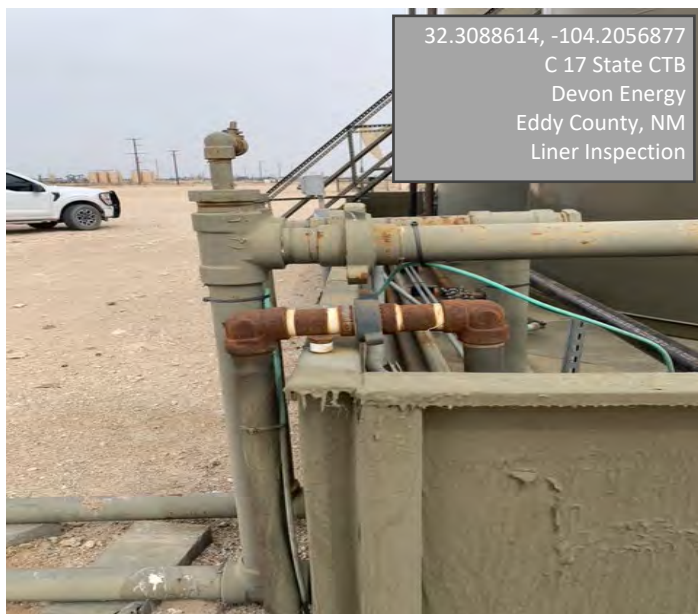
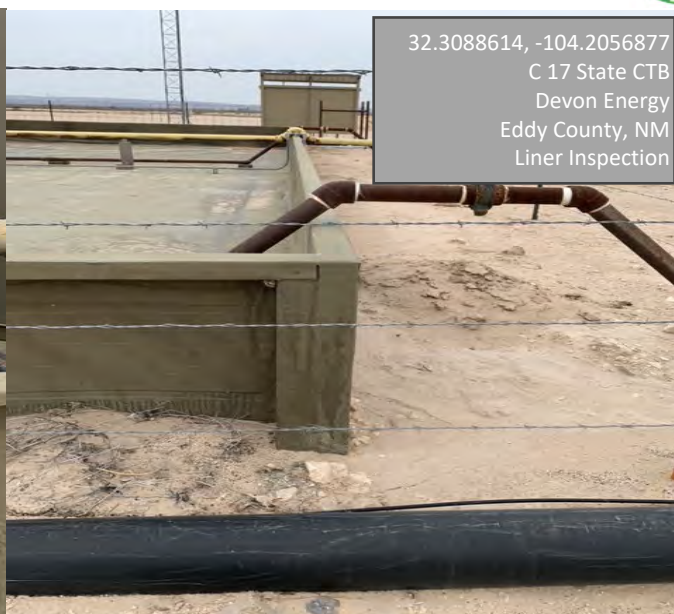
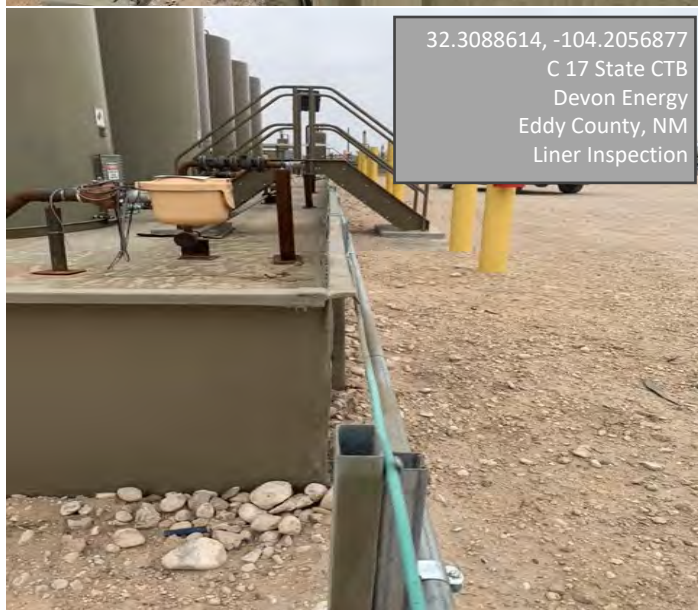
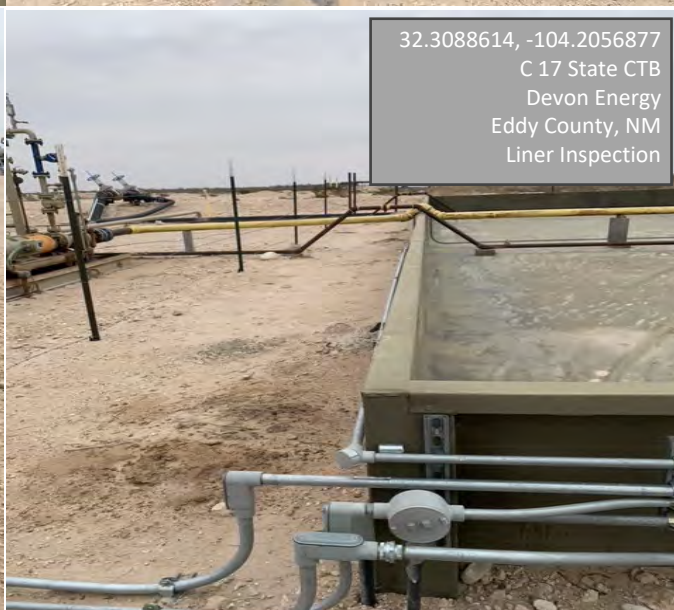
## SITE PHOTOGRAPHS

On February 9, 2024, after submitting the 48-hour notification application ID:311895 to the OCD, Pima Environmental conducted a liner inspection at this location. Pima concluded that this liner and containment maintained its integrity and was able to retain the fluids. The liner inspection form and photographic documentation can be found in Appendix C.

Visualization	Yes	No	Comments
Is there a tear in the liner?		X	
Are there holes in the liner?		X	
Is the liner retaining any fluids?		X	
Does the liner have integrity to contain a leak?	X

After careful review, Pima requests that this incident ID: NAPP2328635425, be closed. Devon has complied with the applicable closure requirements.
