2021 ANNUAL GROUNDWATER REPORT

Gallegos Canyon Unit #142E
Incident Number: nAUTOfAB000219
Meter Code: 03906
T29N, R12W Sec 25, Unit G

SITE DETAILS

Site Location: Latitude: 36.860365 N, Longitude: -108.046700 W
Land Type: Private
Operator: Simcoe LLC

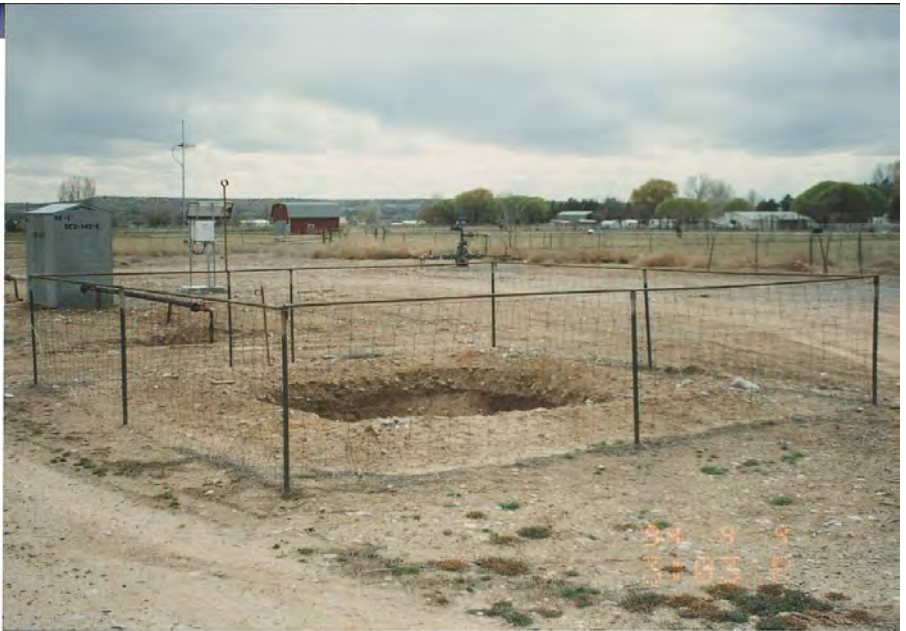
Client:	El Paso CGP Company	Project:	193710238
Site Name:	GCU Com A #142E	Site Location:	San Juan River Basin, New Mexico
Photograph ID: 1

Photo Location: GCU Com A #142E			
Direction: Southwest			
Survey Date: 4/4/1994			
Comments: Former EPNG Dehydrator Pit			
Photograph ID: 2

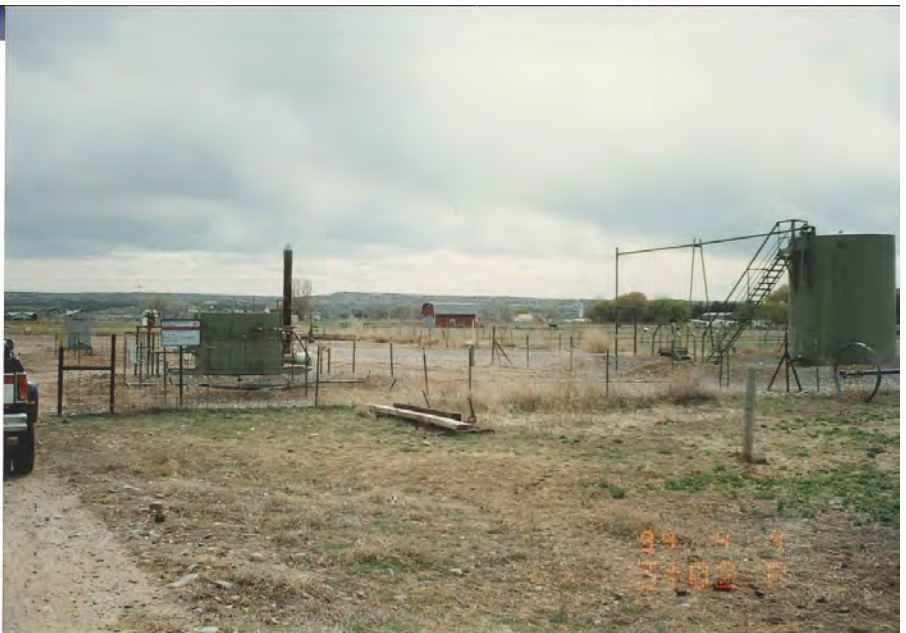
Photo Location: GCU Com A #142E			
Direction: South			
Survey Date: 4/4/1994			
Comments: View of site from the north, including existing BP tanks and overhead pipe.

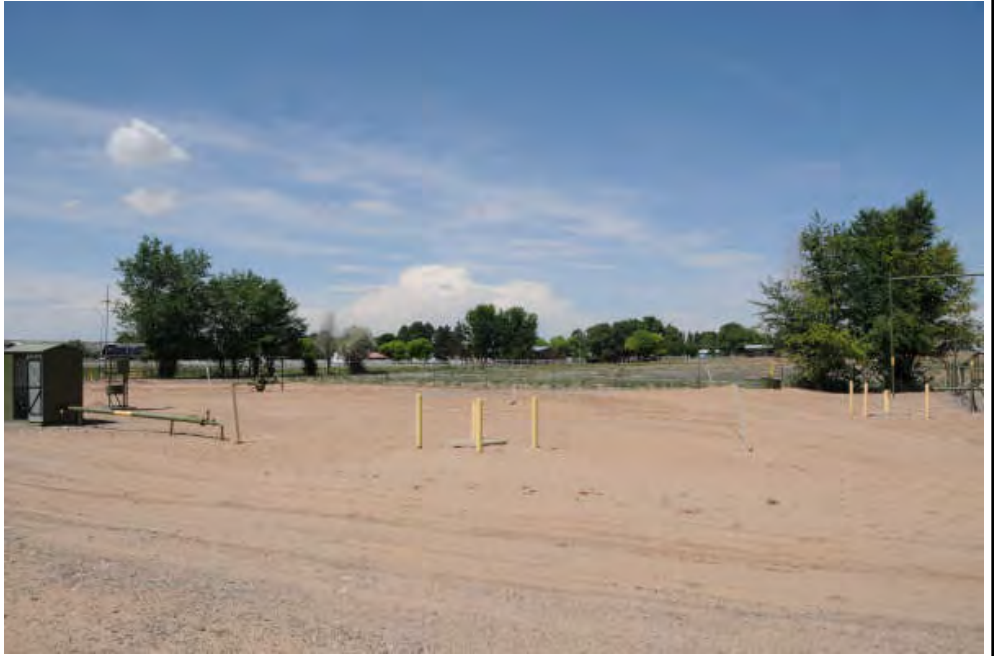
Client:	El Paso CGP Company	Project:	193710238
Site Name:	GCU Com A #142E	Site Location:	San Juan River Basin, New Mexico
Photograph ID: 3

Photo Location: GCU Com A #142E			
Direction: Southwest			
Survey Date: 6/2/2009			
Comments: MW-1 (center), former above-ground tank (right - removed by 2011), and MW-2 (far right)			
Photograph ID: 4

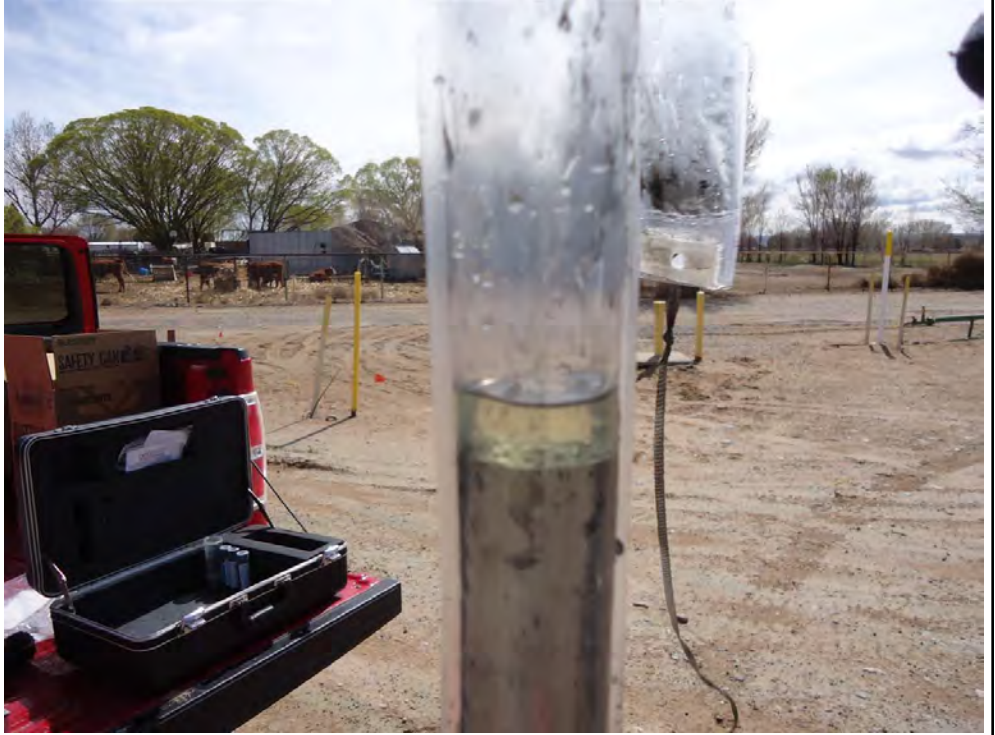
Photo Location: GCU Com A #142E			
Direction: Southeast			
Survey Date: 4/3/2014			
Comments: Free product in HydraSleeve retrieved from MW-1

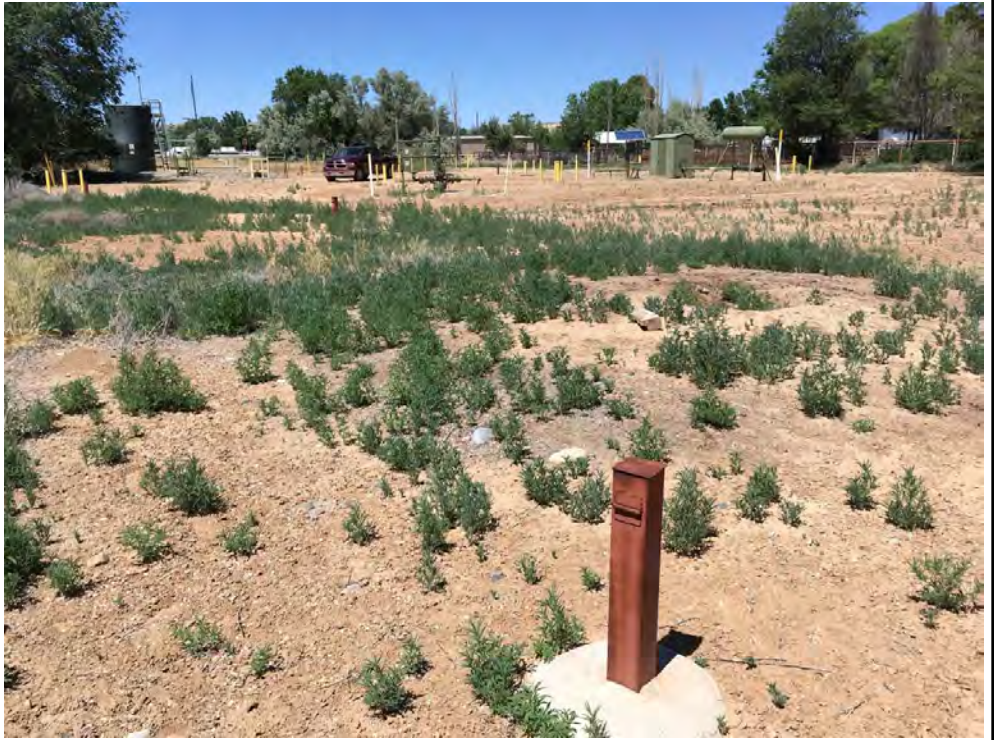
Client:	El Paso CGP Company	Project:	193710238
Site Name:	GCU Com A #142E	Site Location:	San Juan River Basin, New Mexico
Photograph ID: 9

Photo Location: GCU Com A #142E			
Direction: North			
Survey Date: 6/11/2017			
Comments: BP MW-7 and site property looking north			
Photograph ID: 10

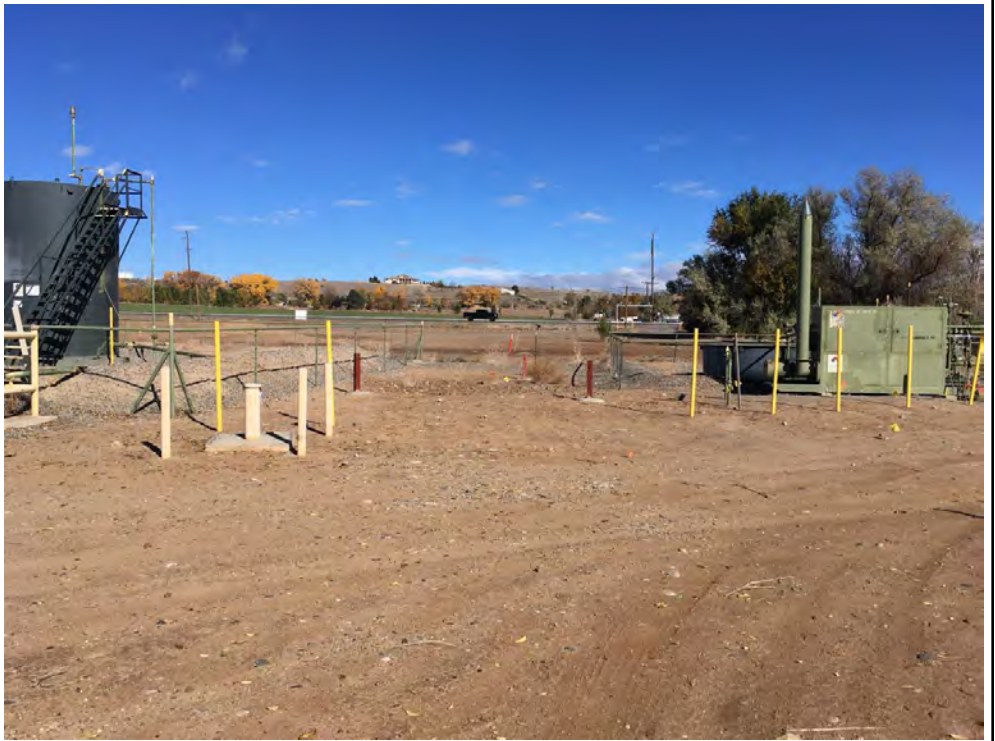
Photo Location: GCU Com A #142E			
Direction: North			
Survey Date: 10/31/2018			
Comments: MW-2 and new BP wells between condensate tank (left) and separator (right)

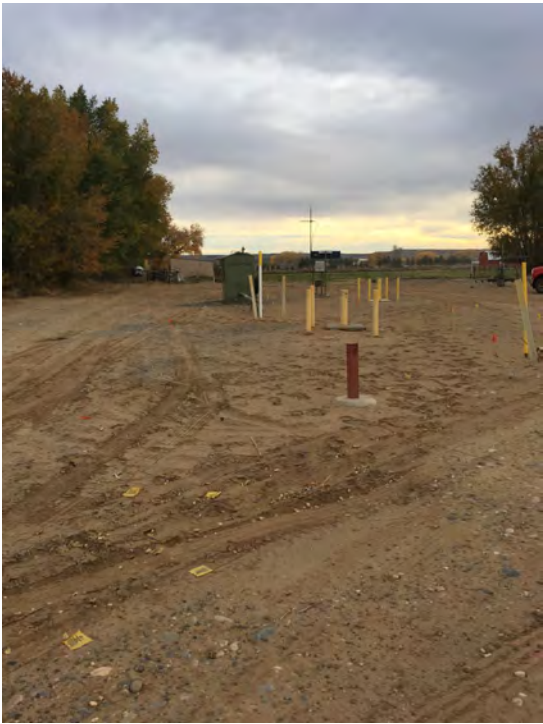
Client:	El Paso CGP Company	Project:	193710238
Site Name:	GCU Com A #142E	Site Location:	San Juan River Basin, New Mexico
Photograph ID: 11

Photo Location: GCU Com A #142E			
Direction: South			
Survey Date: 10/29/2018			
Comments: BP MW-8 (foreground) and MW-1 (center) looking south			
Photograph ID: 12

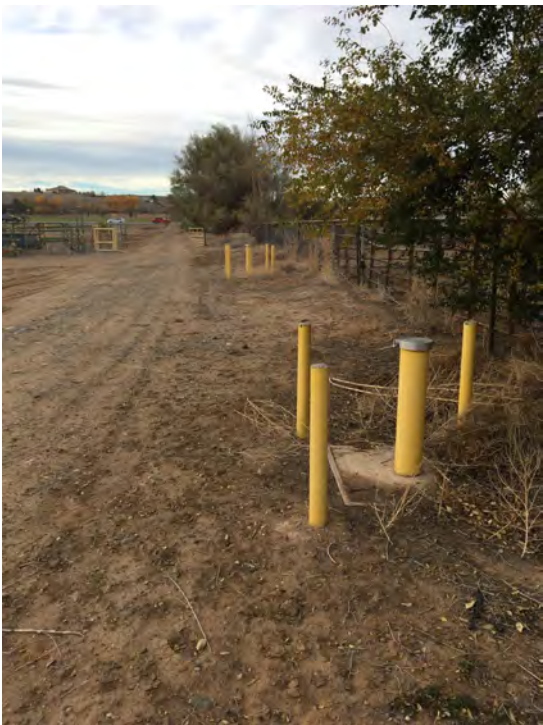
Photo Location: GCU Com A #142E			
Direction: North			
Survey Date: 10/29/2018			
Comments: Eastern fence line with MW-6 (foreground) and MW-5 (background)
