Re: Remediation Work Plan

Sammons #2
San Juan County, New Mexico
Hilcorp Energy Company
NMOCD Incident No: nAPP2336429577

Ensolum, LLC (Ensolum), on behalf of Hilcorp Energy Company (Hilcorp), presents this *Remediation Work Plan* (Work Plan) for a release at the Sammons #2 natural gas production well (Site). The Site is located on private land in Unit G, Section 32, Township 30 North, Range 12 West, San Juan County, New Mexico (Figure 1). This proposed Work Plan includes a summary of delineation activities performed at the Site and the proposed remediation of impacted soil originating from the release of condensate.

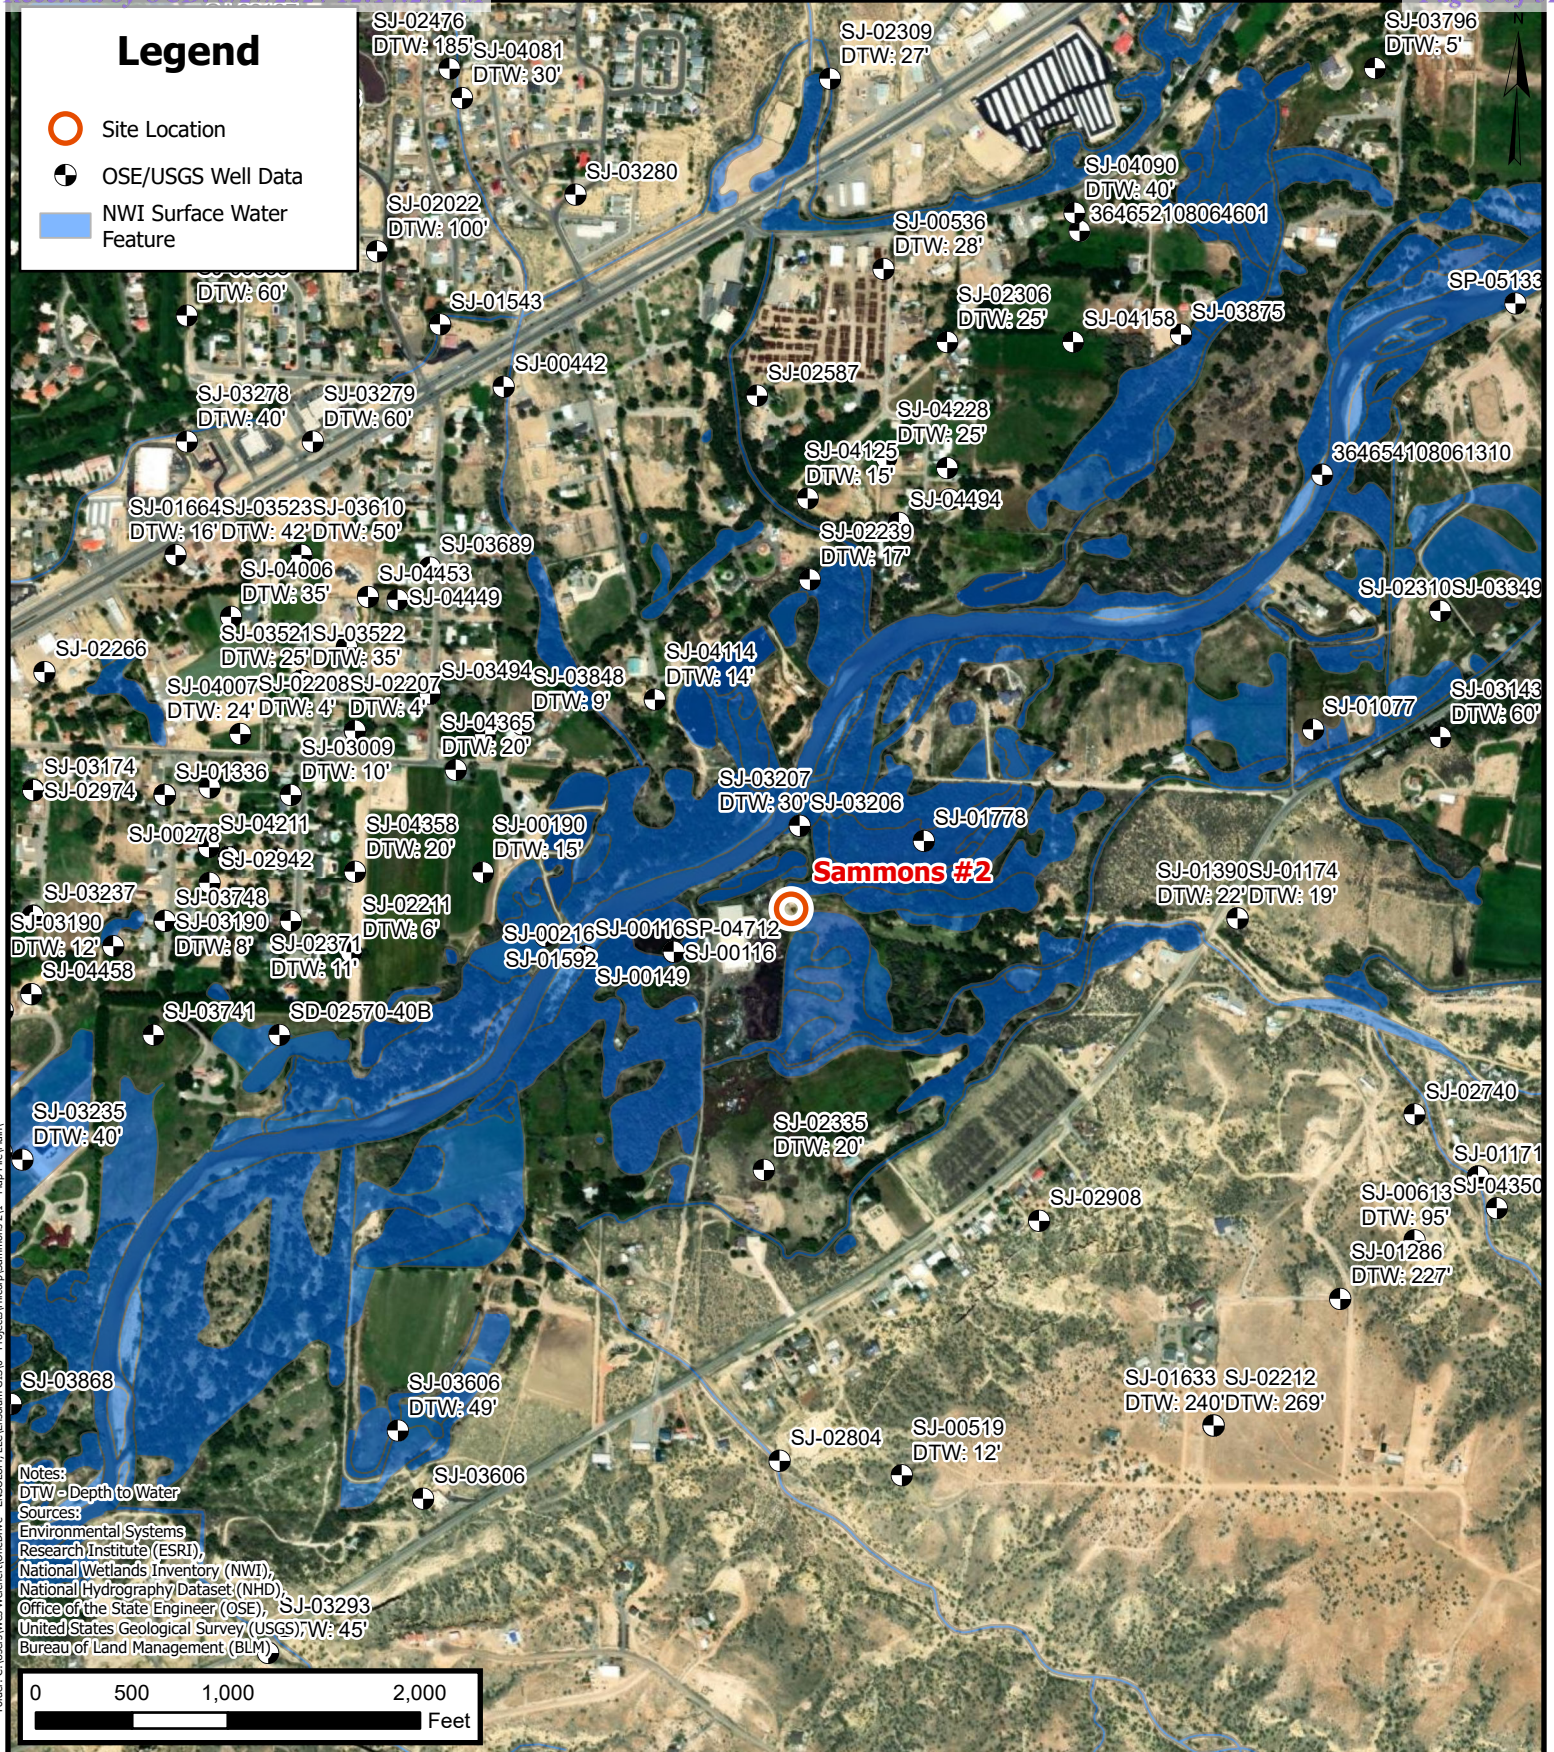
Site Receptor Map

The nearest significant watercourse to the Site is a freshwater pond approximately 165 feet northwest of the wellhead. The Site is located 330 feet from the Animas River and is within a 100-year flood. The Site is also located 60 feet from the nearest wetland. The nearest data point for depth to groundwater to the Site is a domestic water well (NMOSE permit SJ-03206), located approximately 435 feet north of the Site. This well indicates that the shallowest groundwater is approximately 30 feet below ground surface (bgs) in this area (Appendix A); however, during advancement of hand auger boreholes during the Site investigation activities (further described below), groundwater was encountered at a depth of approximately 5 feet bgs.

The Site is greater than 200 feet from any lakebed, sinkhole, or playa lake. The Site is not overlying a subsurface mine or located within an area underlain by unstable geology (area not designated as high potential karst by the Bureau of Land Management). Schools, hospitals, institutions, churches, and/or other occupied permanent residence or structures are not located within 300 feet of the Site. A Site receptor map is shown on Figure 1.

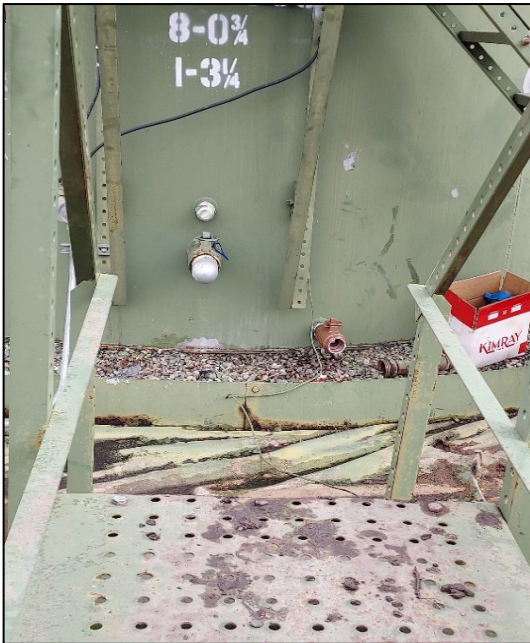
On December 29, 2023, during Audio, Visual, or Olfactory (AVO) inspections, a lease operator from Hilcorp identified an actively leaking condensate release caused by a cracked hammer union on the oil fill line. The fill line was plumbed into the bottom of the tank with no isolation valve to stop the leak. Upon discovery of the leak, a water truck was immediately dispatched to the Site. The water truck extracted condensate pooled in the containment while a new, 2-inch valve was installed to address the problem. After the installation of the new valve, the condensate was returned to the tank without generating a hauling ticket to document the recovered amount. Initially, the release volume was estimated to be 31 barrels (bbls), but due to an accounting error, the actual volume was revised to 6 bbls. Since no hauling ticket was generated, the exact amount of condensate recovered remains unknown and is assumed to be 0 bbls. Although the condensate was contained within the secondary lined berm, holes were observed in the liner and Hilcorp requested Ensolum conduct pothole delineation in the area surrounding the containment. Hilcorp reported the release to the New Mexico Oil Conservation Division (NMOCD) on a *Release Notification Form C-141* on 12/30/2023, 2023. The NMOCD has assigned the Site Incident Number nAPP2336429577.

Photograph: 1 Date: 1/30/2024
Description: Release source, valve.
View: Northeast

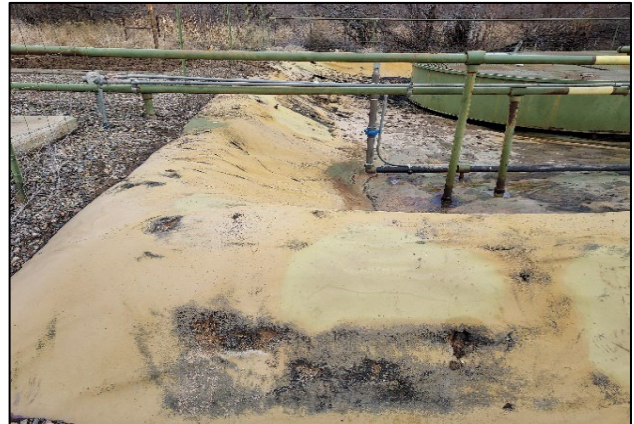
Photograph: 2 Date: 1/30/2024
Description: Damaged liner.
View: Northeast

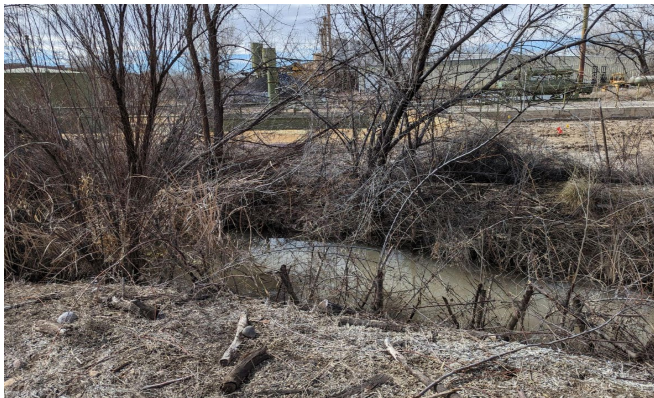
Photograph: 3 Date: 2/21/2024
Description: Drainage Ditch near location of HA01
View: West

Hilcorp proposes to excavate TPH impacted soil at the Site to achieve NMOCD Closure Criteria. Additionally, Hilcorp will excavate shallow soil in the vicinity of HA01 to remove elevated chloride concentrations detected in this area. Based on the lateral and vertical extent of impacts, approximately 175 cubic yards of impacted soil are present at the Site to a depth of approximately 5 feet bgs. Soil will be excavated and transported off-Site for disposal at the Envirotech Landfarm located in San Juan County, New Mexico. Following removal of the impacted soil, 5-point composite soil samples will be collected at least every 200 square feet from the floor and sidewalls of the excavation. The 5-point composite samples will be collected by placing five equivalent aliquots of soil into a 1-gallon, resealable plastic bag and homogenizing the samples by thoroughly mixing. Based on previous analytical results and no prior Closure Criteria exceedances of BTEX, Hilcorp is requesting soil samples only be analyzed for TPH following EPA Method 8015M/D and chloride following EPA Method 300.0 during confirmation sampling.
