**Re: Closure Request
Mesa Gas Line, Mesa 1-12 Transfer Line
Incident Number nAPP2403133055
Lea County, New Mexico**

Ensolum, LLC (Ensolum), on behalf of BTA Oil Producers, LLC (BTA), has prepared this *Closure Request* to document assessment, delineation, and soil sampling activities performed at the Mesa Gas Line, Mesa 1-12 Transfer Line (Site). The purpose of the Site assessment, delineation, and soil sampling activities was to assess for the presence or absence of impacts to soil resulting from a fire and produced water release at the Site. Based on field observations, field screening activities, and soil sample laboratory analytical results, BTA is submitting this *Closure Request*, describing Site assessment and delineation activities that have occurred and requesting closure for Incident Number NAPP2403133055.

BTA Oil Producers, LLC
Closure Request
Mesa Gas Transfer Line, Mesa 1-12 Transfer Line

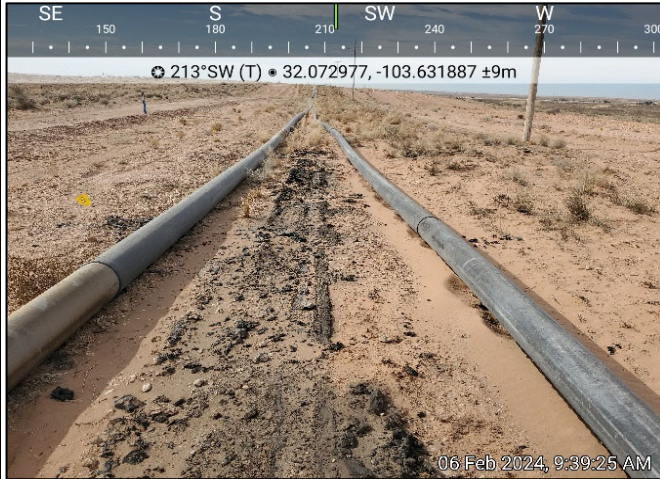
Photograph: 1
Description: Release area
View: Southwest

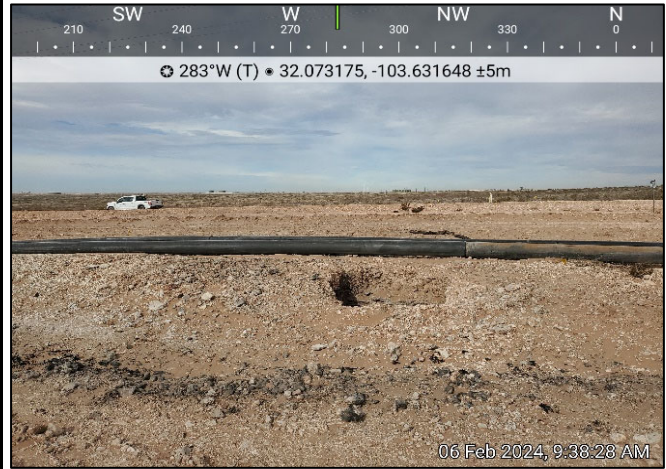
On January 31, 2024, a poly surface gas line caught fire due to static electricity, and as a result, the poly water transfer line next to the gas line was compromised leading to the release of an unknown volume of produced water. The line was isolated, and the fire was extinguished upon discovery. BTA reported the release to the New Mexico Oil Conservation Division (NMOCD) on a Release Notification Form C-141 (Form C-141) on February 12, 2024. The release was assigned Incident Number NAPP2403133055.

Photograph: 2
Description: Potential point of release
View: West

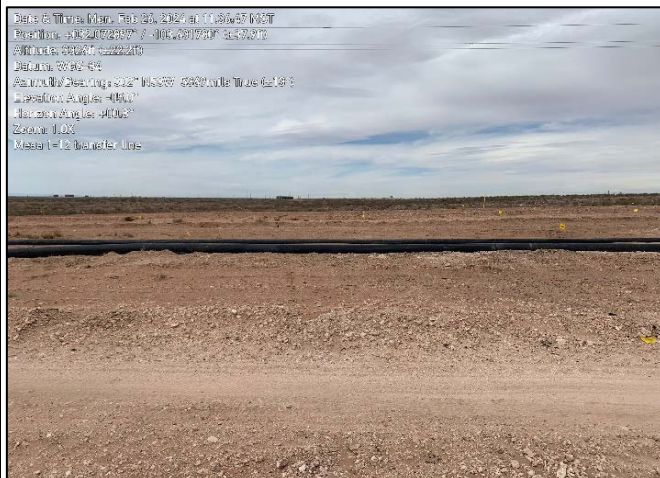
Photograph: 3
Description: Delineation activities
View: Northwest

On February 26, 2024, Ensolum personnel returned to the Site to complete vertical delineation activities to confirm the absence of impacted soil within the release area. Boreholes were advanced via hand auger at the location of assessment samples SS01, SS02, and SS03. The boreholes were advanced to a depth of 1-foot bgs. Soil from the boreholes was field screened for VOCs and chloride. Based on field screening results, discrete delineation soil samples SS01A, SS02A, and SS03A were collected from the boreholes at a depth of 1-foot bgs. The delineation soil samples were collected, handled, and analyzed following the same procedures previously described. The delineation soil sample locations were mapped utilizing a handheld GPS unit and are depicted on Figure 2. Photographic documentation was completed during the Site visit and a photographic log is included in Appendix B.

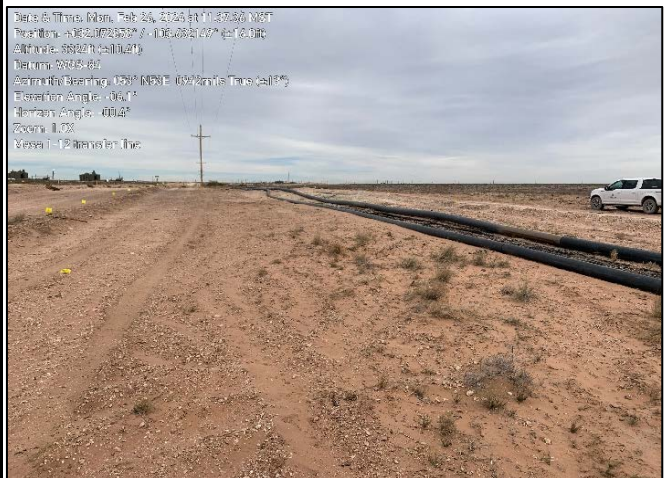
Photograph: 4
Description: Delineation activities
View: Northeast
