Remediation Plan

Remediation Narrative

Mc 5 Com 112H

30-043-35605

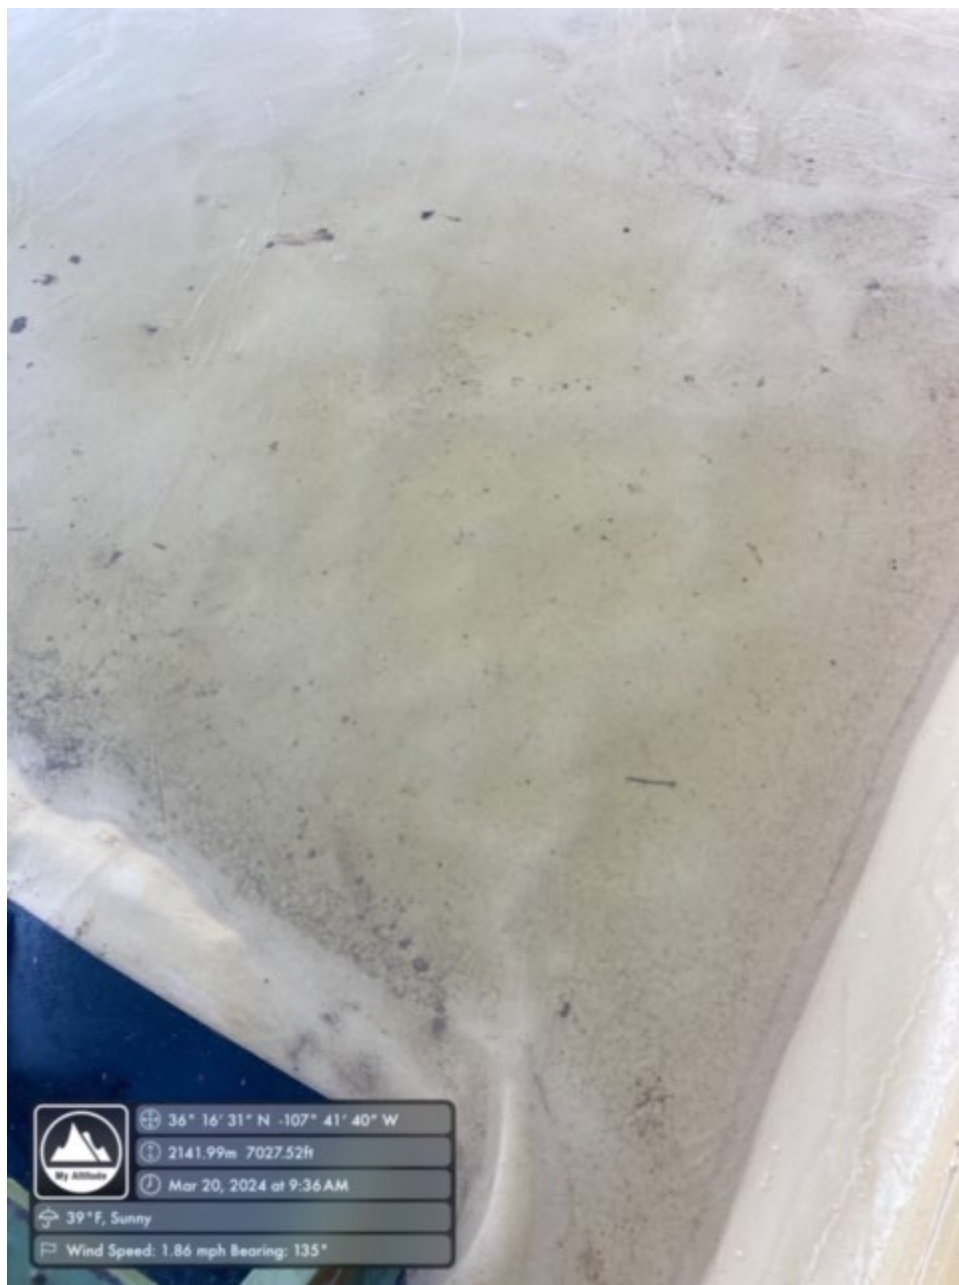
MC 5 Com 112H liner inspection near the stairway to tanks.

Repairs were made to the secondary containment liner in the tank area, where the 4 bbls of oil leaked outside. A 15' X 30' section of liner was replaced, because the old liner appeared to be degraded by the sun.

Enduring HSE personnel were on-site at 9:30 AM to perform the liner inspection. No representative from the NMOCD nor the state to witness the inspection. Inspected 6,160 Square feet of liner the liner, and no evidence of a liner integrity issue was found during the inspection. Pictures were taken of the liner during inspection and are attached to the closure report for reference. No further action is required. See attached *"Photo Page"* for reference.

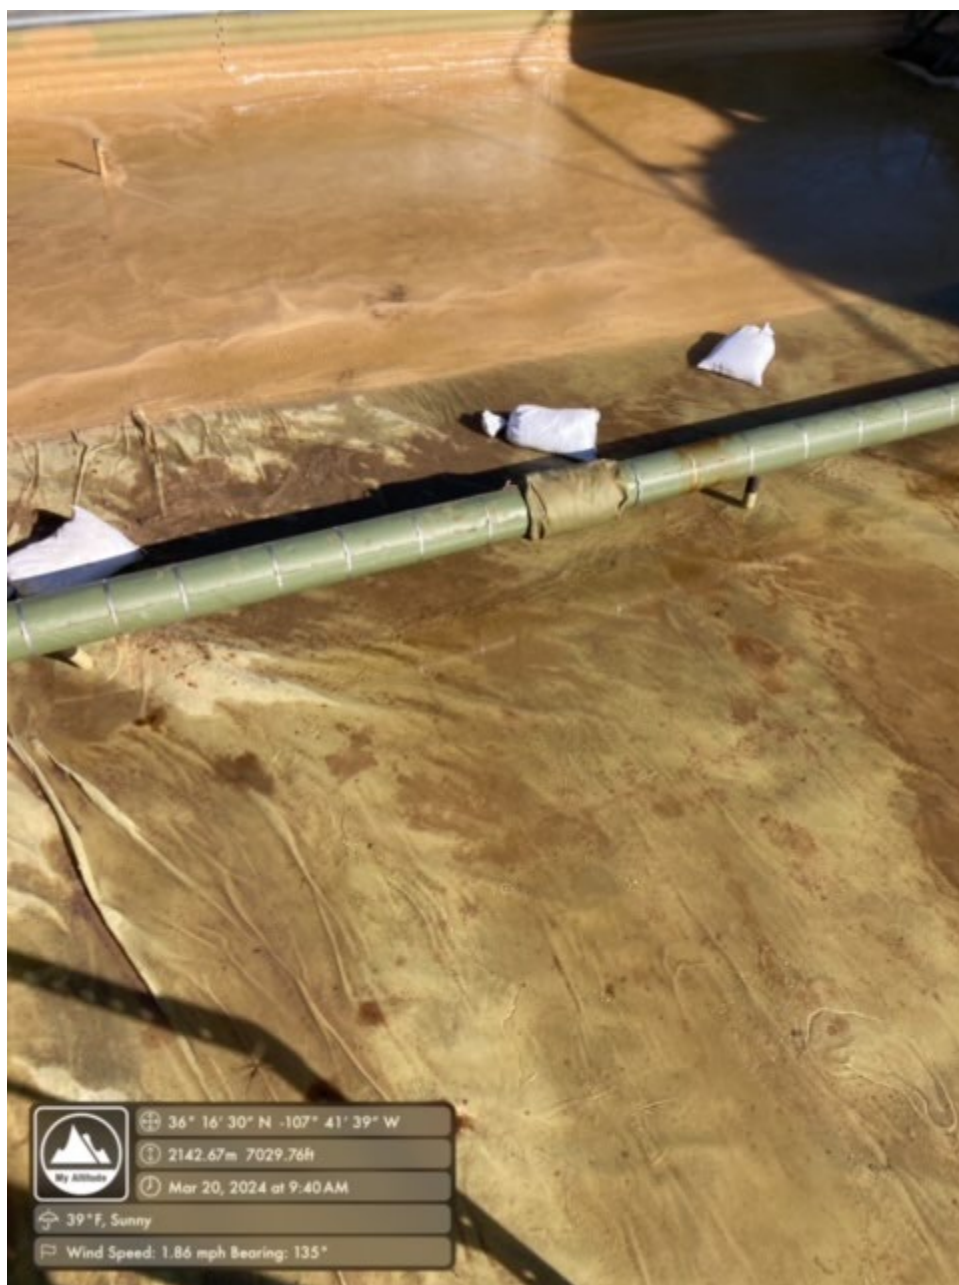
MC 5 Com 112H liner inspection not the new material in repaired area.

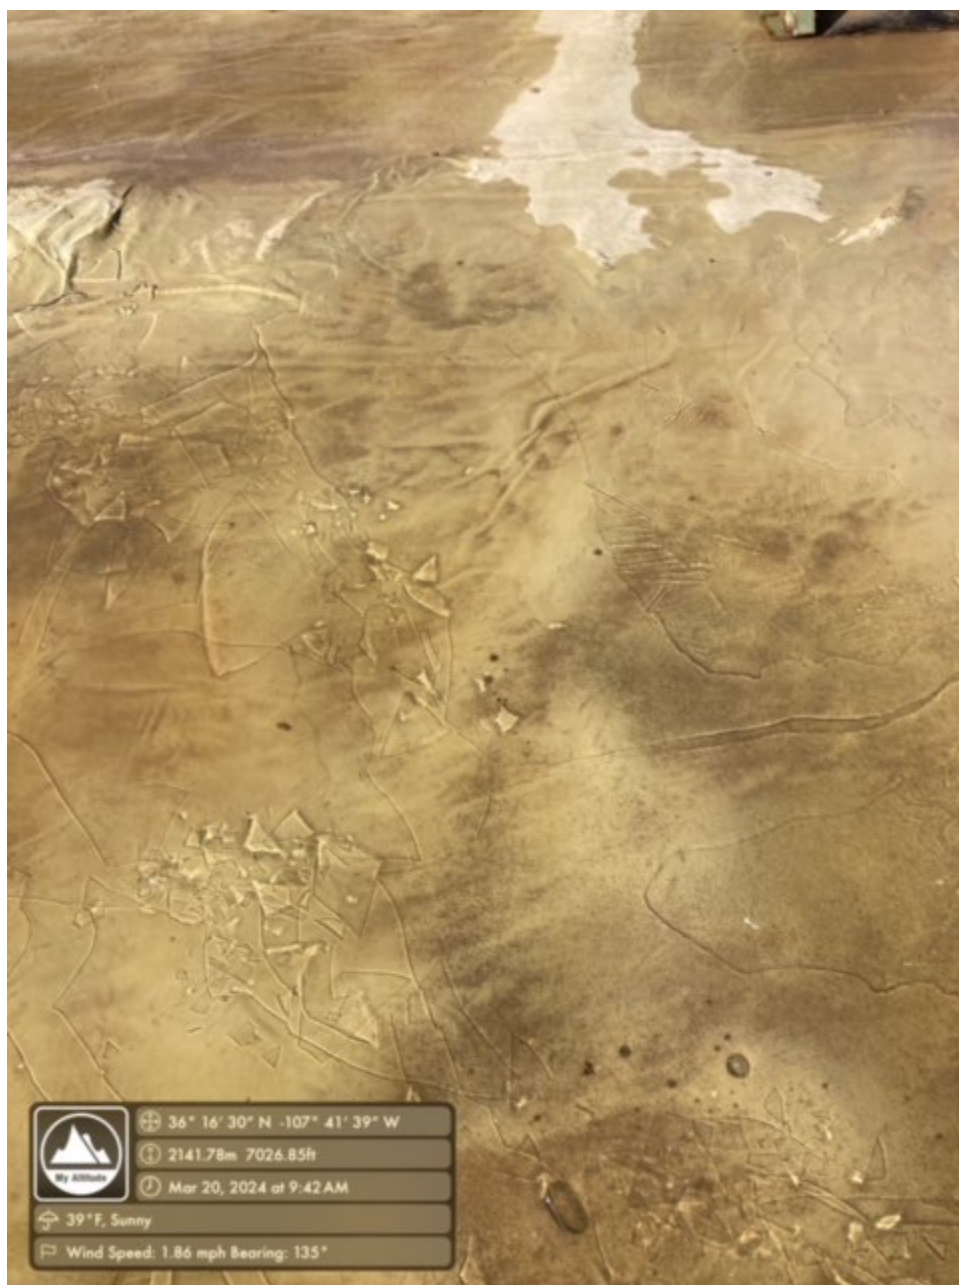
MC 5 Com 112H liner inspection southern area of the tank containment.
