**Re: Site Assessment and Closure Report**  
**BKU 13A Battery**  
**API No. 30-015-02971**  
**GPS: Latitude 32.8364334 Longitude -104.0220566**  
**UL "H", Sec. 13, T17S, R29E**  
**Eddy County, NM**  
**NMOCD Ref. No. NAPP2222751098**

Paragon Environmental, LLC (Paragon) has been contracted by Spur Energy Partners (Spur) to perform a spill assessment, conduct remediation activities and write a closure report for the release site known as the BKU 13A Battery (BKU). Details of the release are summarized below:

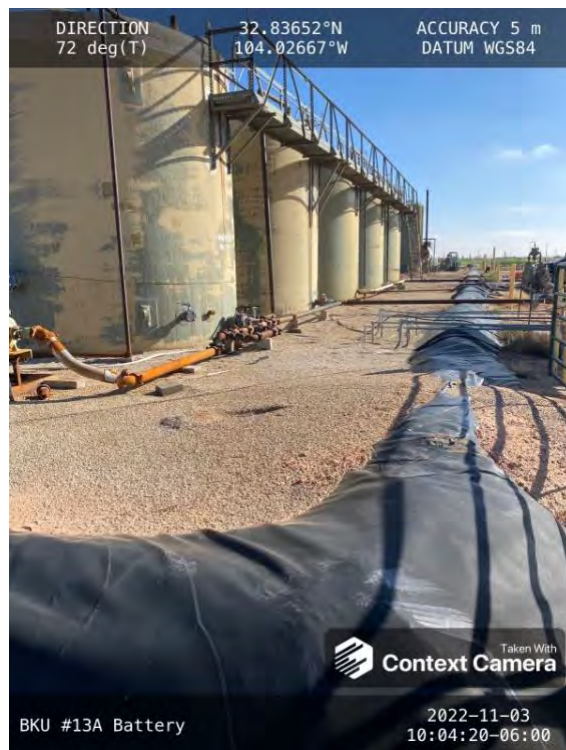
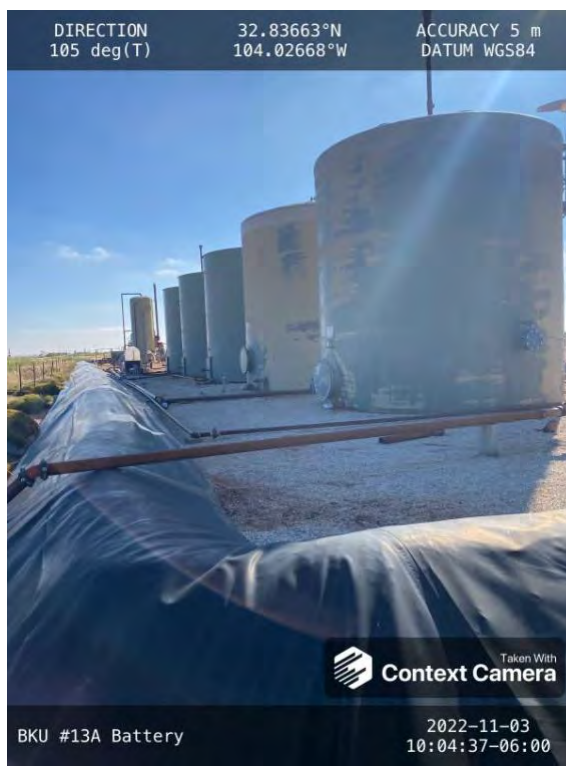
### Before

On October 24, 2022, Paragon conducted a site assessment. Upon arrival, we found that it was a poly-lined containment with dirt and gravel on top. There was no evidence fluids had breached the containment, so no soil samples were obtained.

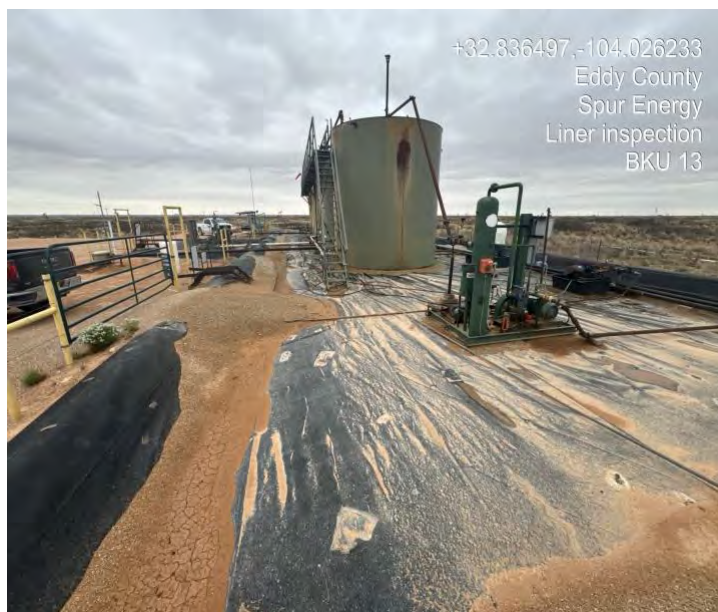
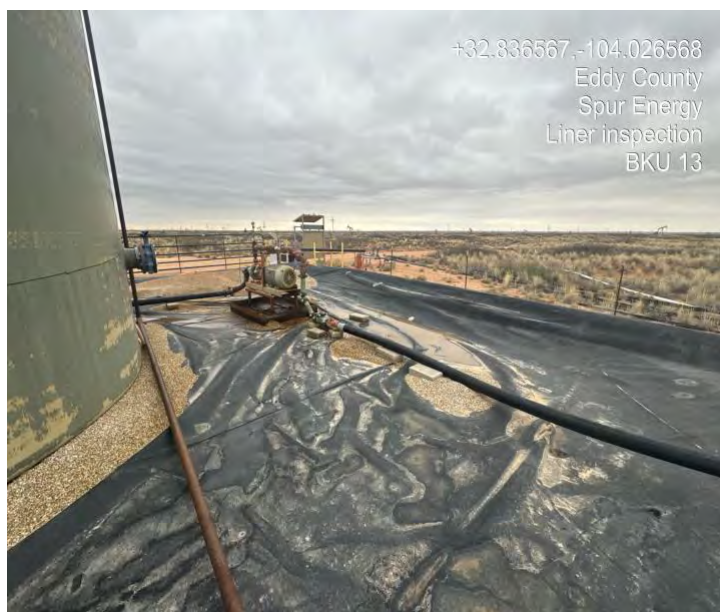
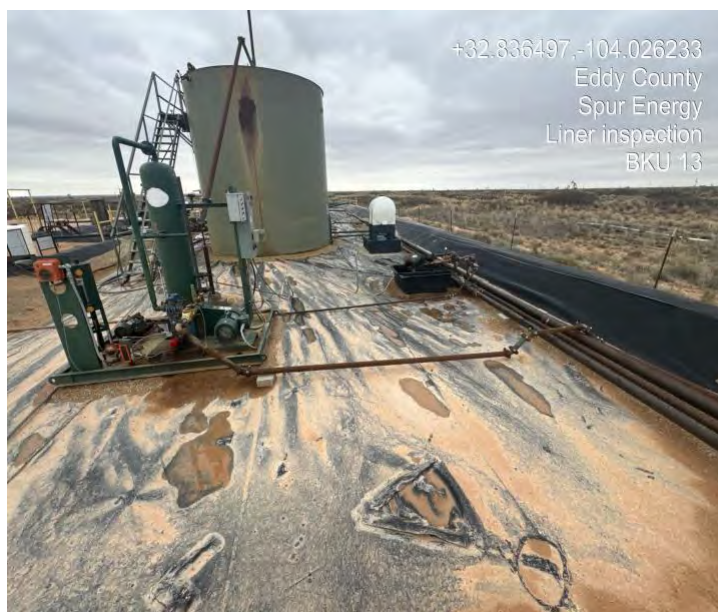
After

Visualization	Yes	No	Comments
Is there a tear in the liner?		x	
Are there holes in the liner?		x	
Is the liner retaining any fluids?		x	
Does the liner have integrity to contain a leak?	x

- We utilized a hand crew and bobcat to remove all the contaminated dirt out of the containment and onto a temporary liner.
- The area measured approximately 2,924 S/F, and we removed app. 55 C/Y of material.
- Once the dirt was removed, we hauled all of it off to Lea Land.
- The liner was then cleaned in preparation for the liner inspection.
- A liner inspection was scheduled and conducted to ensure the liner was intact. The liner notification and inspection report is included in Appendix C.
