LEAK #83 Remediation Summary & Closure Report

NMOCD Incident No. nAPP2321435751 UL "N", Sec. 3, T22S, R37E 32.41567°, -103.15206° Lea County, New Mexico

April 2, 2024

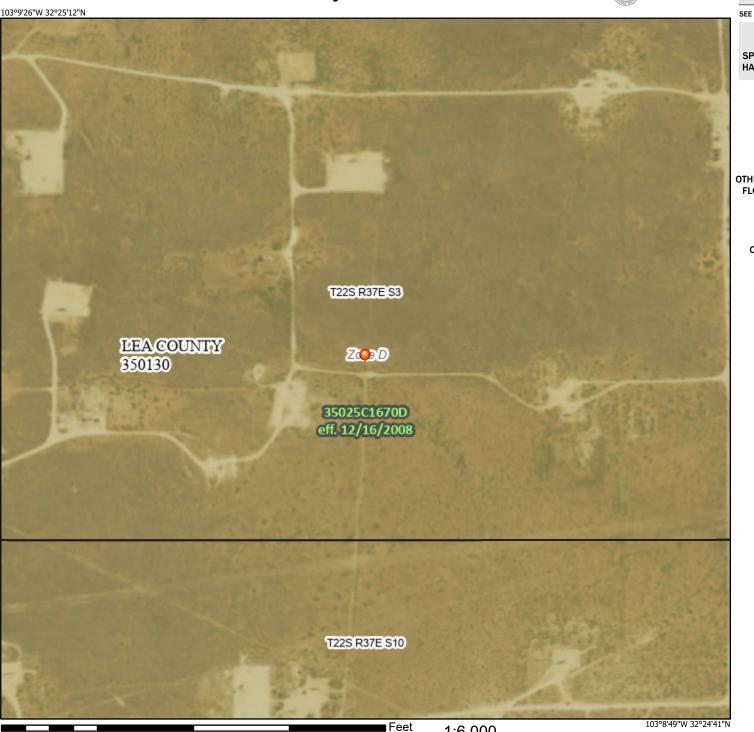
Figure 4

Review of flood map data published by the Federal Emergency Management Agency (FEMA) indicates the site is not located within a 100-year floodplain. A copy of the FEMA FIRMete Map can be found attached as Figure 4.
