**Re: Closure Report
ConocoPhillips (Heritage COG Production, LLC)
Windward Federal Com #001H Steel Flowline Release
Unit Letter D, Section 30, Township 24 South, Range 32 East
DOR: 11/17/2023
Lea County, New Mexico
Incident ID: NAPP2333243662**

According to the C-141 Initial Report, the release occurred on November 17, 2023, and was caused by a pinhole in a flowline due to corrosion. Approximately 0.929 barrels (bbls) of oil and 0.929 bbls of produced water were reported released into a pasture area adjacent to a lease road, and no fluid was recovered. The provided spill calculator indicates a release area of approximately 250 square feet. The New Mexico Oil Conservation Division (NMOCD) received the initial C-141 on November 29, 2023, and assigned the release the Incident ID NAPP2333243662. The C-141 is included as Appendix A.

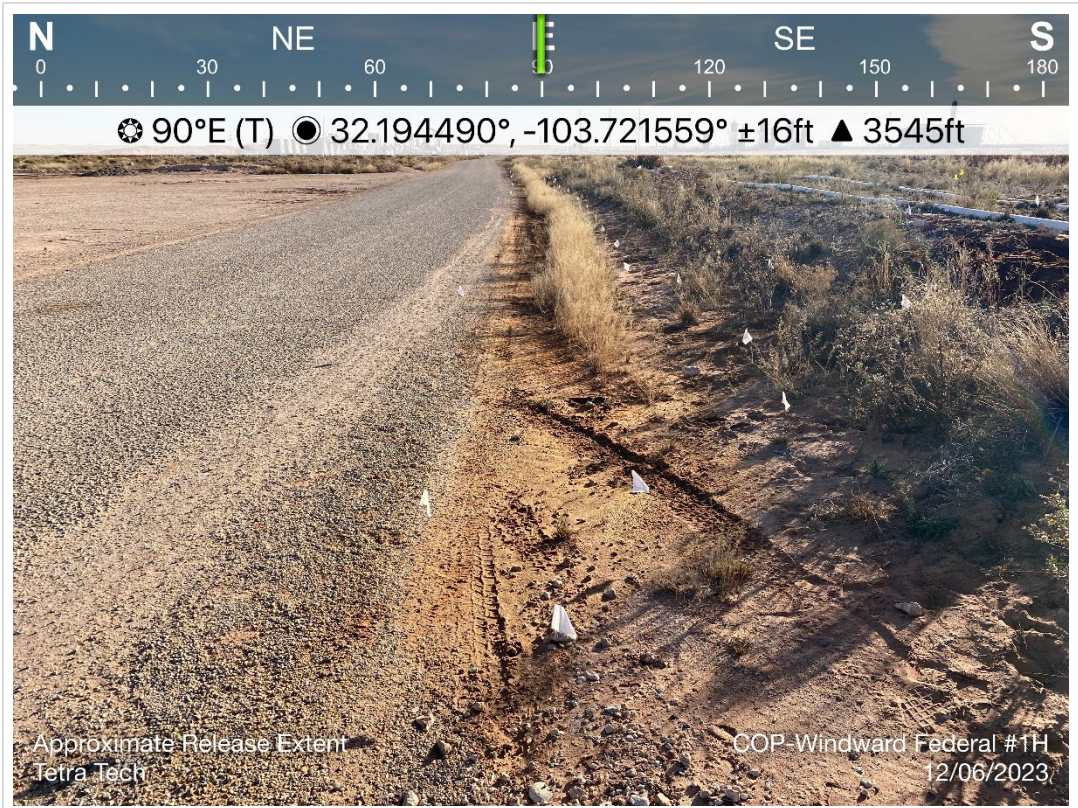
TETRA TECH, INC. PROJECT NO. 212C-MD-03309	DESCRIPTION	View east of release extent, marked with white pin flags.	1
	SITE NAME	Windward Federal Com #001H Release	12/6/2023

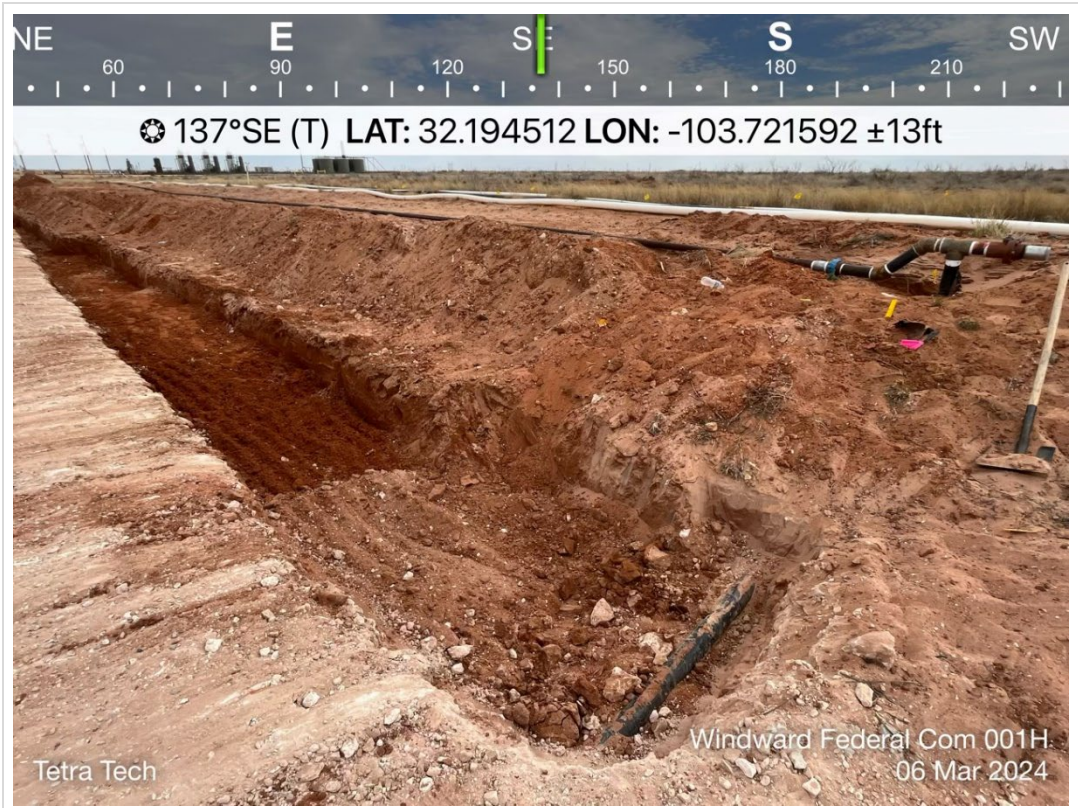
TETRA TECH, INC. PROJECT NO. 212C-MD-03309	DESCRIPTION	View southeast of western portion of the excavation in vicinity of release point.	3
	SITE NAME	Windward Federal Com #001H Release	3/6/2024

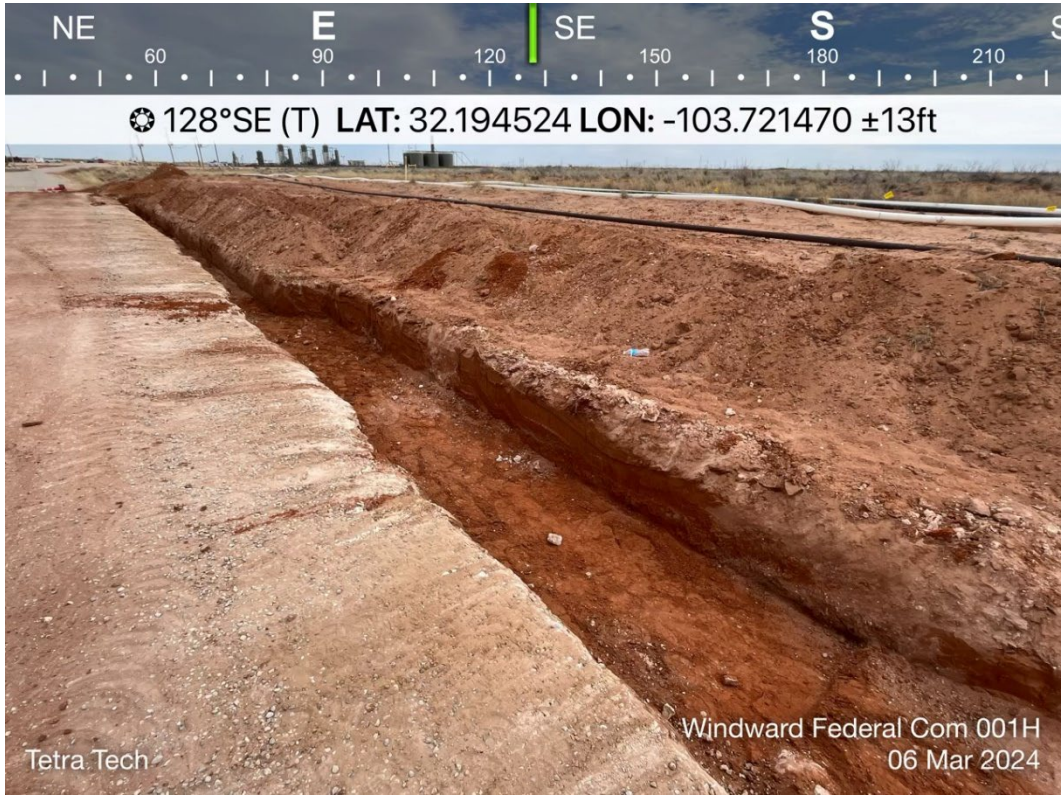
TETRA TECH, INC. PROJECT NO. 212C-MD-03309	DESCRIPTION	View southeast of the excavation prior to backfilling.	4
	SITE NAME	Windward Federal Com #001H Release	3/6/2024

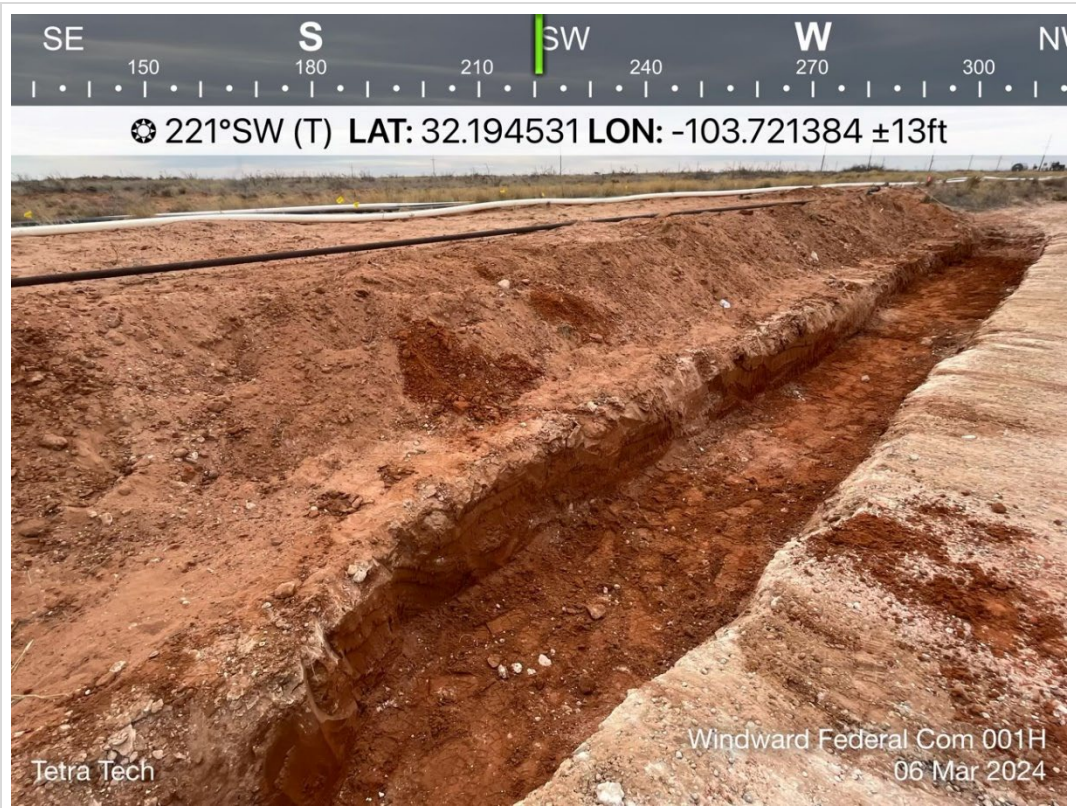
TETRA TECH, INC. PROJECT NO. 212C-MD-03309	DESCRIPTION	View southwest of the excavation prior to backfilling.	5
	SITE NAME	Windward Federal Com #001H Release	3/6/2024

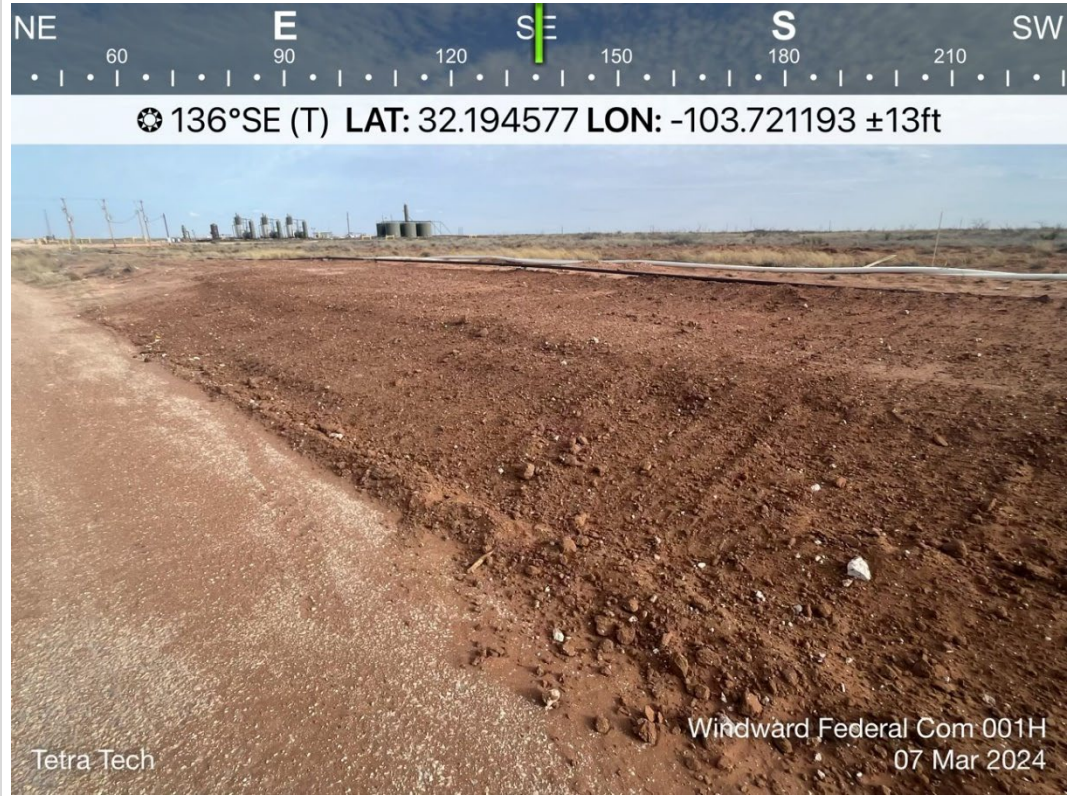
TETRA TECH, INC. PROJECT NO. 212C-MD-03309	DESCRIPTION	View southeast of backfilled excavation.	6
	SITE NAME	Windward Federal Com #001H Release	3/7/2024

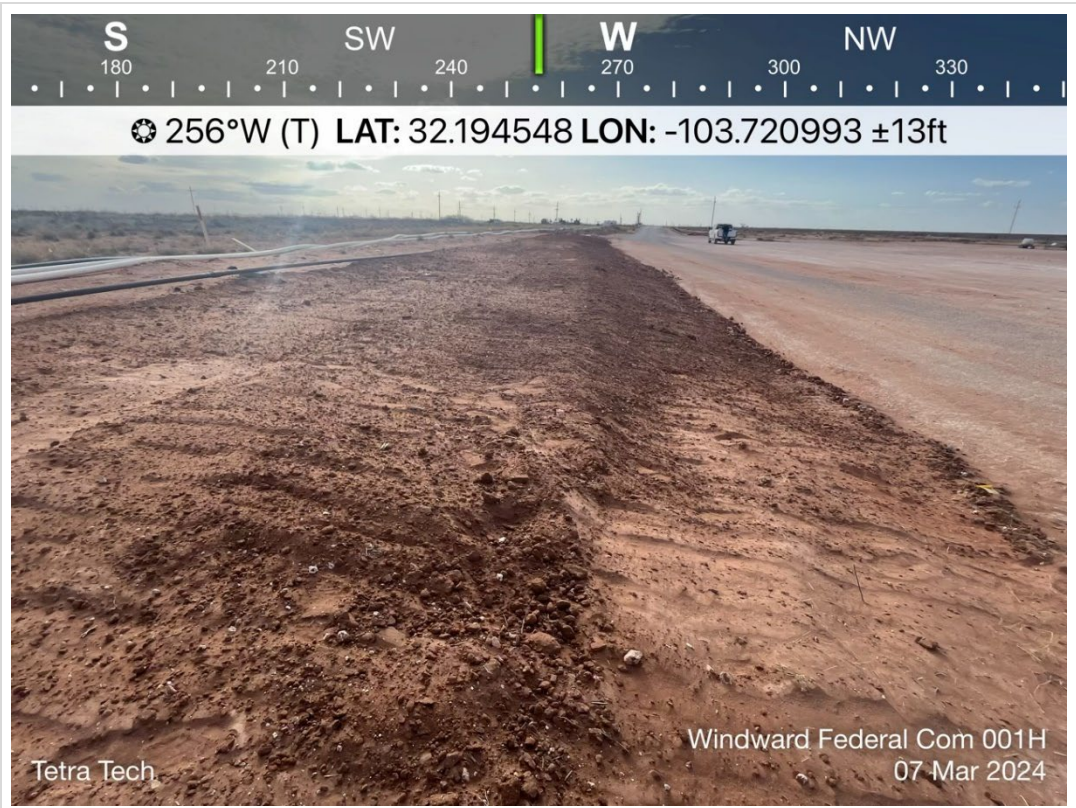
TETRA TECH, INC. PROJECT NO. 212C-MD-03309	DESCRIPTION	View west of backfilled excavation.	7
	SITE NAME	Windward Federal Com #001H Release	3/7/2024
