**Pima Environmental Services**  
**5614 N. Lovington Highway**  
**Hobbs, NM 88240**  
**575-964-7740**

March 28, 2024

**Re: Site Assessment, and Closure Report**  
**Right Meow 31 CTB 7**  
**API No. N/A**  
**GPS: Latitude 32.265616 Longitude -103.710898**  
**UL –B Section 31, T23S, R32E**  
**Eddy County, NM**  
**NMOCD Ref. No. NAPP2311348527**

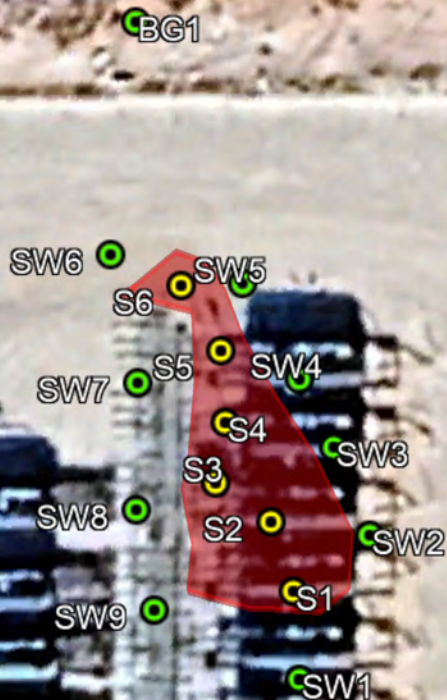
Devon Energy  
API:N/A  
Lea County, NM  
Site Map

On November 16, 2023, Pima mobilized personnel to the site to begin collecting soil samples from the spill area. The laboratory results of this sampling event can be found in the following data table. A Site Map can be found in Figure 4.

Spill Area 1,748 Sqft

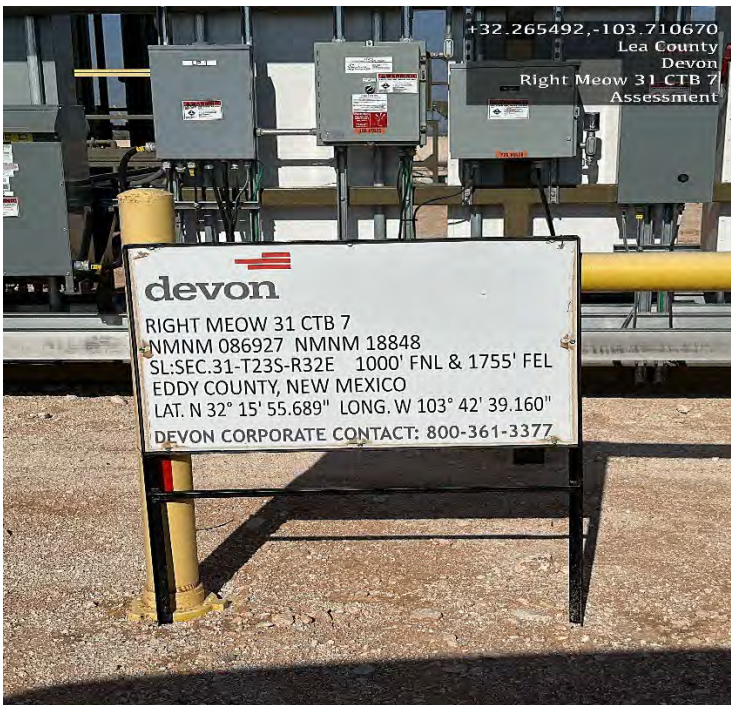
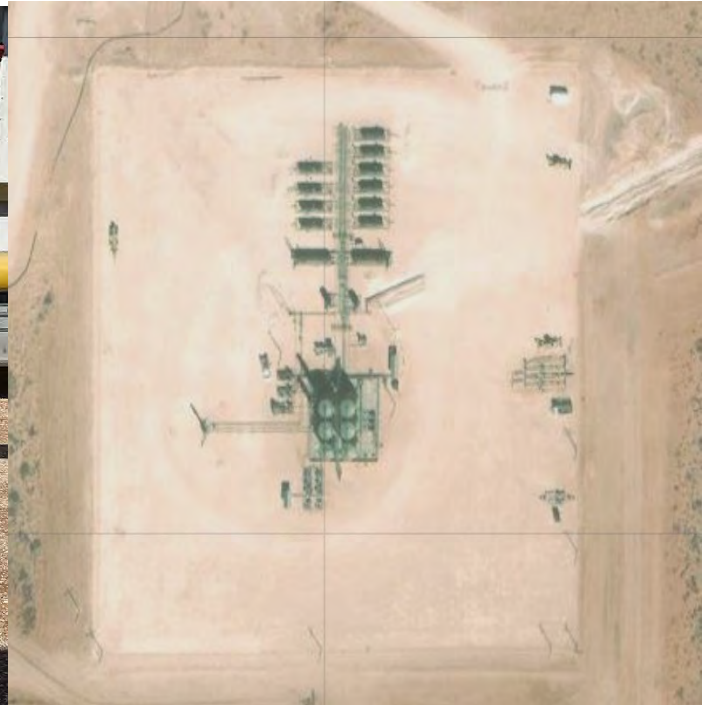
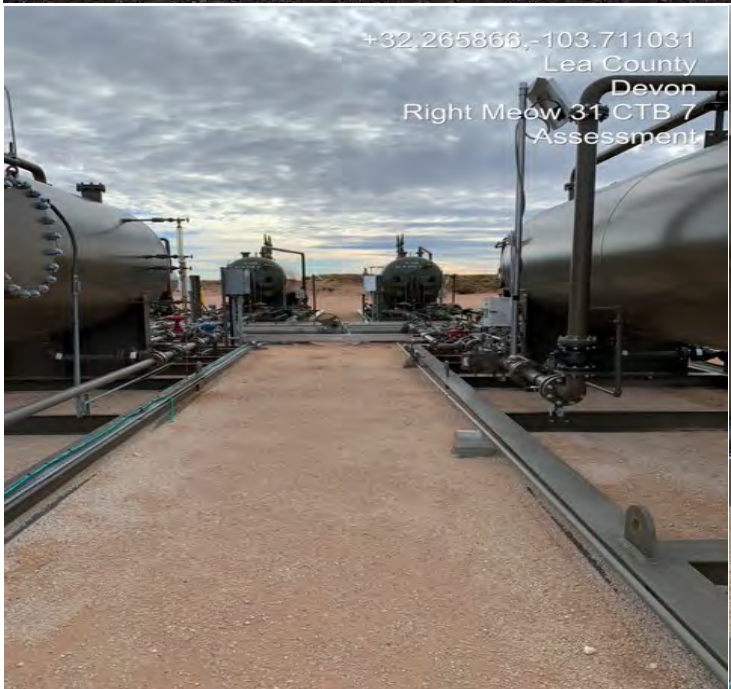
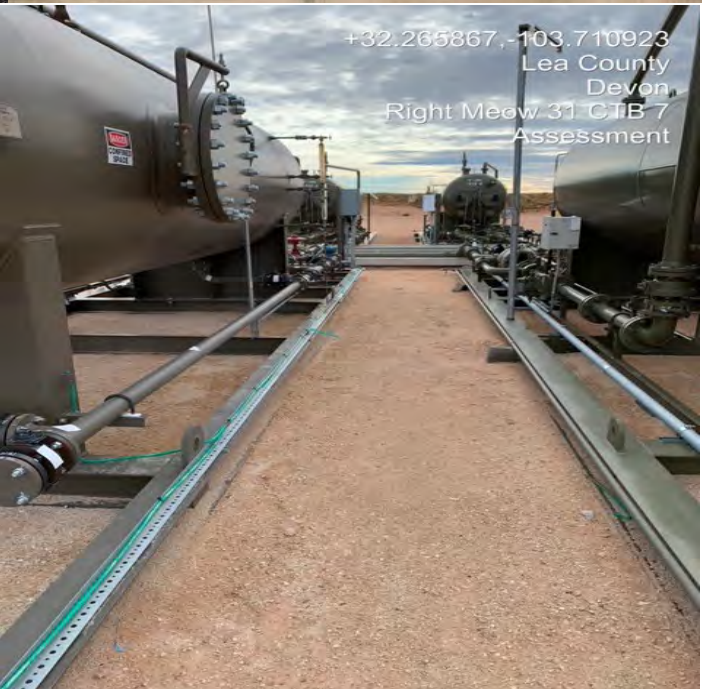
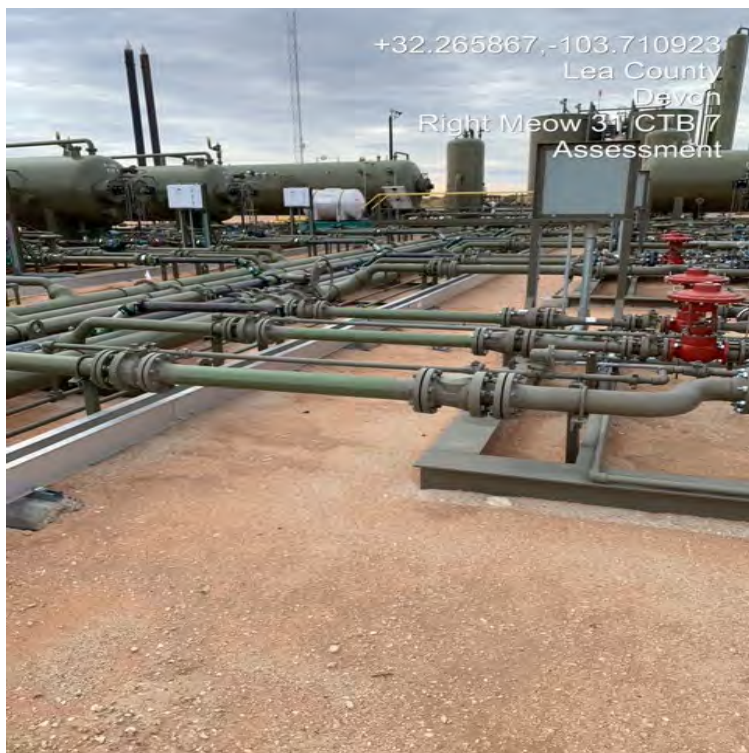
**SITE PHOTOGRAPHS  
DEVON ENERGY  
RIGHT MEOW 31 CTB 7**

Based on the sample results, the bottoms and sidewalls were below NMOCD Closure Criteria 19.15.29 NMAC. See Appendix D for Photographic Documentation.
