Remediation Summary & Deferral Request

Mewbourne Oil Company

Hoss 11 SWD #1

NMOCD Reference No. nAPP2334251764

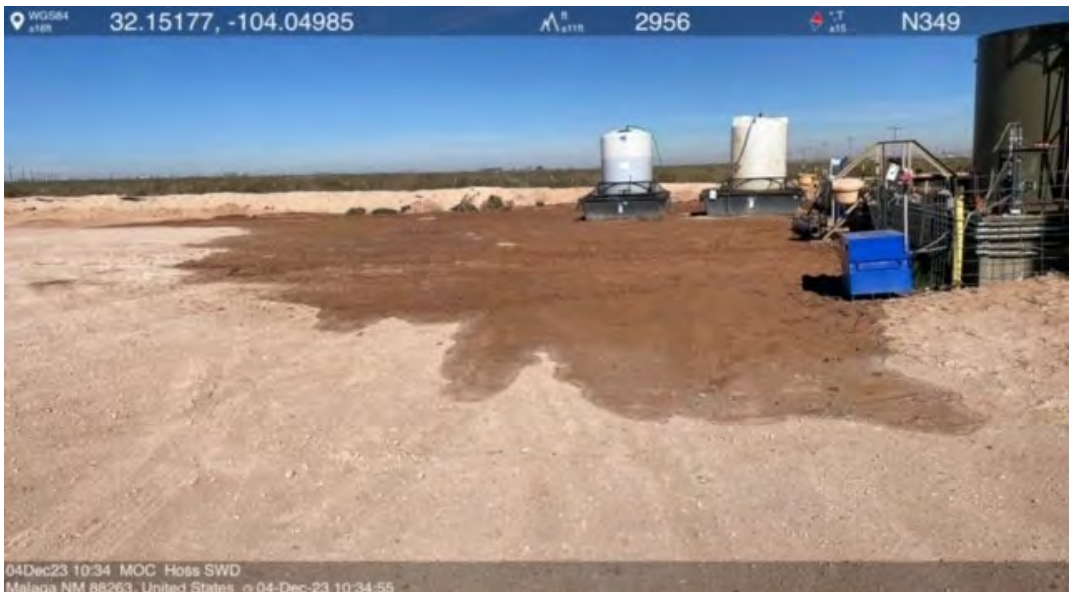
Photo Number: 10

Photo Direction: North	
Photo Description: View of the affected area.

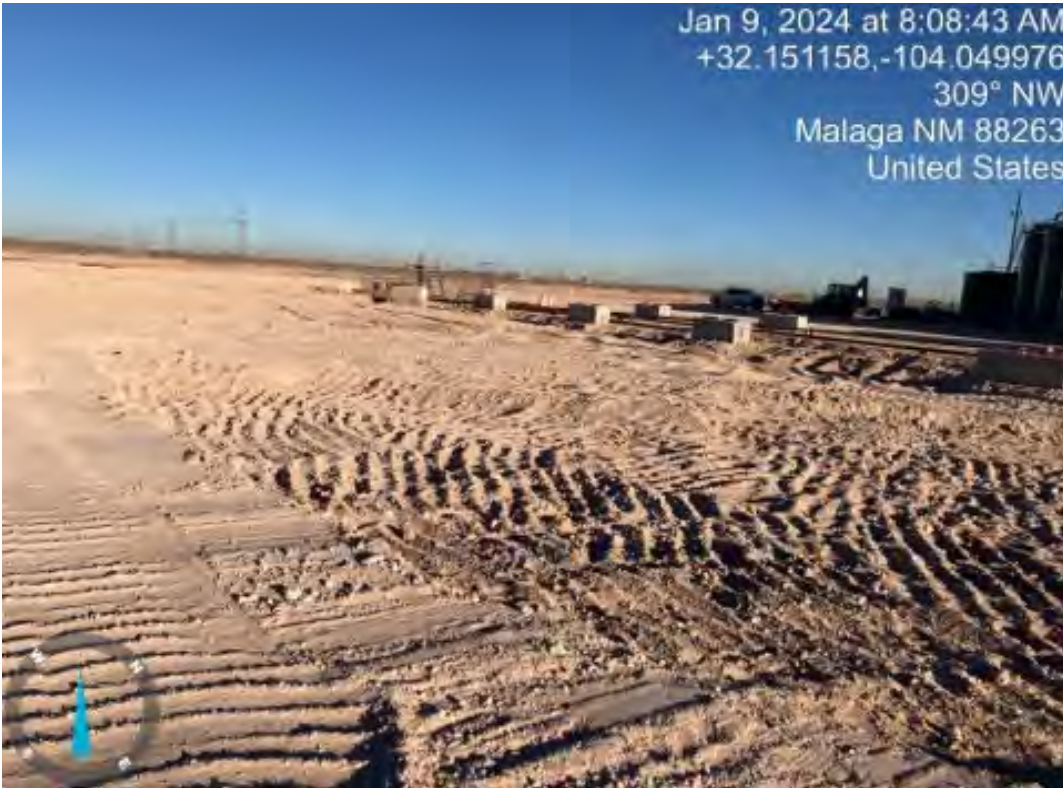
Photo Number: 11

<p>Jan 9, 2024 at 8:08:43 AM +32.151158,-104.049976 309° NW Malaga NM 88263 United States</p>
Photo Direction: Northwest	
Photo Description: View of the excavated area.

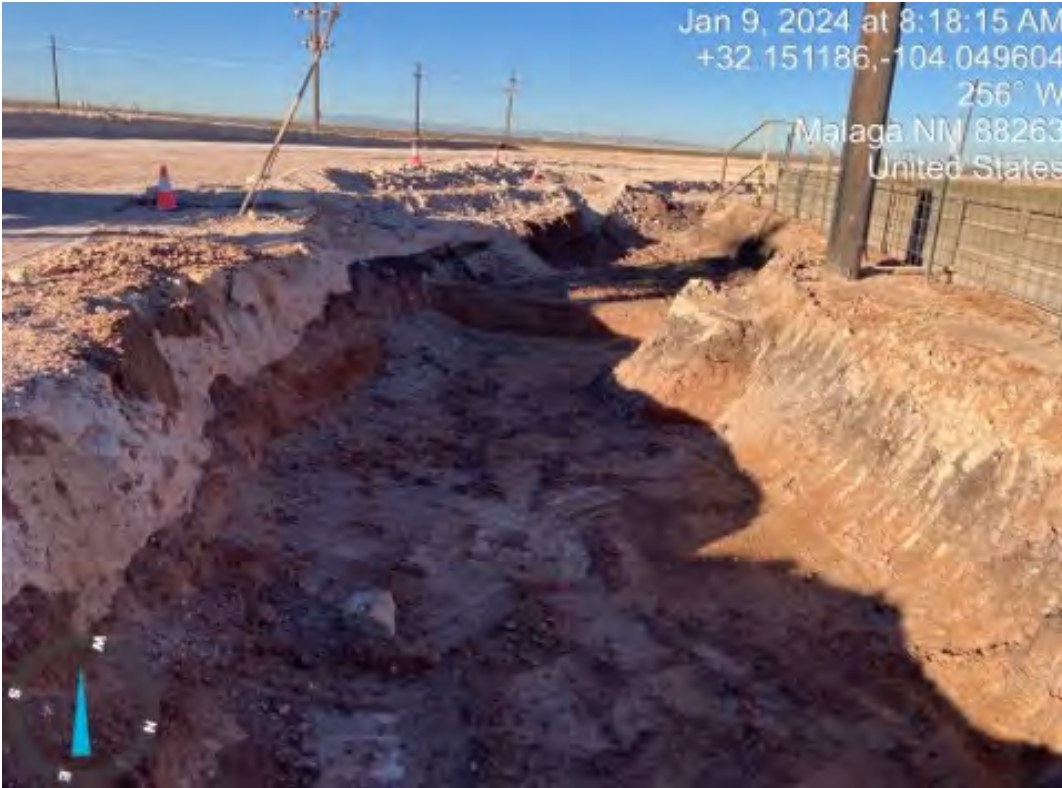
Photo Number: 14

Photo Direction: West-Southwest	
Photo Description: View of the excavated area.

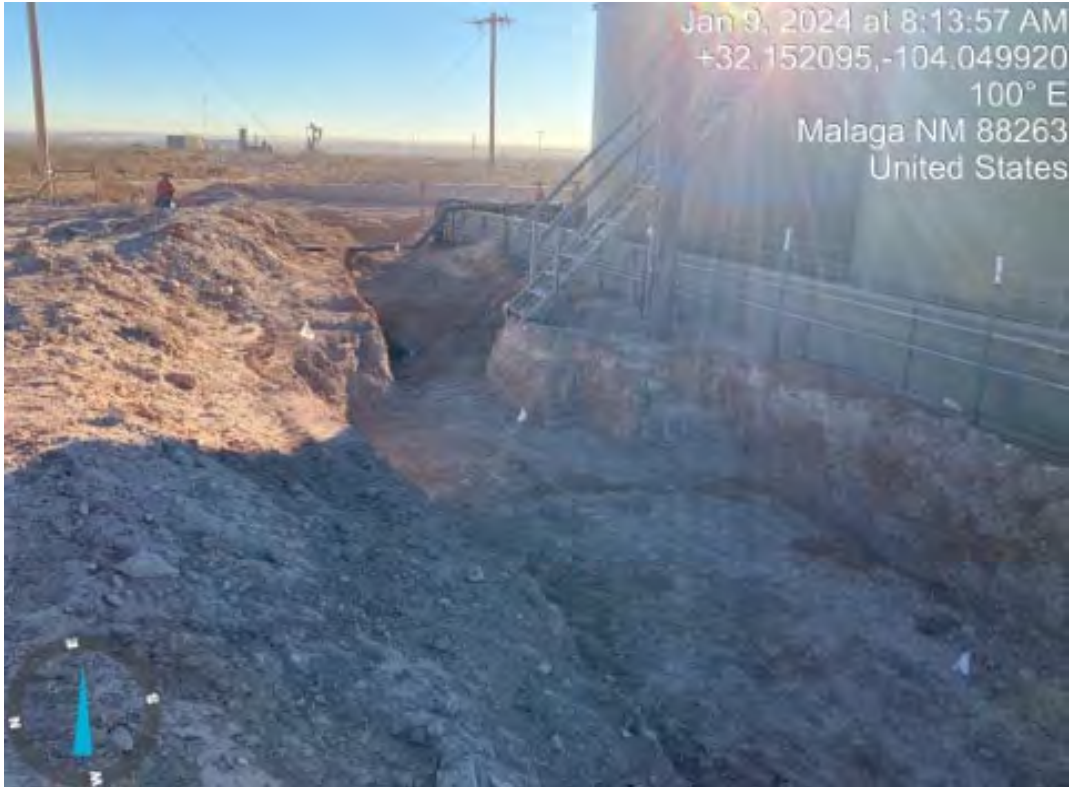
Photo Number: 22

<p>Jan 9, 2024 at 8:13:57 AM +32.152095,-104.049920 100° E Malaga NM 88263 United States</p>
Photo Direction: East	
Photo Description: View of the excavated area.

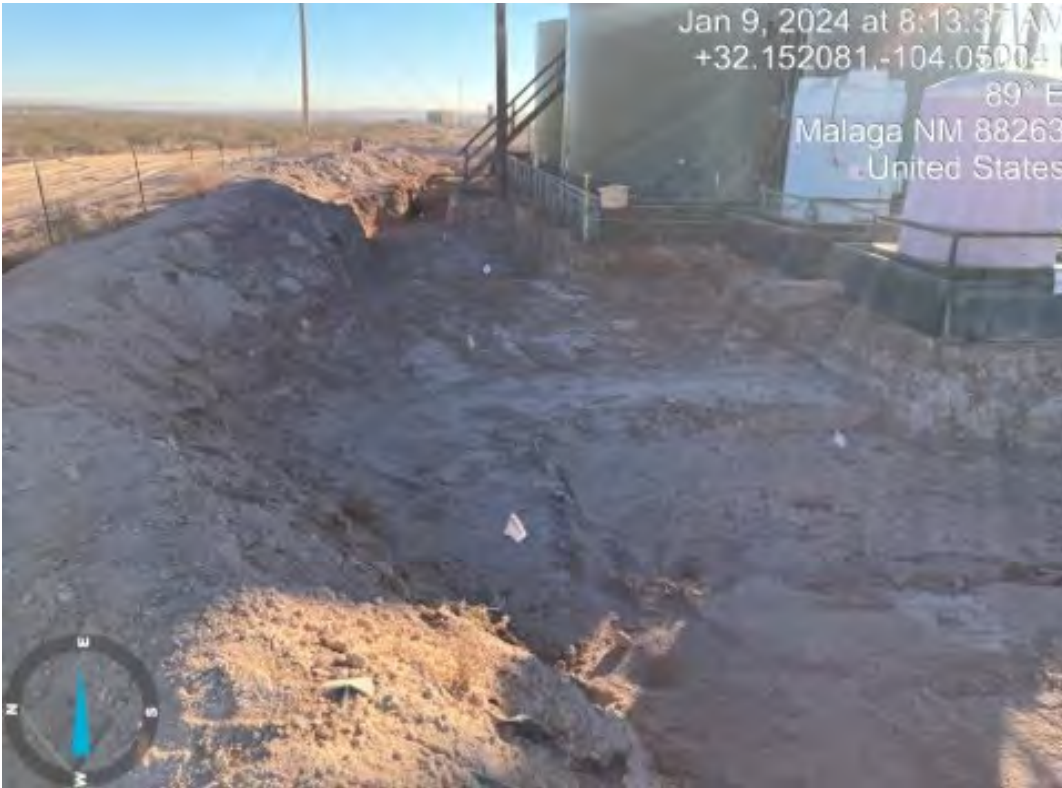
Photo Number: 23

<p>Jan 9, 2024 at 8:13:37 AM +32.152081,-104.050041 89° E Malaga NM 88263 United States</p>
Photo Direction: East	
Photo Description: View of the excavated area.

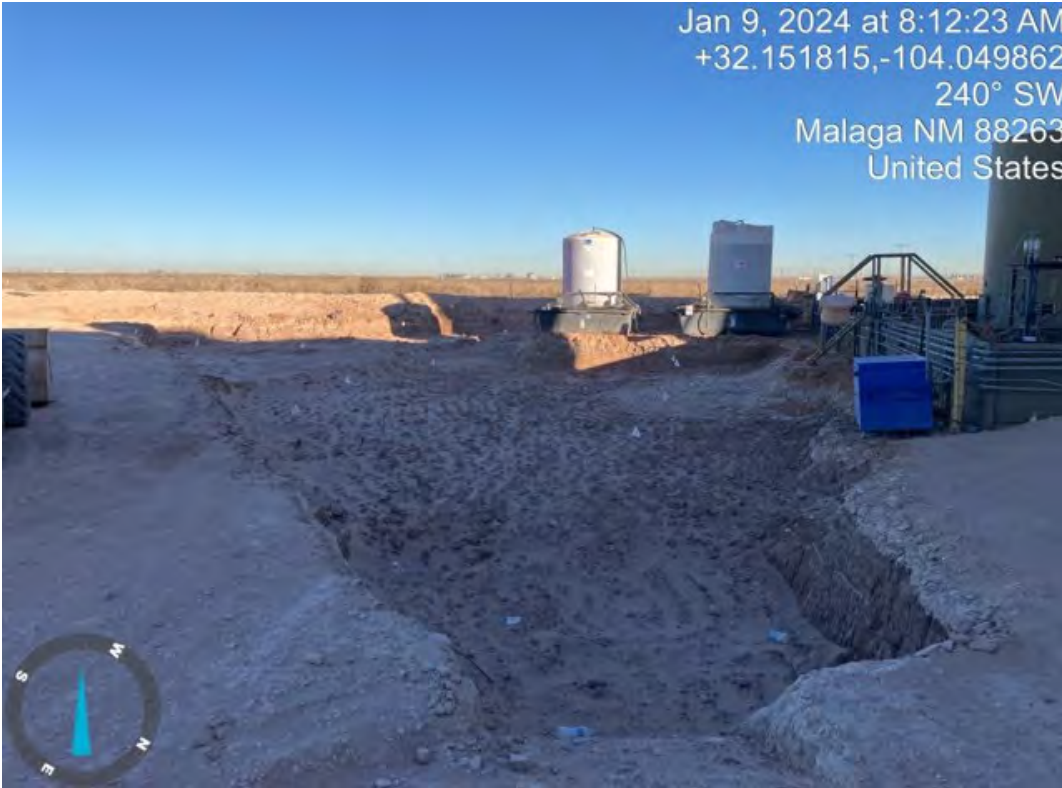
Photo Number: 24

<p>Jan 9, 2024 at 8:12:23 AM +32.151815,-104.049862 240° SW Malaga NM 88263 United States</p>
Photo Direction: West-Southwest	
Photo Description: View of the excavated area.

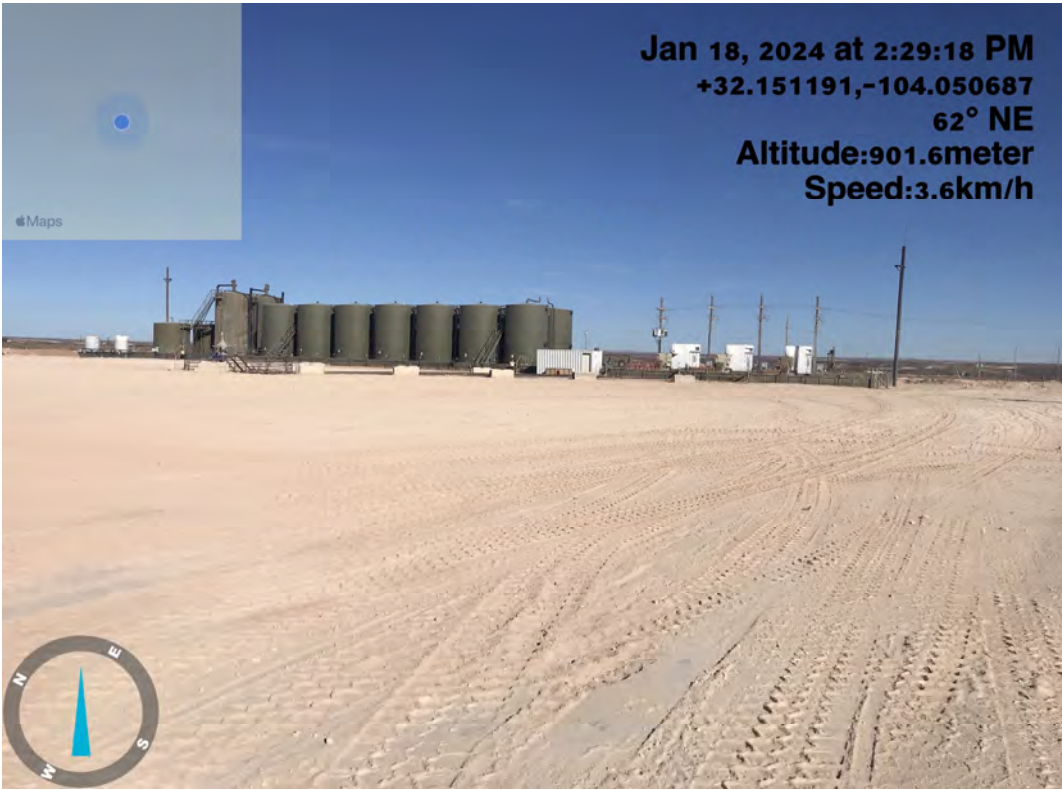
Photo Number: 27

Photo Direction: East-Northeast	
Photo Description: View of the remediated area after backfill and regrading.

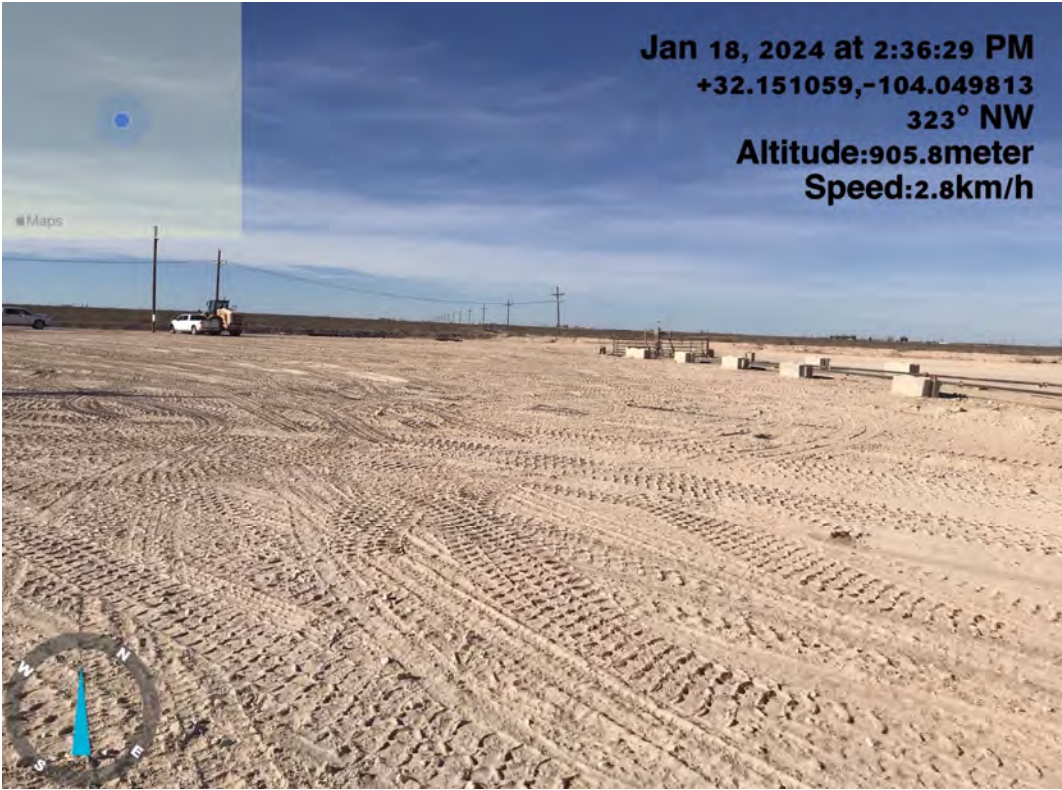
Photo Number: 28

Photo Direction: Northwest	
Photo Description: View of the remediated area after backfill and regrading.

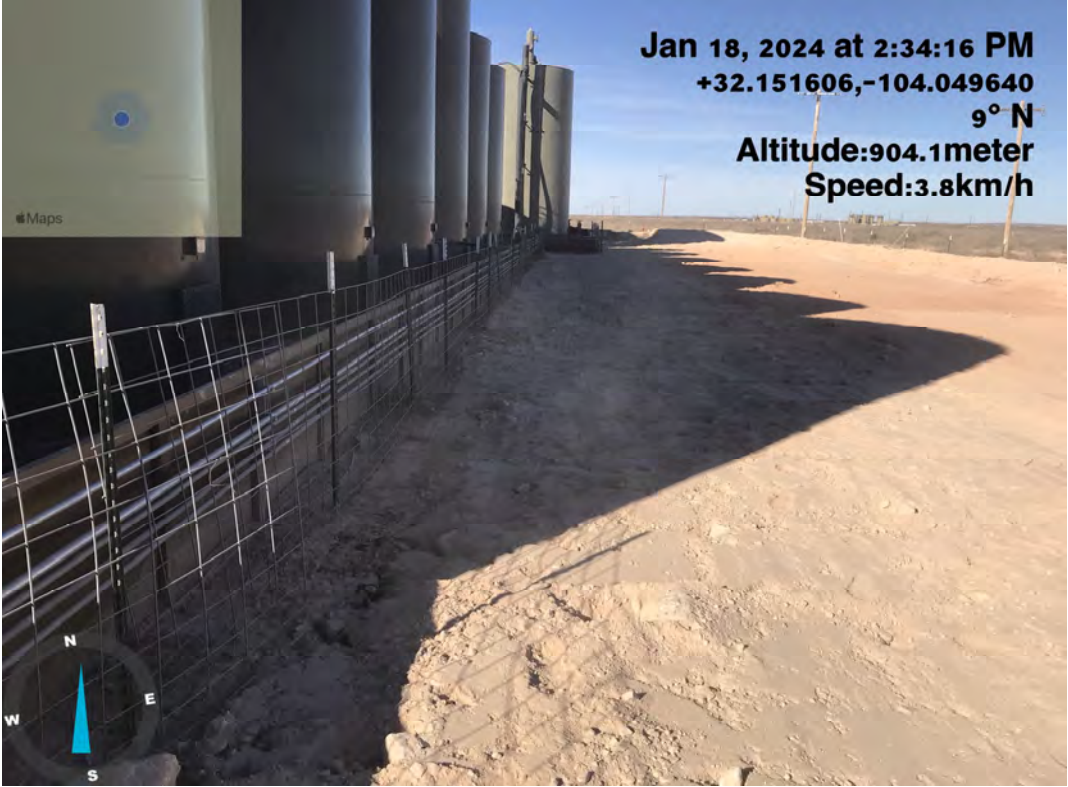
Photo Number: 33

Photo Direction: North	
Photo Description: View of the remediated area after backfill and regrading.

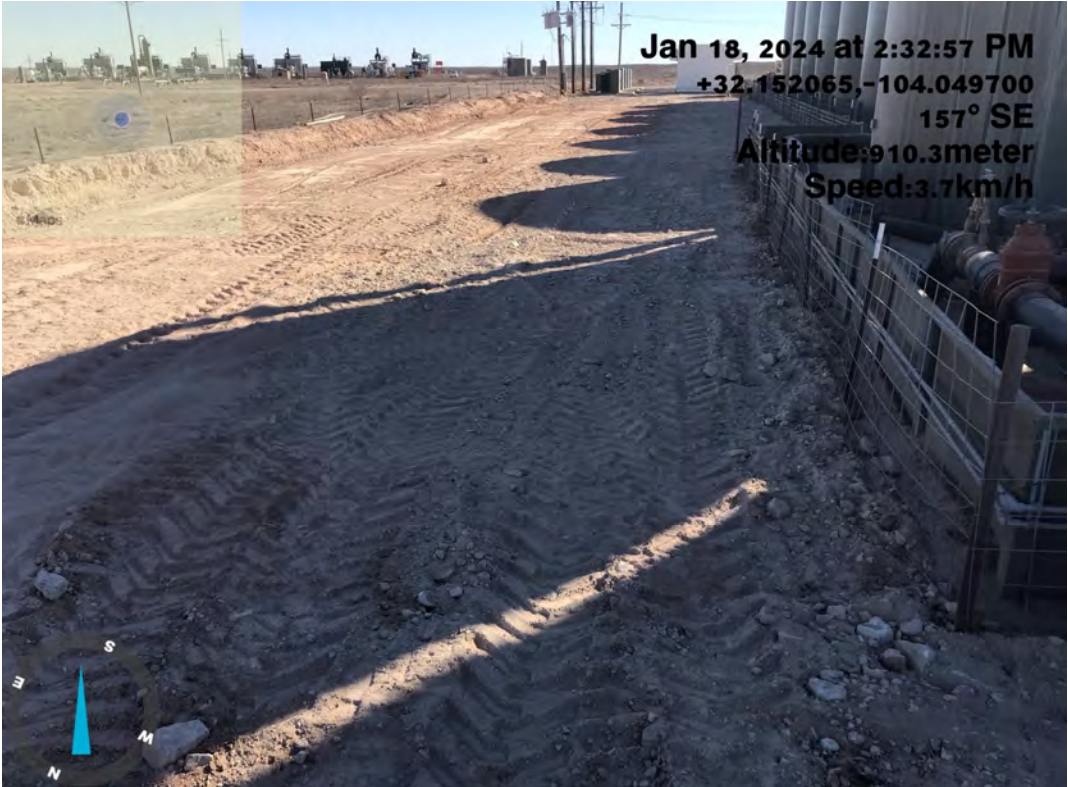
Photo Number: 34

Photo Direction: South-Southeast	
Photo Description: View of the remediated area after backfill and regrading.

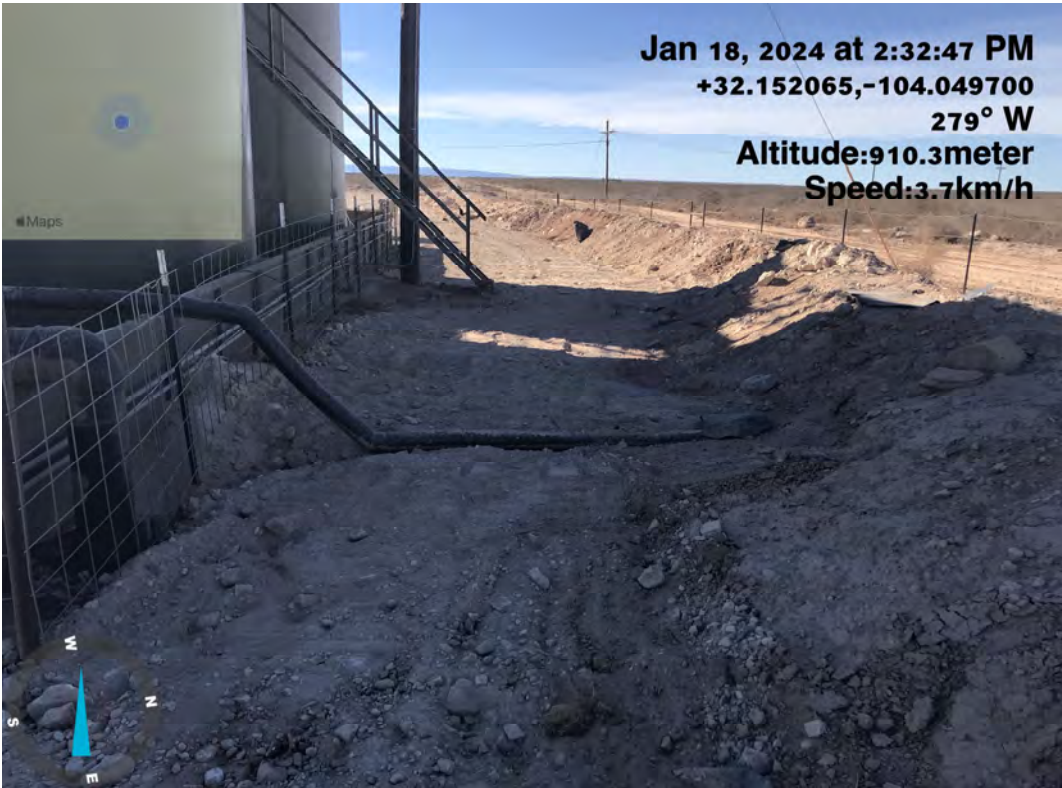
Photo Number: 35

Photo Direction: West	
Photo Description: View of the remediated area after backfill and regrading.

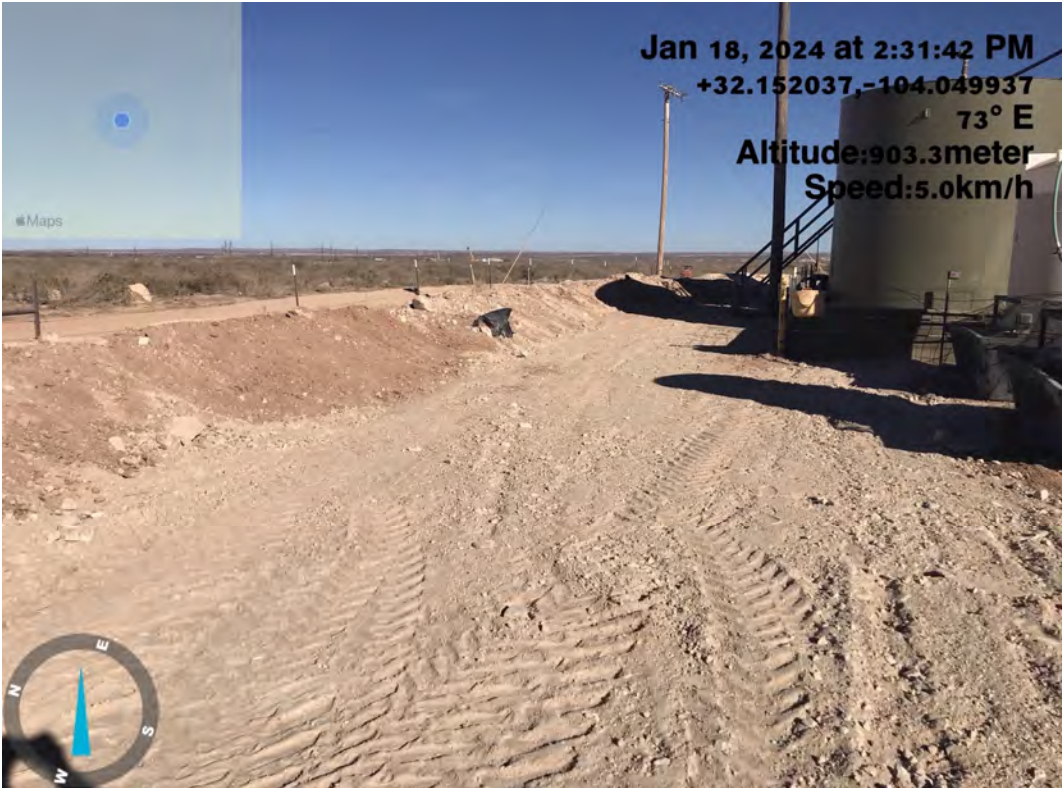
Photo Number: 36

Photo Direction: East-Northeast	
Photo Description: View of the remediated area after backfill and regrading.

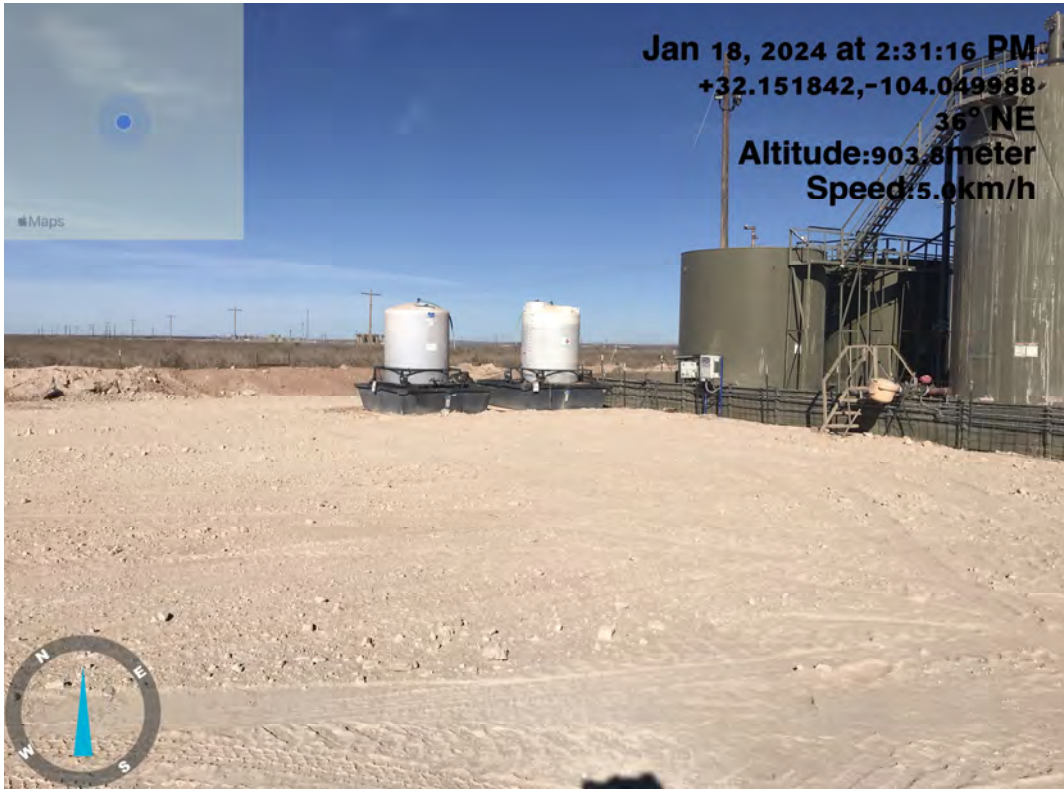
Photo Number: 37

Photo Direction: Northeast	
Photo Description: View of the remediated area after backfill and regrading.

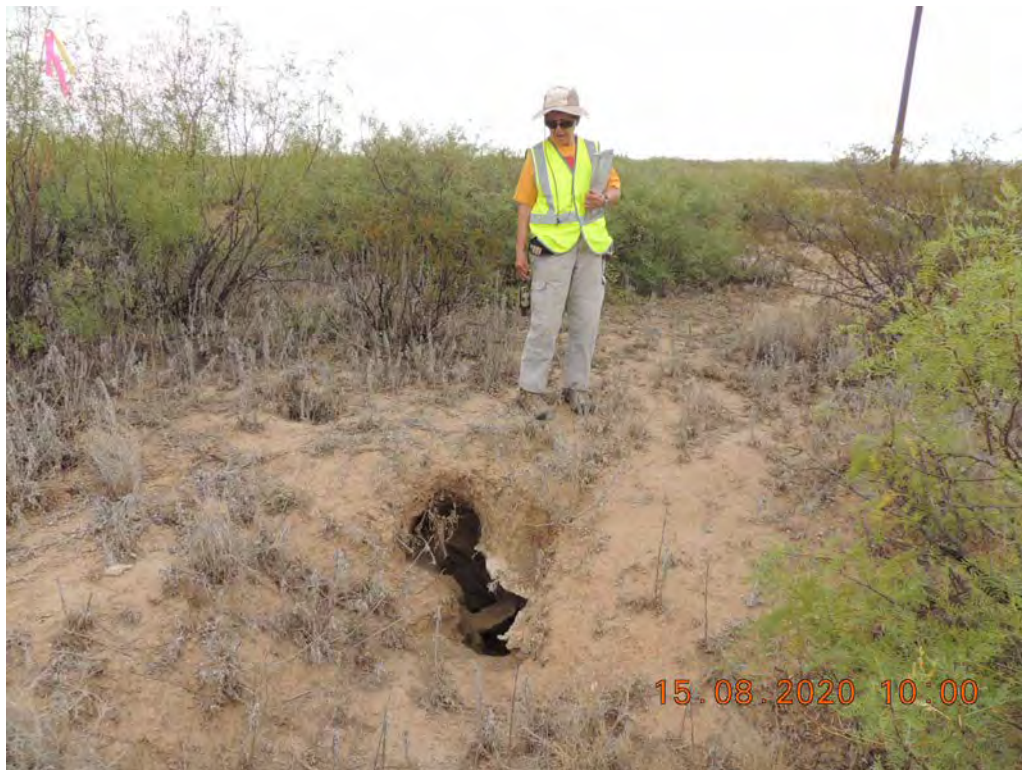
SURFACE DRAIN, 589304E, 3557882N, DEPTH UNKNOWN

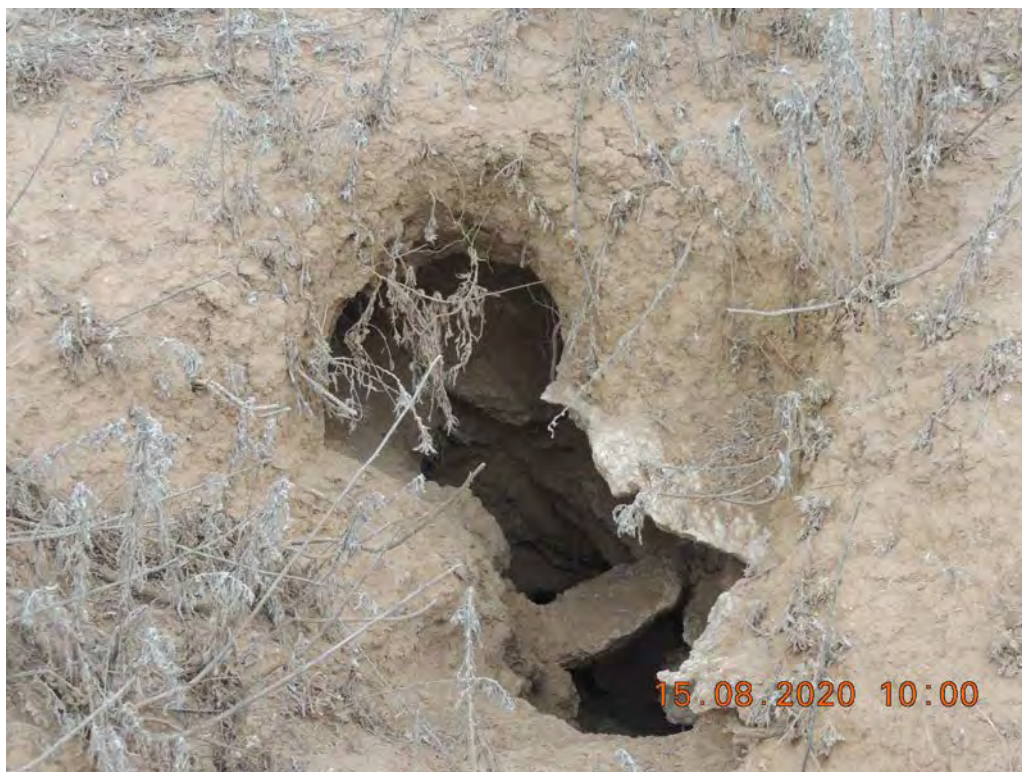
SURFACE DRAIN, 589304E, 3557882N, DEPTH UNKNOWN

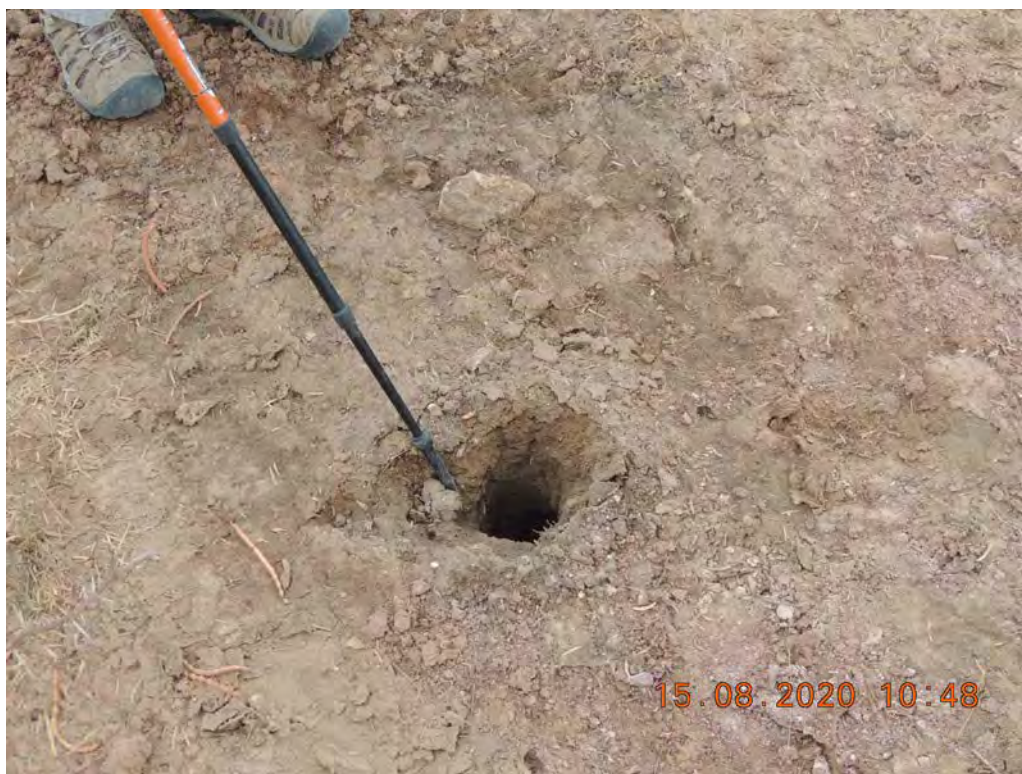
A 4" DIAMETER X 4+ FOOT DEEP HOLE DRILLED IN A SPILL AREA

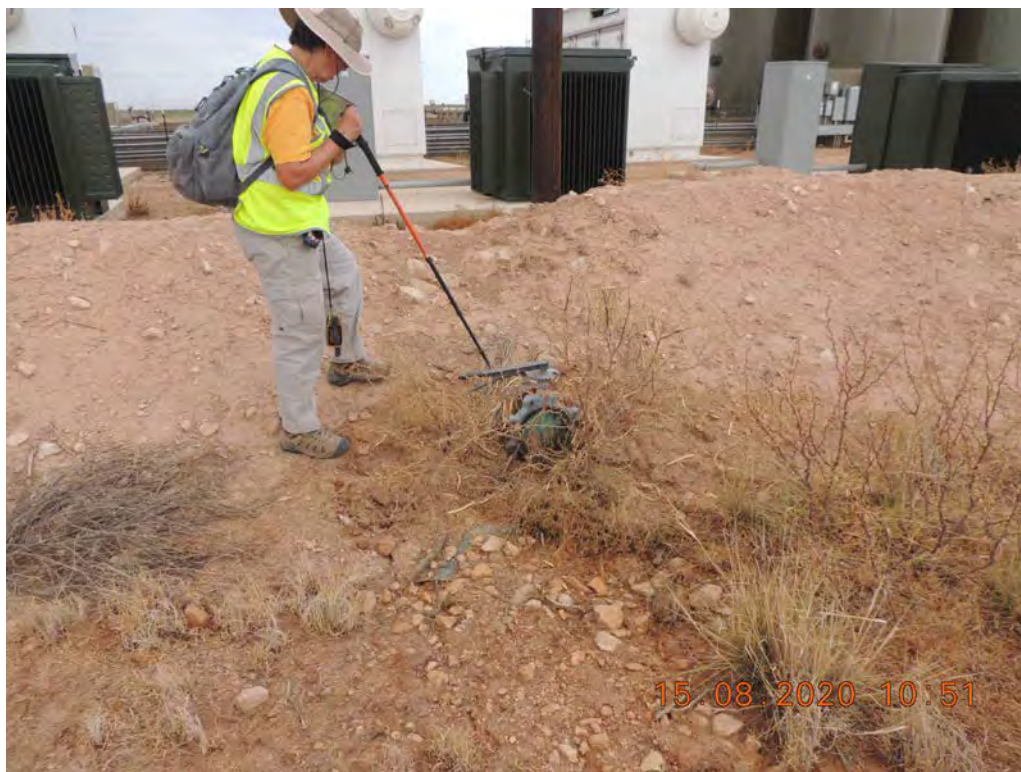
A VALVE IN THE SPILL AREA, 589632E, 3557605N

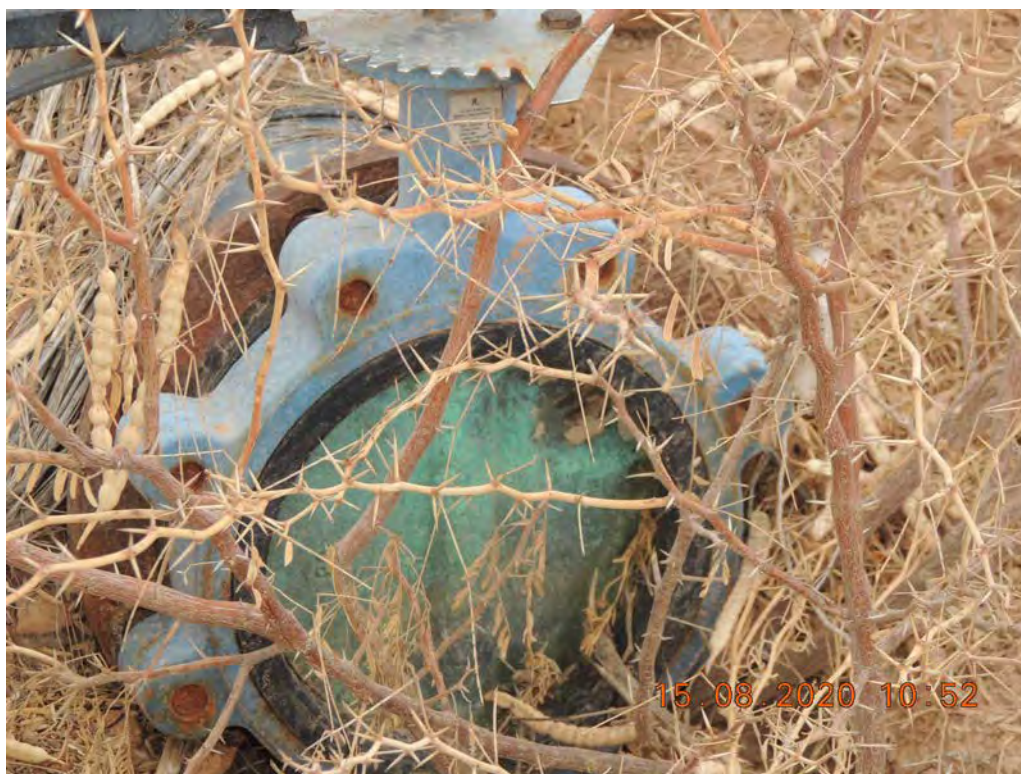
A VALVE IN SPILL AREA, 589632E, 3557605N

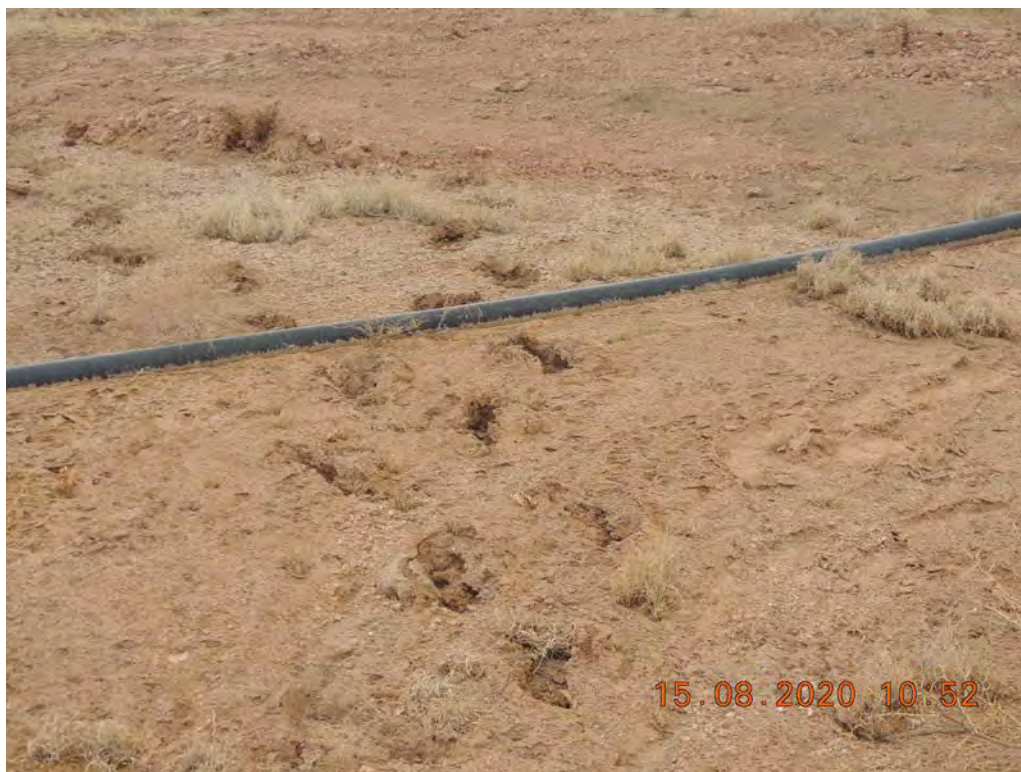
TYPICAL SPILL AREA

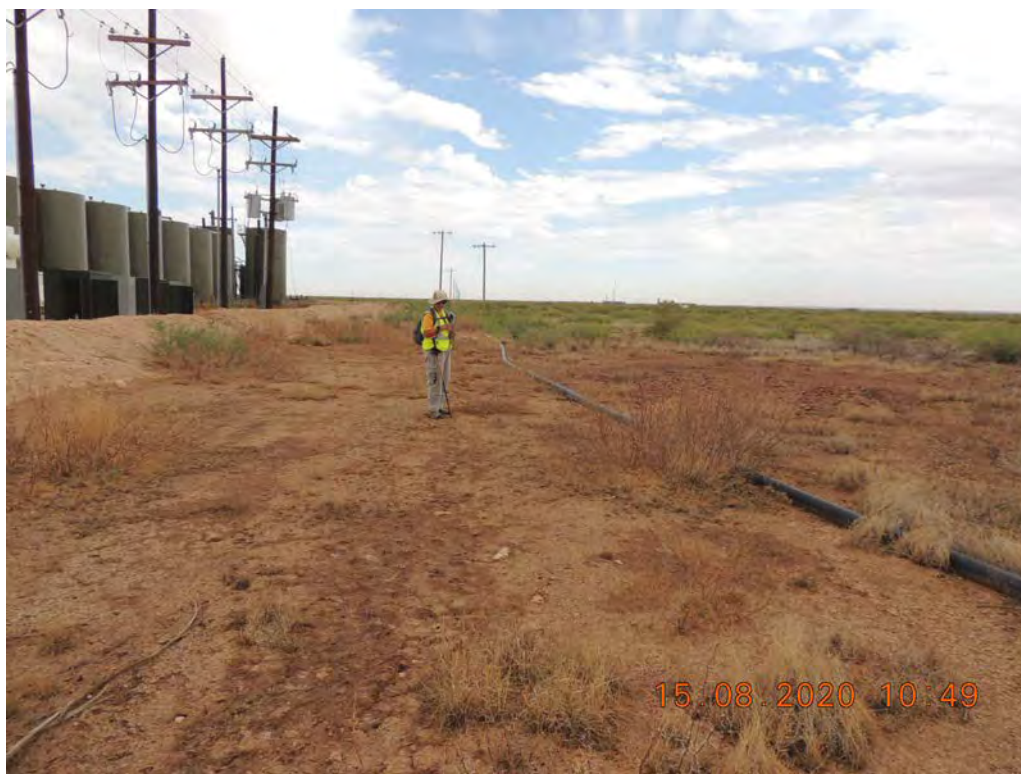
CENTER OF SPILL AREA
