Tracking Number: nAPP2311640670
Revised Closure Report
Produced Water Release
Salado Draw CTB 24
Lea County, New Mexico

LAI Project No. 23-0102-04

April 12, 2024

Tracking Number: nAPP2311640670
Closure Report - Produced Water Release
Chevron USA Inc., Salado Draw CTB 24
April 12, 2024

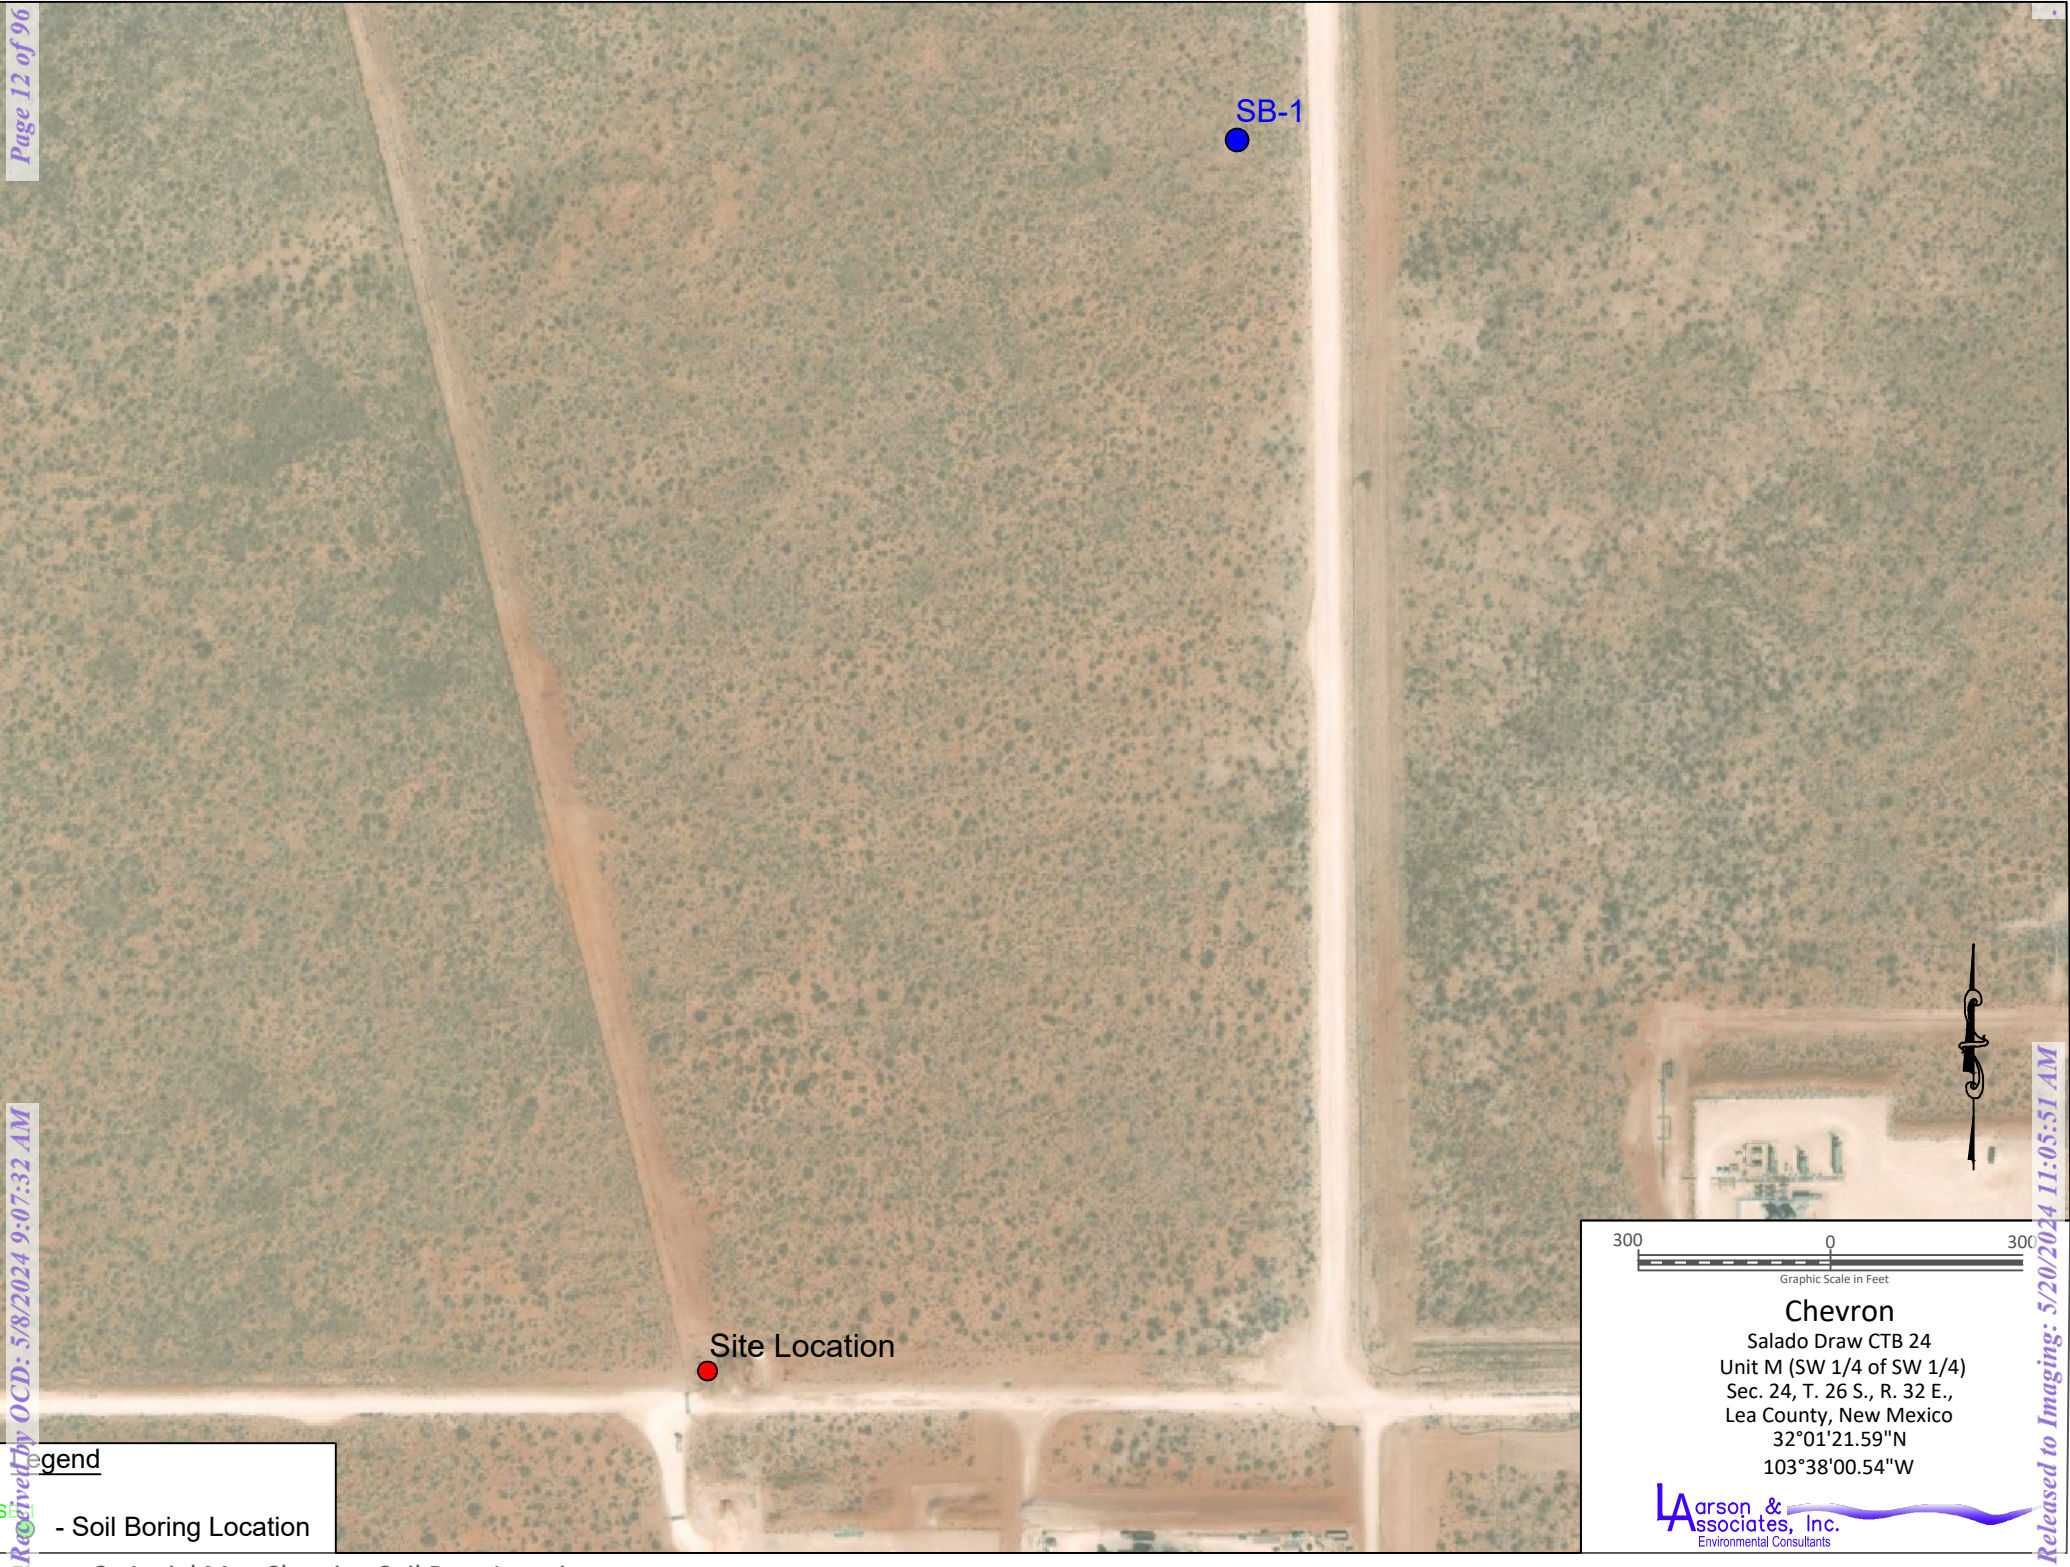
Figure 3- Aerial Map Showing Soil Bore Location

- Soil Boring Location

Figure 3 presents the soil boring location. Appendix B presents USGS data depicting karst risk potential map. Appendix C presents the boring log.

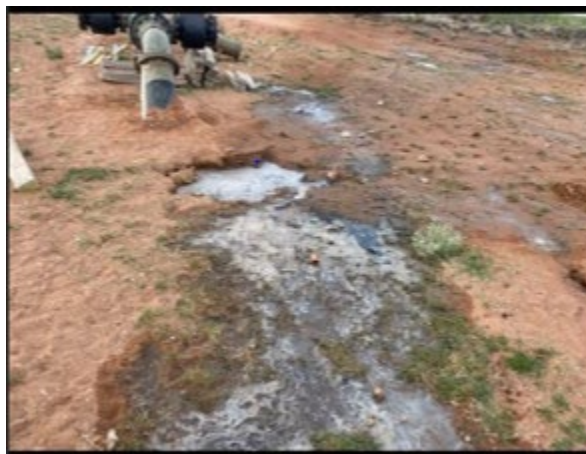
Impacted area viewing north, photo taken by Chevron personnel

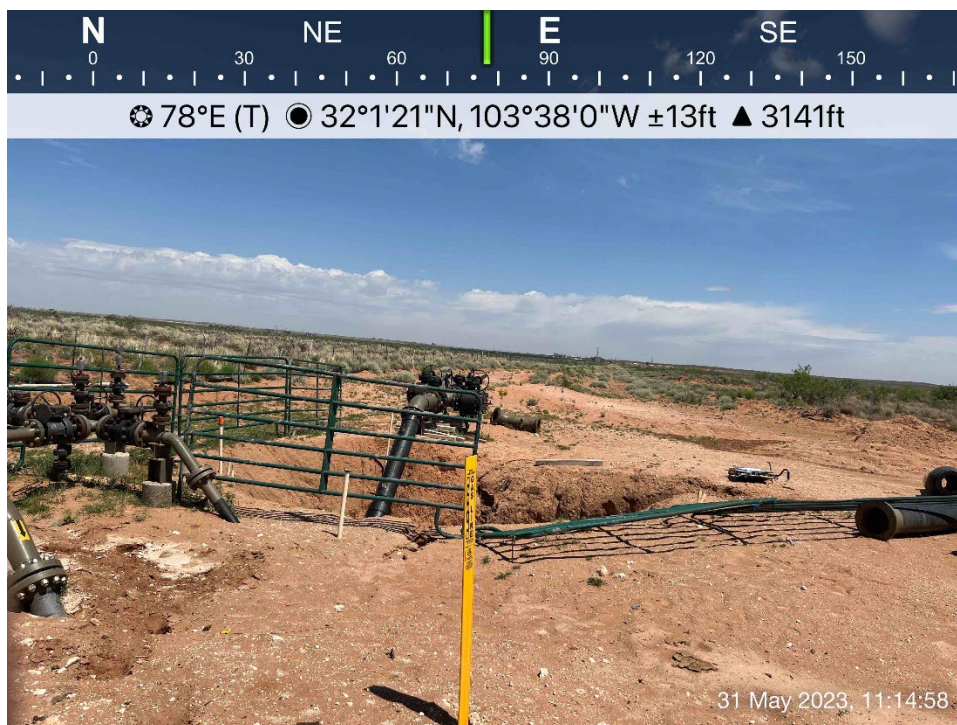
Impacted area viewing east, May 31, 2023

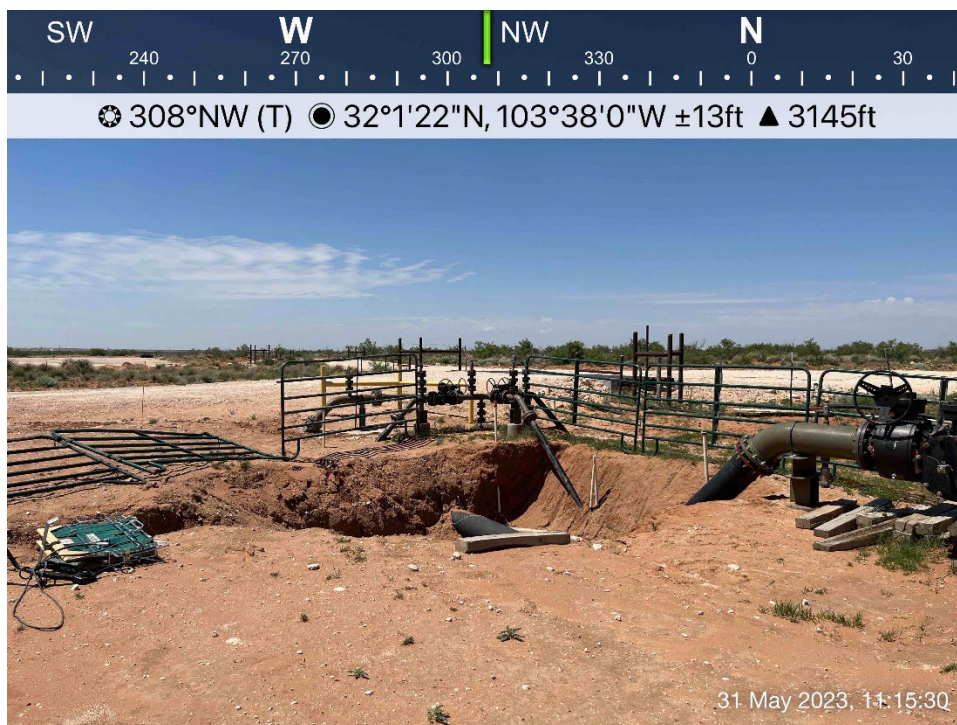
Impacted area viewing northwest, May 31, 2023

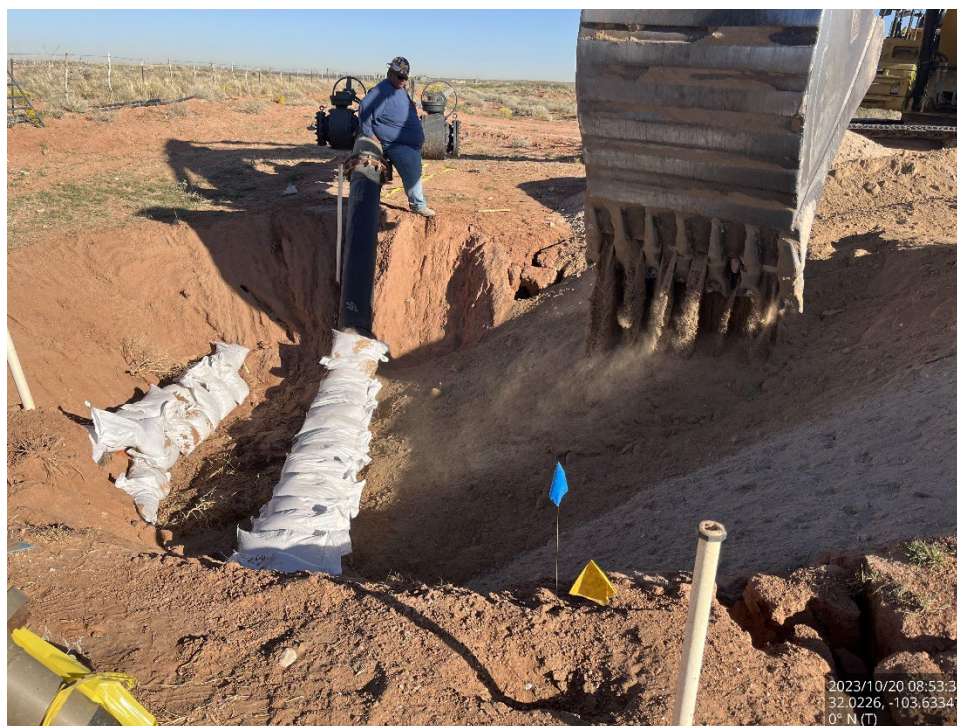
Additional excavated soil encompassing sample location C-3 and C-5 viewing north, October 20, 2023

On October 9, 2023, Warrior Technologies, LLC (Warrior), under supervision from LAI personnel utilized a hydrovac to excavate an additional one (1) foot encompassing sidewall sample locations C-3 and C-5. Contaminated soil was contained within the hydrovac and approximately fifteen (15) cubic yards was hauled to the Milestone Environmental Services disposal facility northeast of Orla, Texas. LAI personnel collected two (2) samples C-3 and C-5 and delivered them under chain of custody and preservation to the Eurofins – Xenco Laboratories (Xenco) in Midland, Texas. The laboratory analyzed the confirmation soil samples for BTEX, TPH, and chloride by EPA SW-846 Methods 8021B, 8015M, and 300.0E, respectively. The laboratory reported BTEX, TPH, and chloride in both samples below the NMOCD closure criteria.

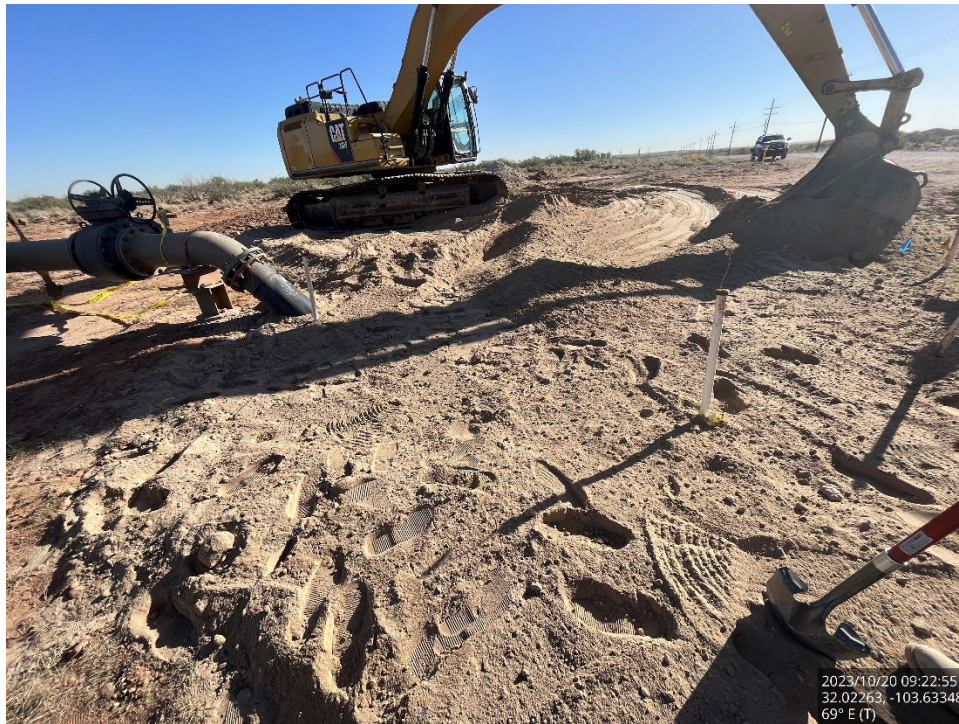
Backfilled excavation viewing east, October 20, 2023

On October 16, 2023, LAI personnel submitted an excavation backfill notice to the NMOCD. On October 19, 2023, Apeck Construction, LLC (Apeck) backfilled the excavation within the right-of-way (ROW) with clean topsoil. LAI personnel collected one (1) composite soil sample (B-F) of clean topsoil from a nearby burrow pit. Xenco analyzed the sample for BTEX, TPH, and chloride. Benzene, BTEX, and TPH were below

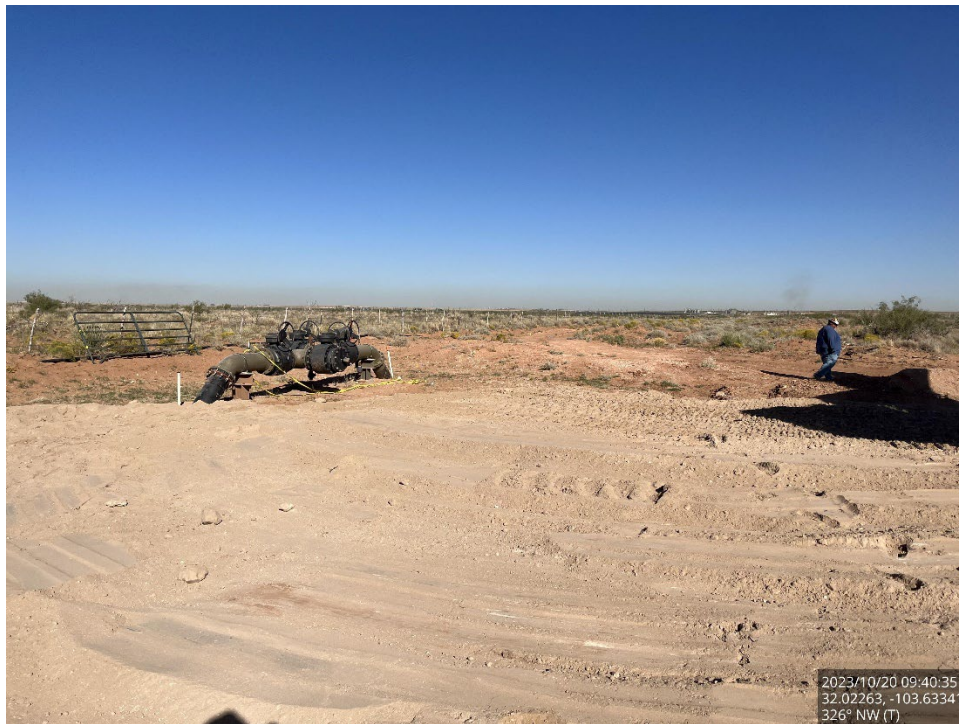
Backfilled excavation viewing northwest, October 20, 2023

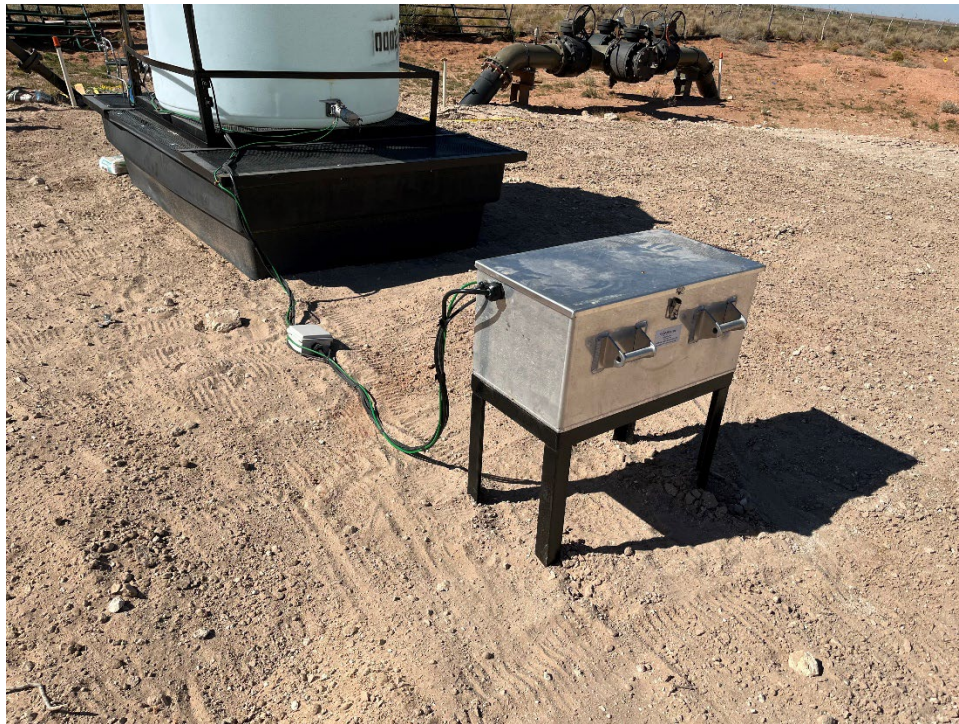
Backfilled and seeded excavation area viewing northwest, November 6, 2023

the method reporting limit (RL's) and chloride was less than 600 mg/Kg. On November 1, 2023, LAI personnel seeded the excavation area with BLM Mix #2. Table 1 presents the delineation and confirmation soil sample analytical data summary. Appendix E presents the laboratory reports. Appendix F presents the photographic documentation.

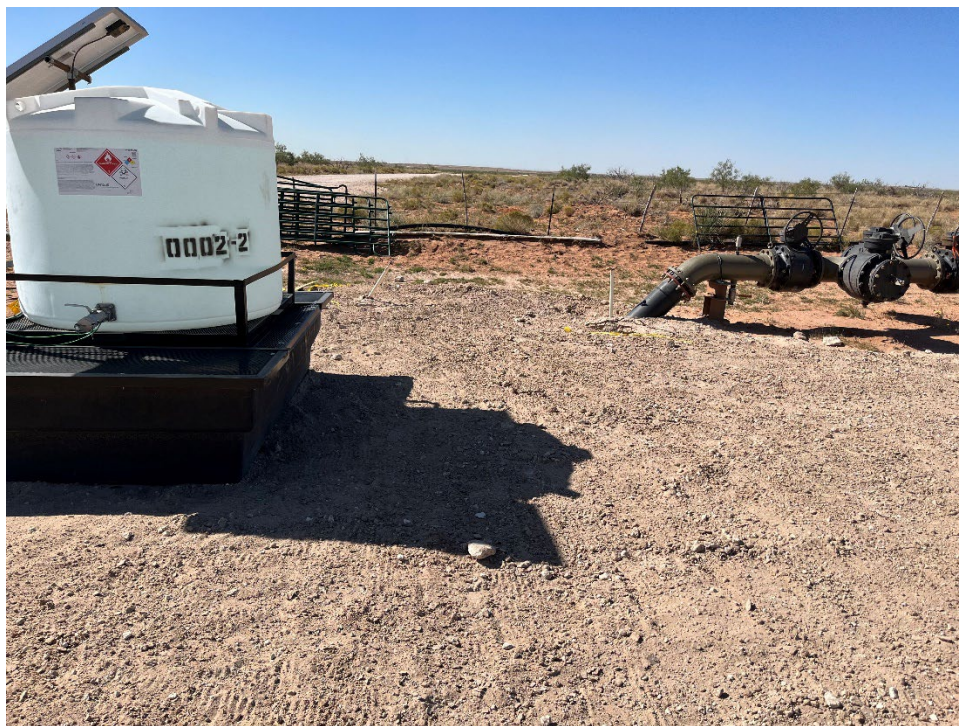
Backfilled and seeded excavation area viewing west, November 6, 2023

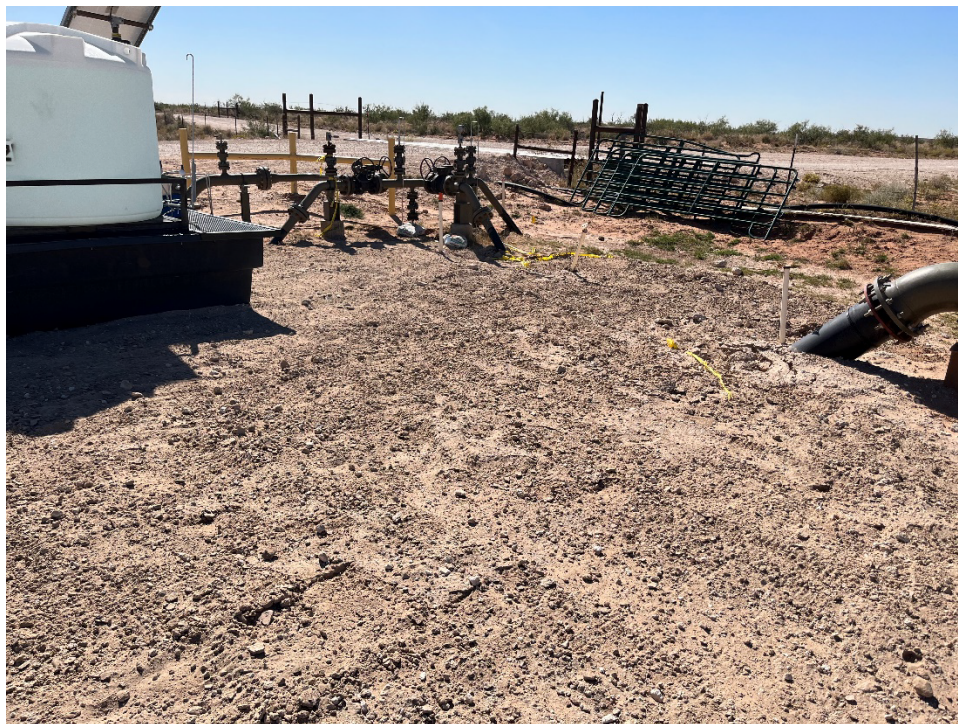
Backfilled and seeded excavation area viewing southwest, November 6, 2023
