**Earthstone Operating, LLC.  
300 N Marienfeld St., Suite 1000  
Midland, TX 79701  
432-695-4222**

May 14, 2024

**Re: Site Characterization and Remediation Closure Report  
Thunderball CTB  
API No. N/A  
GPS: Latitude 32.637162 Longitude -103.527776  
UL -- B, Sec. 26, T19S, R34E  
Lea County, NM  
NMOCD Ref. No. nAPP2412321969**

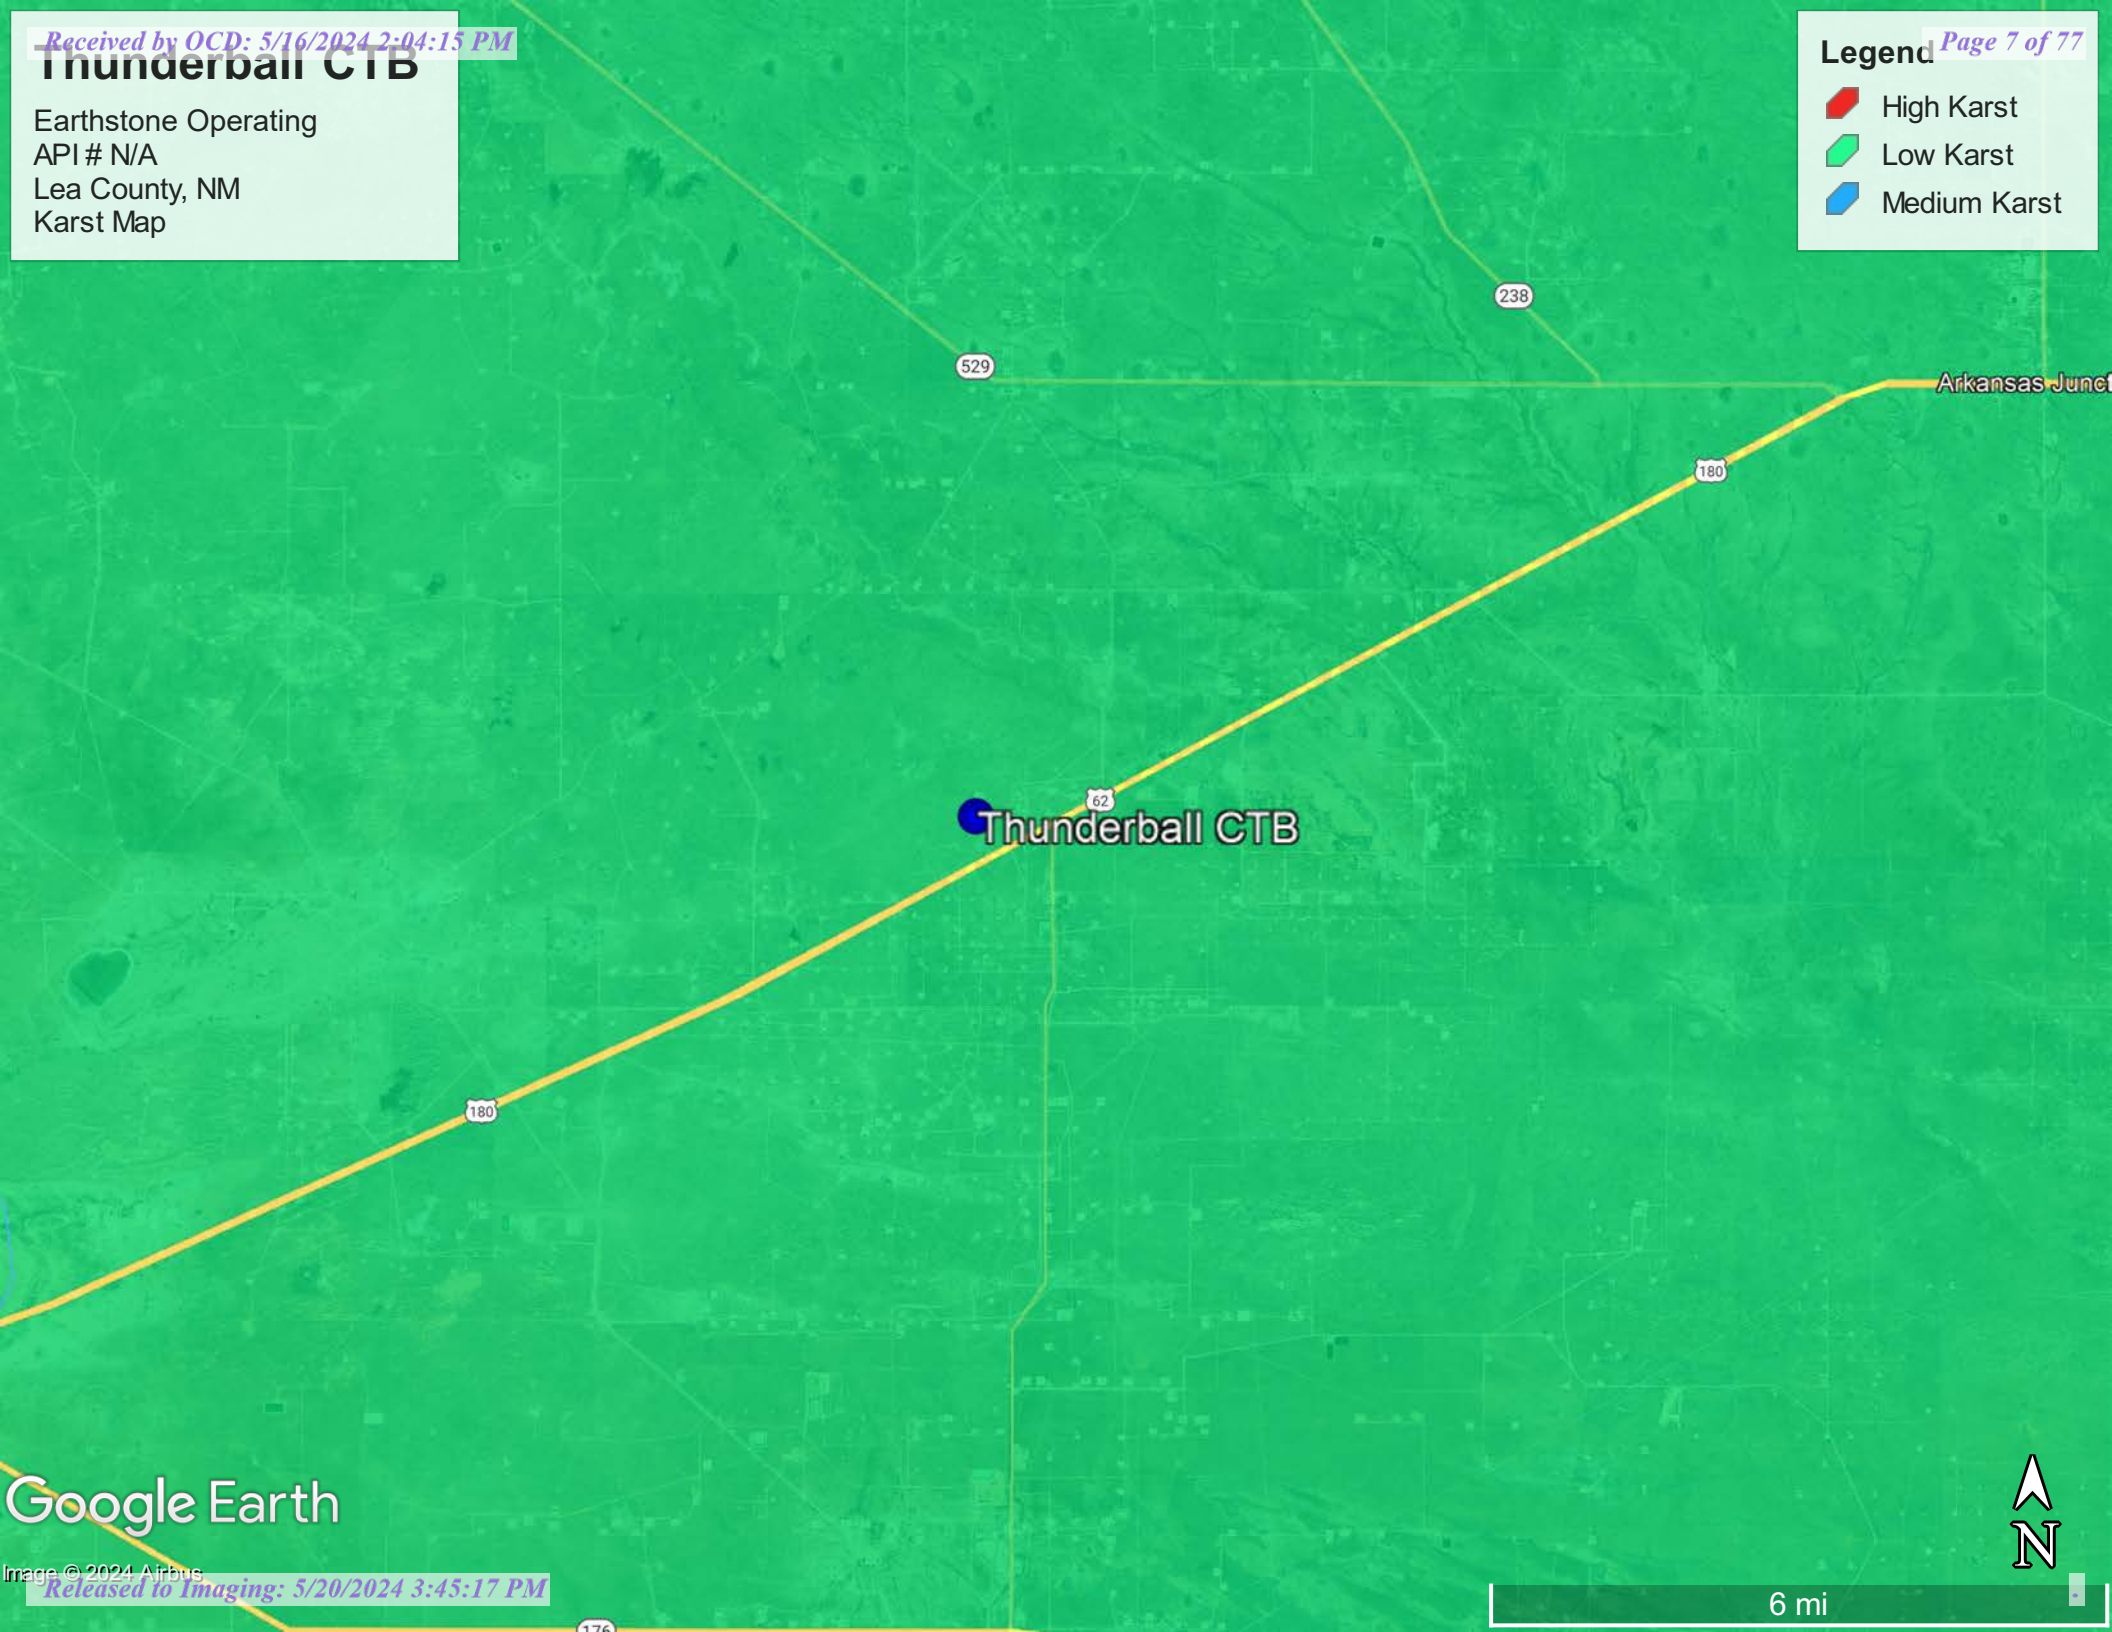
Earthstone Operating  
API # N/A  
Lea County, NM  
Karst Map

Per the New Mexico Bureau of Geology and Mineral Resources, the geology in this area is made up of eolian and piedmont deposits; Interlayered eolian sands and piedmont-slope deposits along the eastern flank of the Pecos River valley, primarily between Roswell and Carlsbad. Typically capped by thin eolian deposits. The soil in this area is made up of Kermit soils and dune land, 0 to 12 percent slopes according to the United States Department of Agriculture Natural Resources Conservation Service soil survey. The drainage class in this area is: Excessively drained (Appendix B). A Topographic Map can be found in Figure 2. The nearest surface water feature is a salt pond located approximately 10.3 miles to the southwest of this site. There is a low potential for karst geology to be present around the Thunderball (Figure 3).

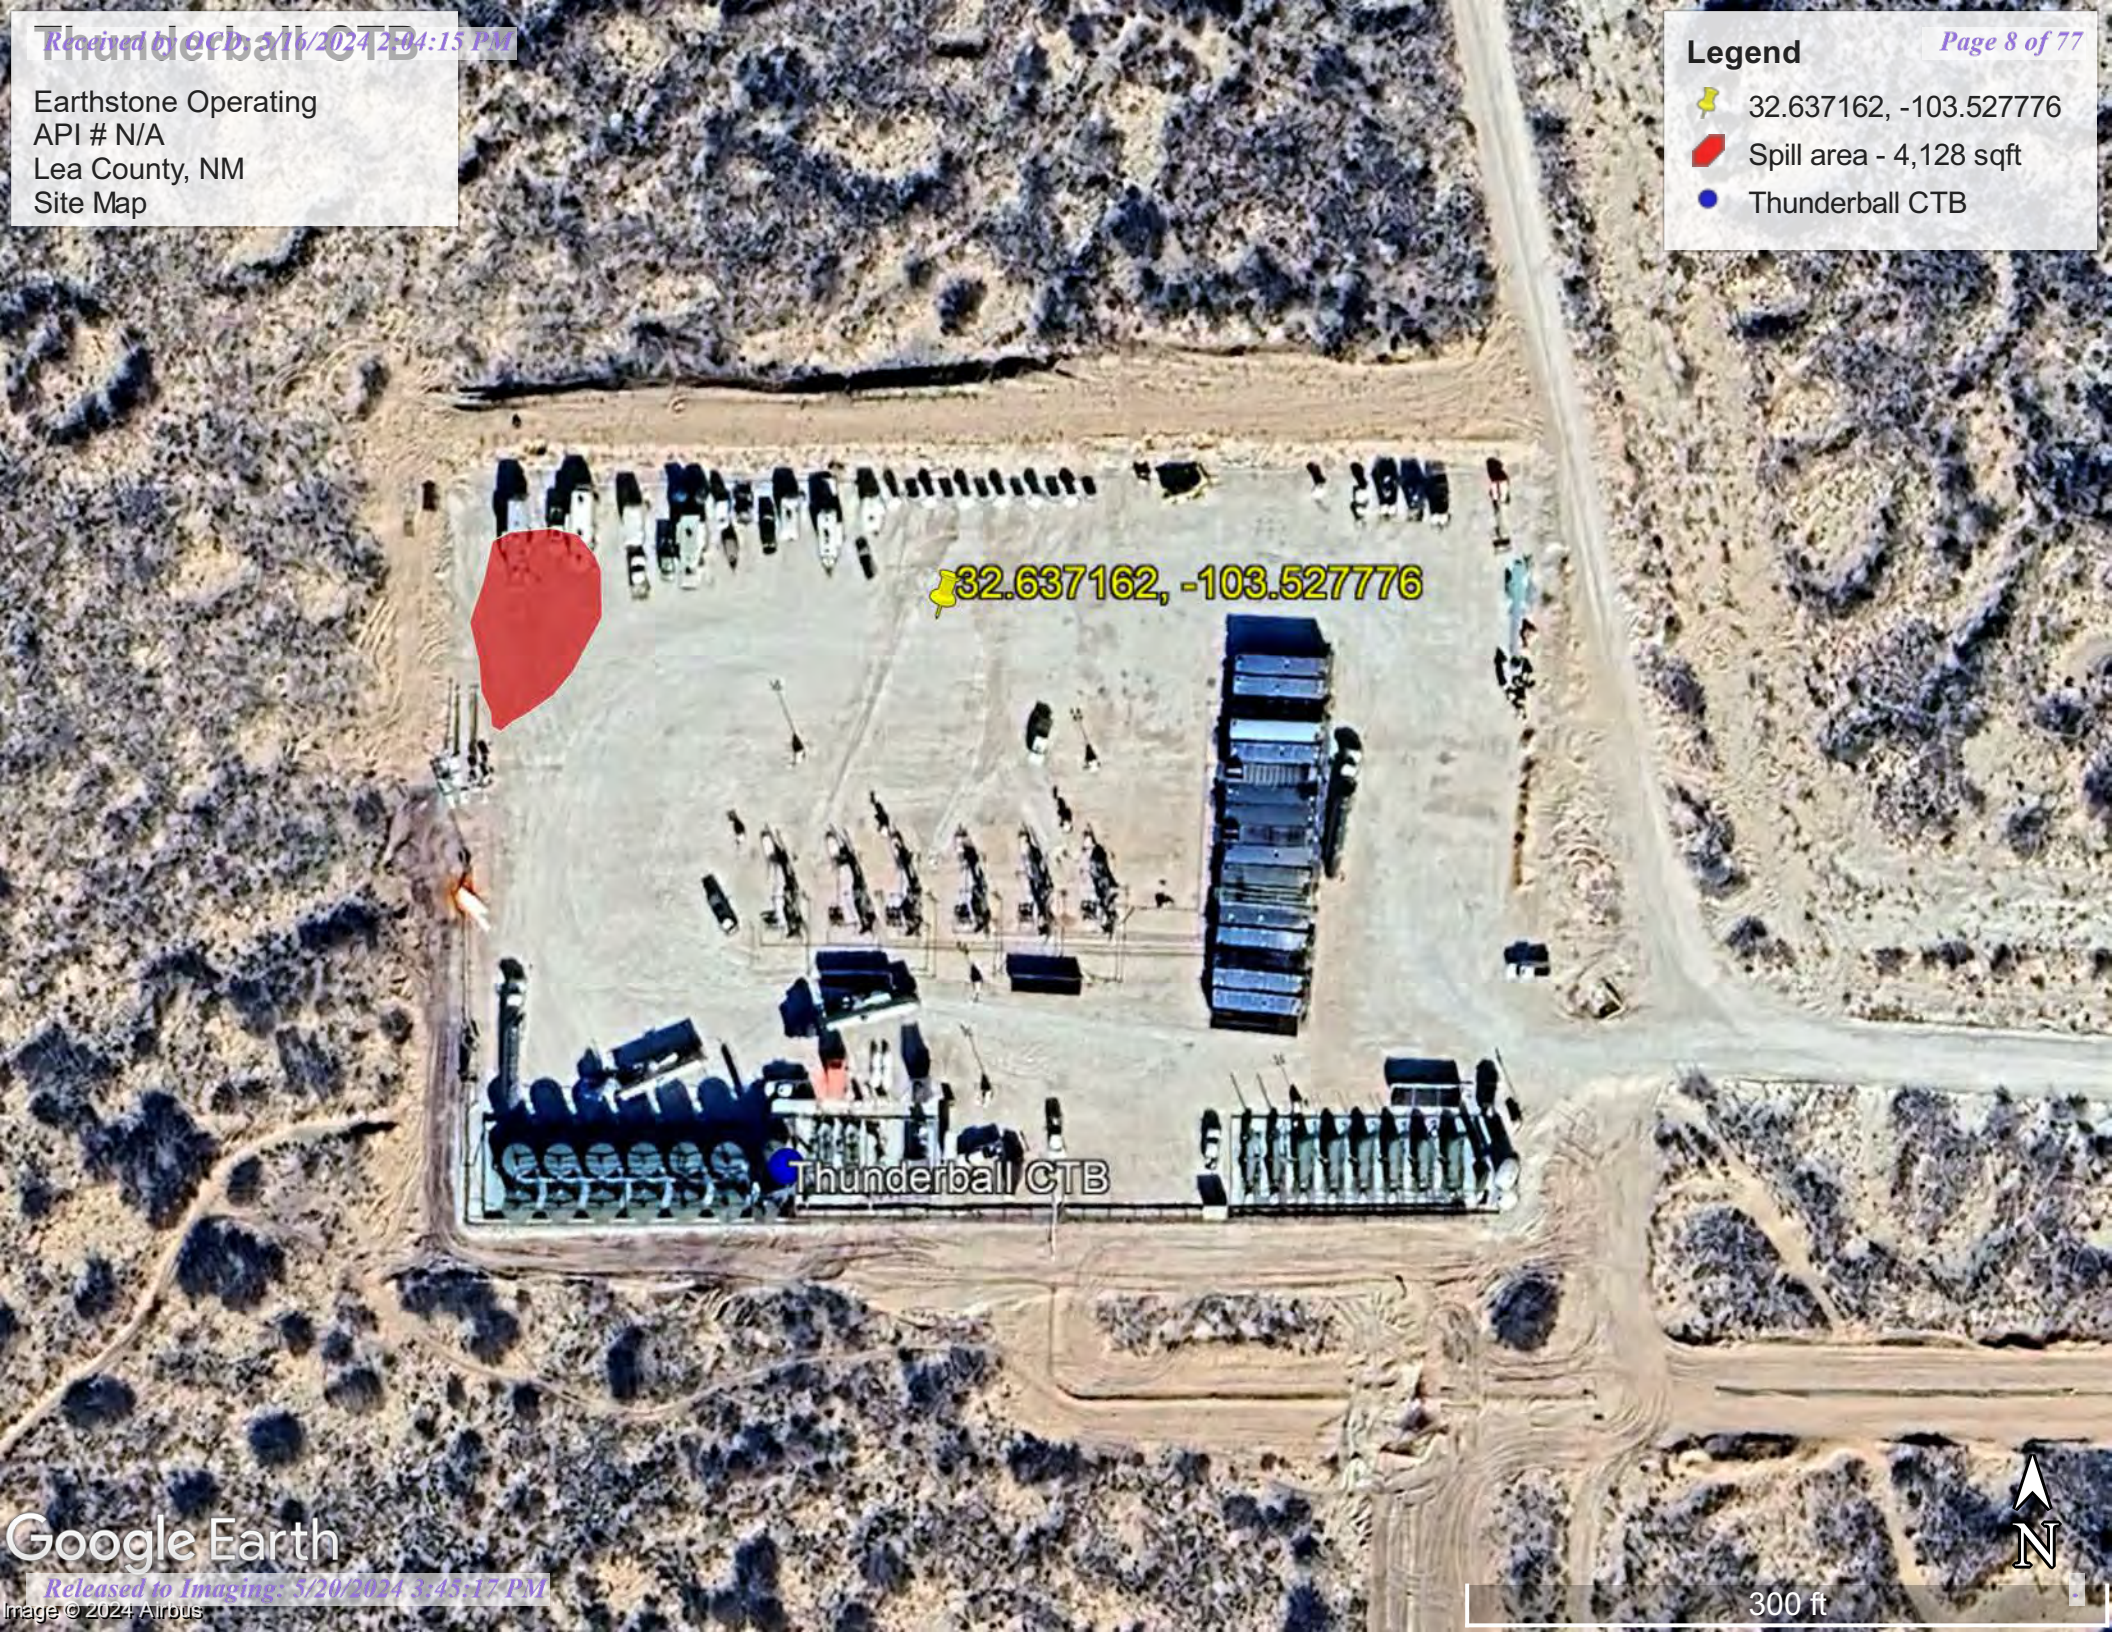
**nAPP2412321969:** On February 15, 2024, during flowback an operator routed production through a VRT but the outlet valve to the tanks was still shut resulting in the overflow of the VRT sending fluid directly to the flare. This resulted in a flash fire which was largely self-extinguished and contained to the pad. However, a forklift, which was trespassing on the location, was in the line of fire and Hobbs FD was called to extinguish the burnt forklift. Approximately 1.5 barrels (bbls) of crude oil was released and 0 bbls were recovered due to being consumed by the fire. A Site Map can be found in Figure 4.

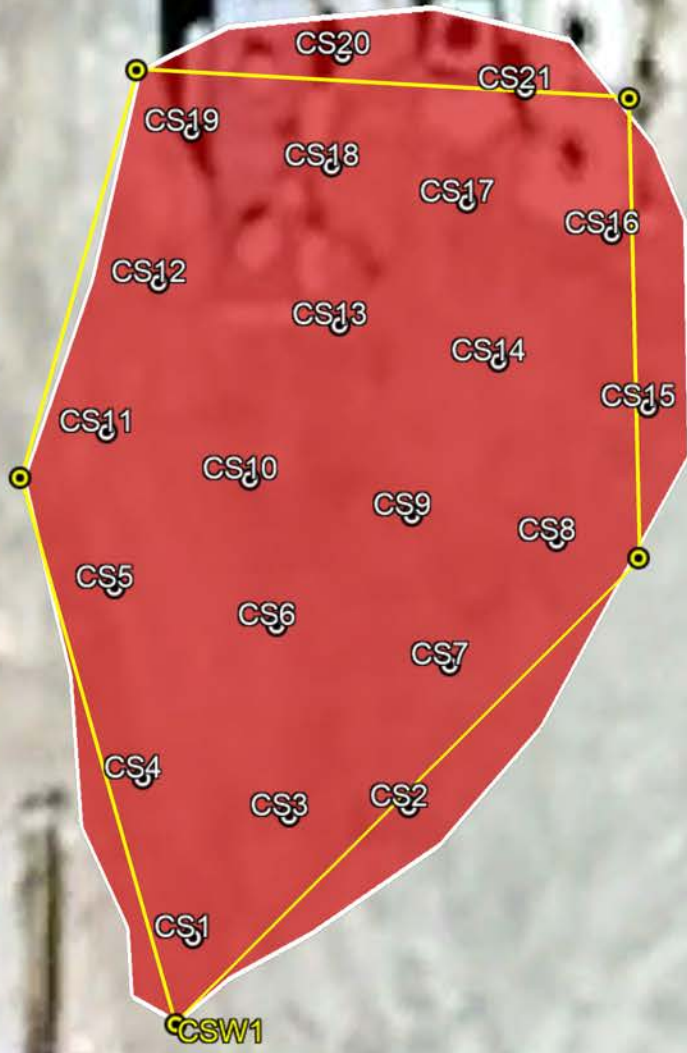
Earthstone Operating  
API # N/A  
Lea County, NM  
Confirmation Sample Map

Based on the sample results, the contamination levels are less than the regulatory limits of the <50' closure criteria in Table 1 of NMAC 19.15.29.1. A Confirmation Sample Map can be found in Figure 5. After careful review, Earthstone requests that this incident, nAPP2412321969, be closed. Earthstone has complied with the applicable closure requirements set forth in rule 19.15.19.12 NMAC.

- 5-Point Composite Base Samples
- 5-Point Composite Wall Sample
- Spill area - 4,128 sqft
