Incident ID: nAPP2227880032
REVISED REMEDIATION AND CLOSURE REPORT
Salado Draw Corridor Line 3rd Spill
Crude Oil and Produced Water Release
Lea County, New Mexico

LAI Project No. 23-0102-04

May 2, 2024

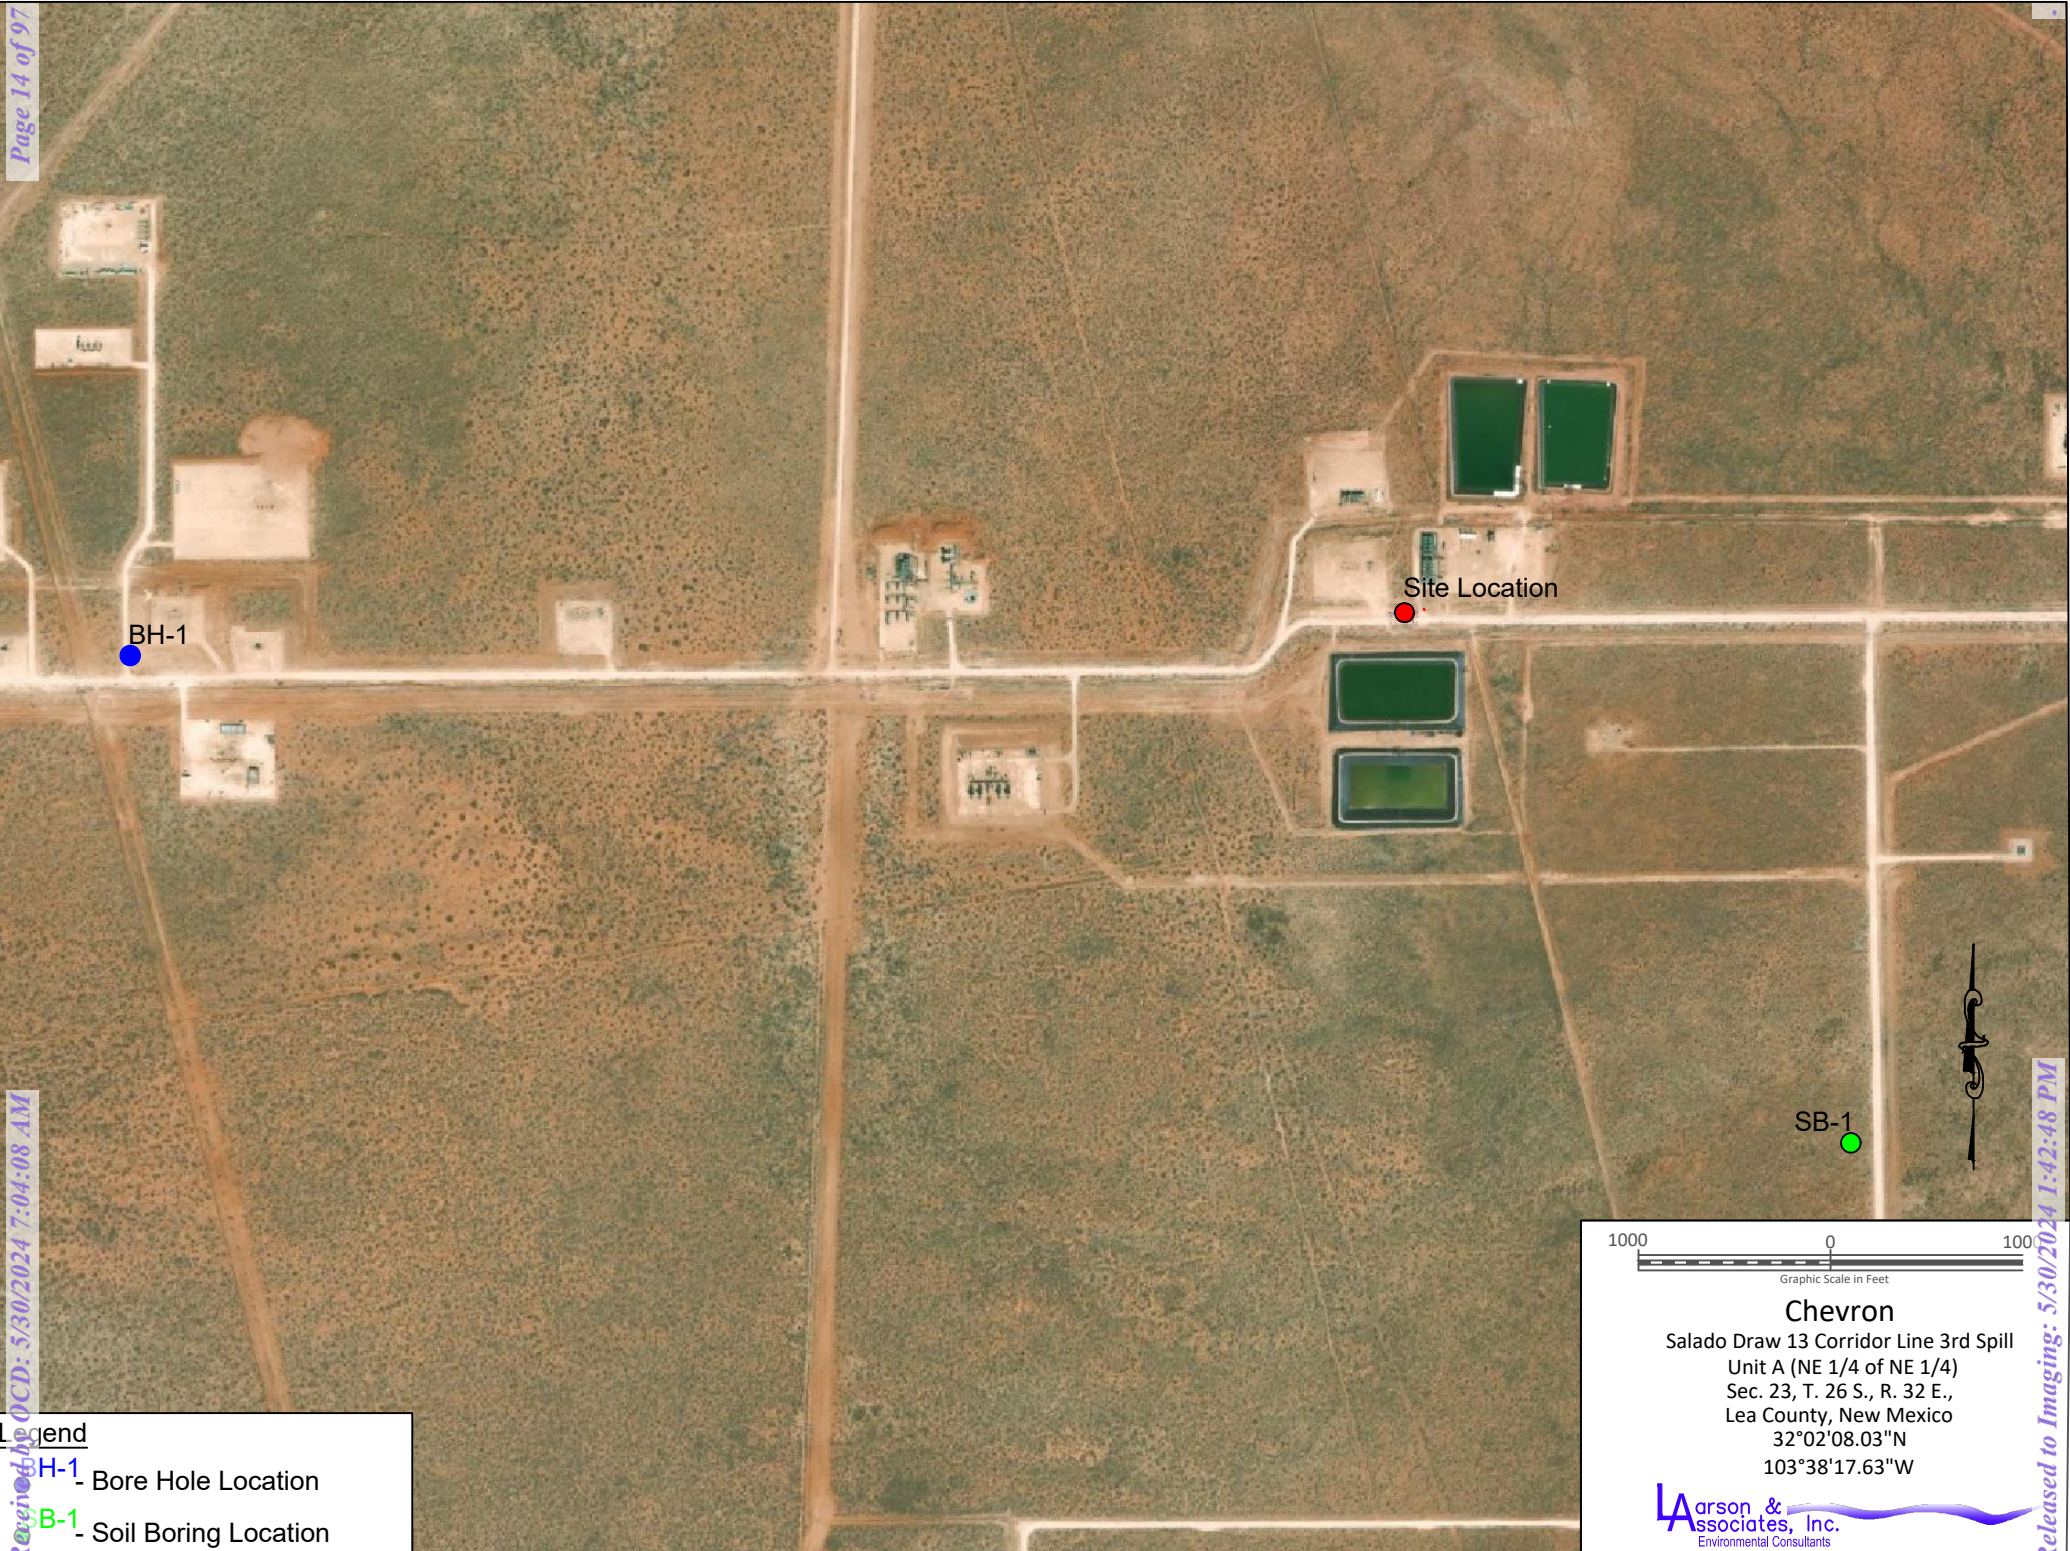
Figure 3 - Aerial Map Showing Boring Locations

- Groundwater occurs at a depth greater than 101.5 feet below ground surface (bgs), based on two dry groundwater bores, SB-1 and BH-1, located 0.68 miles southeast and 1.26 miles west of the Site, respectfully, and gauged for depth to groundwater 72 hours after completion.

- BH-1 - Bore Hole Location
- SB-1 - Soil Boring Location

Figure 3 presents an aerial map with the site location and groundwater borehole locations. Appendix B presents the groundwater borehole logs. Appendix C presents the karst potential map.

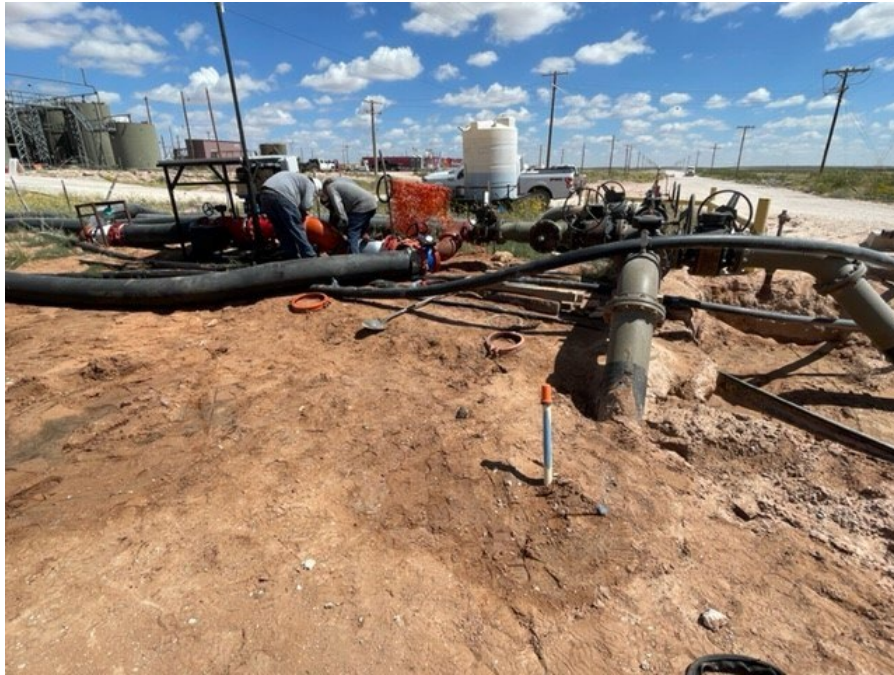
Impacted area on September 19, 2022, viewing east.

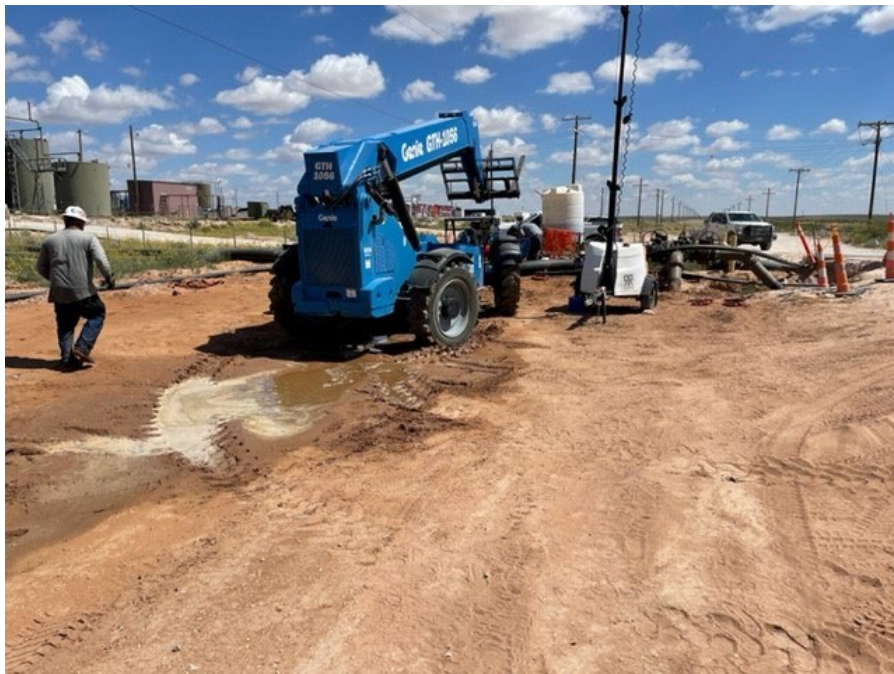
Impacted area on September 19, 2022, viewing northeast.

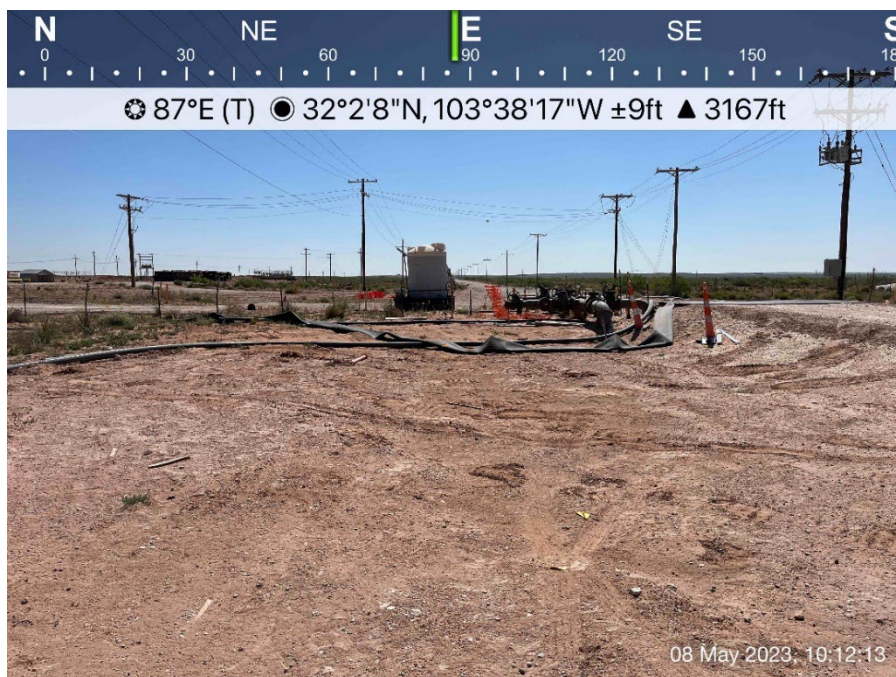
Impacted area in pasture, viewing to the east.

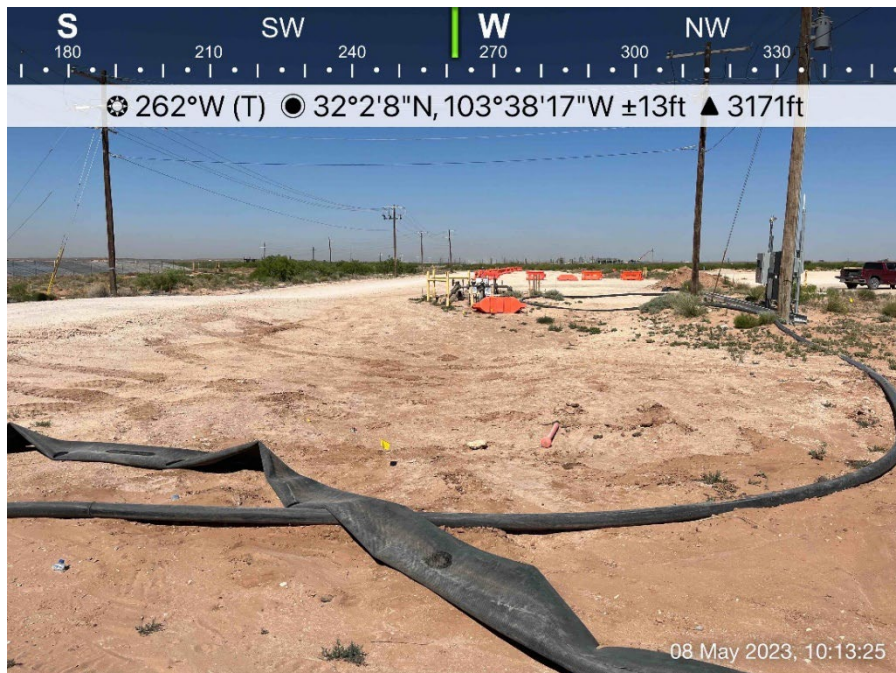
Impacted area in pasture, viewing to the west.

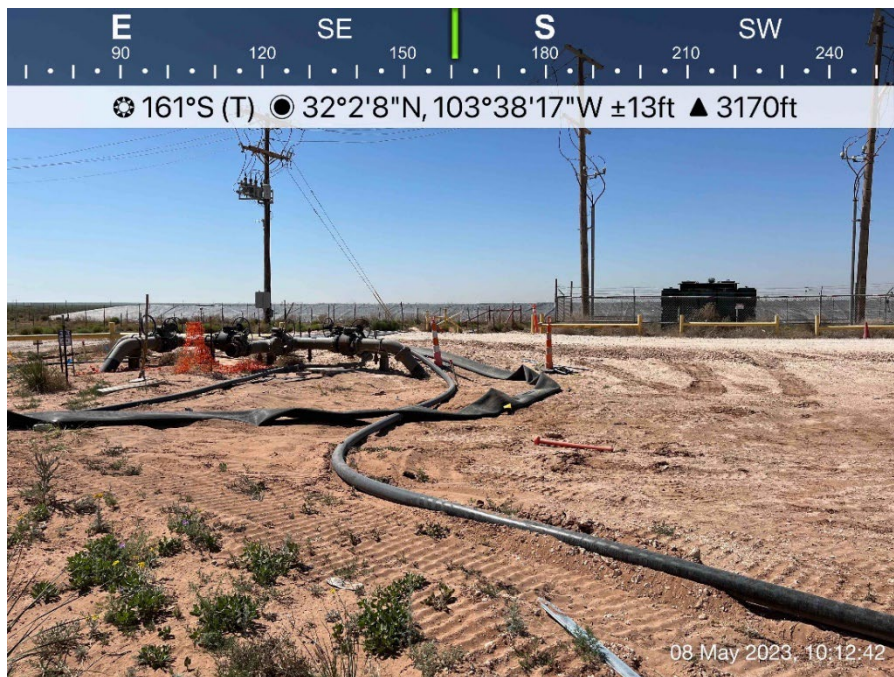
Impacted area in pasture, viewing to the south.

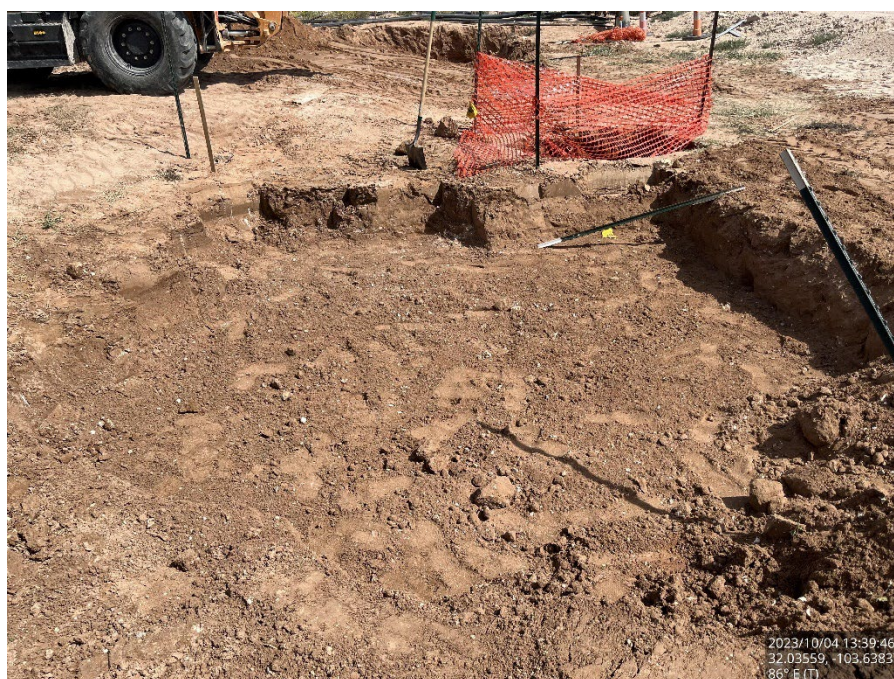
Excavated area in pasture, viewing to the east.

On October 4, 2023, R&M Trucking and Backhoe Service, LLC (R&M) under supervision for LAI personnel, used mechanical excavation methods to excavate approximately 45.1 cubic yards of impacted soil from an area of about 374 square feet. The excavated soil was disposed of at the Milestone Environmental disposal facility near Orla, Texas.

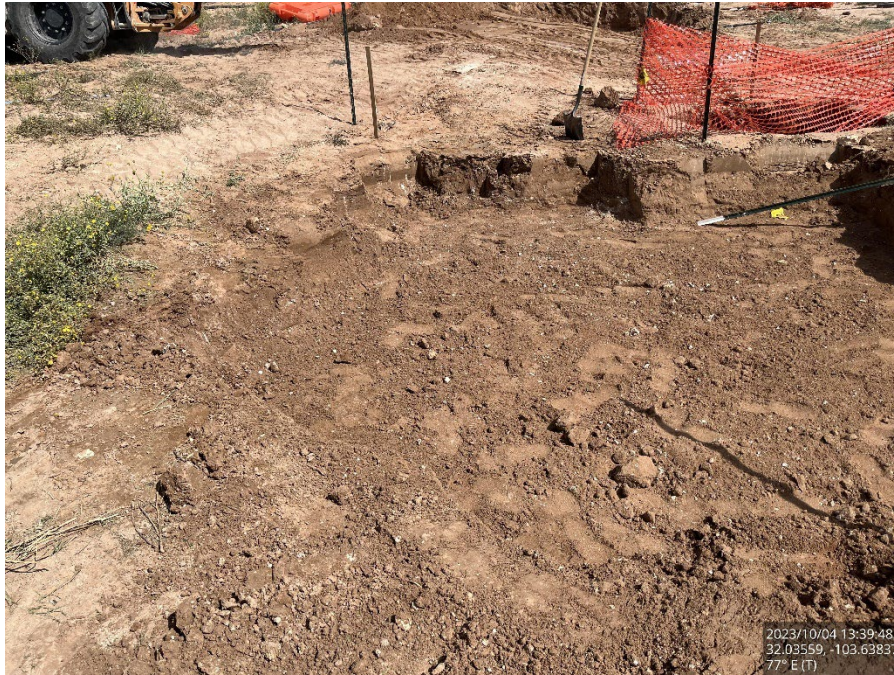
Excavated area in the pasture, viewing to the east.

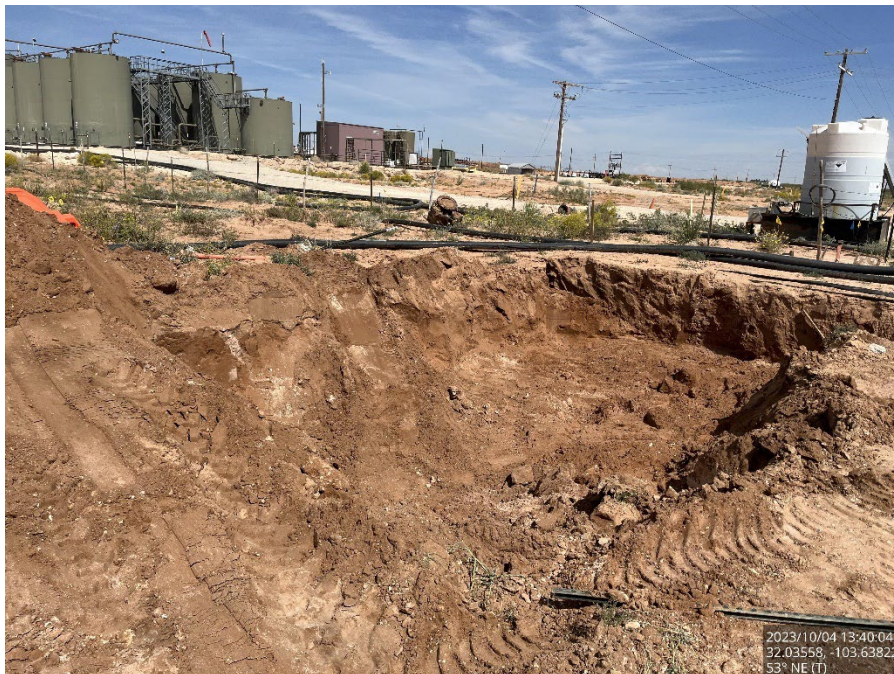
Excavated area in the pasture, viewing to the to the northeast.

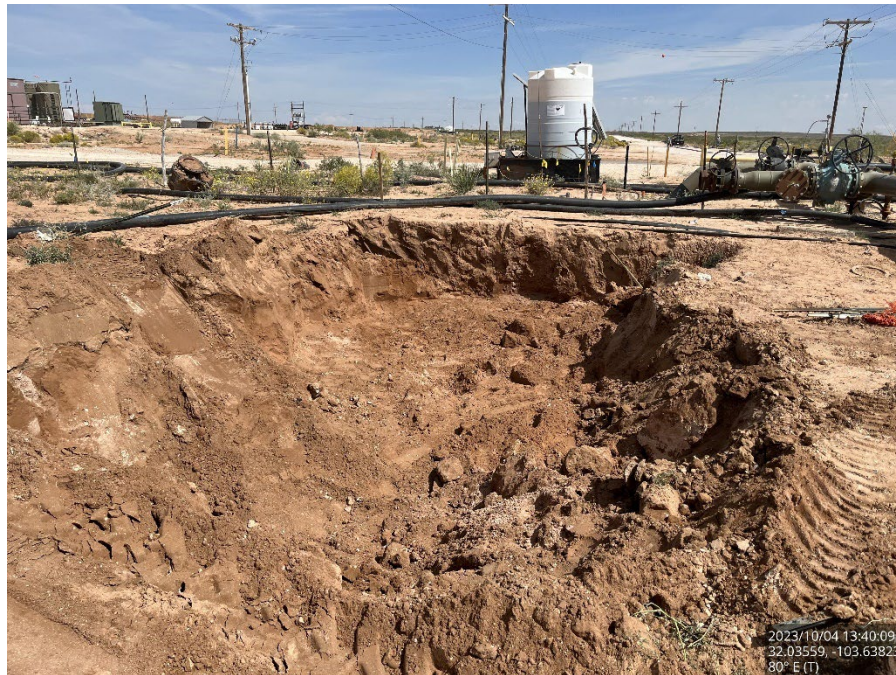
Excavated area in the pasture, viewing to the east.

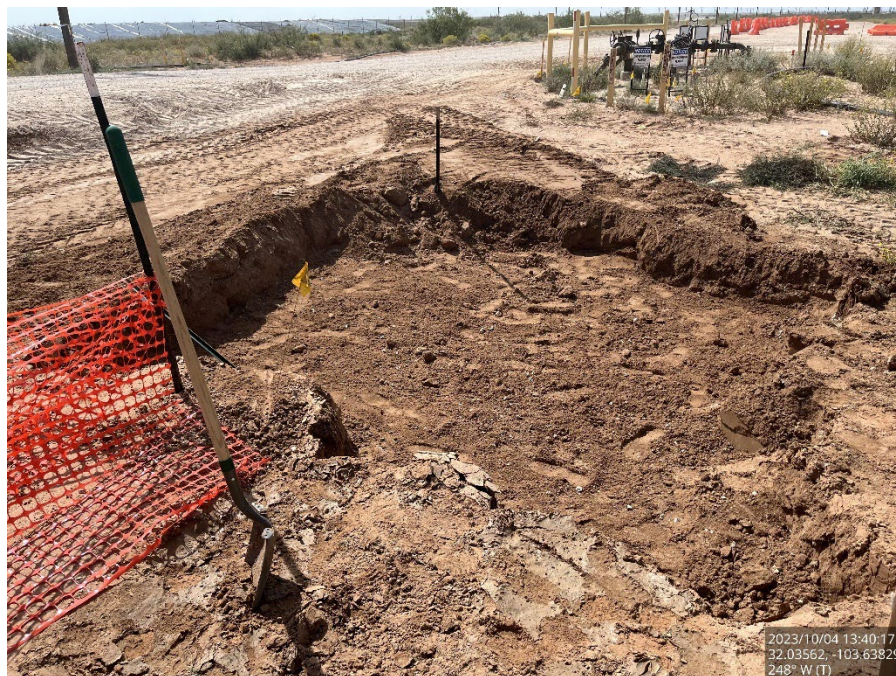
Excavated area in the pasture, viewing to the west.

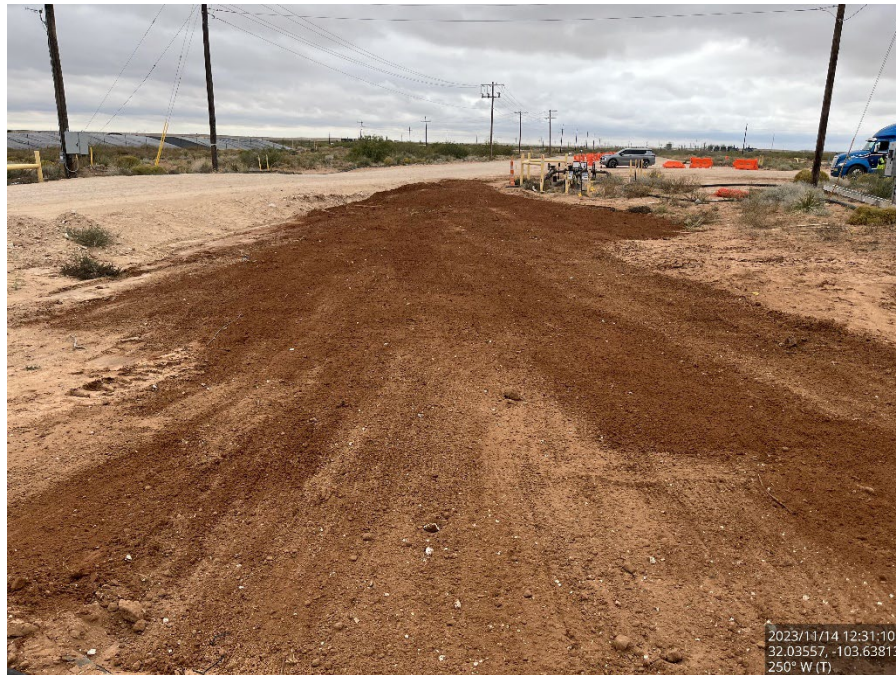
Backfilled and seed excavation, viewing to the west.

On November 14, 2023, R&M backfilled the excavation with non-waste containing backfill material from the Battle Axe Headquarters borrow pit. Additional topsoil was used to recontour offsite areas to resemble previous surface conditions. LAI personnel seeded the remediation area with BLM Mix #2. Backfill notification was provided to the NMOCD on November 16, 2023. Appendix D presents NMOCD communications. Appendix E presents the laboratory reports. Appendix F presents photographic documentation.

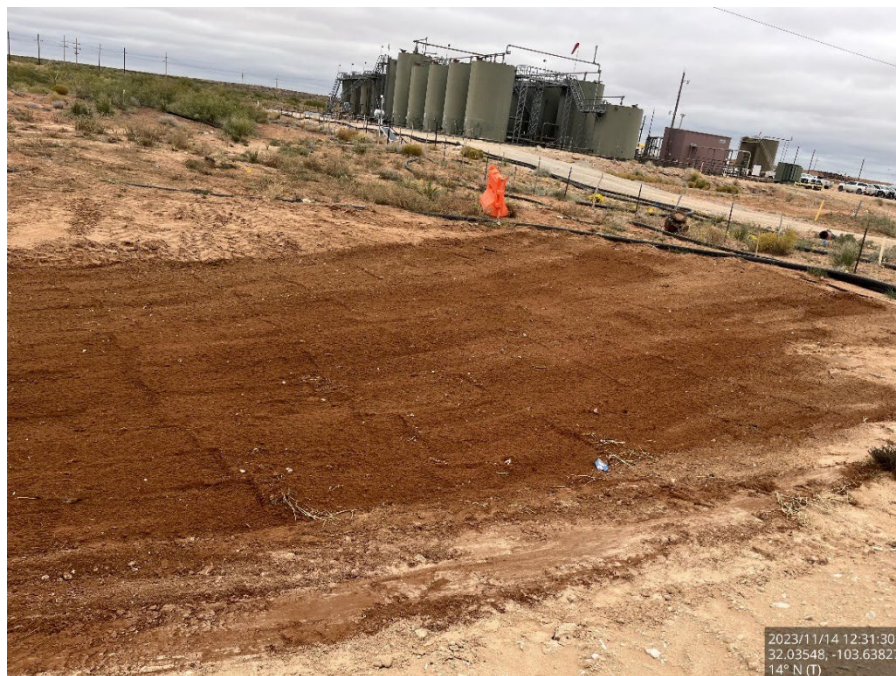
Backfilled and seeded excavation, viewing to the north.

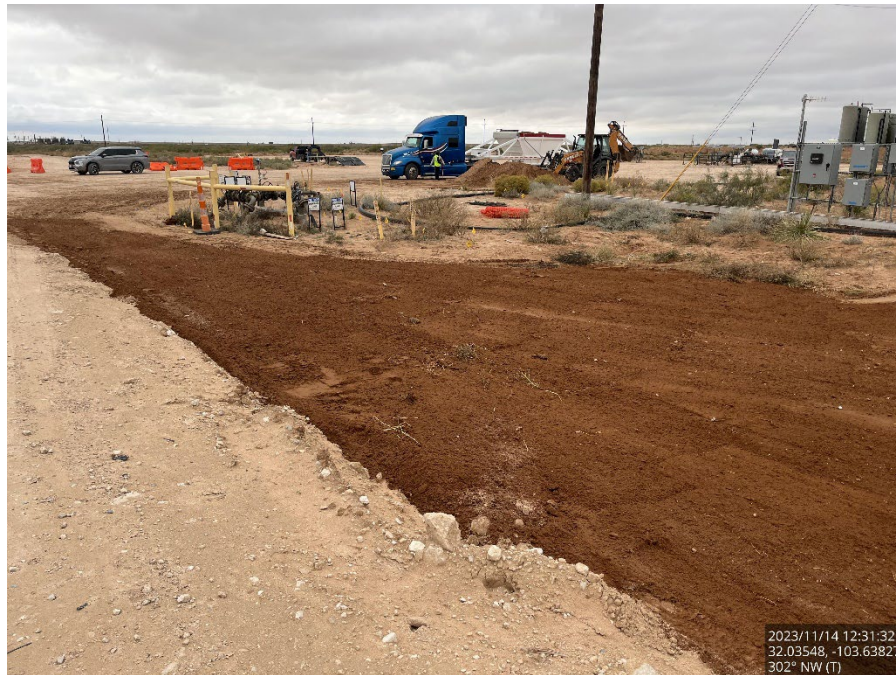
Backfilled and seeded excavation, viewing to the northwest.

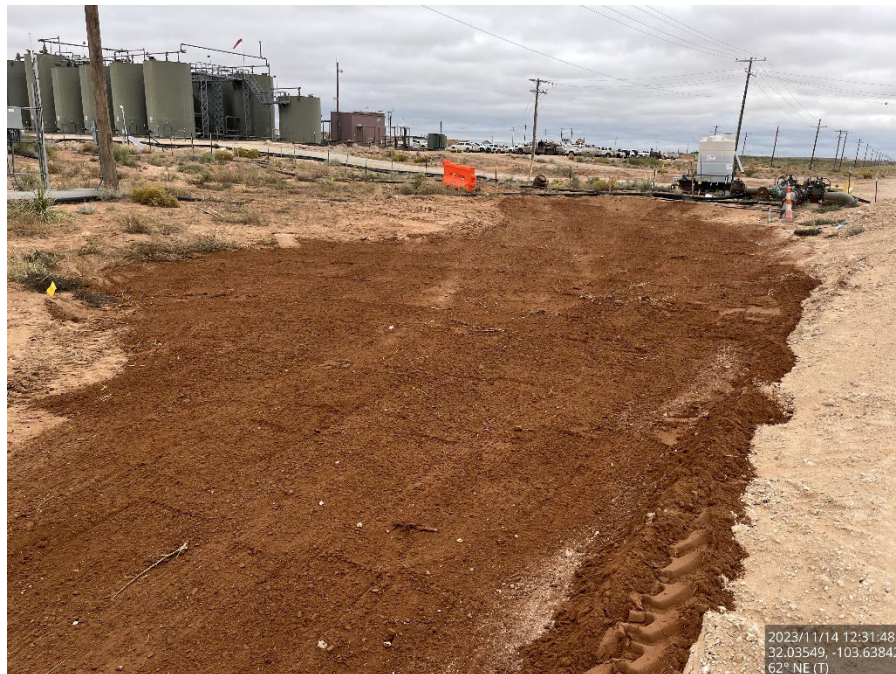
Backfilled and seeded excavation, viewing to the northeast.
