Re: Site Assessment and Closure Report
Bragg 10 Fee #1H
API No. 30-015-41462
GPS: Latitude 32.6682816 Longitude -104.3772125
UL "M", Sec. 10, T19S, R26E
Eddy County, NM
NMOCD Ref. No. nAPP2408543583

Paragon Environmental, LLC (Paragon) has been contracted by Spur Energy Partners (Spur) to perform a spill assessment, conduct remediation activities and write a closure report for the release site known as the Bragg 10 Fee #1H (Bragg). Details of the release are summarized below:

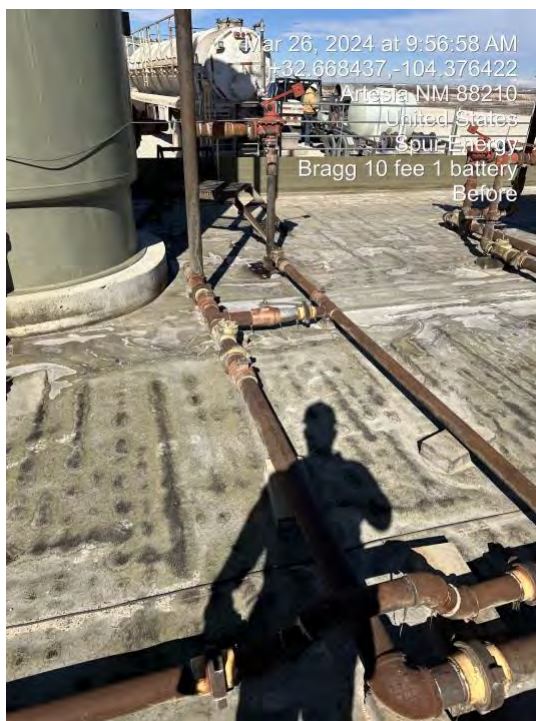
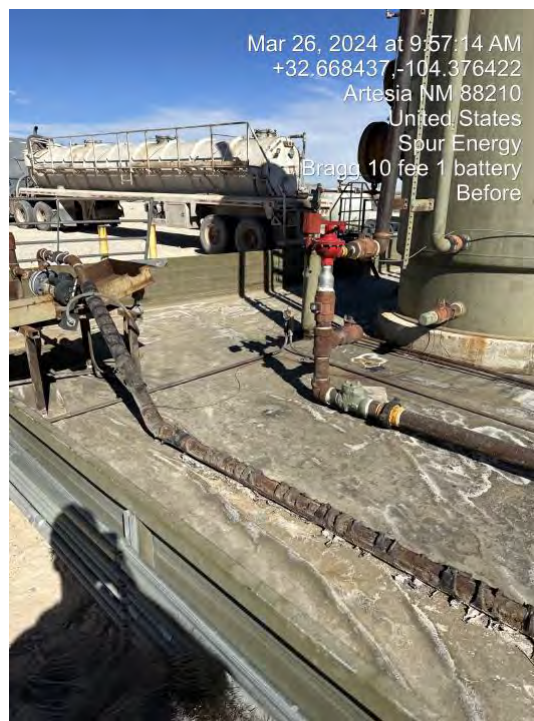
Before

On March 26, 2024, Paragon conducted a site visit to evaluate the site. Upon arrival, we found that it was a falcon lined containment. There was no evidence that any fluids had breached the containment, therefore no samples were taken. However, there was still an area of the containment that needed to be cleaned.

- We utilized a vac truck, power washer and hand crew to clean up the residue and staining of the liner.
- The surface staining affected an area measured app 930 S/F.
- After the cleaning was performed, a notification was submitted, and a liner inspection was performed to ensure the liner was intact. The liner inspection sheet can be found in Appendix C.

Comments: liner is cleaned up and looks good
