CLOSURE REQUEST REPORT

**Hayhurst 17 Federal #001H
Eddy County, New Mexico
Incident Number nRM2017141758**

**Prepared For:
Chevron USA, Inc.
6301 Deauville Blvd.
Midland, TX 79706**

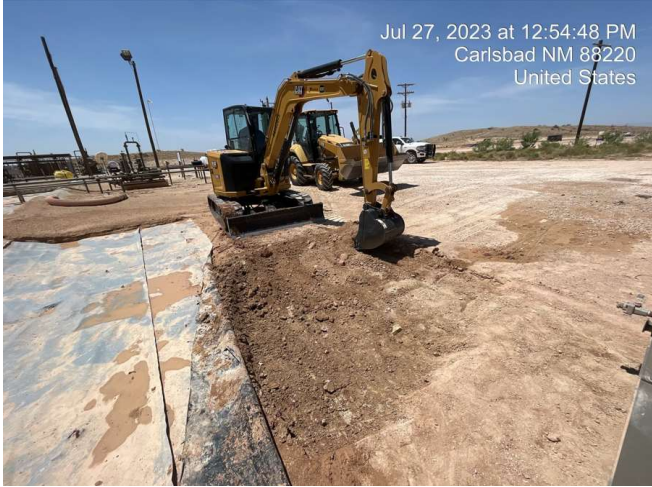
Photograph 1

Description: Southern view of excavation activities.

Between July 27, 2023, and July 28, 2023, Etech personnel conducted excavation activities via mechanical equipment based on results of laboratory analytical results for delineation soil samples and visual observations. Excavation activities were driven by field screening soil samples for volatile organic compounds (VOCs) using a photoionization detector (PID) and chloride using Hach® chloride QuanTab® test strips.

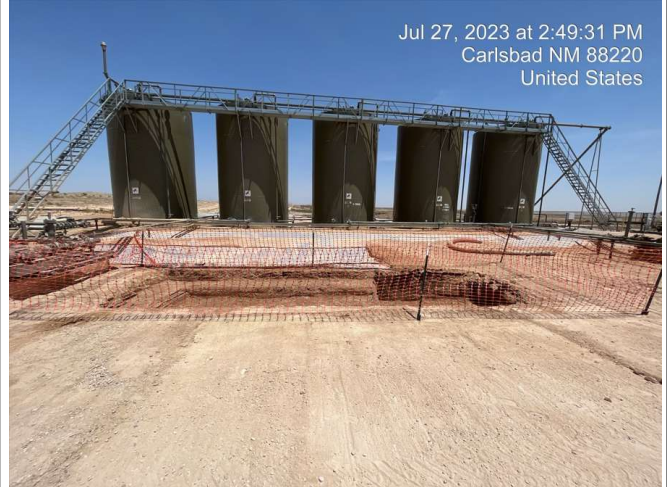
Photograph 2

Description: Eastern view of excavation activities.

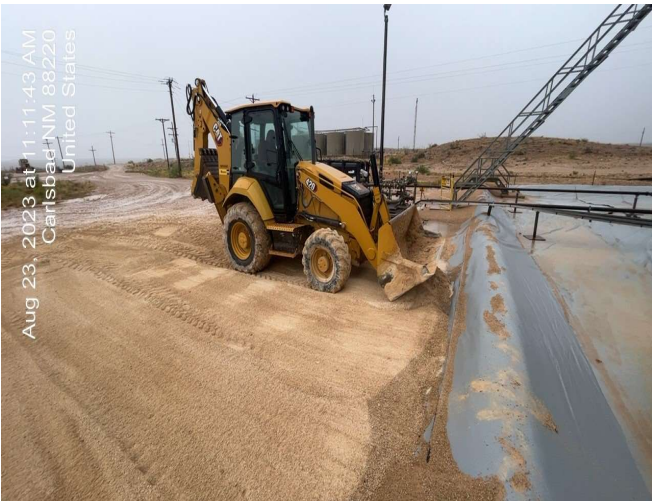
Photograph 3

Description: Northwestern view of restoration activities.
