**Re: Site Assessment, Remediation, and Closure Request**  
**Ouimet #4 State TB**  
**API No. N/A**  
**GPS: Latitude 32.86413 Longitude -104.03831**  
**UL "H", Sec. 2, T17S, R29E**  
**Eddy County, NM**  
**NMOCD Ref. No. nAPP2410048454**

Paragon Environmental, LLC (Paragon) has been contracted by Spur Energy Partners (Spur) to perform a spill assessment and conduct remediation activities for the release site known as the Ouimet #4 State TB (Ouimet). Details of the release are summarized below:

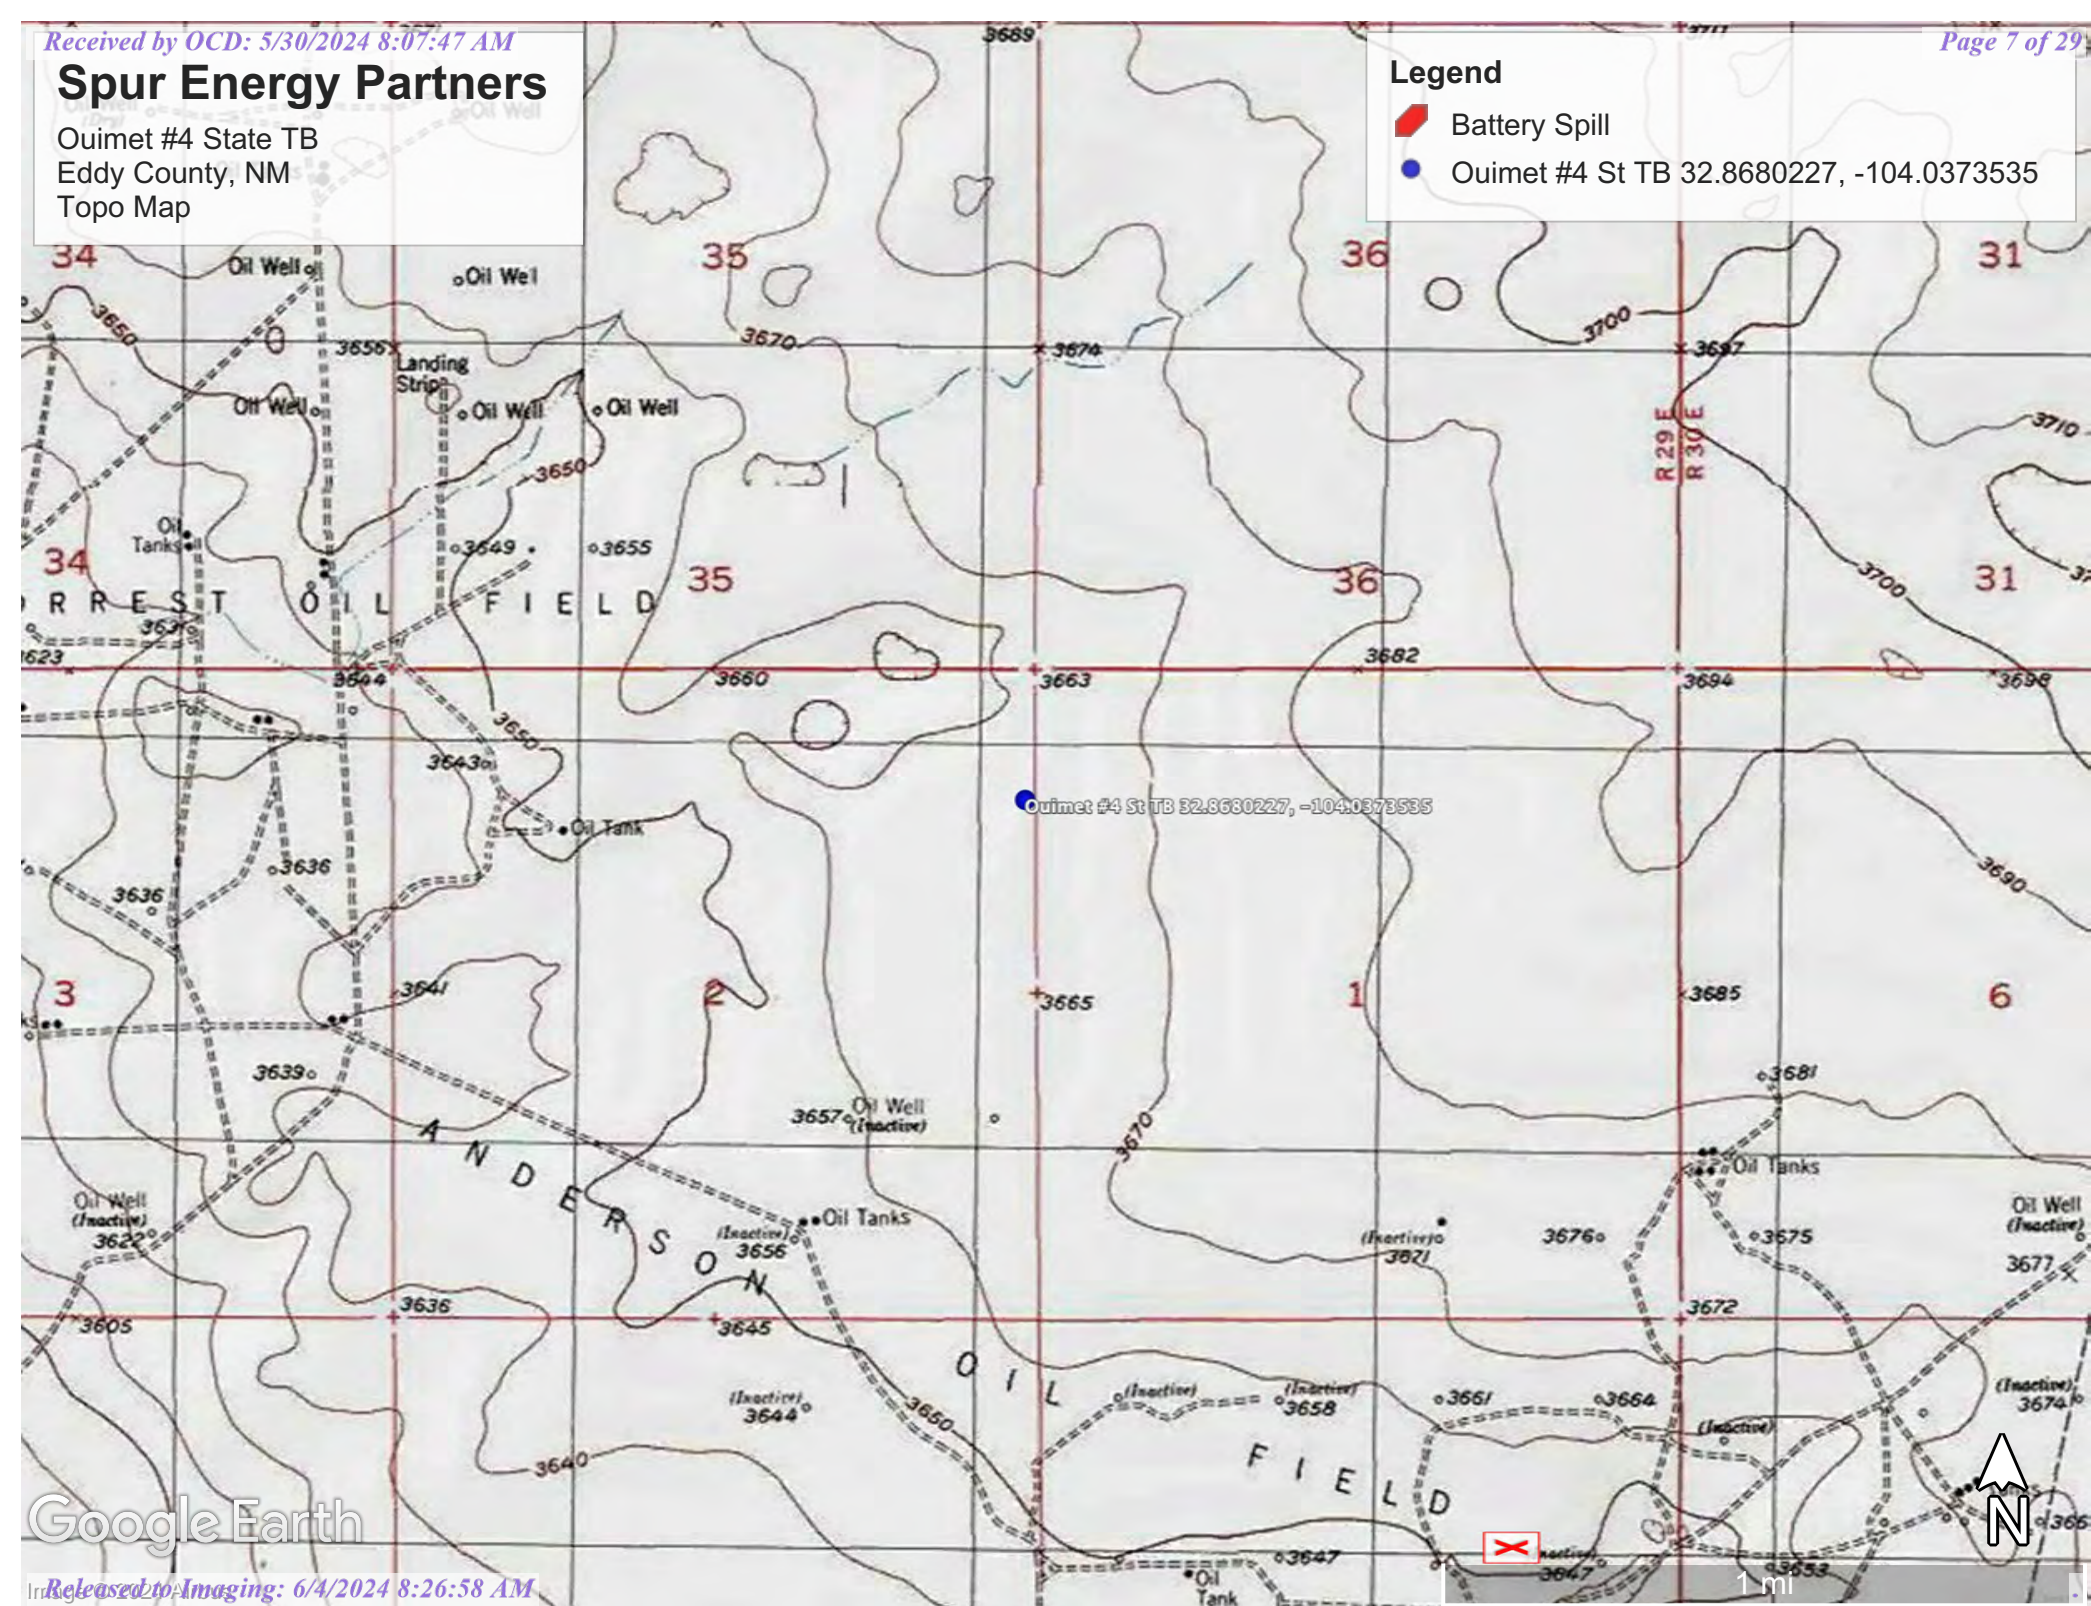
Ouimet #4 State TB  
Eddy County, NM  
Topo Map

Topographical and Aerial Maps are provided in Figures #2 and #4.

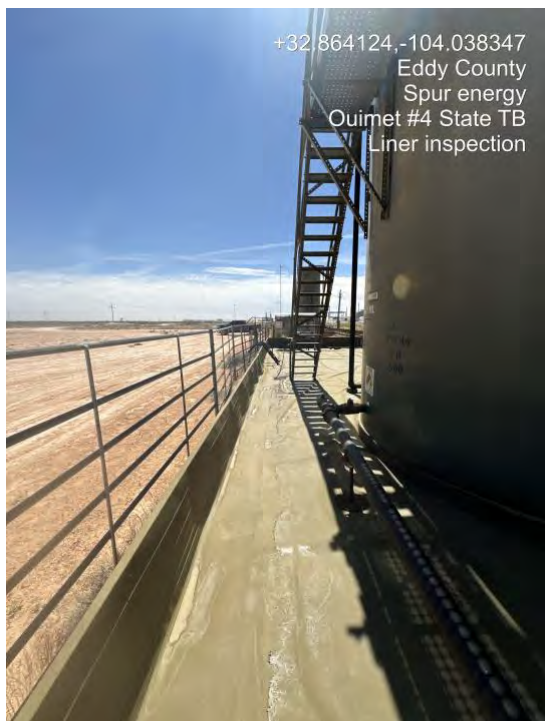
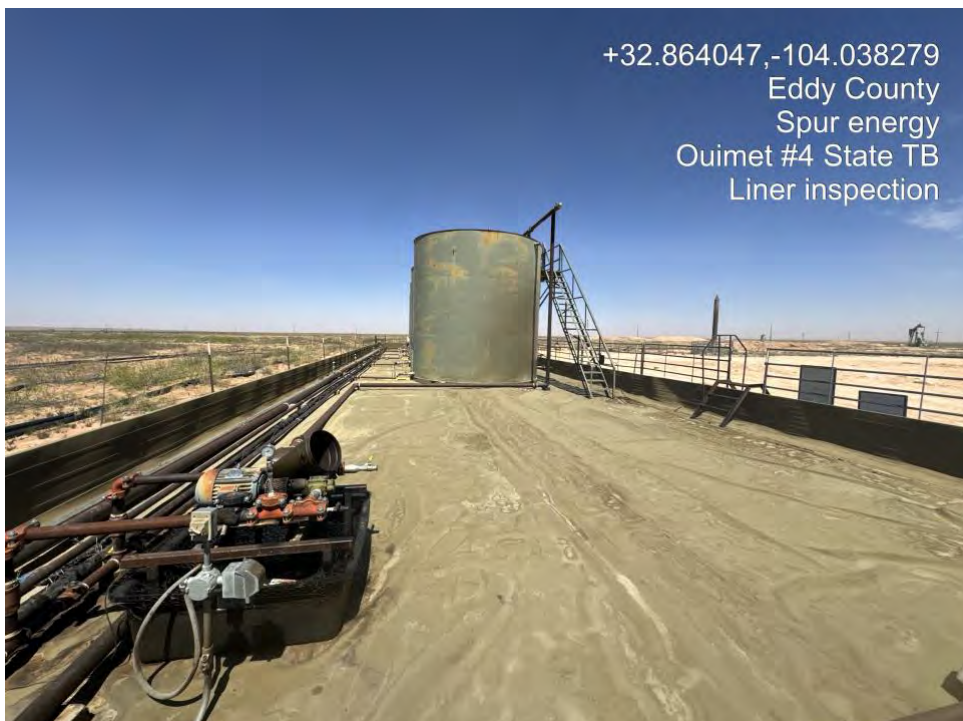
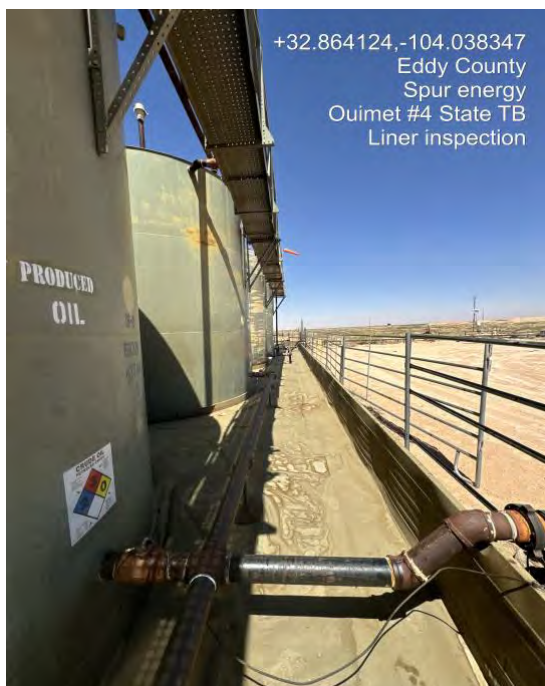
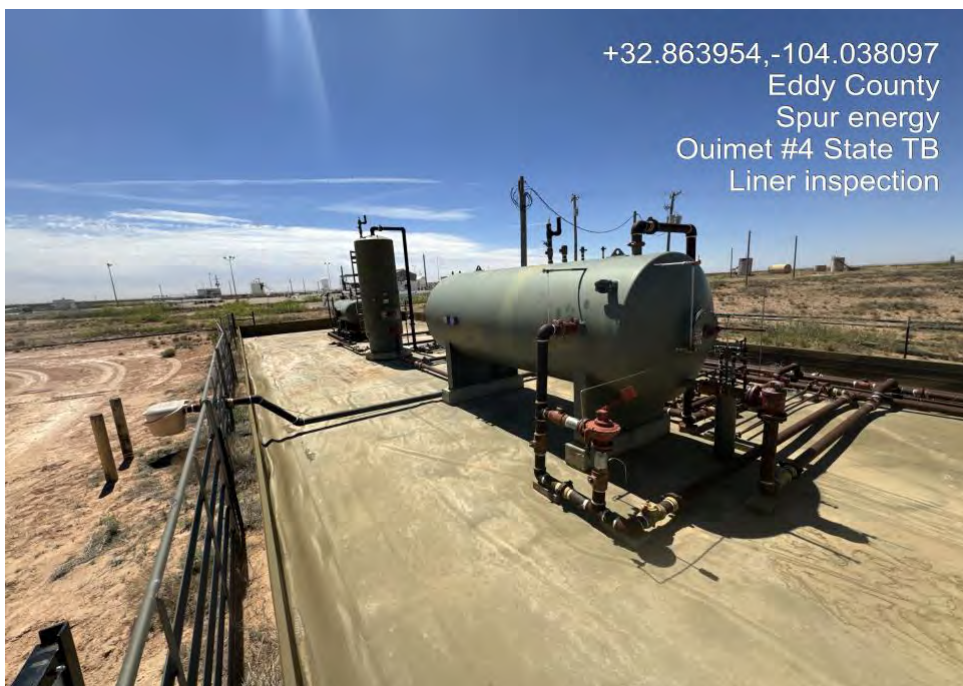
### Liner Inspection

On April 15, 2024, Paragon returned to the site to conduct a liner inspection. A 48-hour notification was sent out to the NMOCD on April 11, 2024. The liner inspection concluded that the liner was all intact and in good condition. The integrity of the liner appears to have the ability to contain spills. See Appendix C for the email notification and liner report.

Visualization	Yes	No	Comments
Is there a tear in the liner?		X	
Are there holes in the liner?		X	
Is the liner retaining any fluids?		X	
Does the liner have integrity to contain a leak?	X

Comments: Liner is in good condition.\_\_\_\_\_
