**Devon Energy Production Company, LP.  
6488 Seven Rivers HWY  
Artesia, NM 88210  
575-748-0167**

**Re: Site Characterization and Remediation Plan Report  
Regulus 26 Fed 5H Wellpad  
API No. 30-015-42489  
GPS: Latitude 32.637432 Longitude -103.833465  
UL -- A, Sec. 26, T19S, R31E Eddy County, NM  
NMOCD Incident IDs. nRM2026532878 & nAPP2118853816**

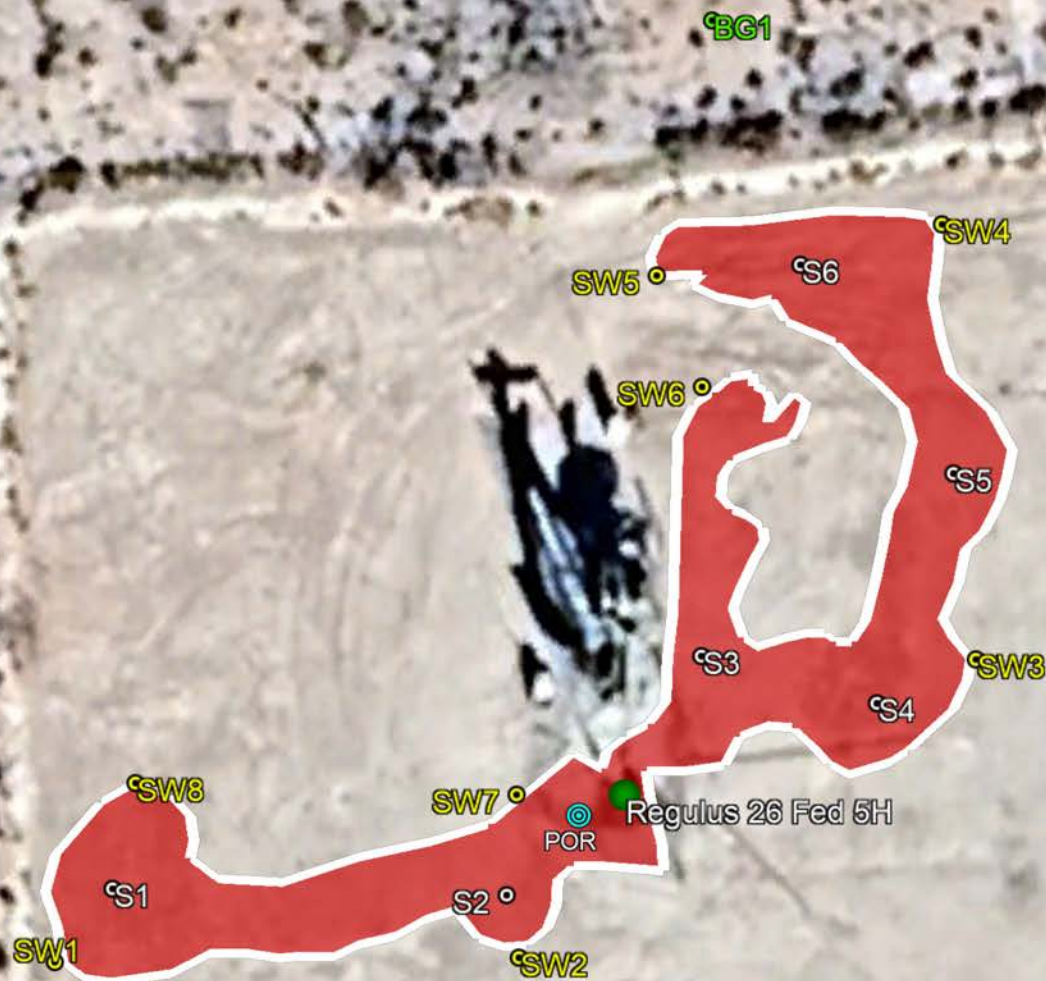
**nAPP2118853816:** On June 16, 2021, a valve washed out on well causing fluid release. Approximately 20.42 barrels (bbls) of produced water was released and 20 bbls were recovered via vacuum truck. A Site Map can be found in Figure 4.

- BG1
- Horizontal Delineation Samples
- POR
- Spill Area - 4,291 sqft
- Vertical Delineation Samples

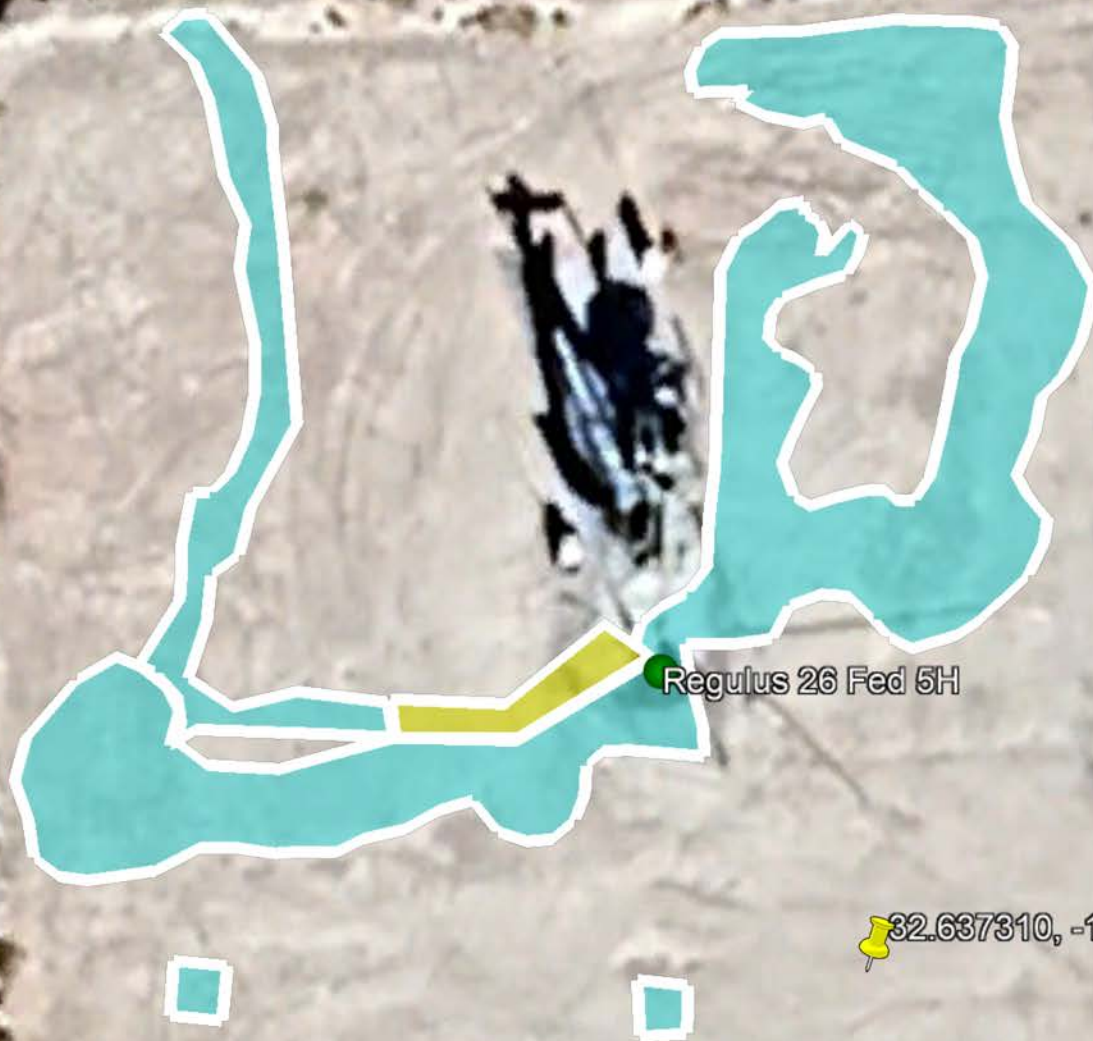
- Submit a one-call through the NM811 system.
- The estimated total combined volume of soil to be remediated is approximately 208 cubic yards. Approximately 1' of soil will be excavated from a 4,988 square foot area. Approximately 3' of soil will be excavated from a 204 square foot area. A Combined Excavation Map can be found in Figure 5.

3' Excavation - 204 sqft 23 cuys

**nRM2026532878**: On behalf of Devon Energy, Pima proposes to excavate the previously SA1000 treated soil, and haul it to an approved, lined disposal facility. Clean, fresh backfill material will be brought back to the site to backfill the excavated area. Further details can be found below as this excavation will be combined with the excavation for nAPP2118853816.
