303 Veterans Airpark Lane Midland, TX 79705

## **Remediation Plan**

Re: NEDU 613  
Case nAPP240744539

Attachment: Closure Report Dated October 25, 2019

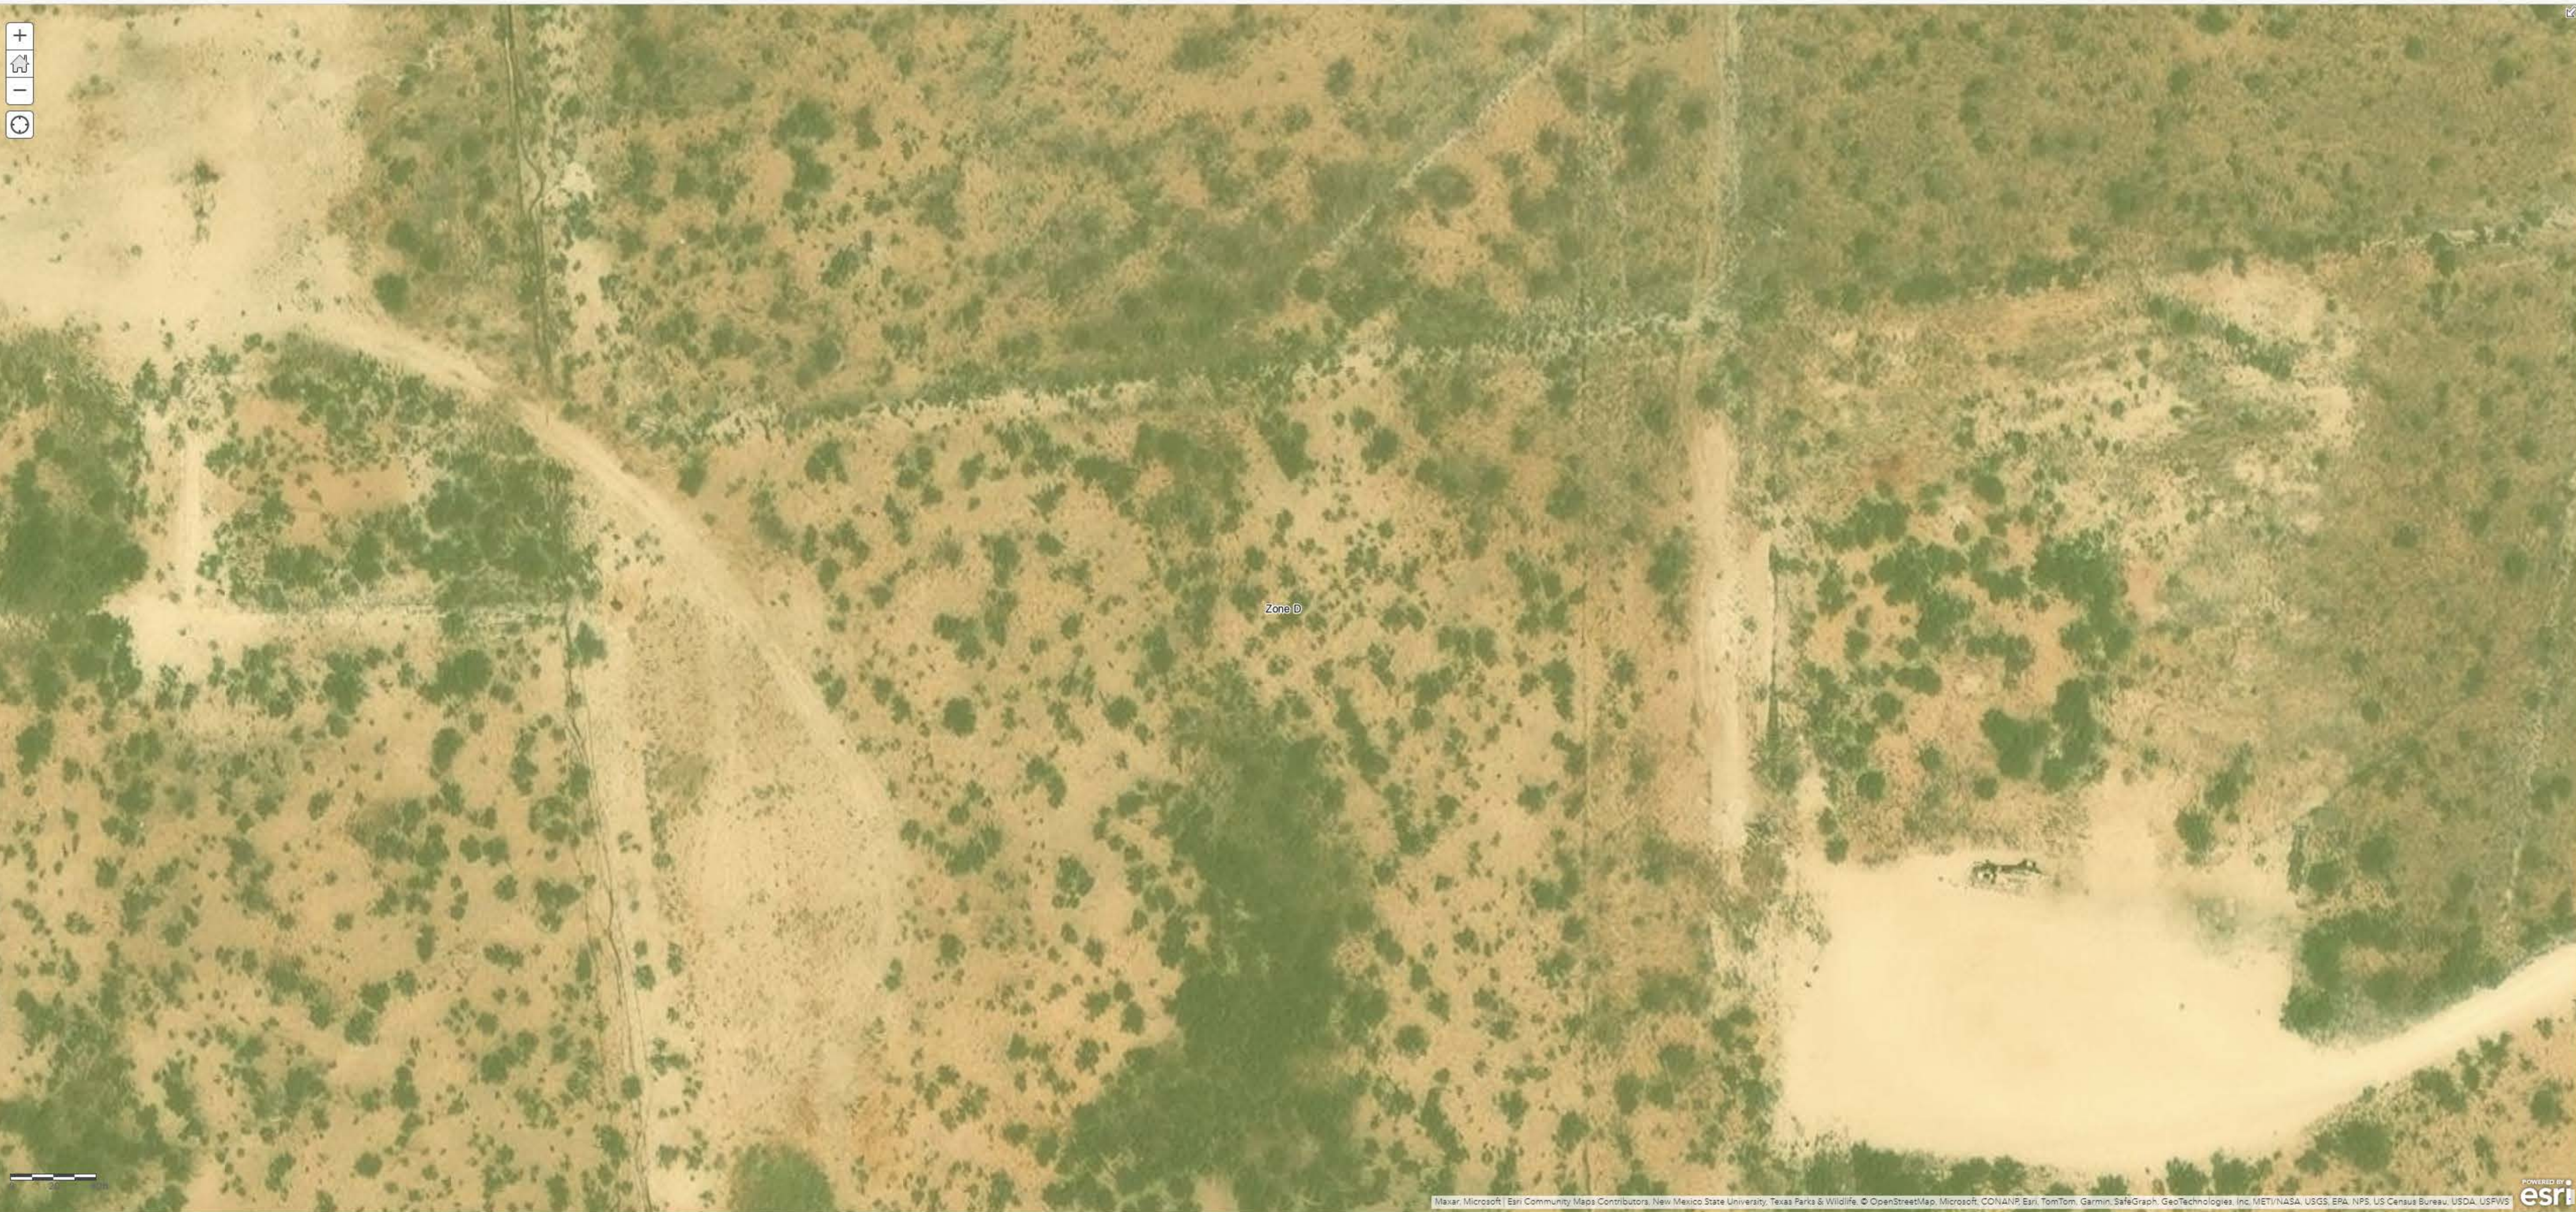
# Sample Map

- Sample Points
- Release Area

Apache Corporation proposes that the release area to be excavated to depths ranging from 2 to 4 feet. Final 5-point bottom and wall samples will be collected not to exceed 400 square feet. All samples collected will be submitted to a commercial laboratory for analysis of chloride, TPH, and BTEX. All excavated (2,176 yards) soil will be disposed of at an OCD approved disposal facility. Once Laboratory results are less than table one standards for releases greater than 100 feet to groundwater and the reclamation are achieved the excavation will be backfilled with clean imported topsoil to ground to ground surface and contoured to the surrounding area. The disturbed area will be reseeded in accordance with the revegetation and noxious weed plan. The remediation will be completed within 90 days of OCD and SLO approval of the plan.
