Chevron Brininstool Closure Report

Brininstool CTB

Incident ID: nAPP2319355921

February 28, 2024

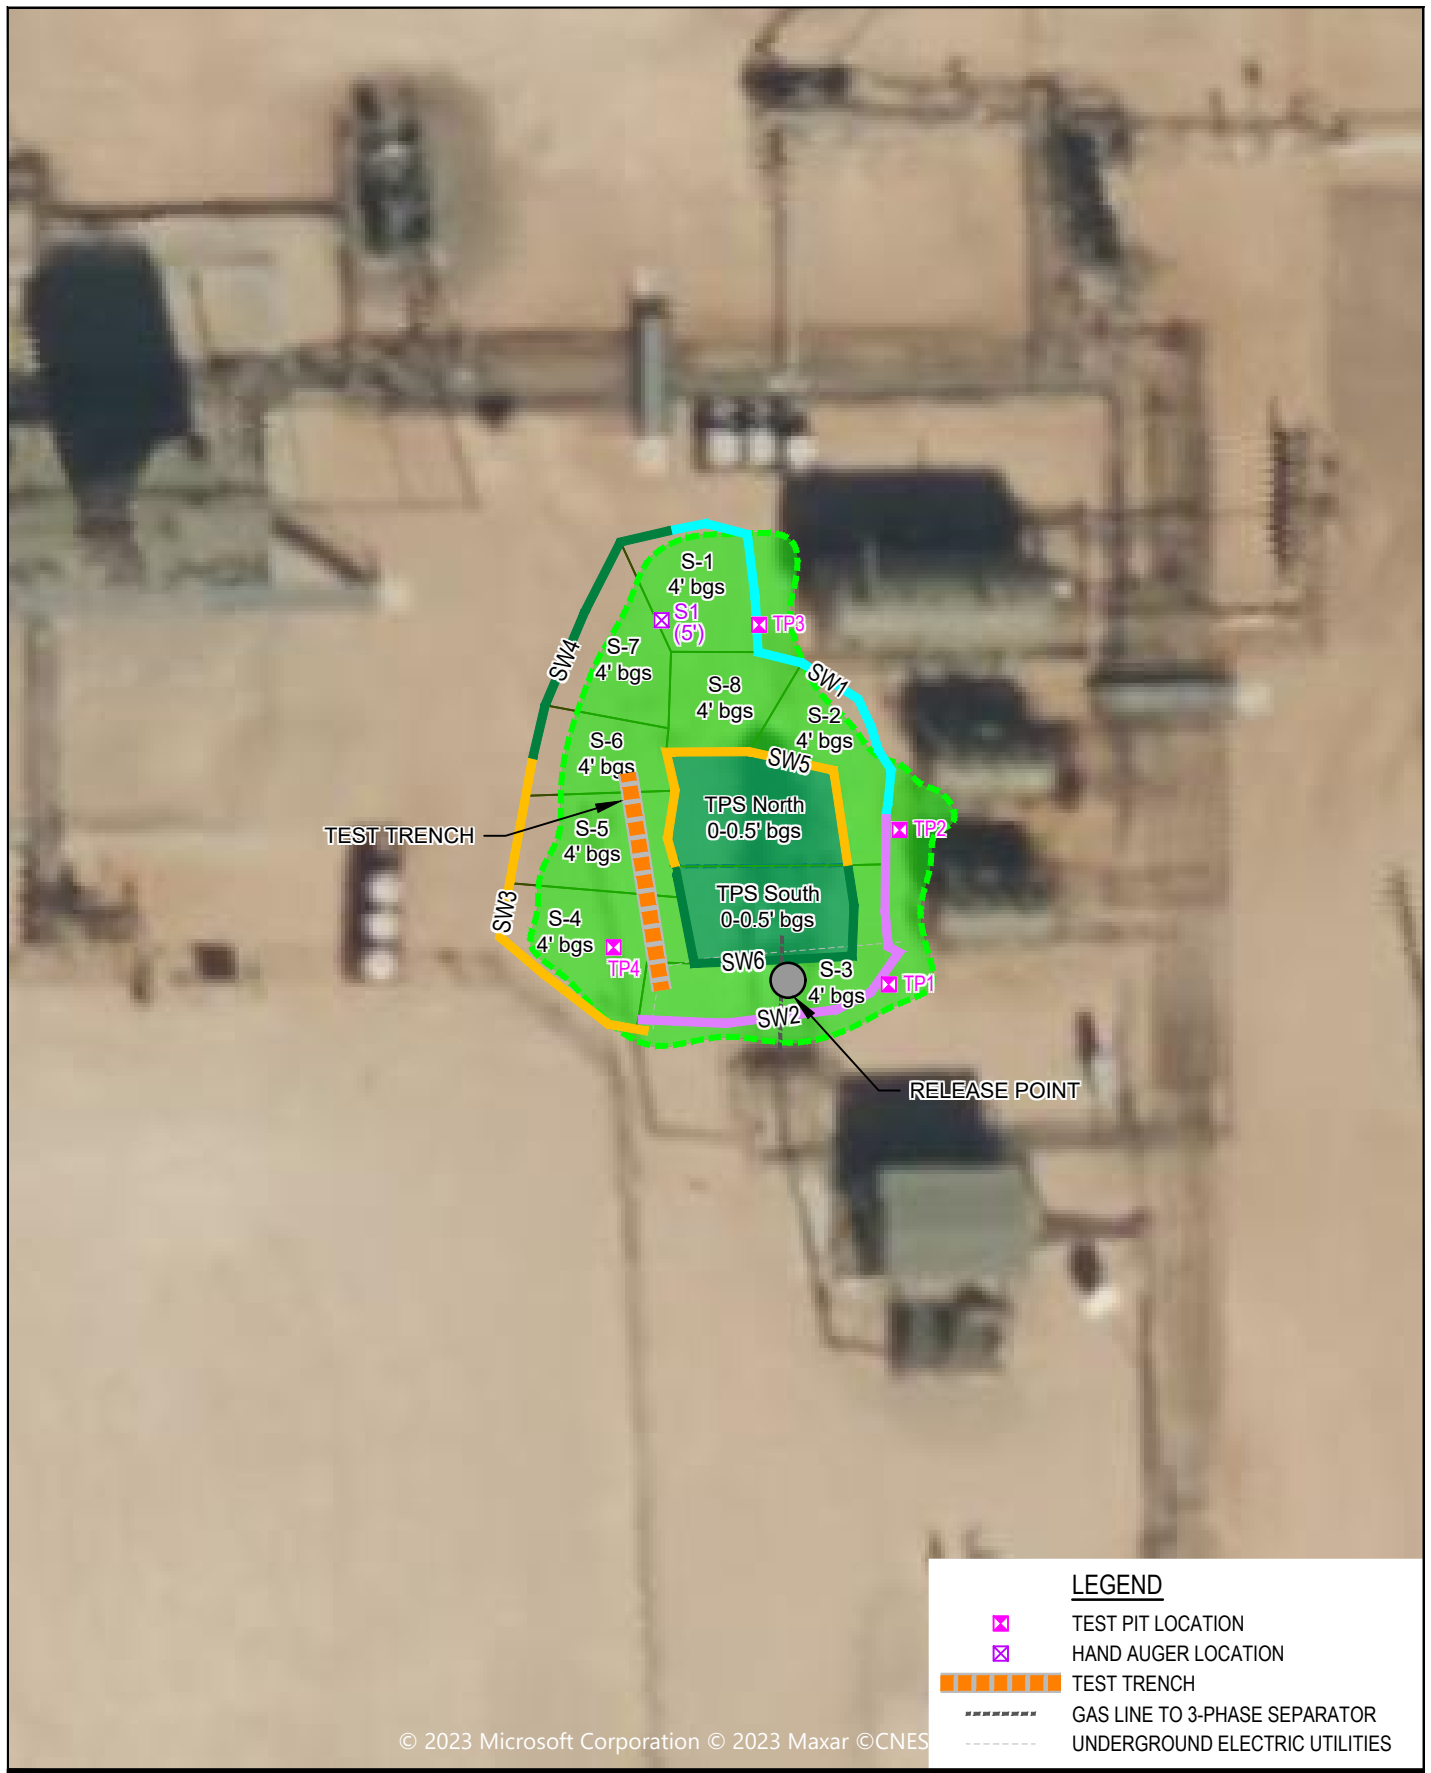
FIGURE 3

CONFIRMATION SAMPLE LOCATIONS MAP

From October 23, 2023 through November 1, 2023, a total of 10 bottom hole and 7 sidewall composite confirmation soil samples were collected as confirmation samples in accordance with NMAC 19.15.29. All composite confirmation soil samples represented areas no greater than 200 square feet. Sample locations with samples that exceeded Table I Closure Criteria were also further excavated and resampled. Results from the confirmation soil samples were determined to be below applicable Table 1 Closure Criteria except for sample SW-5. Sample SW-5 could not be safely excavated horizontally due to the presence of oil and gas production equipment (3-Phase Separator). To vertically delineate the area of SW-5, one hand-augured soil boring was advanced between sample locations S-1 and S-7, to a depth of 5 ft. bgs, (S1-HA5). A test trench was also advanced in the areas of S3, S4, S5, and S6 (S4-TT 6') to delineate the area. In addition to the vertical delineation sampling that was conducted around SW-5 and the production equipment, two surface soil samples (0-1 ft. bgs) were collected (TPS-N and TPS-S) to confirm concentrations that would be left in place due to infrastructure stability and safety issues. Due to the safety issues, the area was only hand scraped to remove surficial staining.

Soil samples were placed in laboratory-provided containers, which were immediately labelled, sealed, and stored/transported in a cooler containing ice to a laboratory certified by the National Environmental Laboratory Program (NELAP) for analysis. Samples were transported via Chain-of-Custody to Hall Laboratories in Albuquerque, New Mexico. All soil samples were analyzed for BTEX by EPA Method 8021B, TPH by EPA Method 8015B, and Chlorides by EPA Method 300. The complete laboratory report is provided in Appendix D and summarized in Table 1. Sample locations are presented in Figure 3.

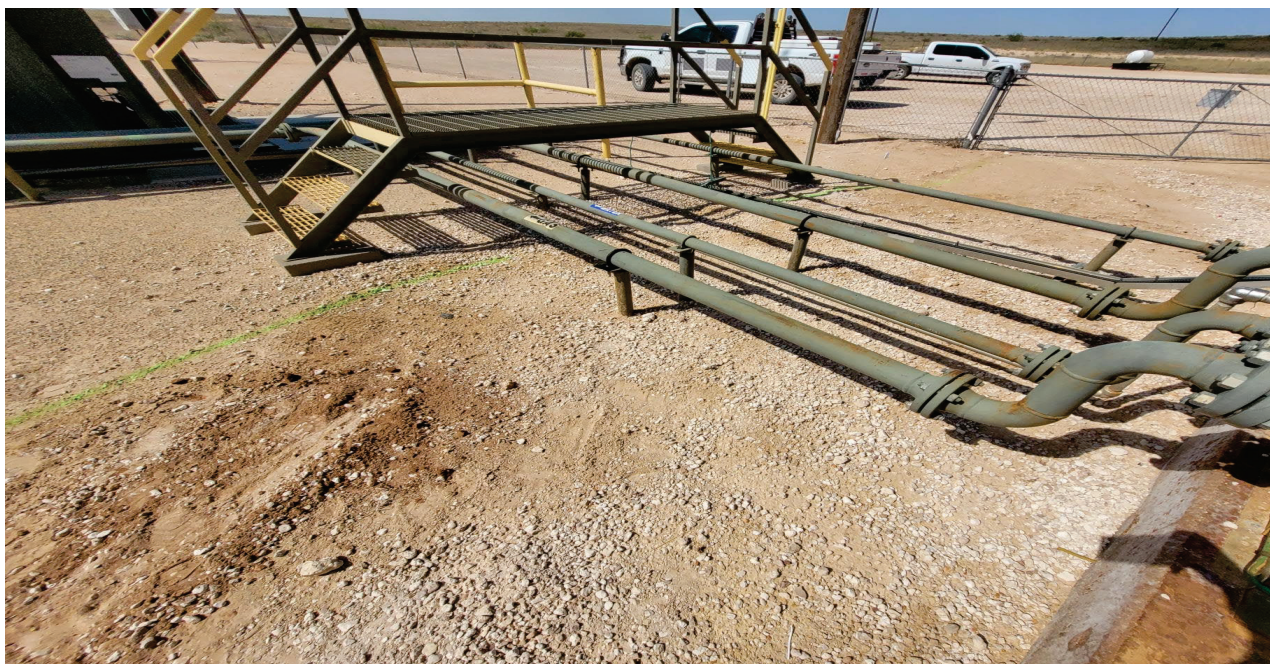
Photo 1 Southern Impact Area prior to Excavation on 08/07/2023

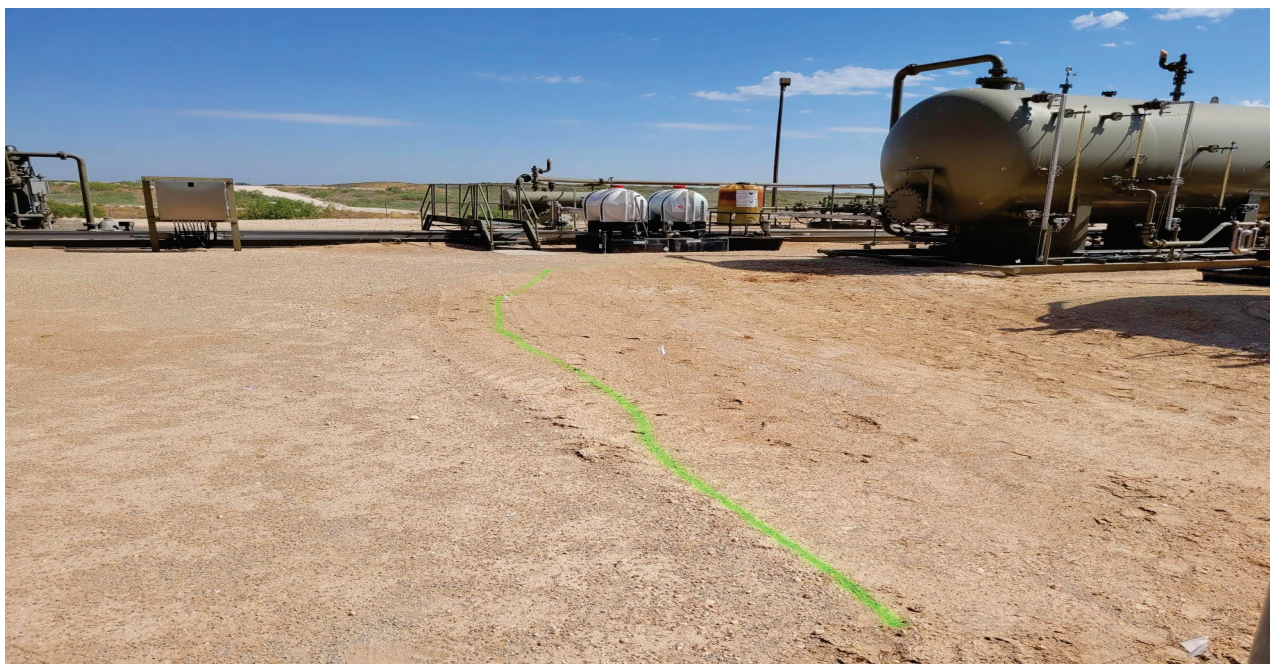
Photo 2 Western Impact Area prior to Excavation on 08/07/2023

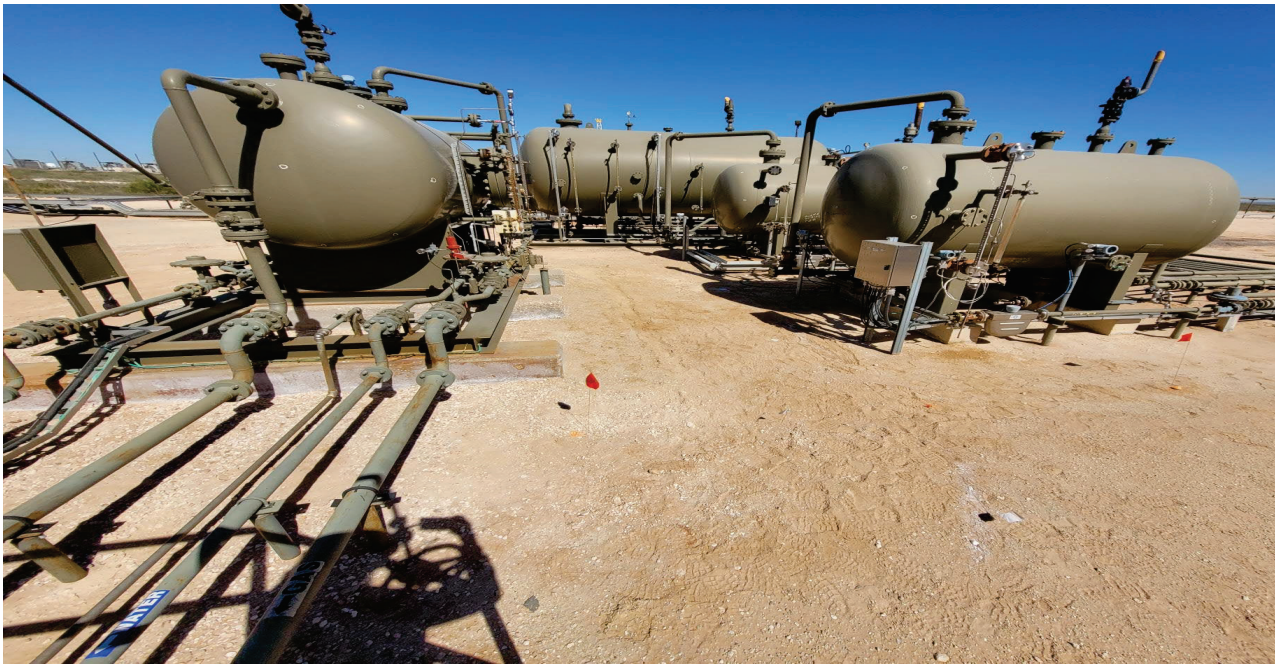
Photo 3 Eastern Excavation Area on 10/16/2023

GHD and Standard Safety (SS) conducted soil excavation activities between October 16, 2023, and November 22, 2023. Field titration for chloride was utilized to screen soil and guided the excavation activities. The impacted area was excavated to a total depth of four ft. bgs.

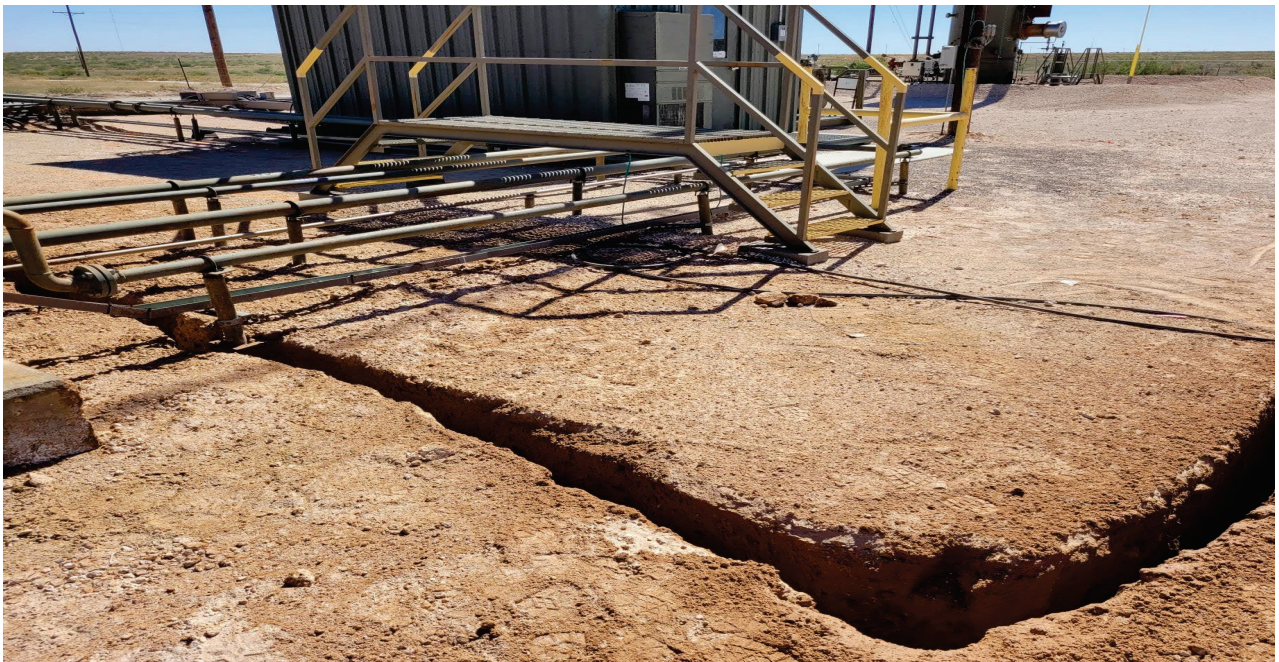
Photo 4 Hydrovacted Electrical Line on 10/17/2023

The excavation was backfilled with clean, virgin soil (sand and caliche) transported to the Site from a locally sourced pit. The excavated area around the underground electrical lines were backfilled with sand to prevent impediment to the lines. The remaining excavation was backfilled with clean caliche, compacted, and restored to grade.

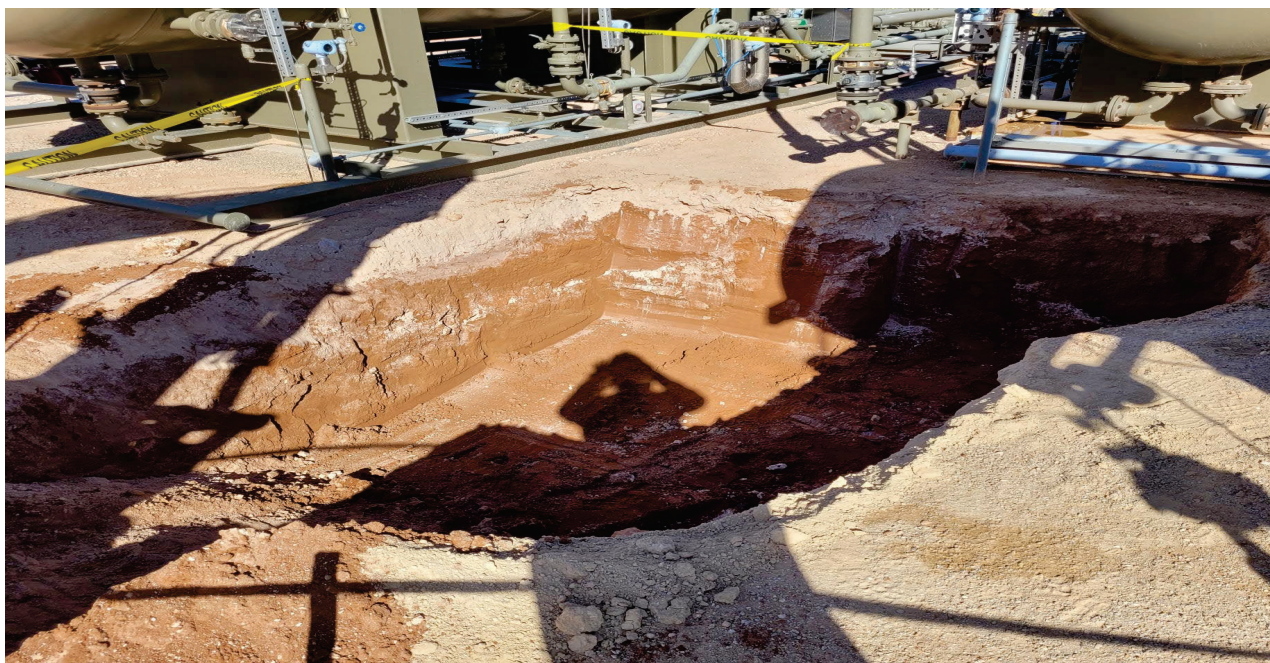
Photo 5 Northeast Excavation Area on 10/17/2023

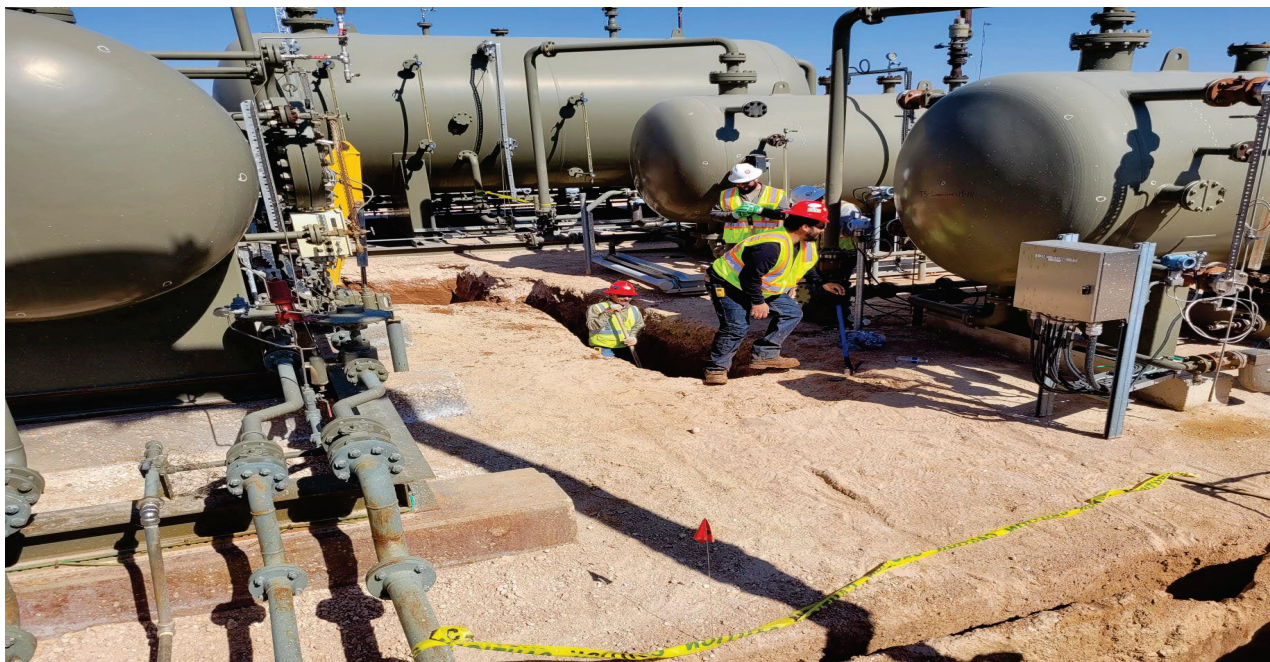
Photo 6 Digging Eastern Excavation Area on 10/18/2023

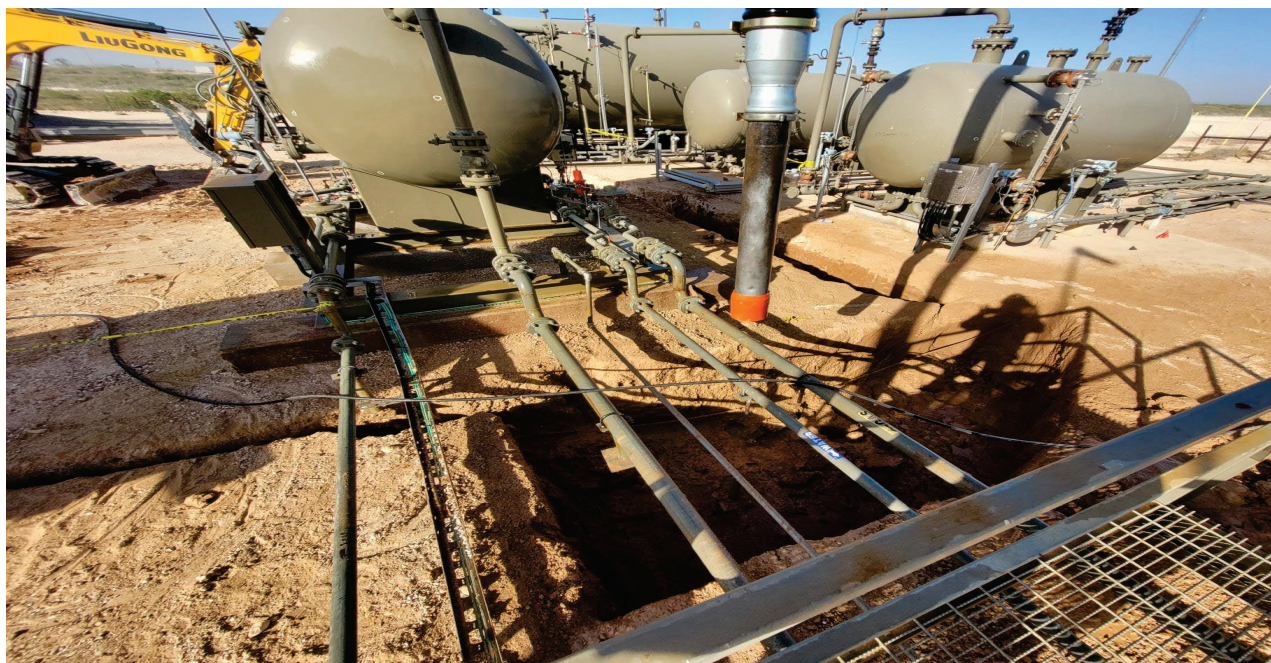
Photo 7 Hydrovaccing and Hand Digging Progress on 10/18/2023

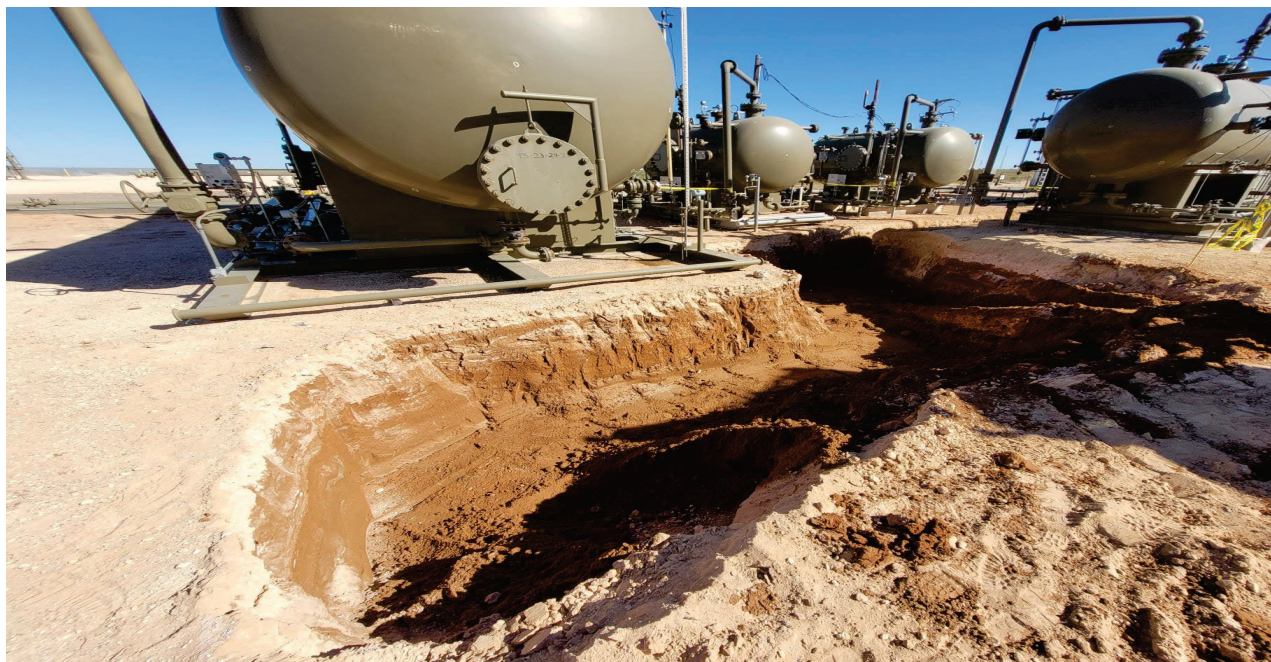
Photo 8 Northern Excavation Area on 10/19/2023

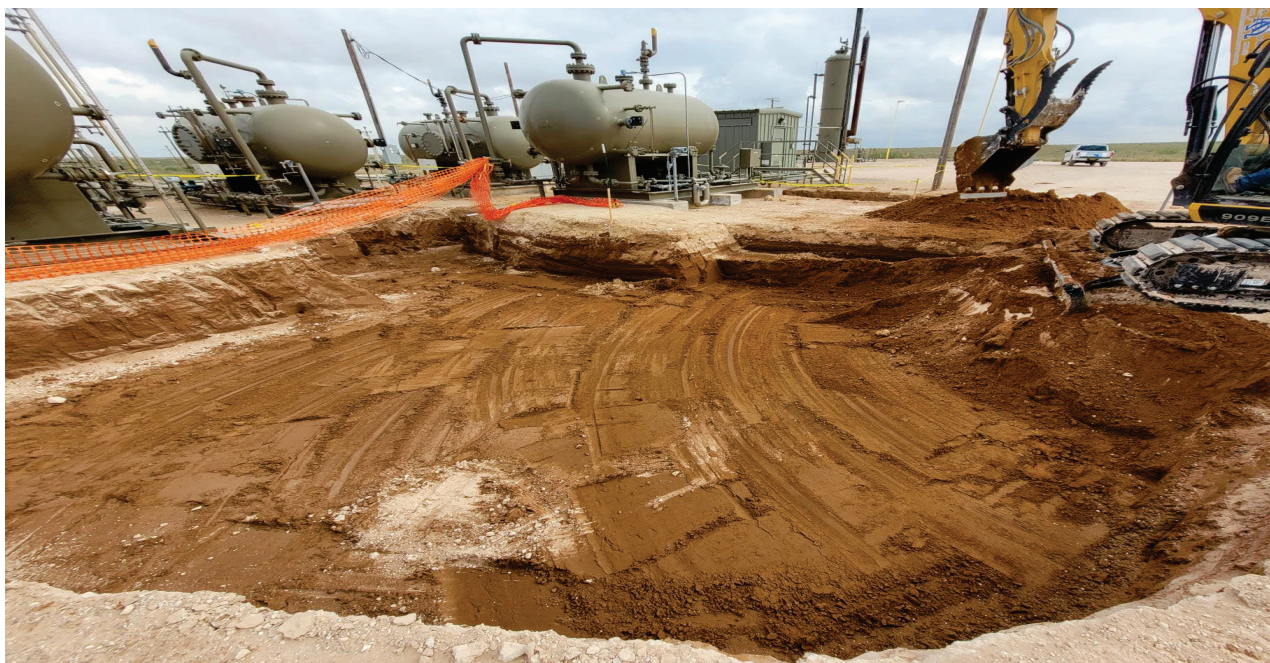
Photo 9 Northwestern Excavation Area on 10/23/2023

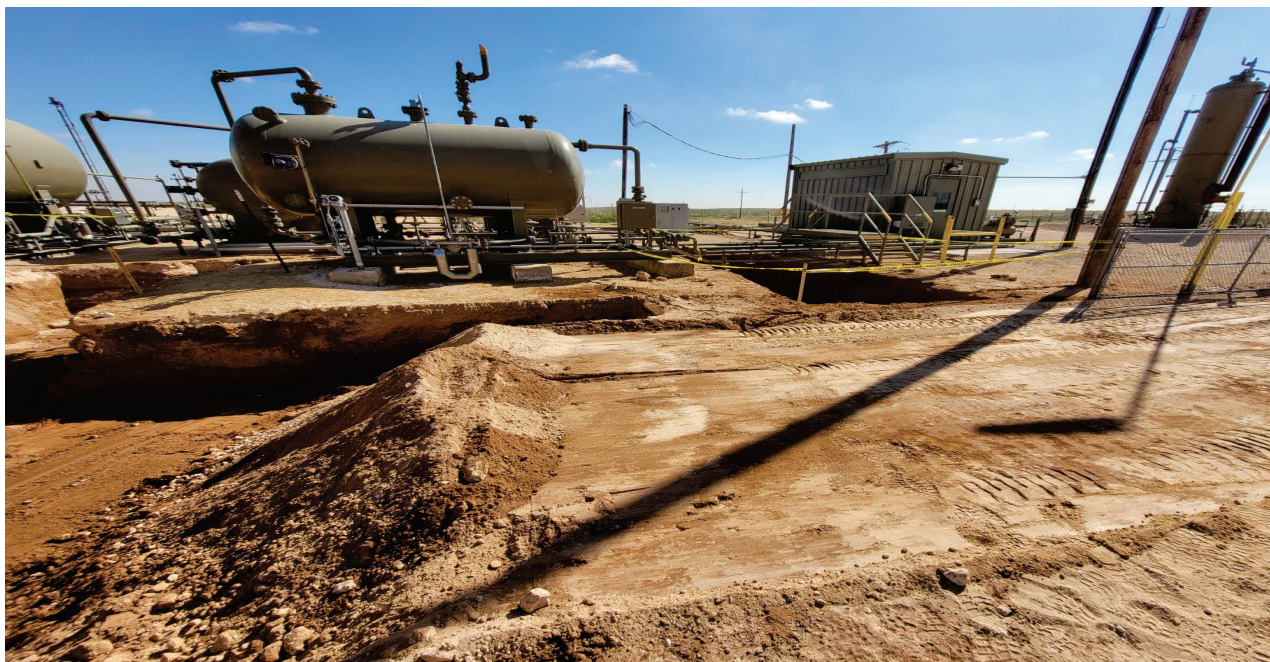
Photo 10 Southwestern Excavation Area on 10/24/2023

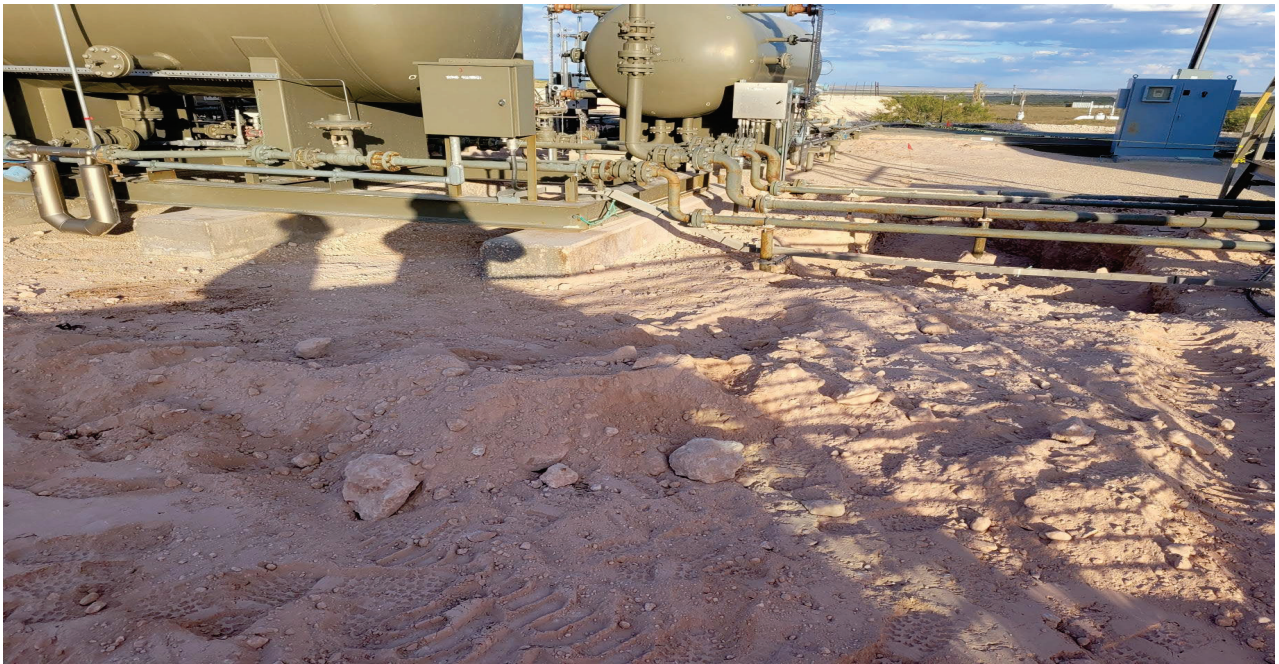
Photo 11 **Southwestern Backfill Progress on 11/20/2023**

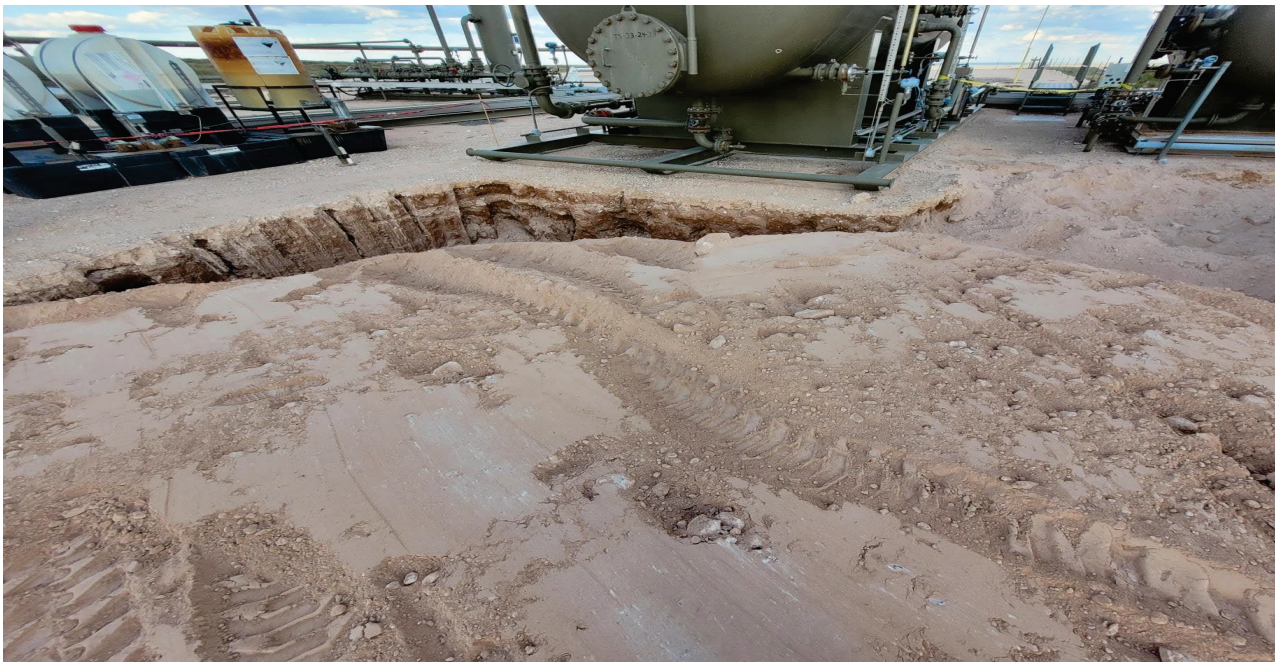
Photo 12 **Northern Backfill Progress on 11/20/2023**

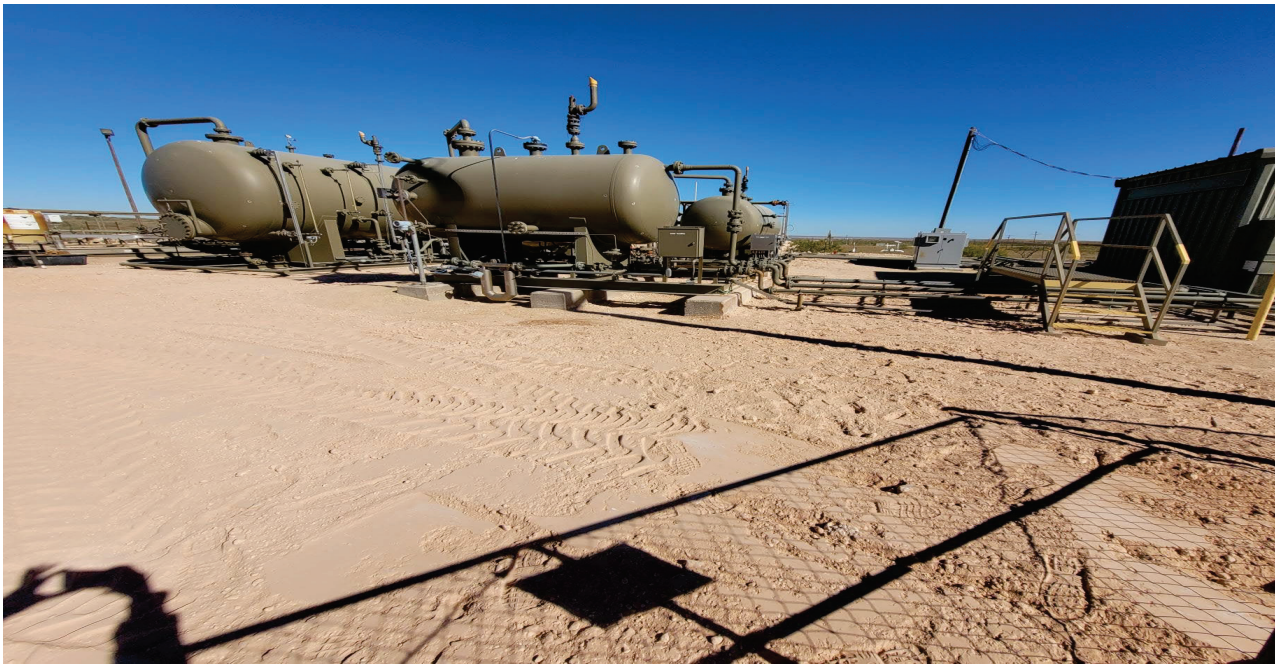
Photo 13 Southwest Backfill Completion on 11/22/2023

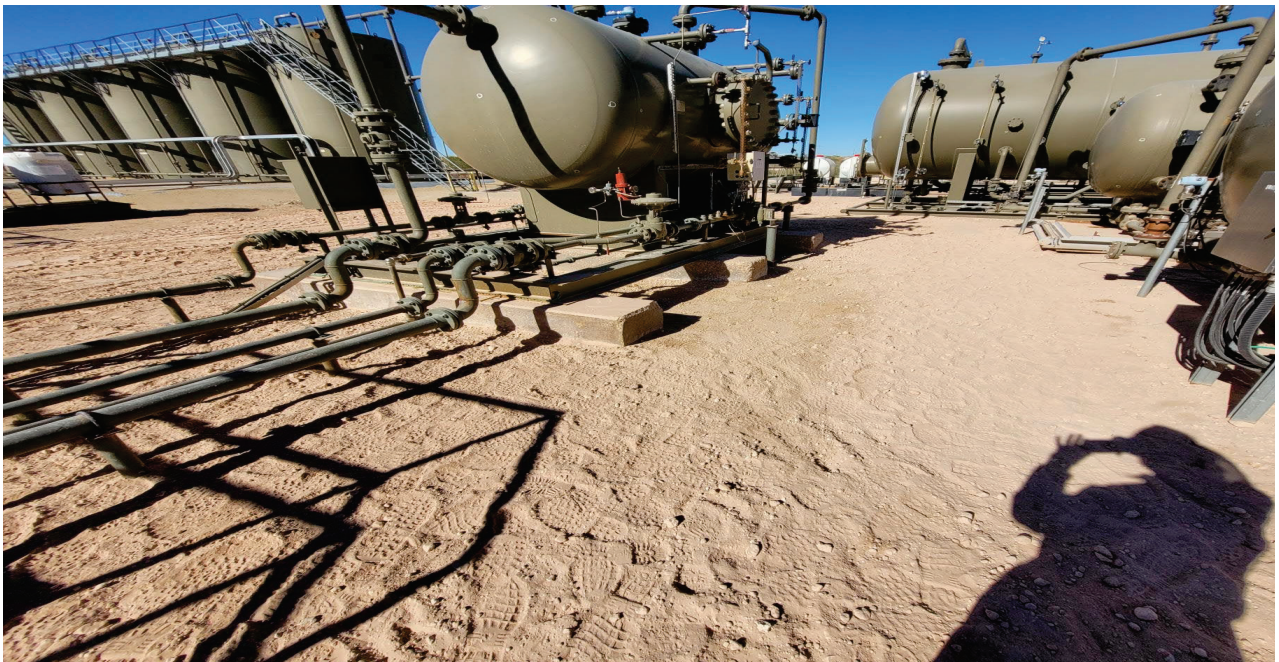
Photo 14 Southeast Backfill Completion on 11/22/2023

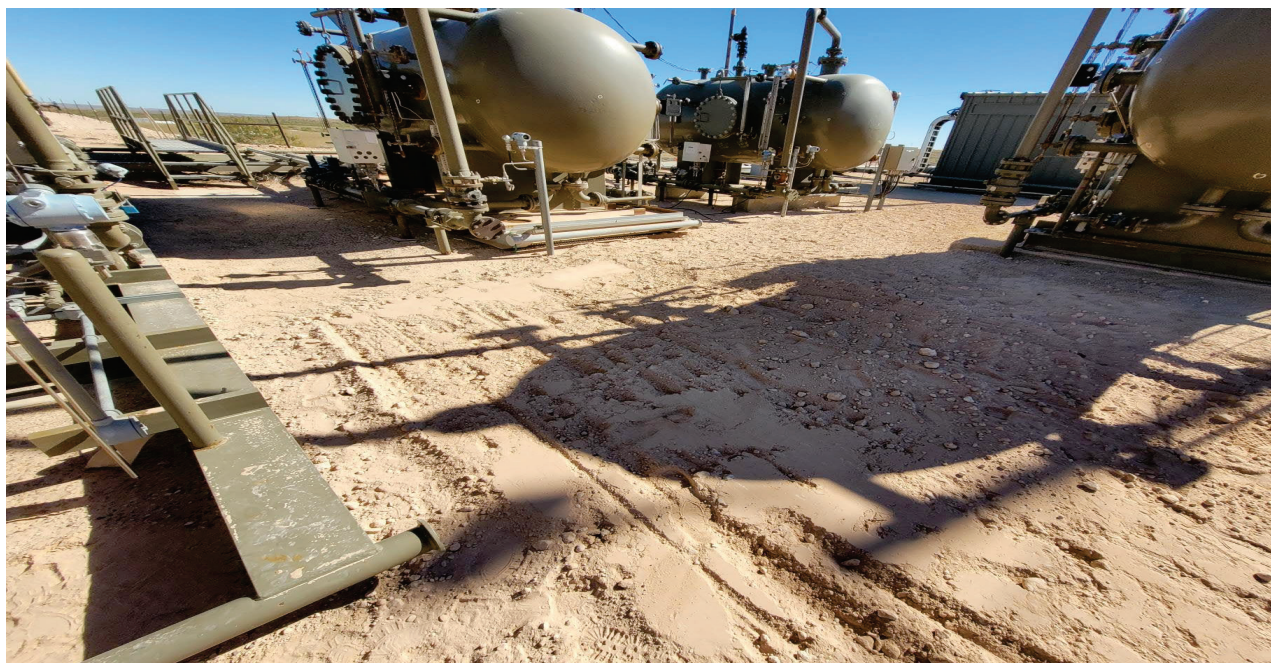
Photo 15 North Backfill Completion on 11/22/2023
