**Re: Revised Closure Report  
ConocoPhillips Company (Heritage COG Operating LLC)  
GJ West Coop Unit South Tank Battery Release  
Unit Letter B, Section 28, Township 17 South, Range 29 East  
Eddy County, New Mexico  
2RP-4923  
Incident ID nMAP1822950996**

Revised Closure Report  
May 24, 2024

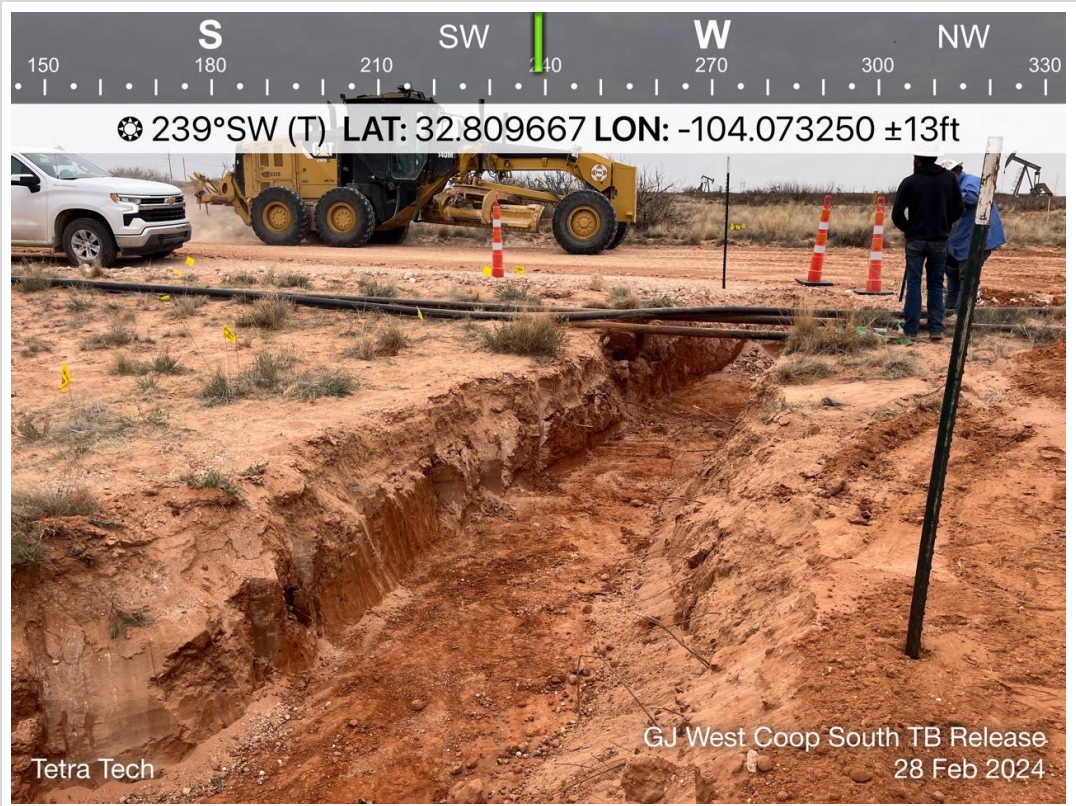
TETRA TECH, INC. PROJECT NO. 212C-MD-02848	DESCRIPTION	View west-southwest of open excavation and surface steel lines.	1
	SITE NAME	GJ WEST COOP SOUTH TB Release	2/28/2024

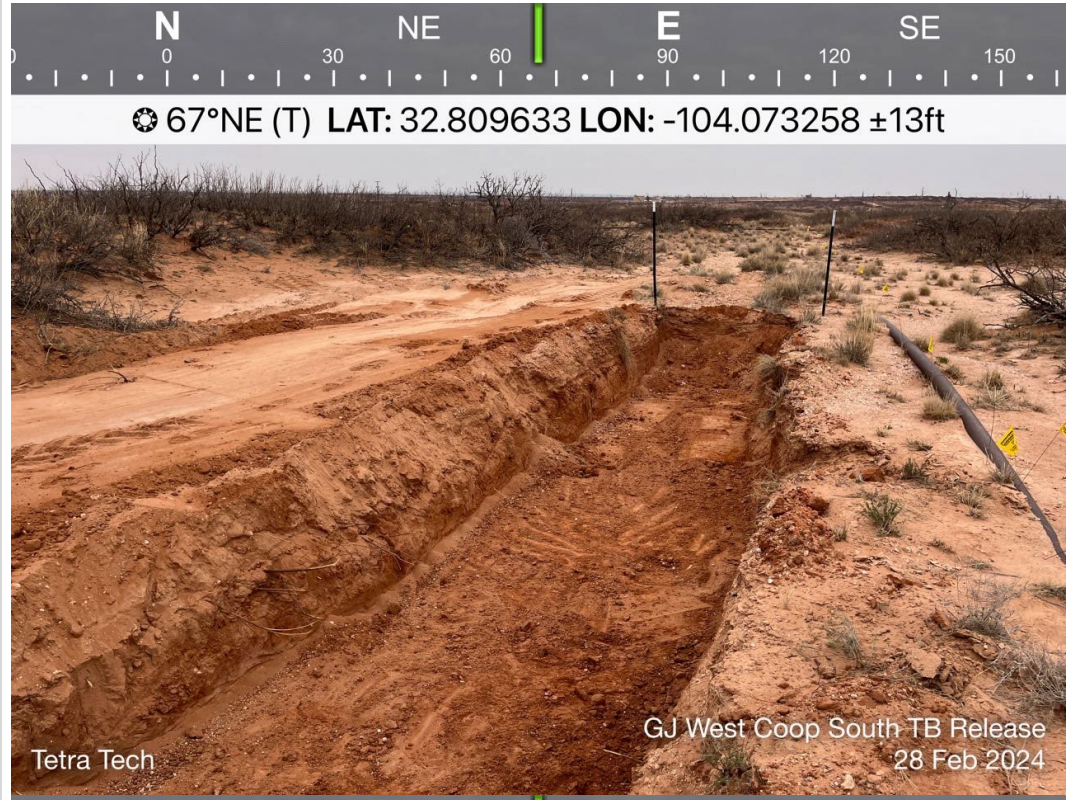
TETRA TECH, INC. PROJECT NO. 212C-MD-02848	DESCRIPTION	View east-northeast of open excavation and Plains pipeline.	2
	SITE NAME	GJ WEST COOP SOUTH TB Release	2/28/2024

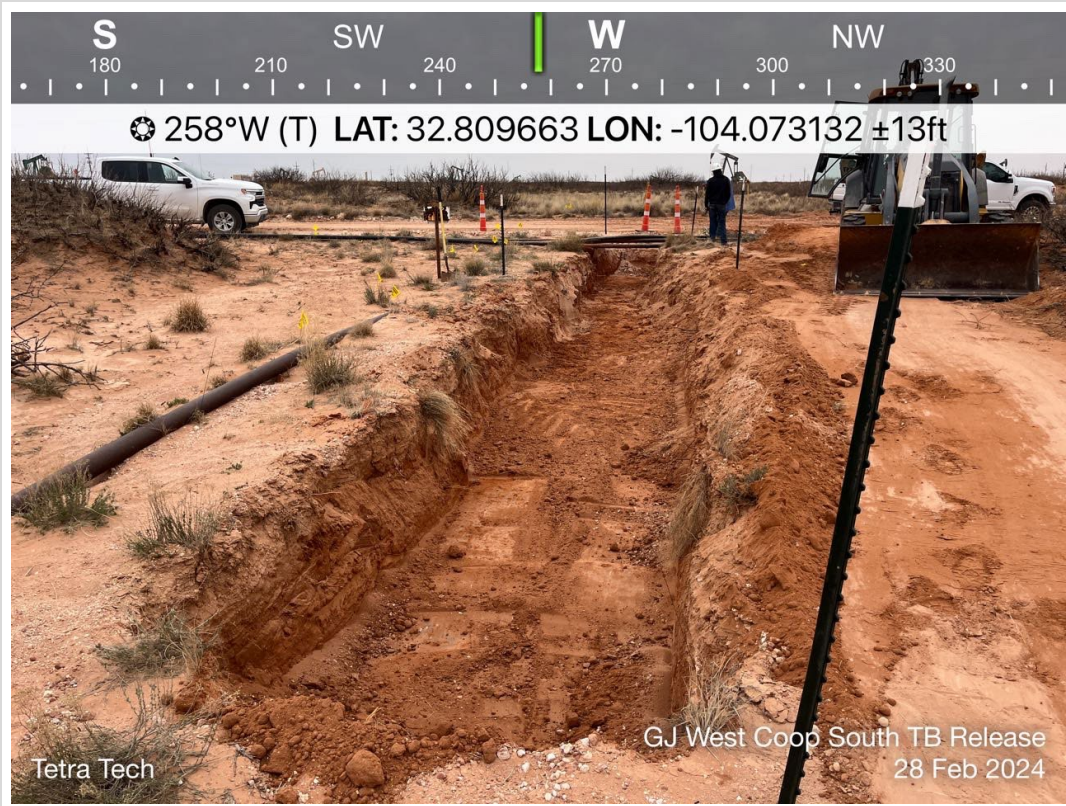
TETRA TECH, INC. PROJECT NO. 212C-MD-02848	DESCRIPTION	View west-southwest of open excavation. Plains pipeline and surface steel lines.	3
	SITE NAME	GJ WEST COOP SOUTH TB Release	2/28/2024

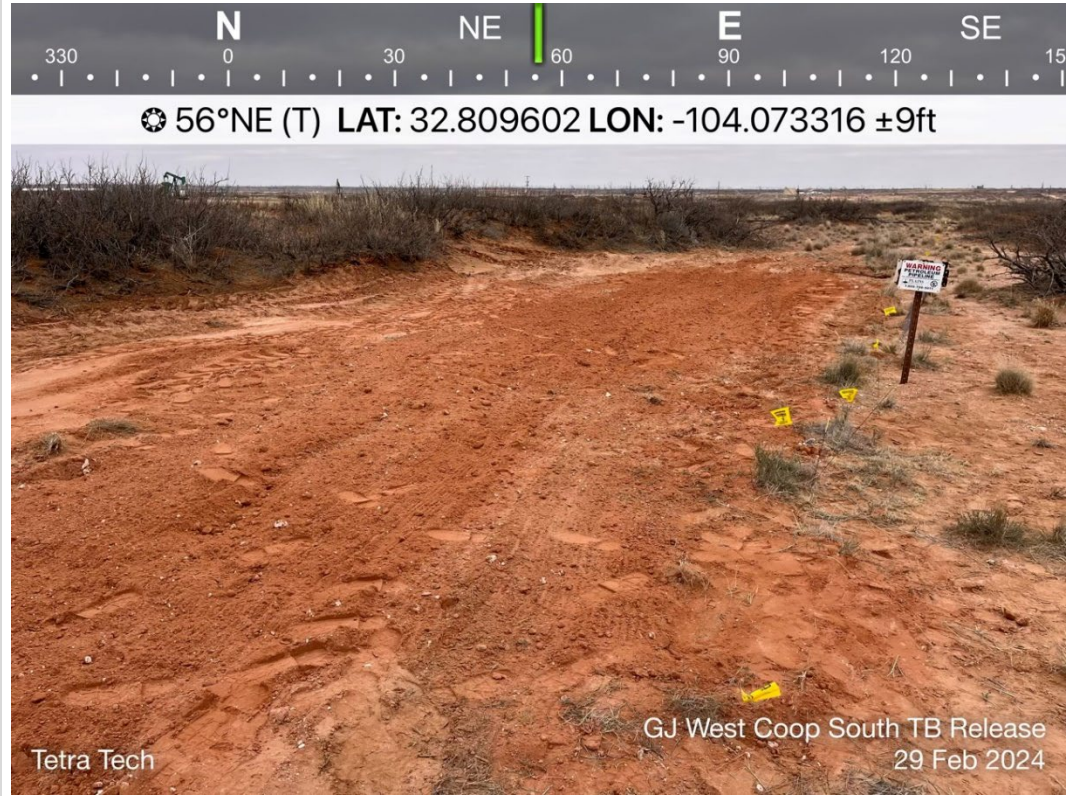
TETRA TECH, INC. PROJECT NO. 212C-MD-02848	DESCRIPTION	View east-northeast of backfilled and seeded excavation.	4
	SITE NAME	GJ WEST COOP SOUTH TB Release	2/29/2024

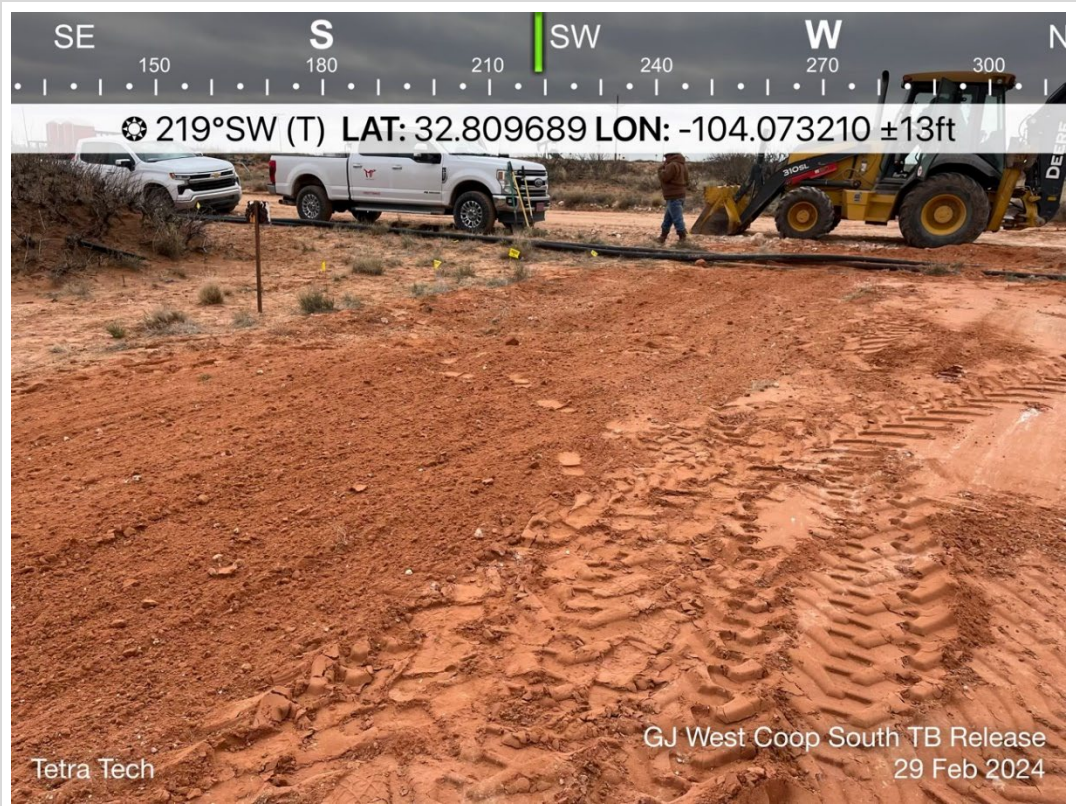
TETRA TECH, INC. PROJECT NO. 212C-MD-02848	DESCRIPTION	View southwest of backfilled and seeded excavation.	5
	SITE NAME	GJ WEST COOP SOUTH TB Release	2/29/2024

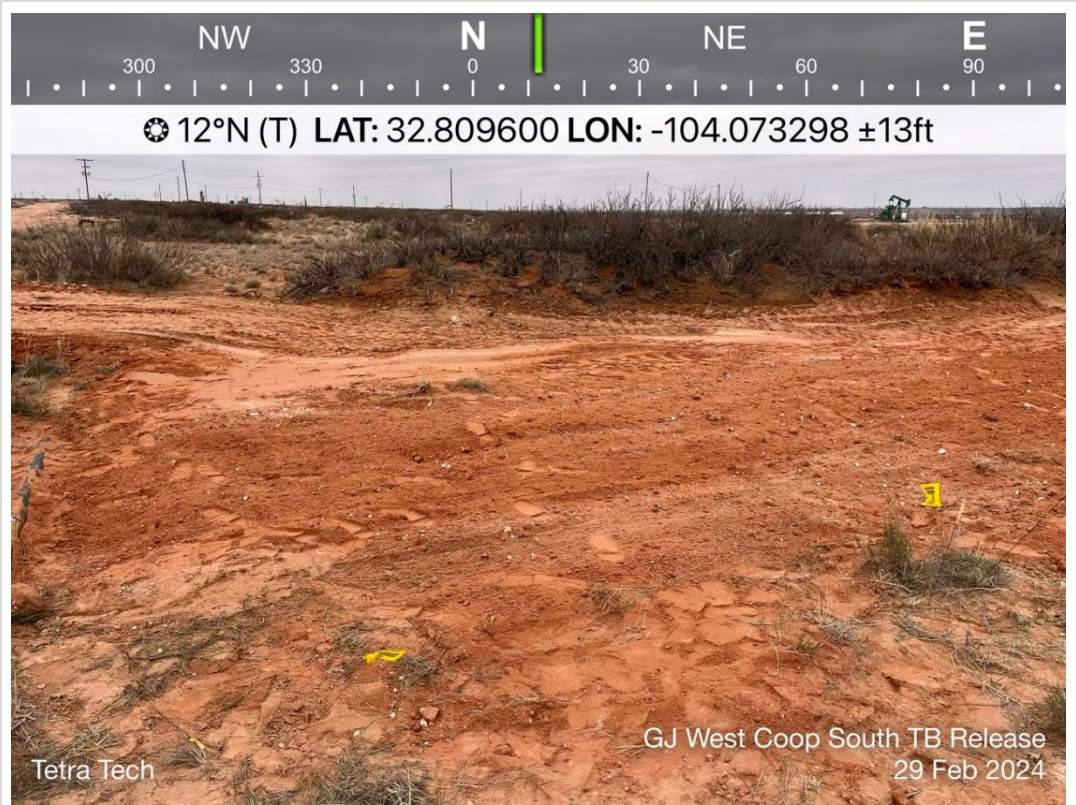
TETRA TECH, INC. PROJECT NO. 212C-MD-02848	DESCRIPTION	View north-northeast of backfilled and seeded excavation.	6
	SITE NAME	GJ WEST COOP SOUTH TB Release	2/29/2024
